SFUND RECORDS CTR
2385815

DATE: 11·14·85 NAME: Schmit #1
DESCRIPTION: GenDyn-Bldg 1
Ground floor substation w/ 3 retrofilled Westinghouse transformers, #3011134 → #3011136.

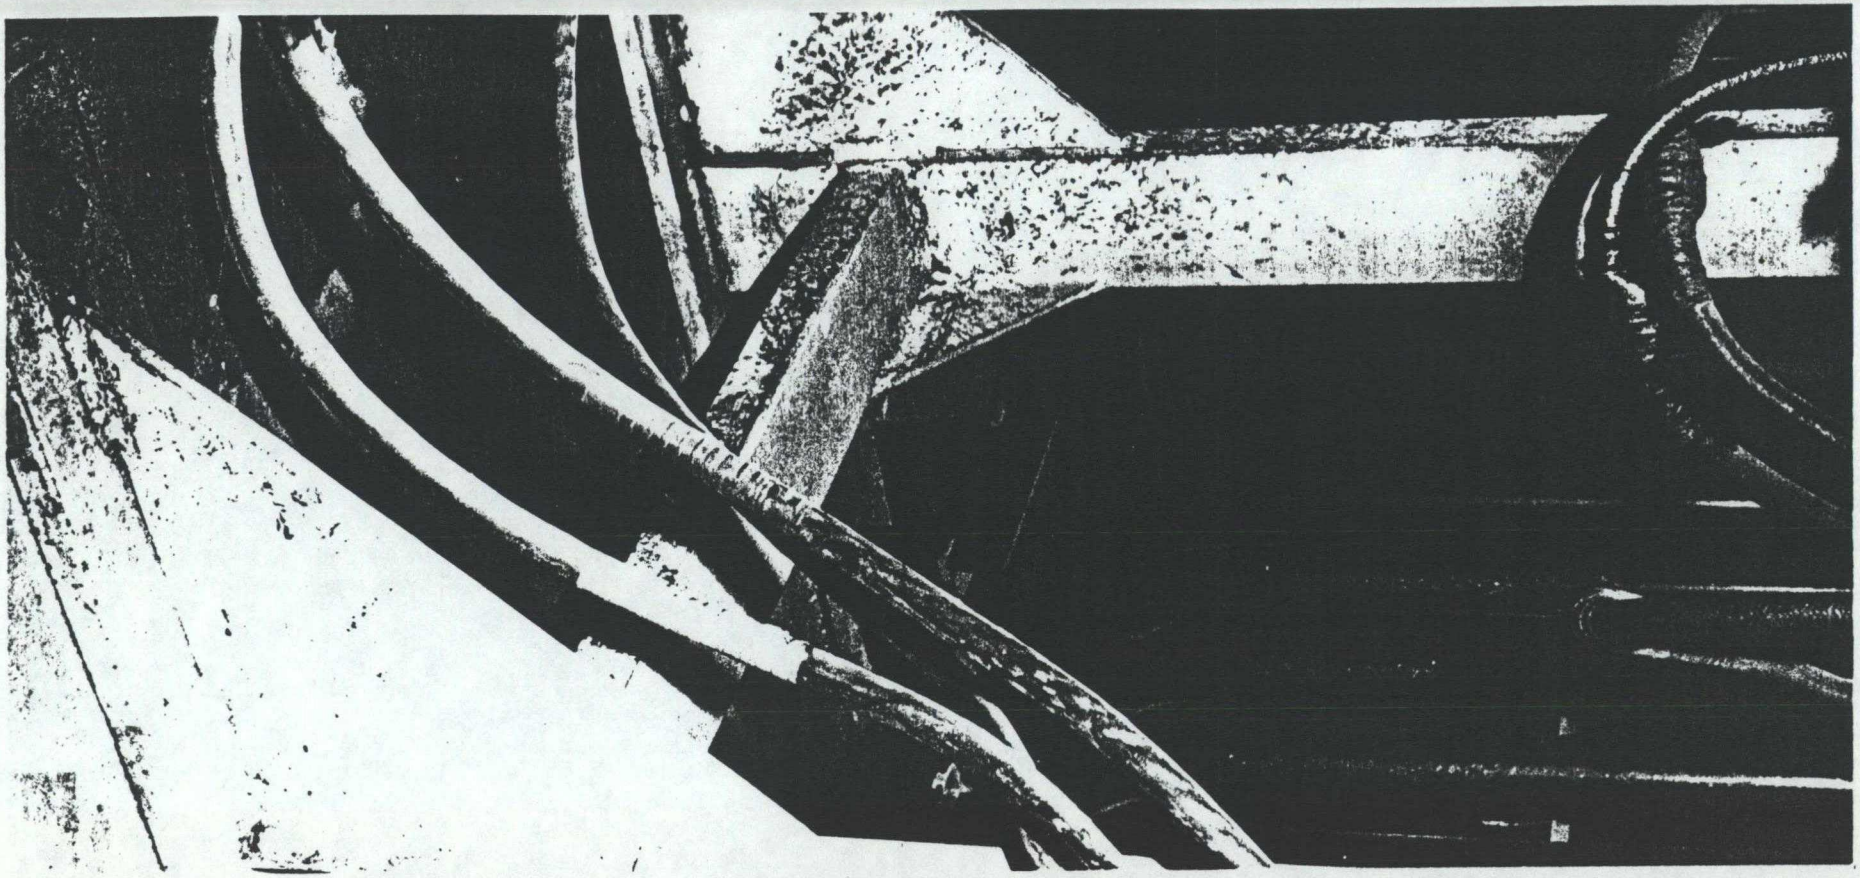
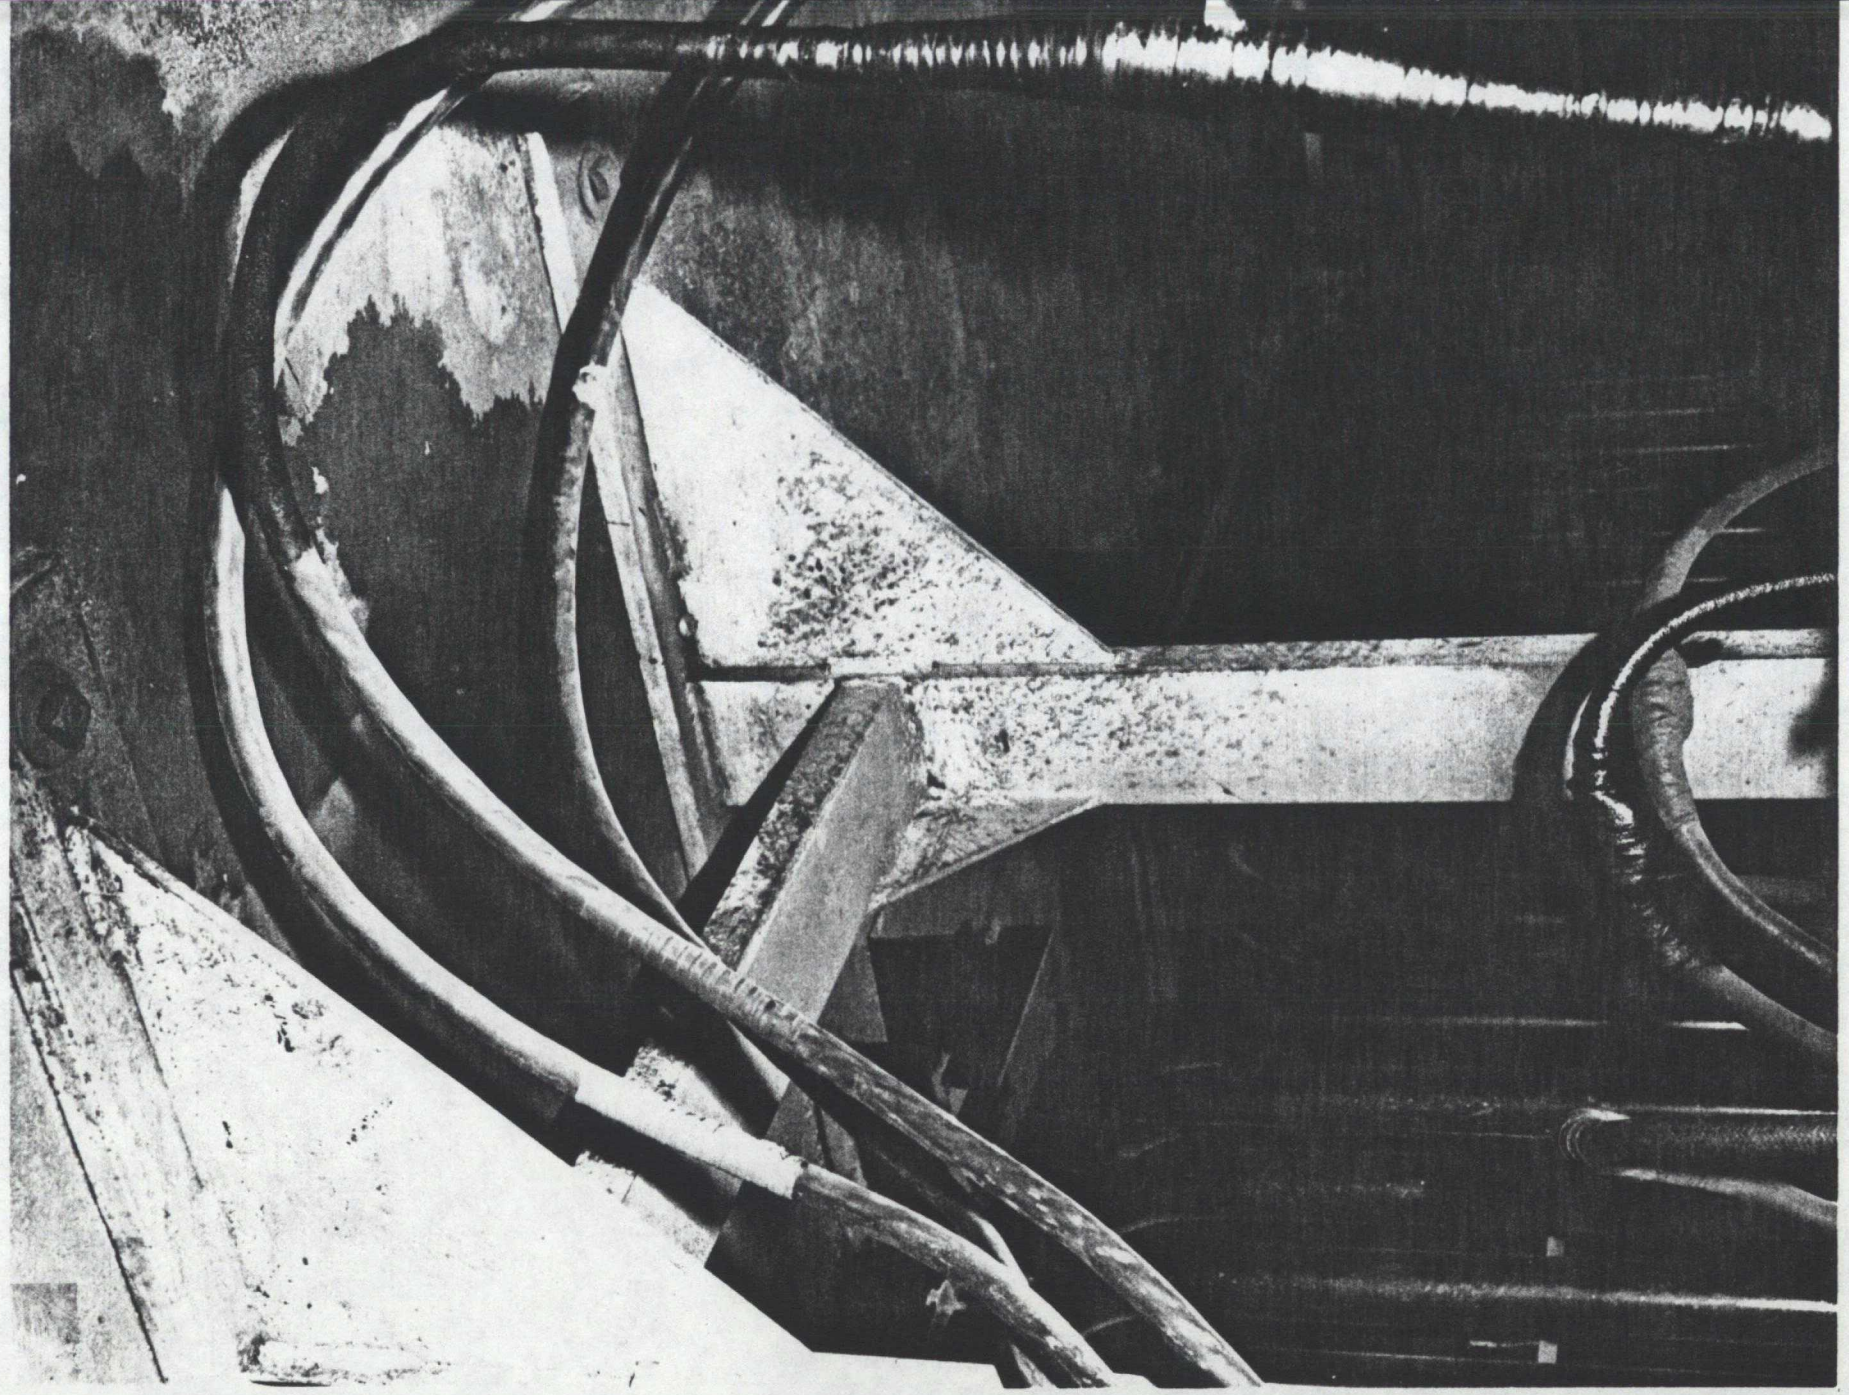
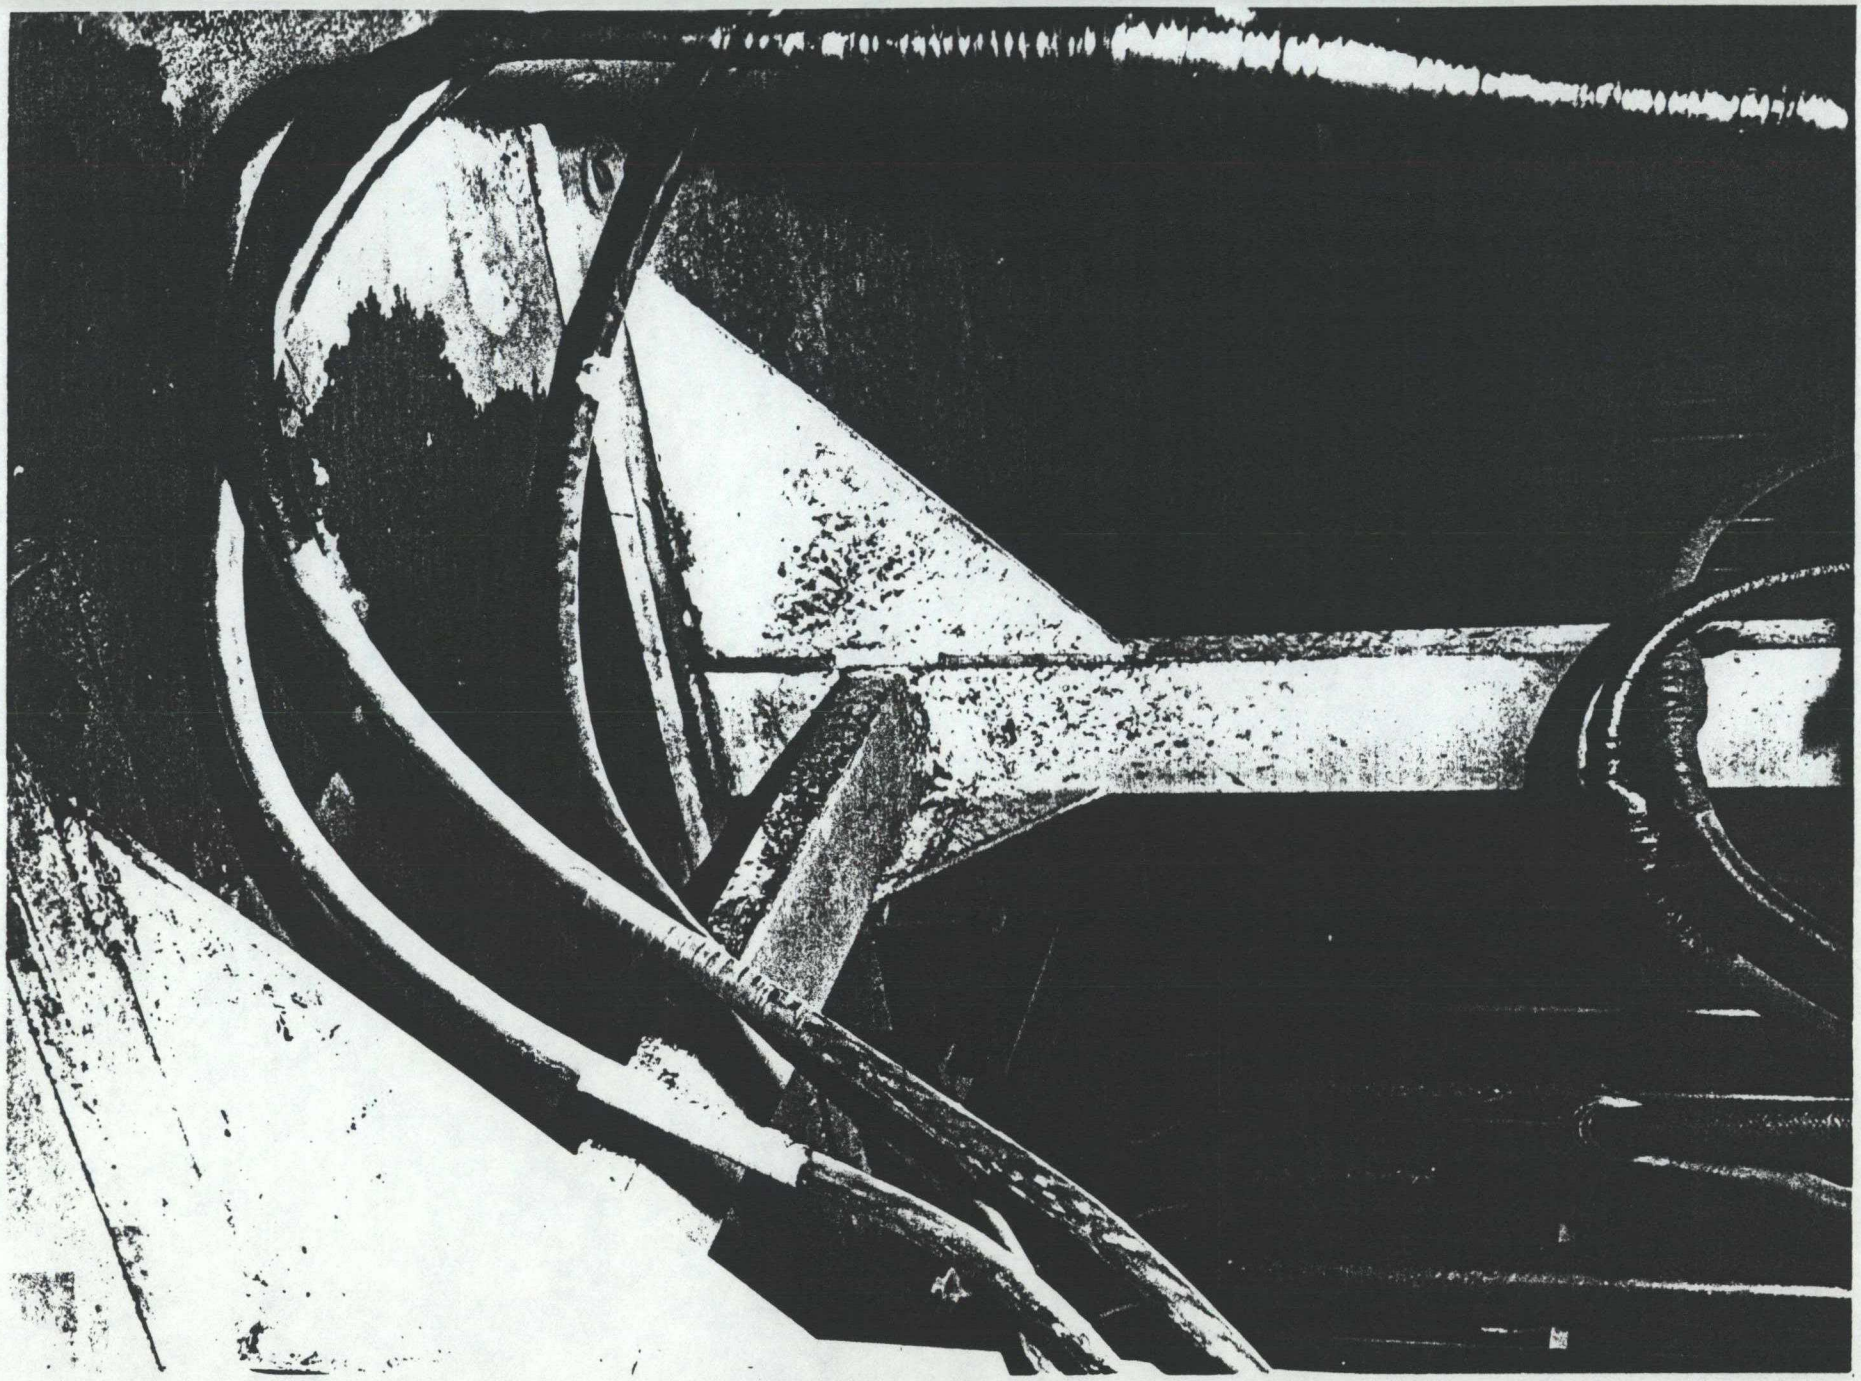
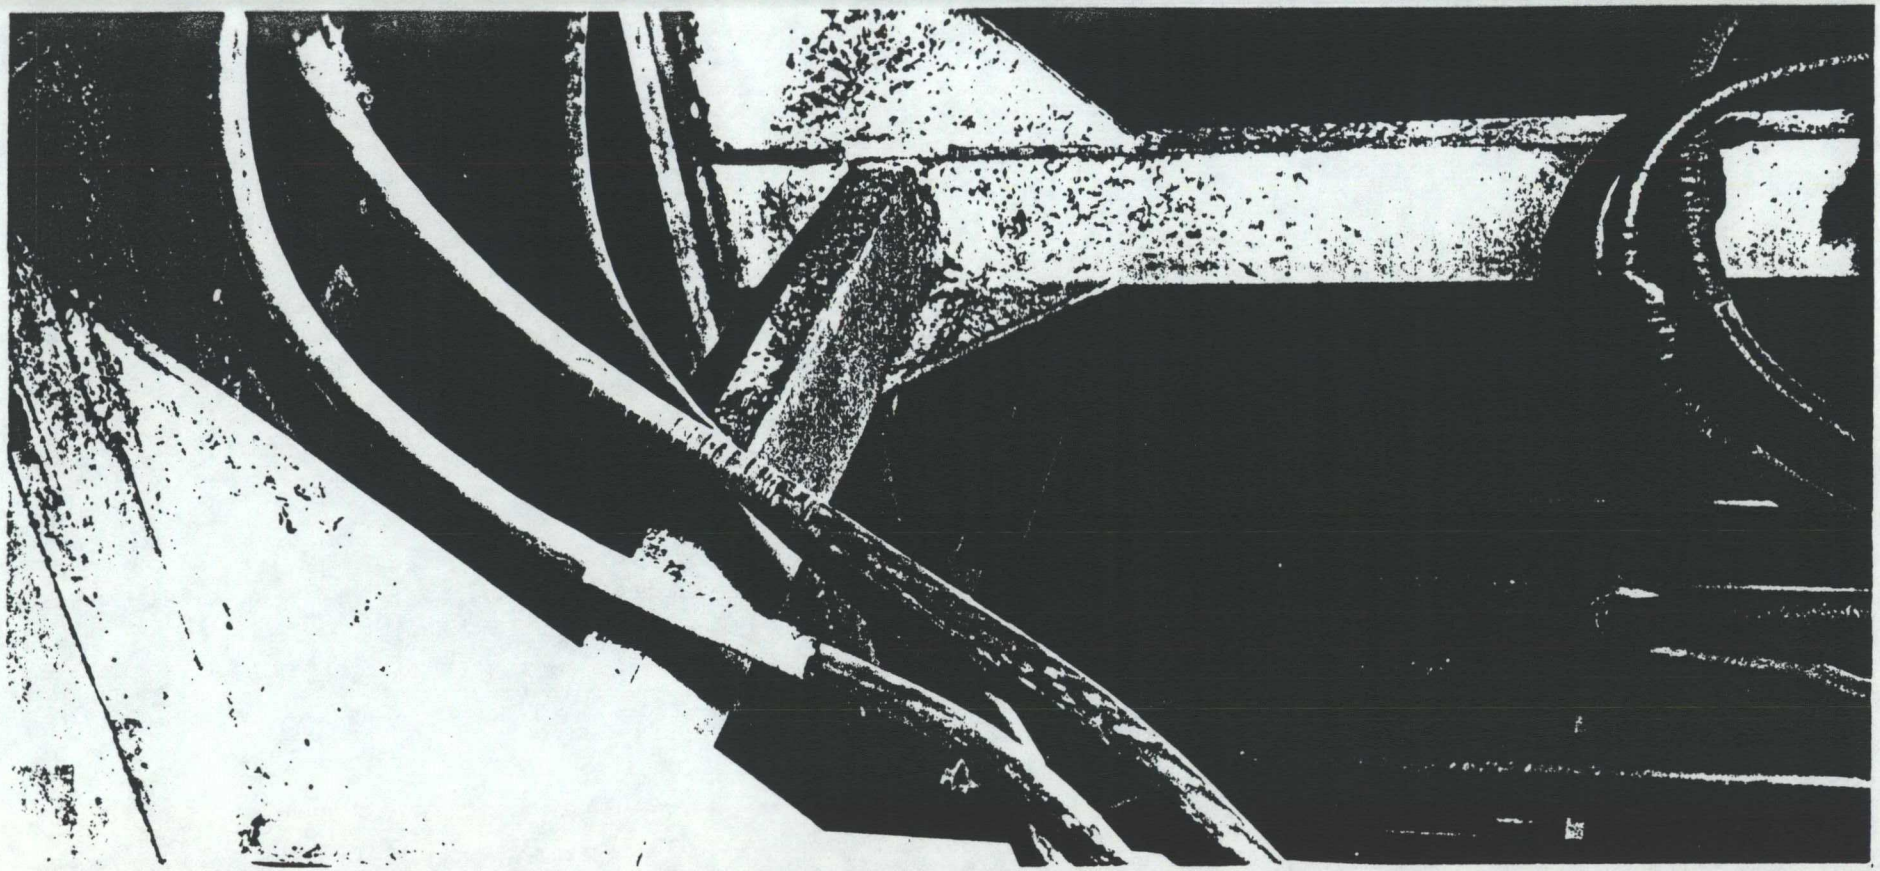
DATE: 11·14·85 NAME: Schmit #10

Wiring beneath switches located next to transformers shown in #1-#9. Note that fluid is migrating down insulated wire and dripping extensively onto floor.

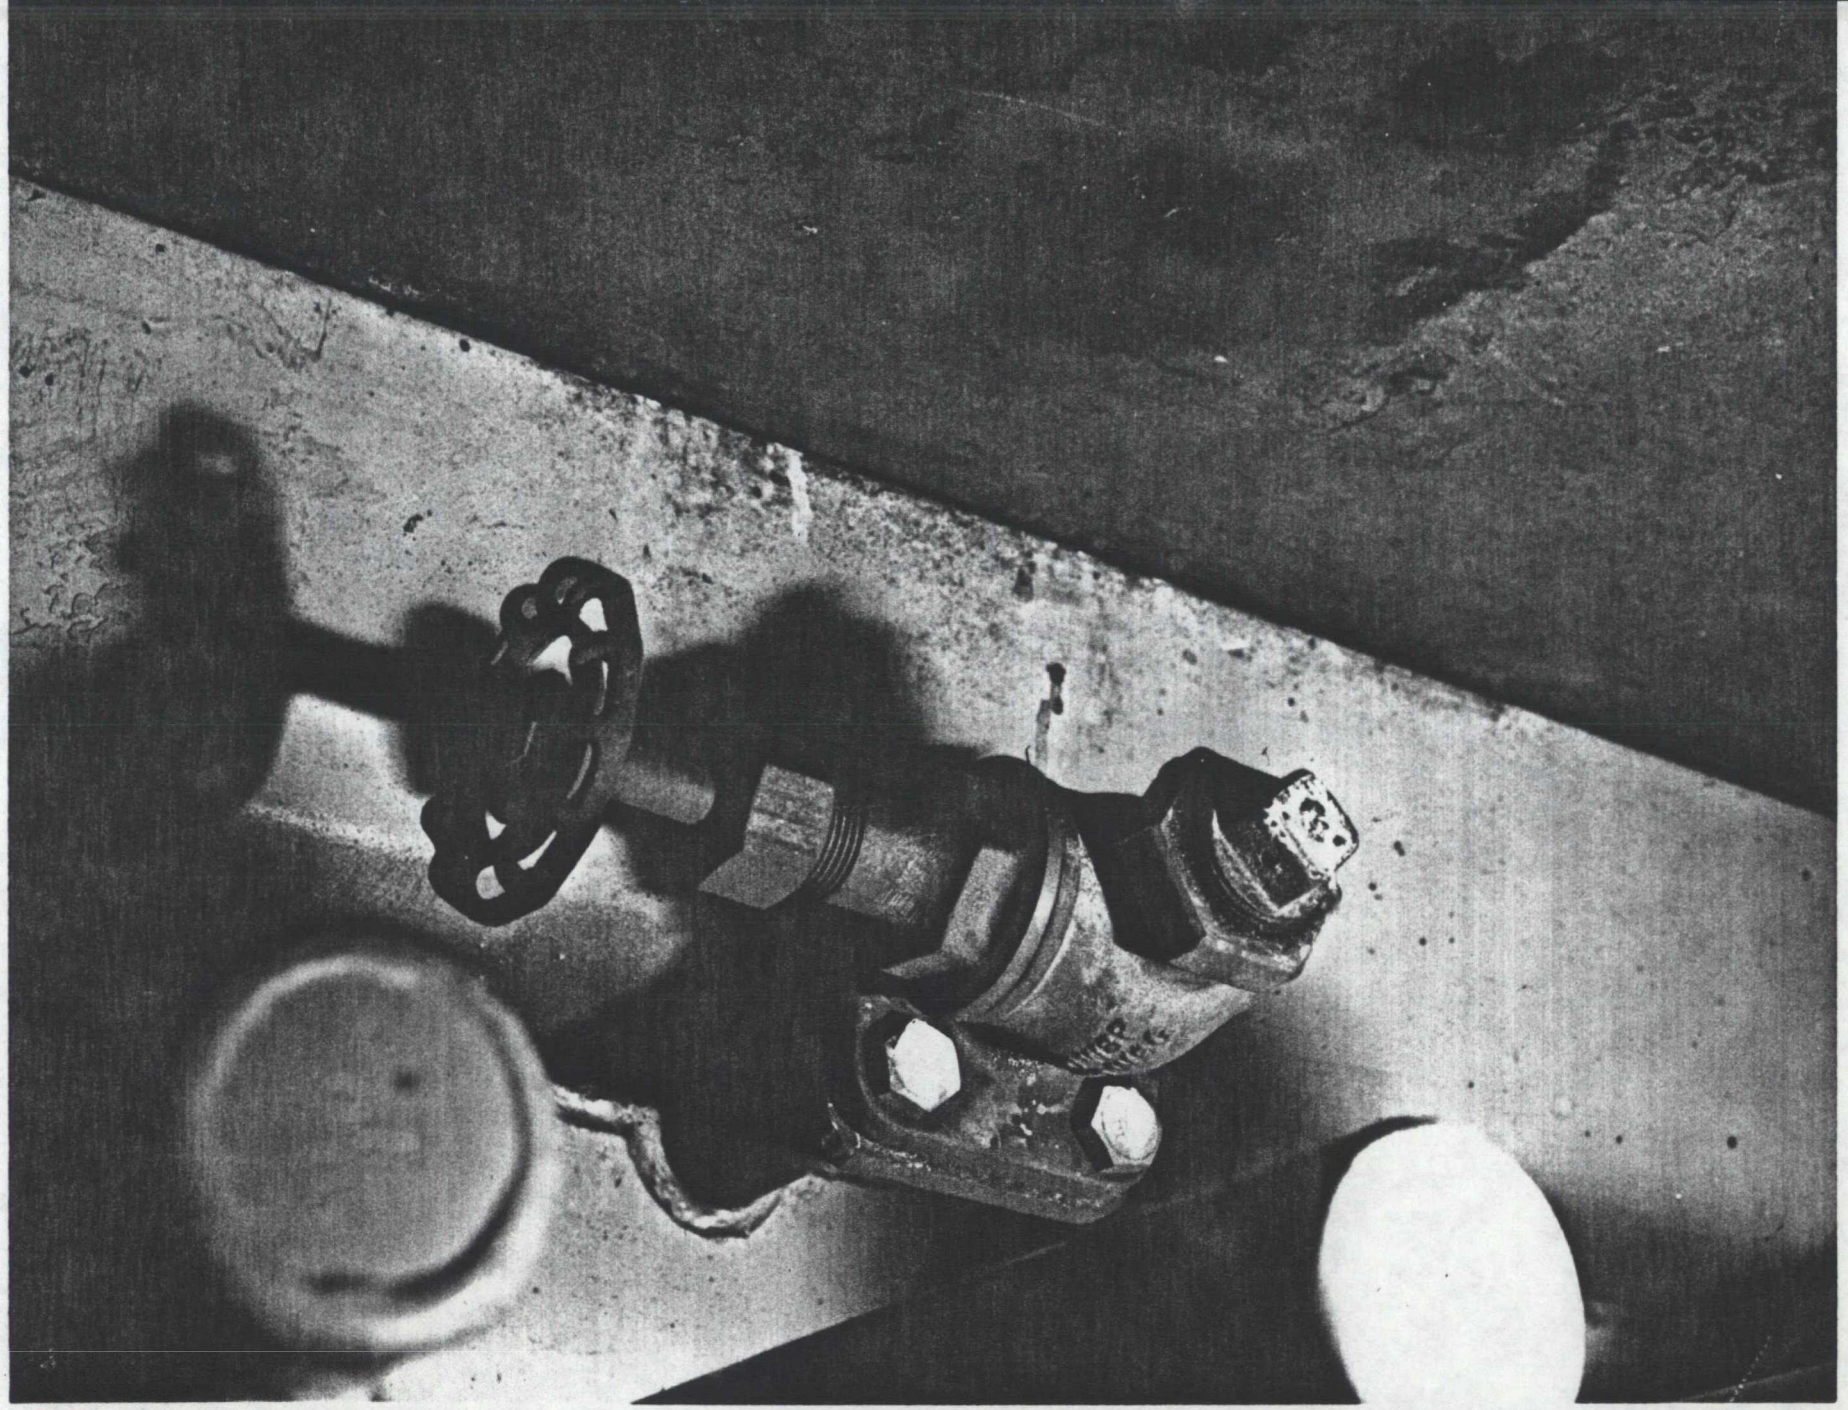
DATE: 11·14·85 NAME: Schmit #12
DESCRIPTION: GenDyn-Blok1
Leak from drain valve of GE C-856753.

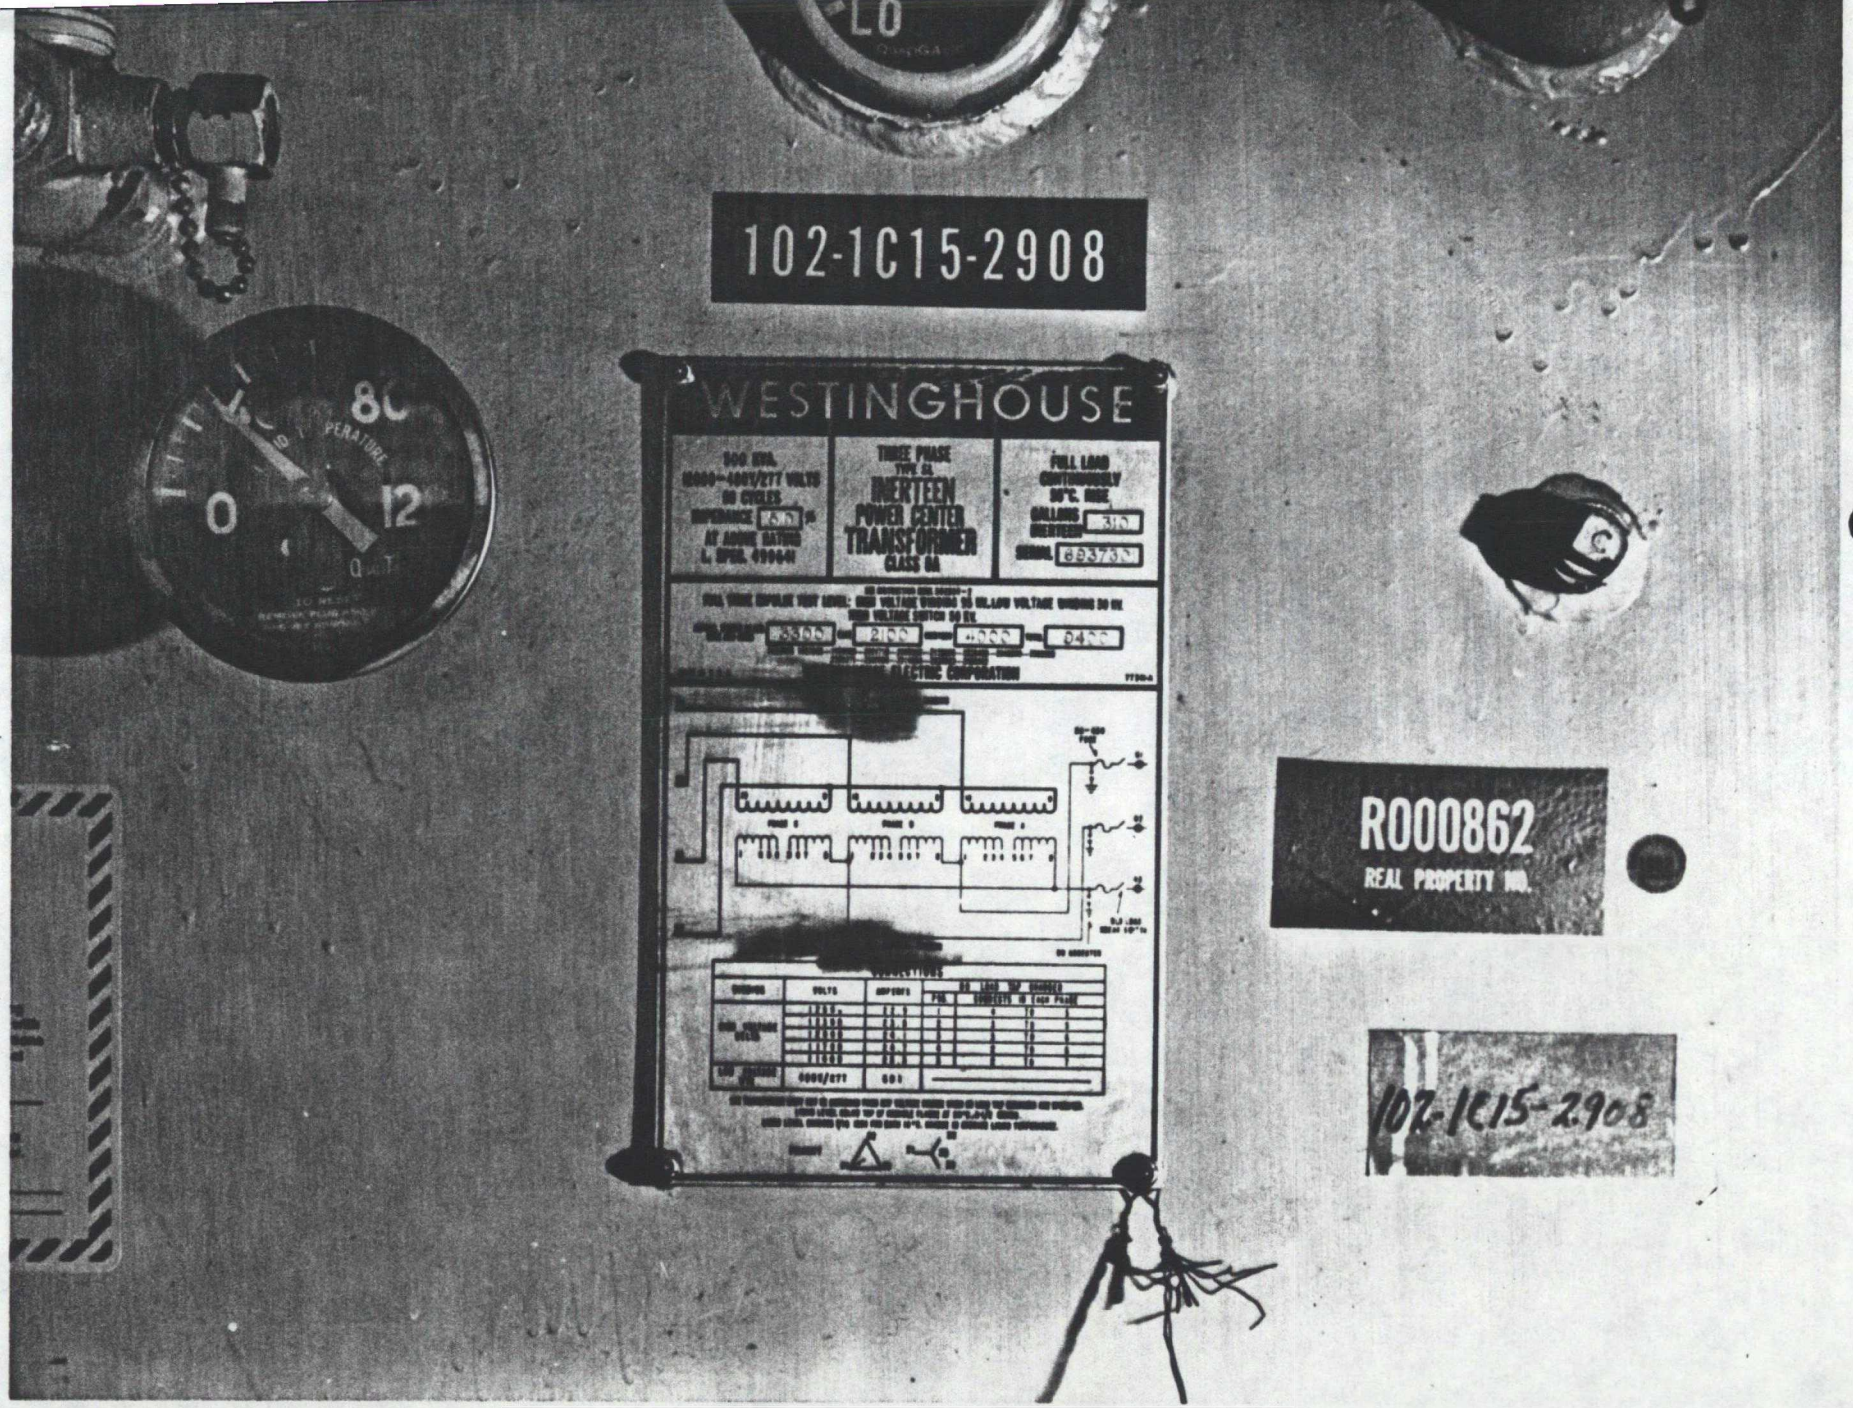
DATE: 11.14.85 NAME: Schmitt #13
DESCRIPTION: GenDyn-Bldg 1
Westinghouse #6937301. Note drip forming on underside of drain tap near temperature gauge

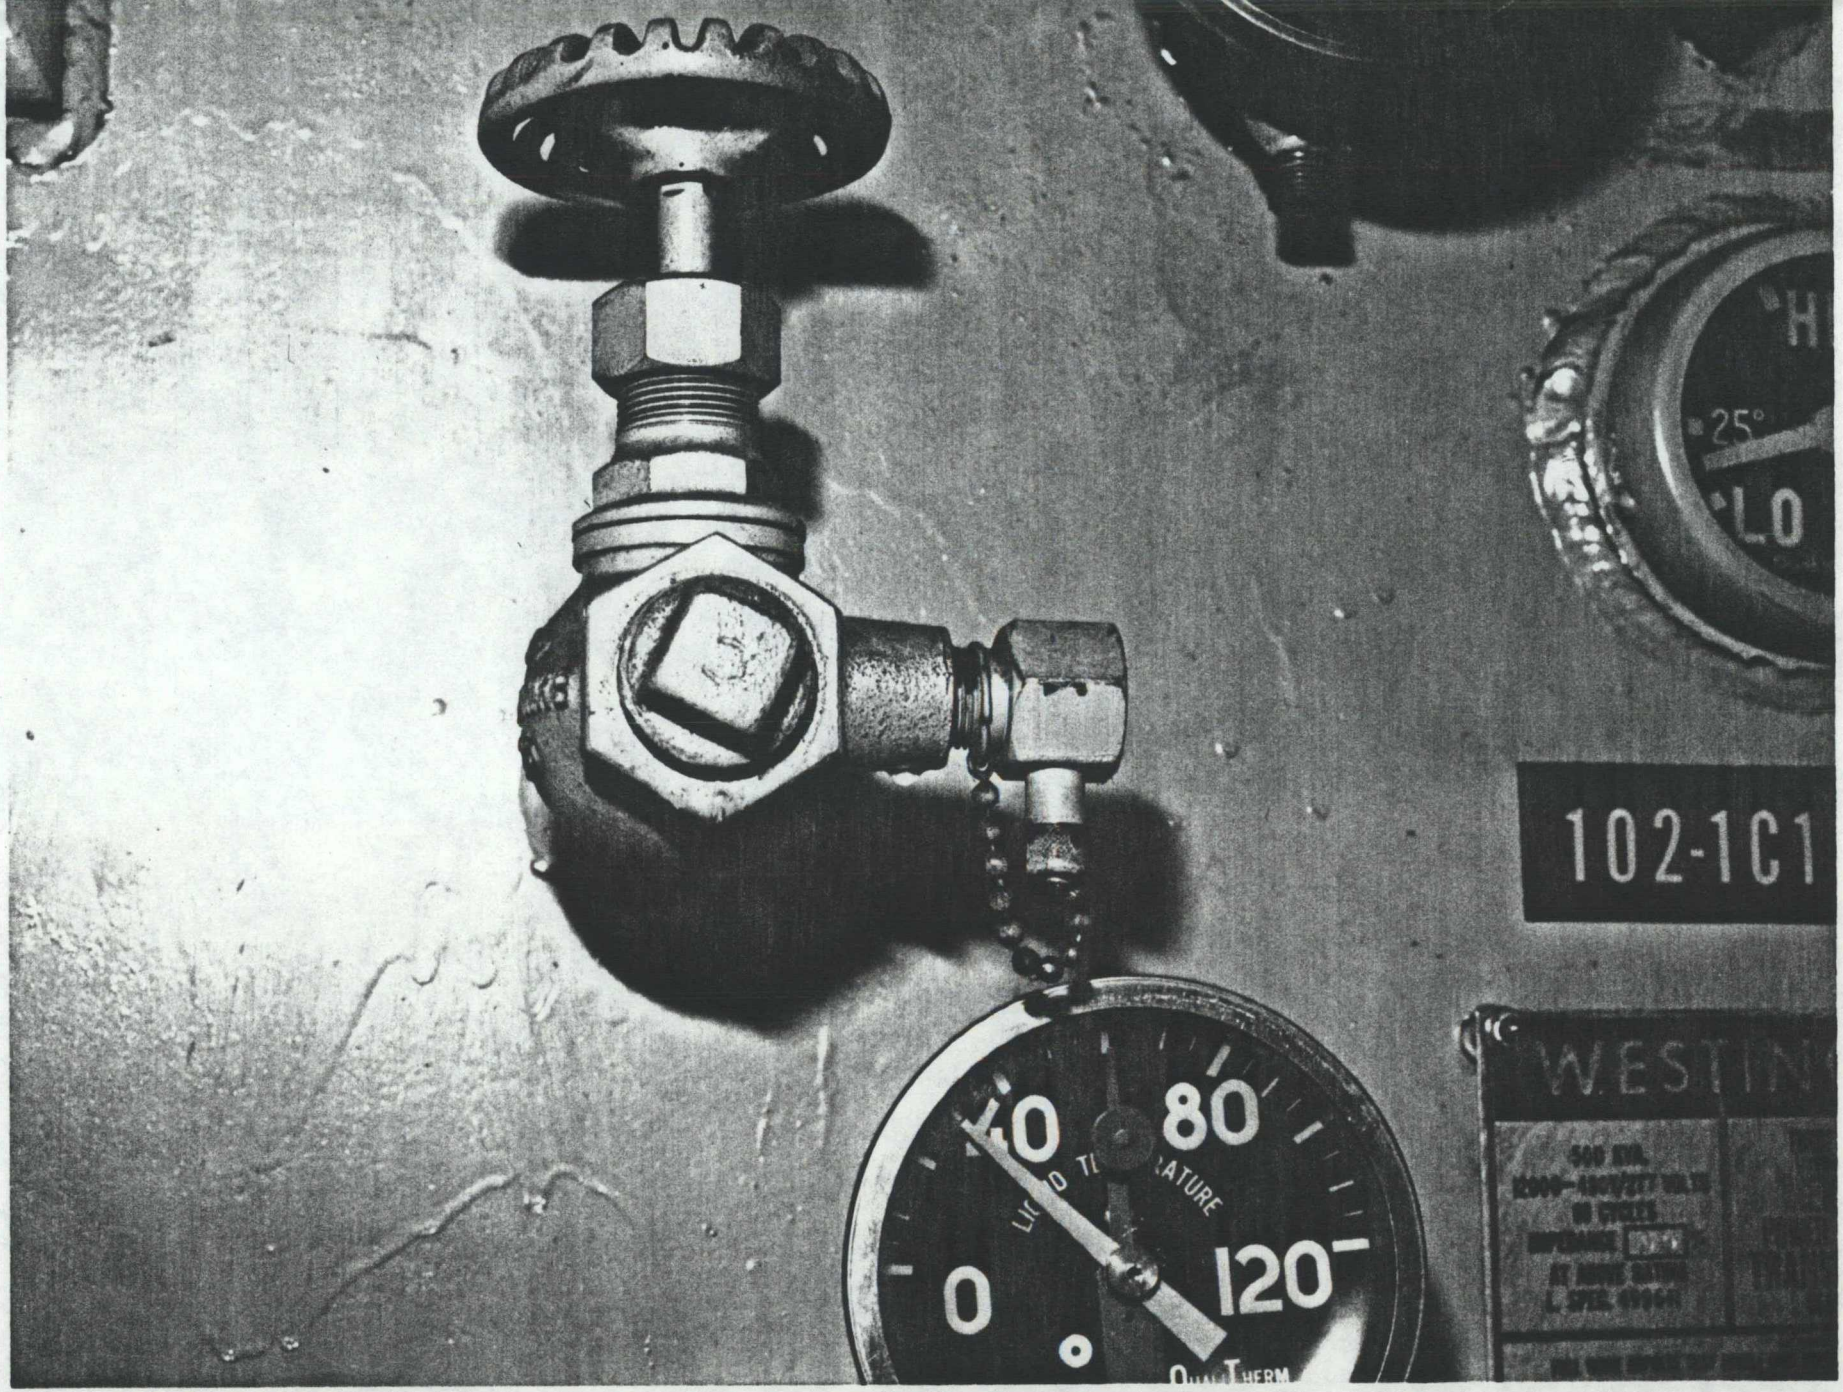
DATE: 11-14-85 NAME: Schmit #14

Westinghouse #6931301. Note drip from tap.

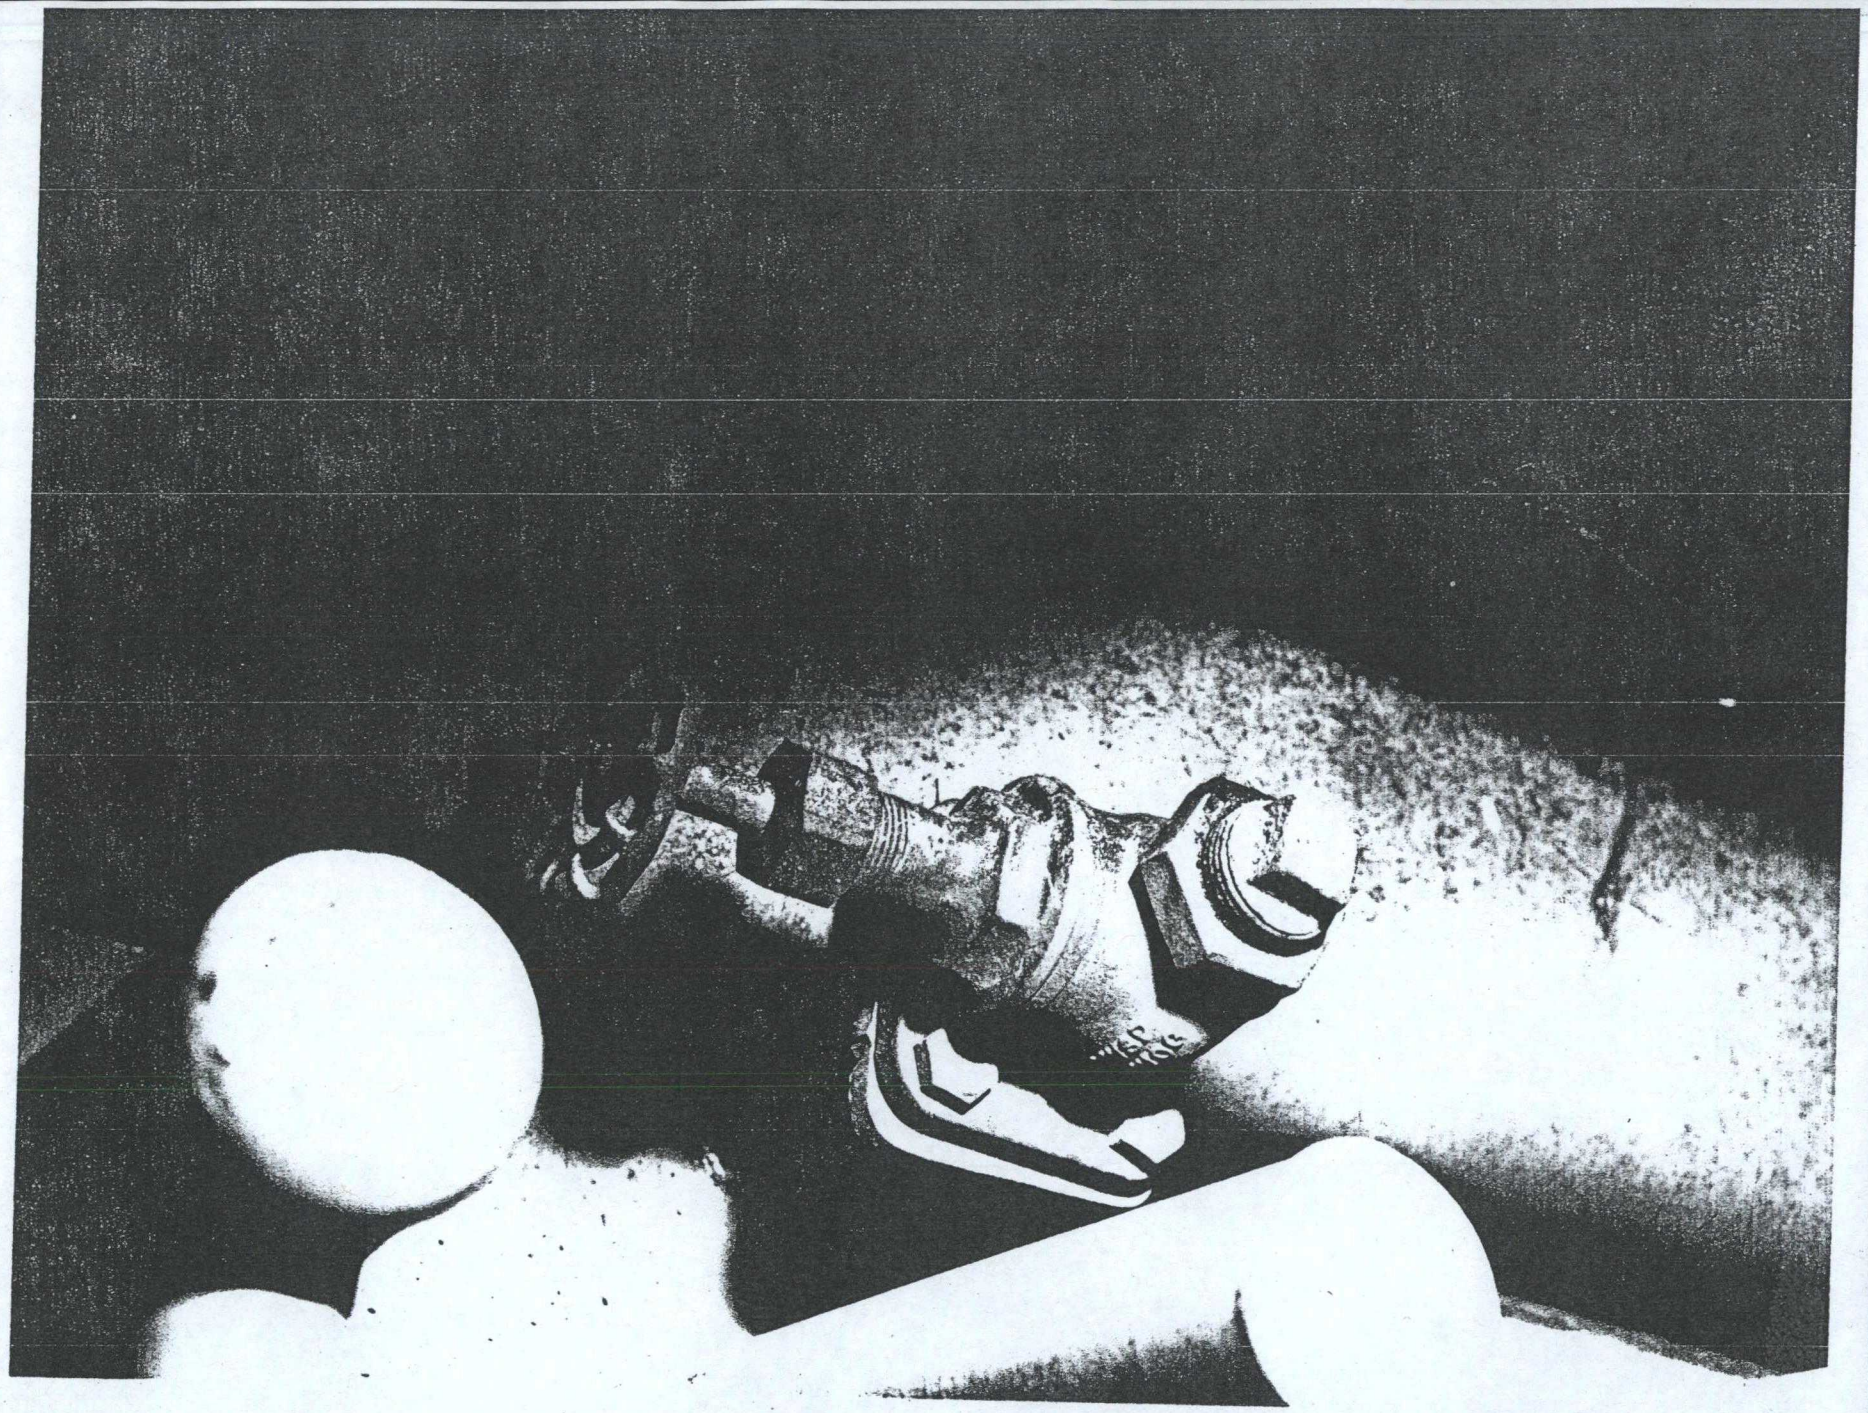
DATE: 11.14.85 NAME: Schmit #15

Westinghouse #6937301. Note only seep along bottom of drain tap.

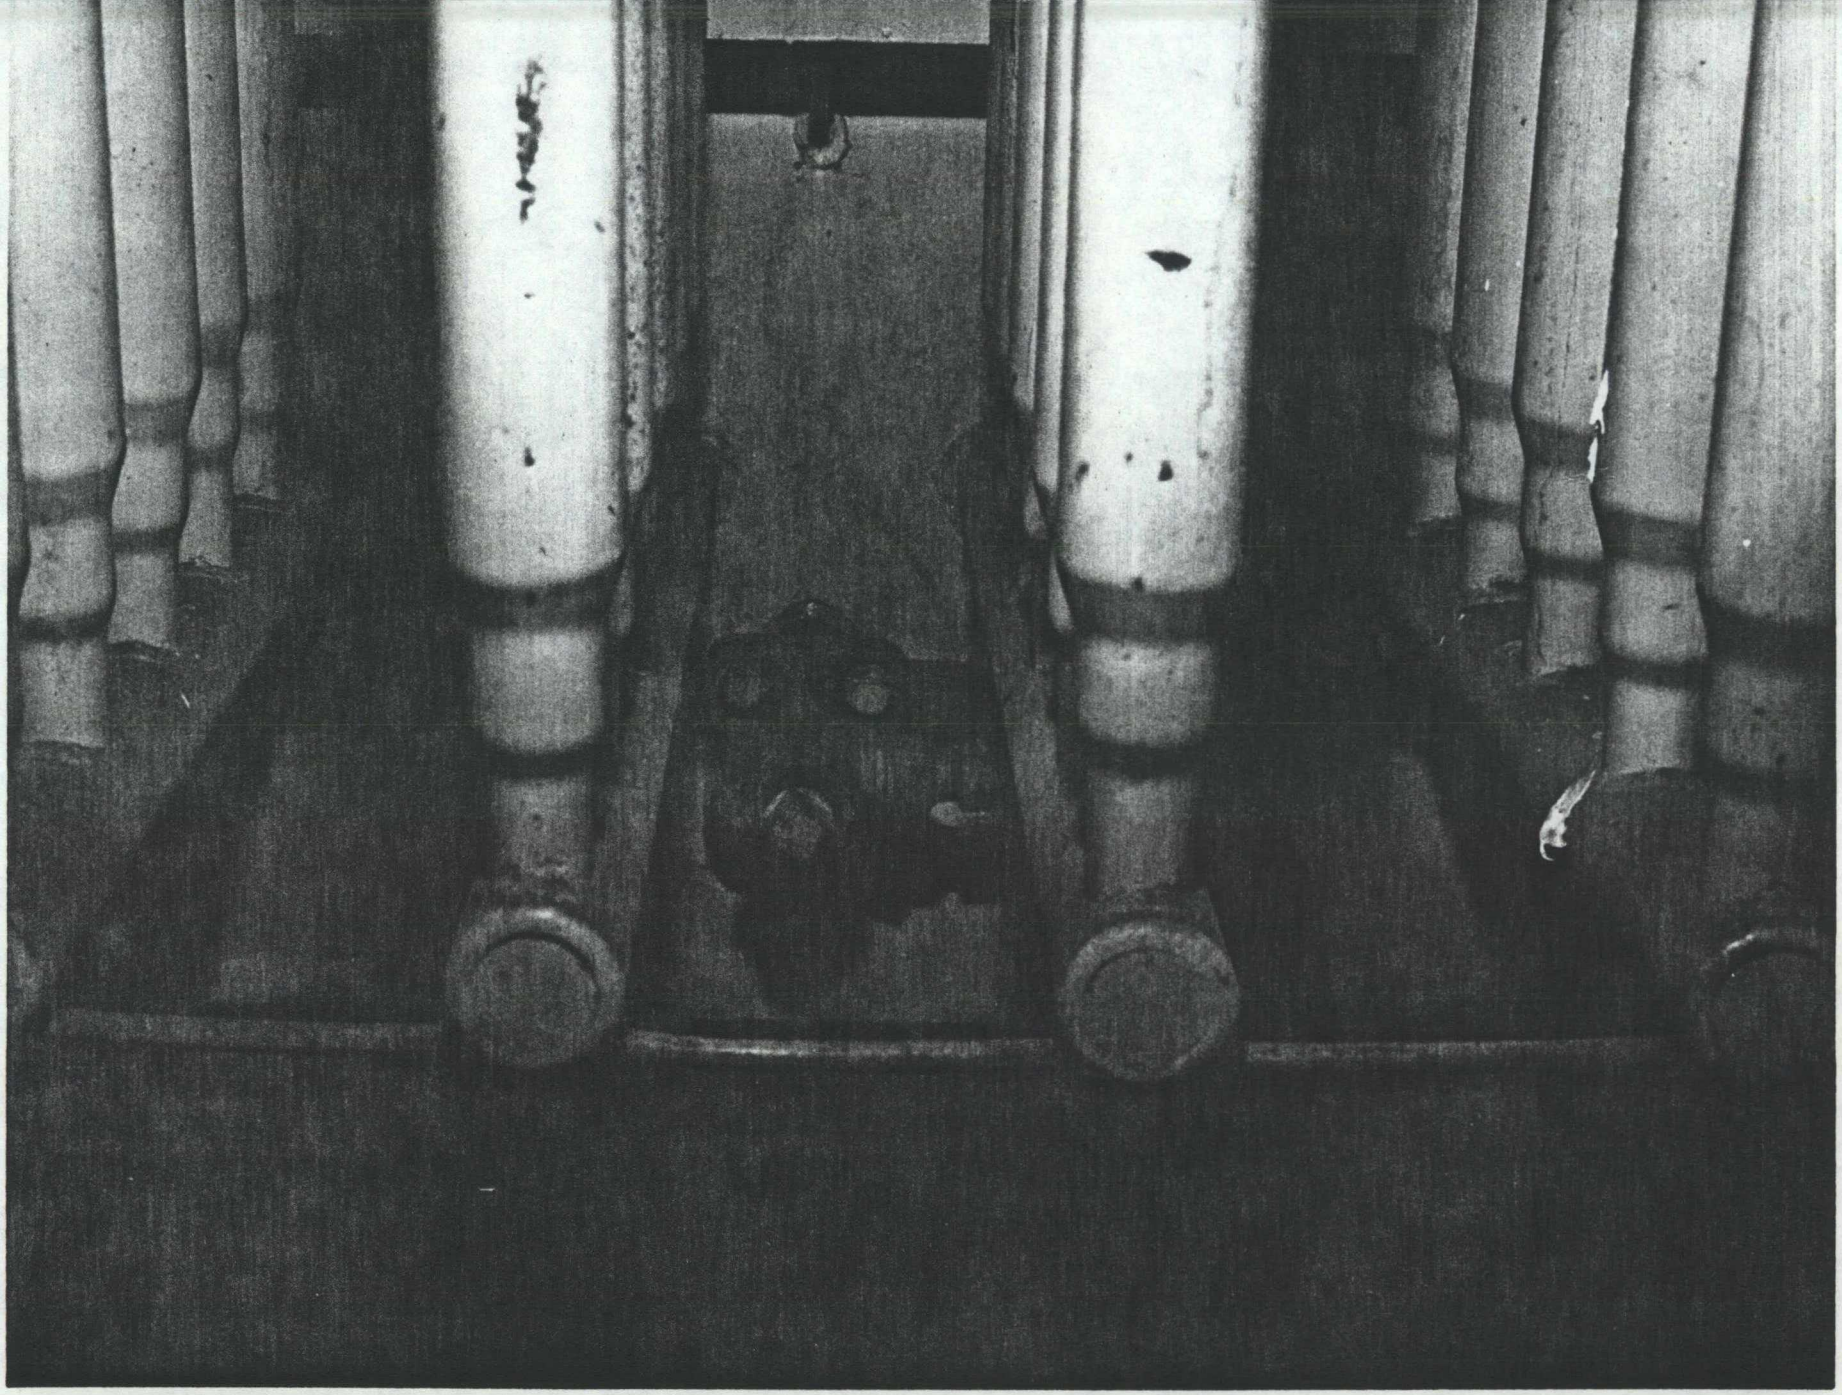
DATE: 11.14.86 NAME: Schmit #17

GE#C-856751. Note leak from drain tap.
