SFUND RECORDS CTR
2385815

DATE: 11·14·85 NAME: Schmit #1
DESCRIPTION: GenDyn-Bldg 1
Ground floor substation w/ 3 retrofilled Westinghouse transformers, #3011134 → #3011136.

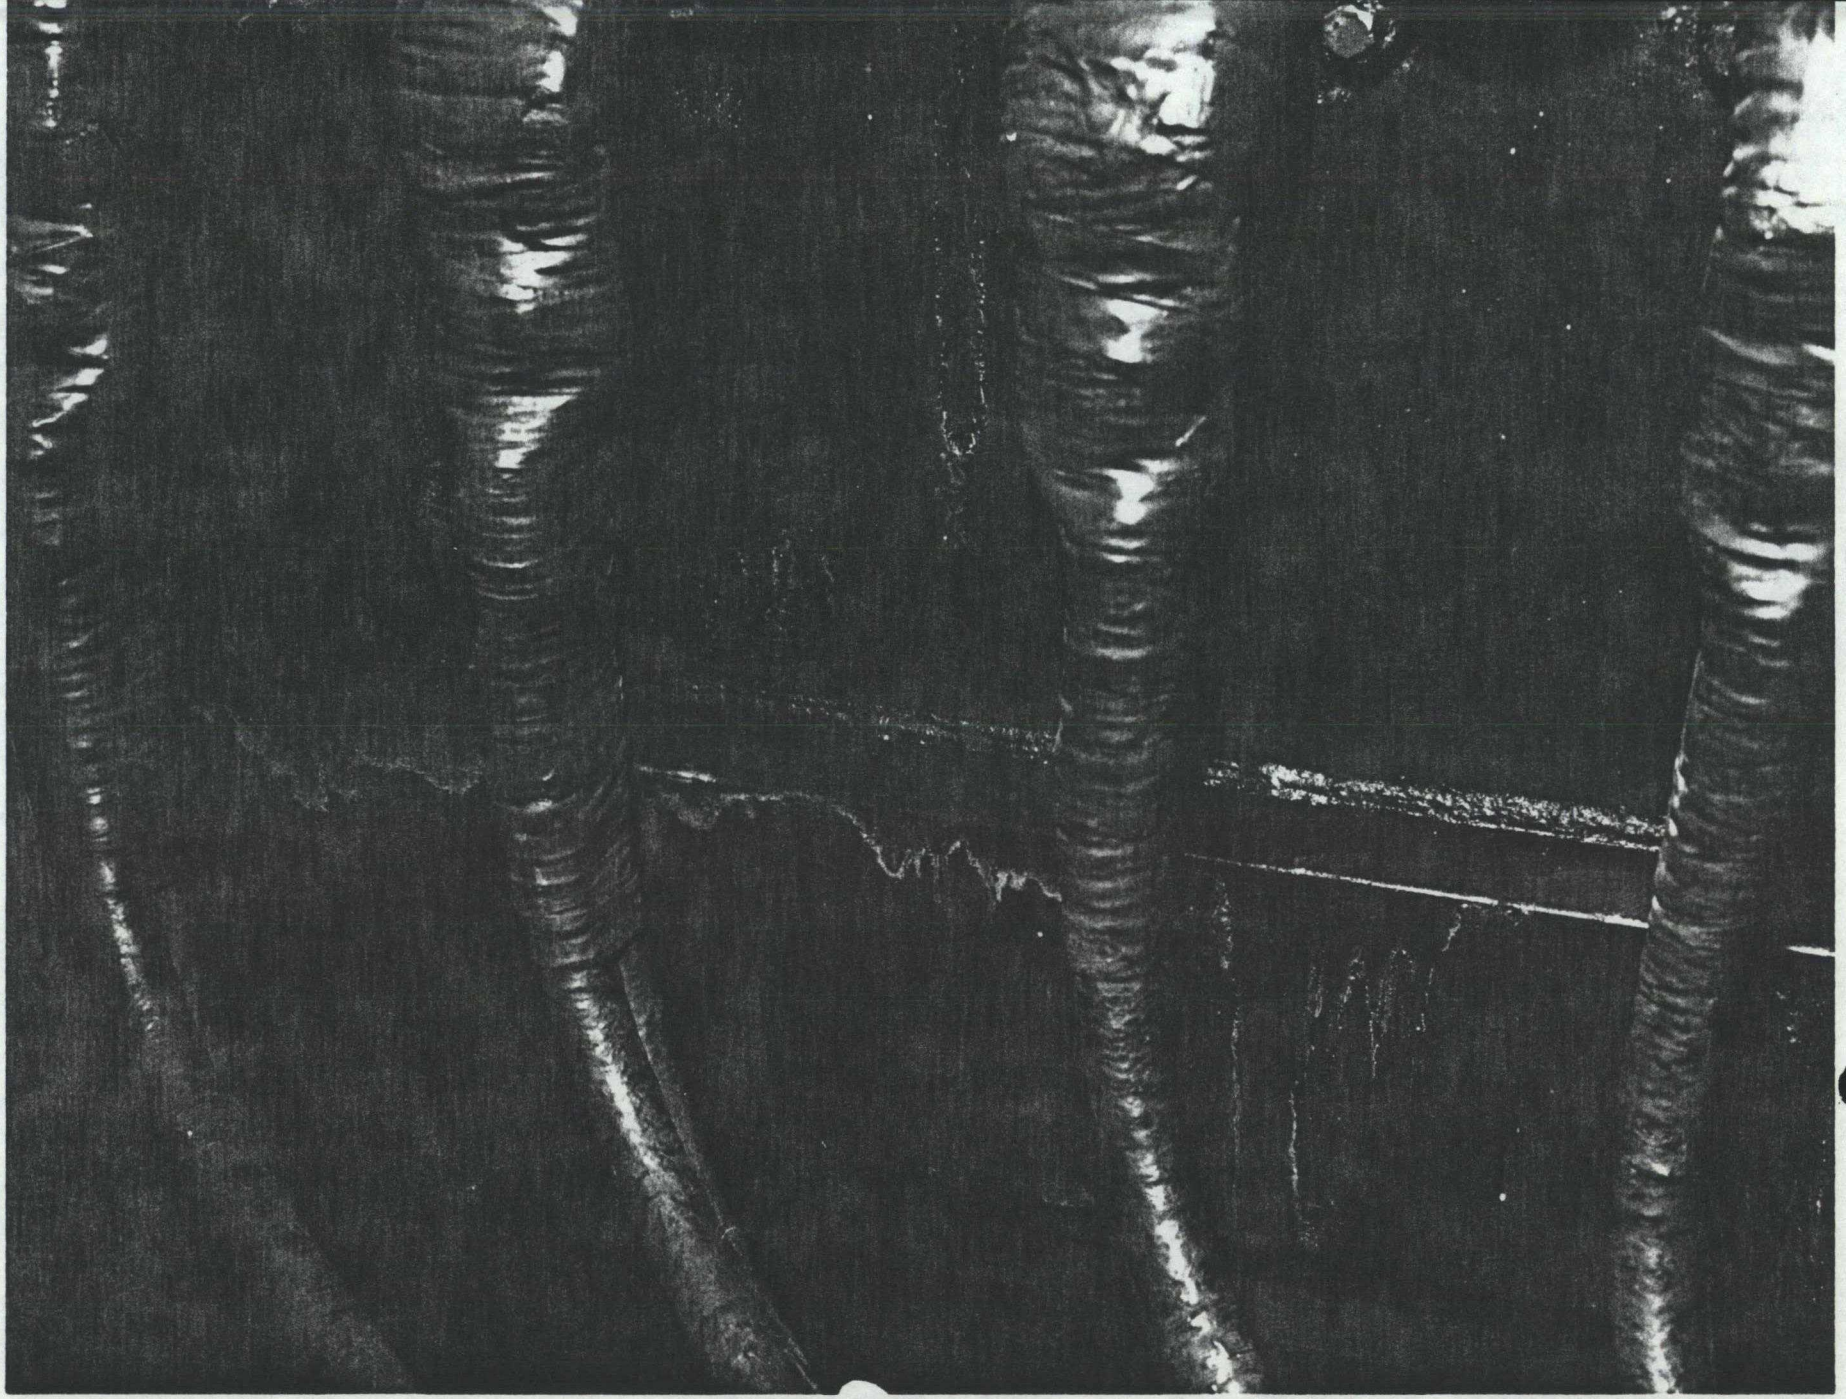
DATE: 11-15-86 NAME: Schmit #19

GE #617574. Note leak at bushings and fluid collecting on Tin below. Bushings on both high and low side leaking extensively.

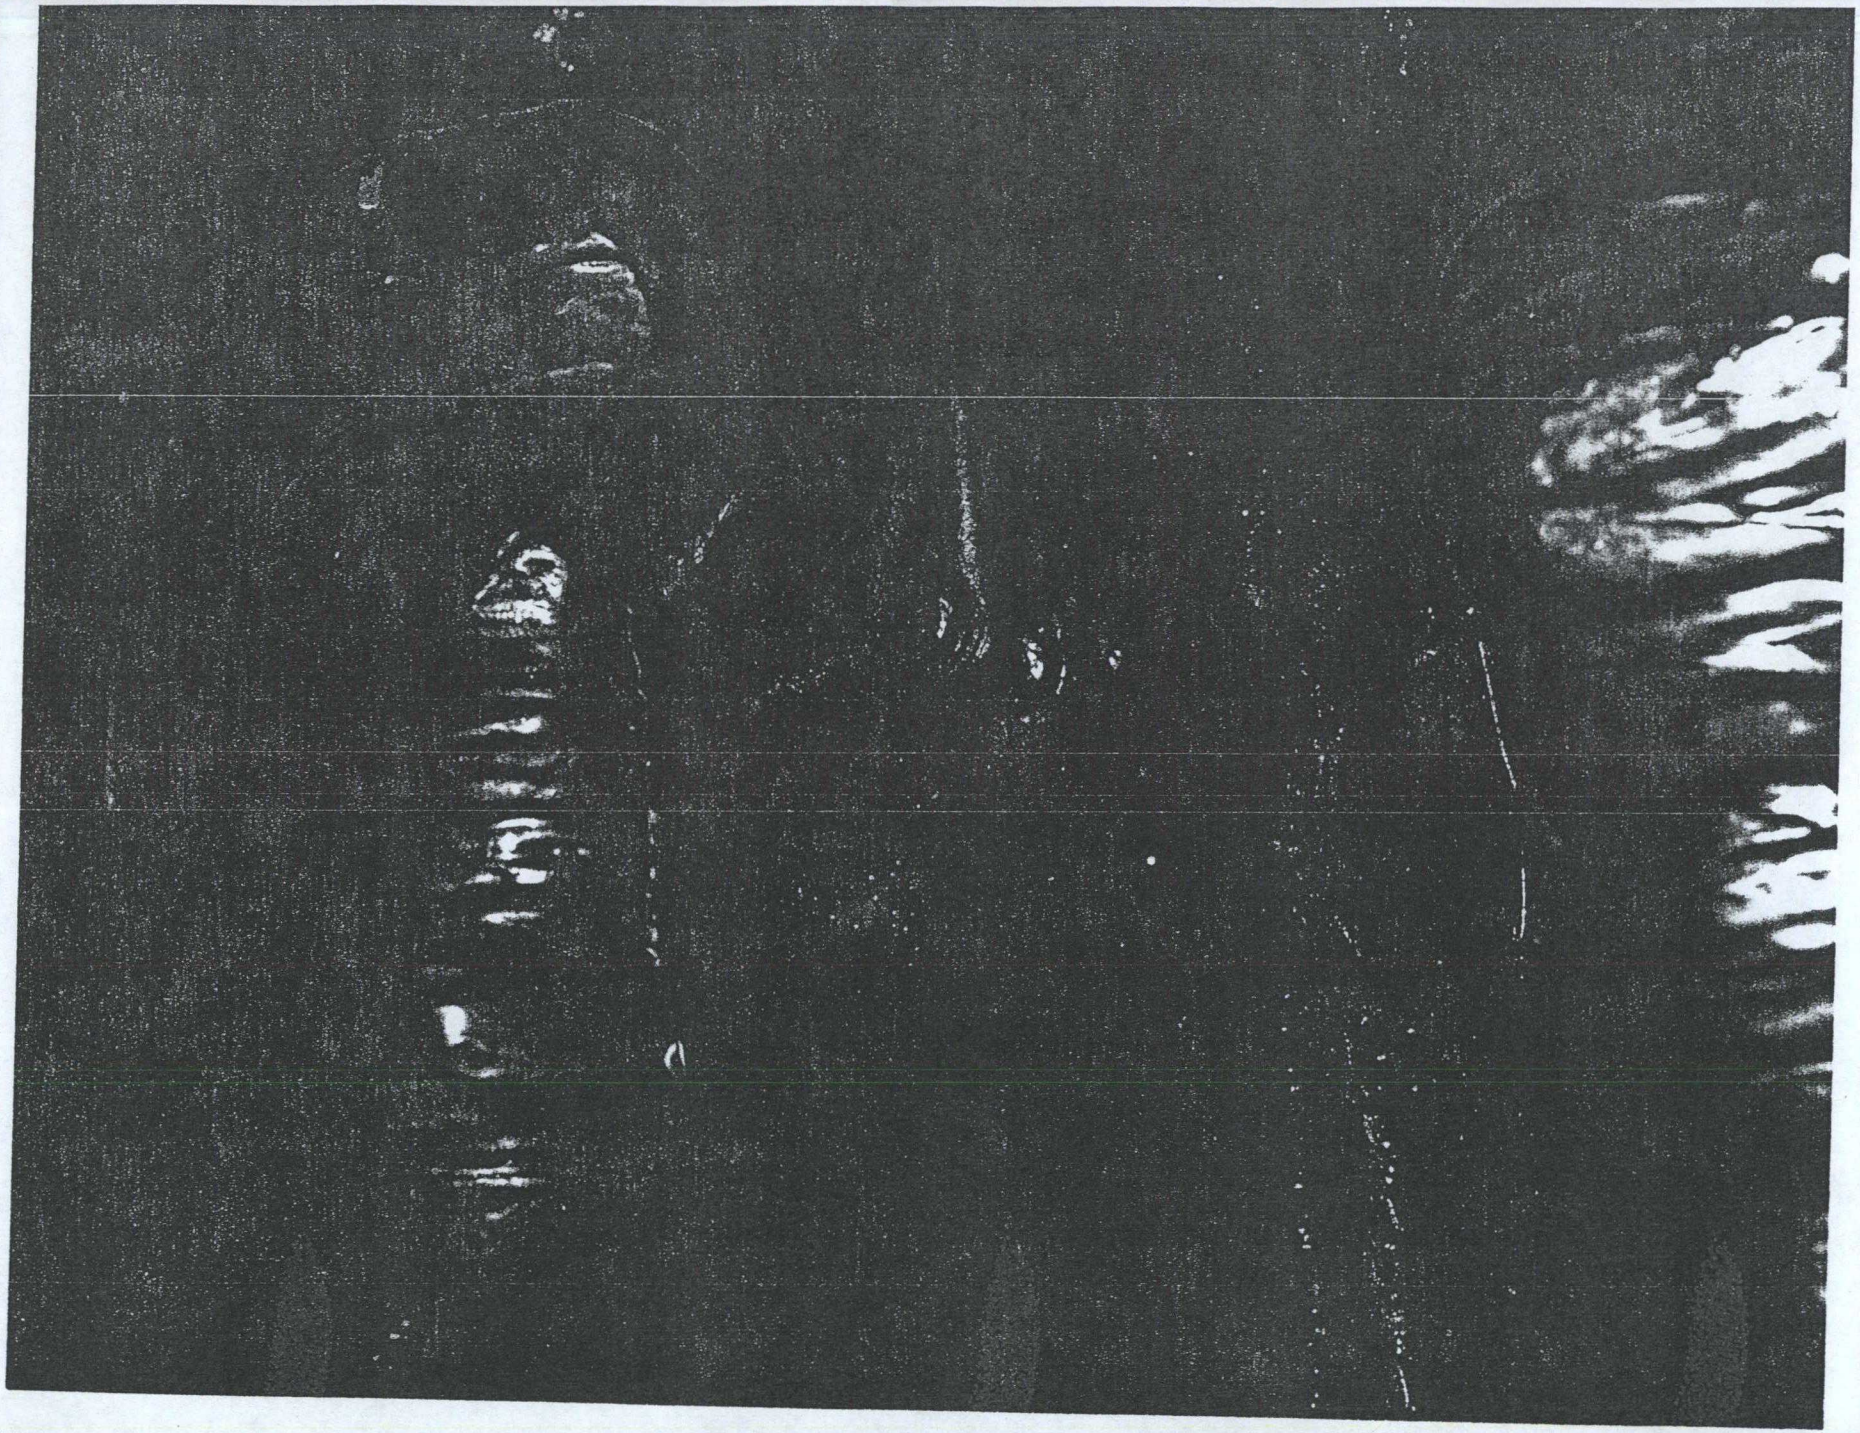
DATE: 11.15.86 NAME: Schmit #20
DESCRIPTION: GenDyn-Bldg
GE #6417514. close-up of buildings leaks.

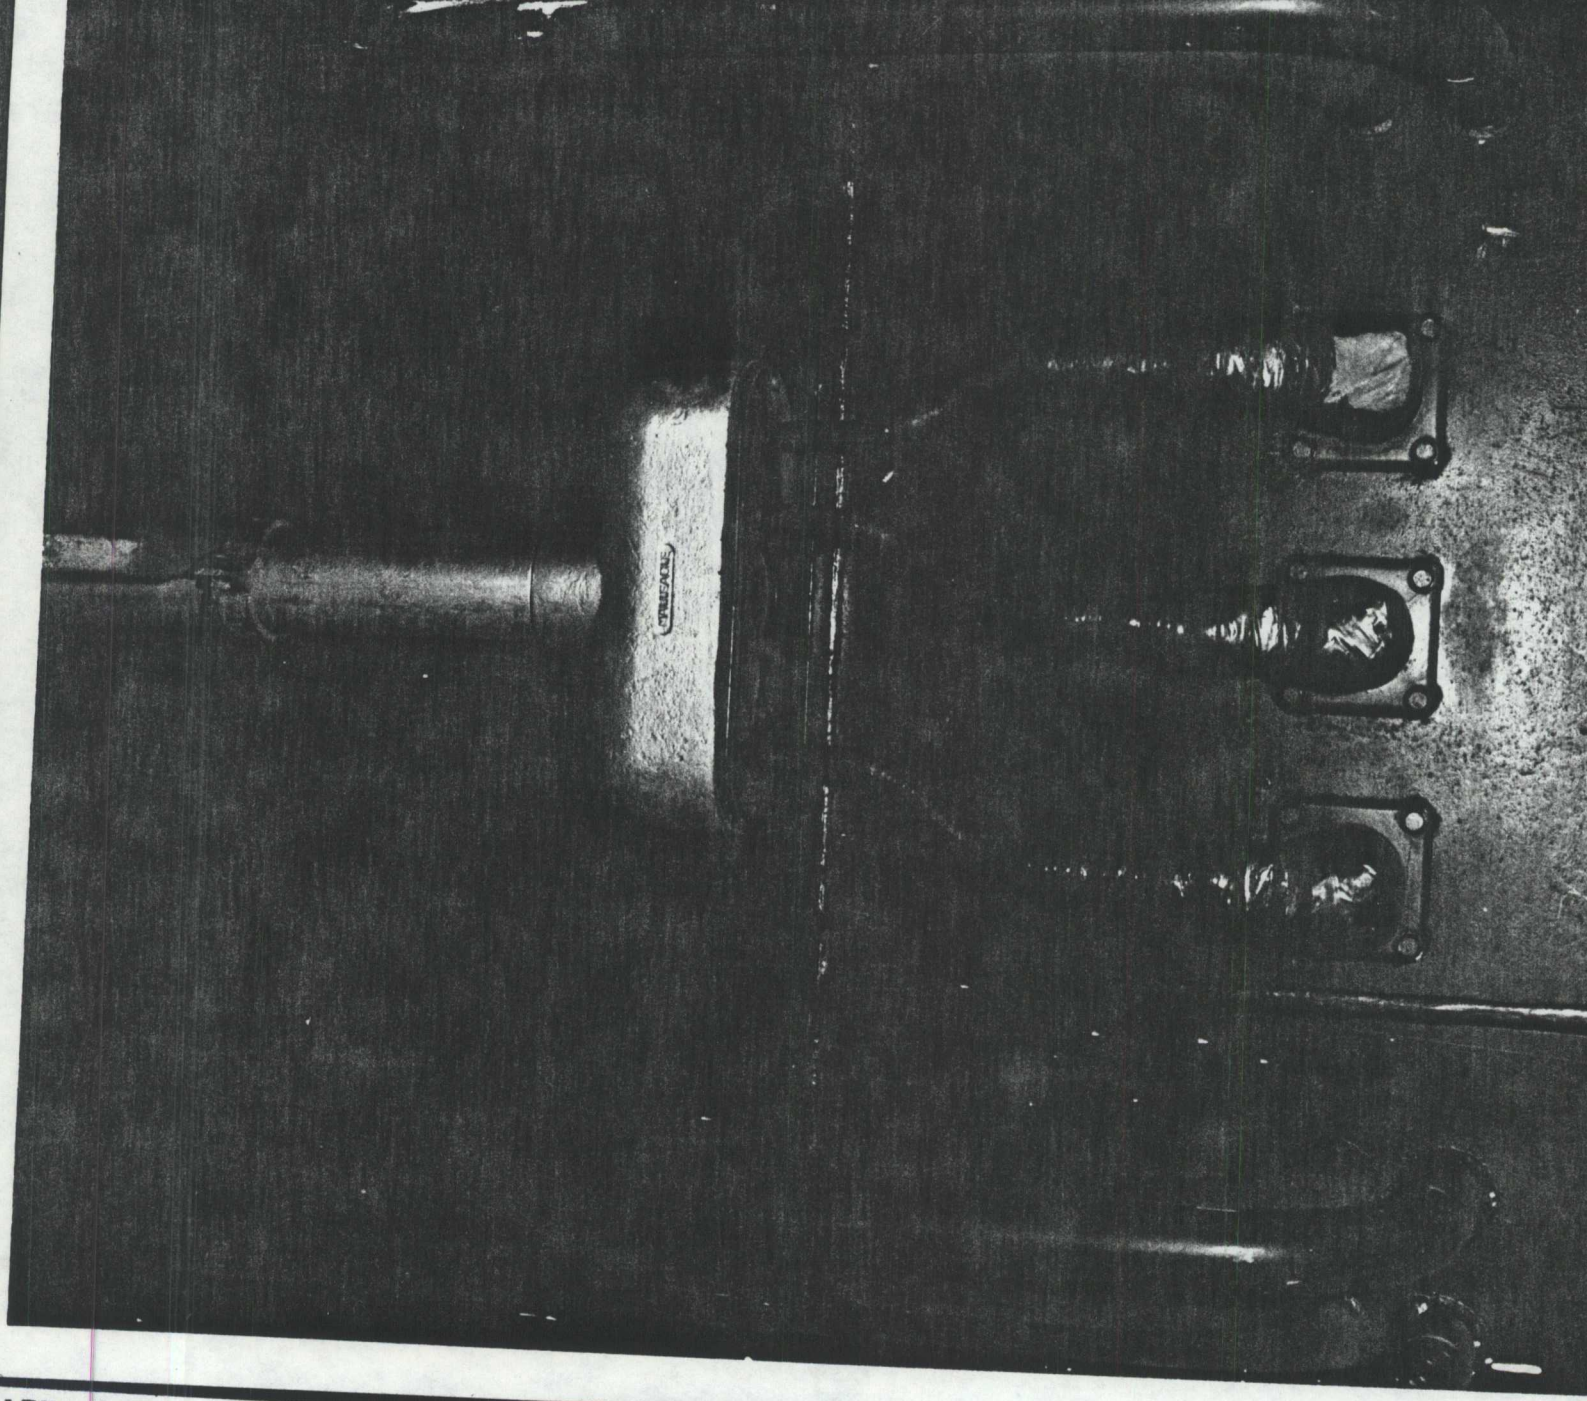
DATE: 11-15-86 NAME: Schmit #21

GE#641754. Note extent of oily area.

GE#6917574. Note leaked material flowing down insulated cables and into bus.

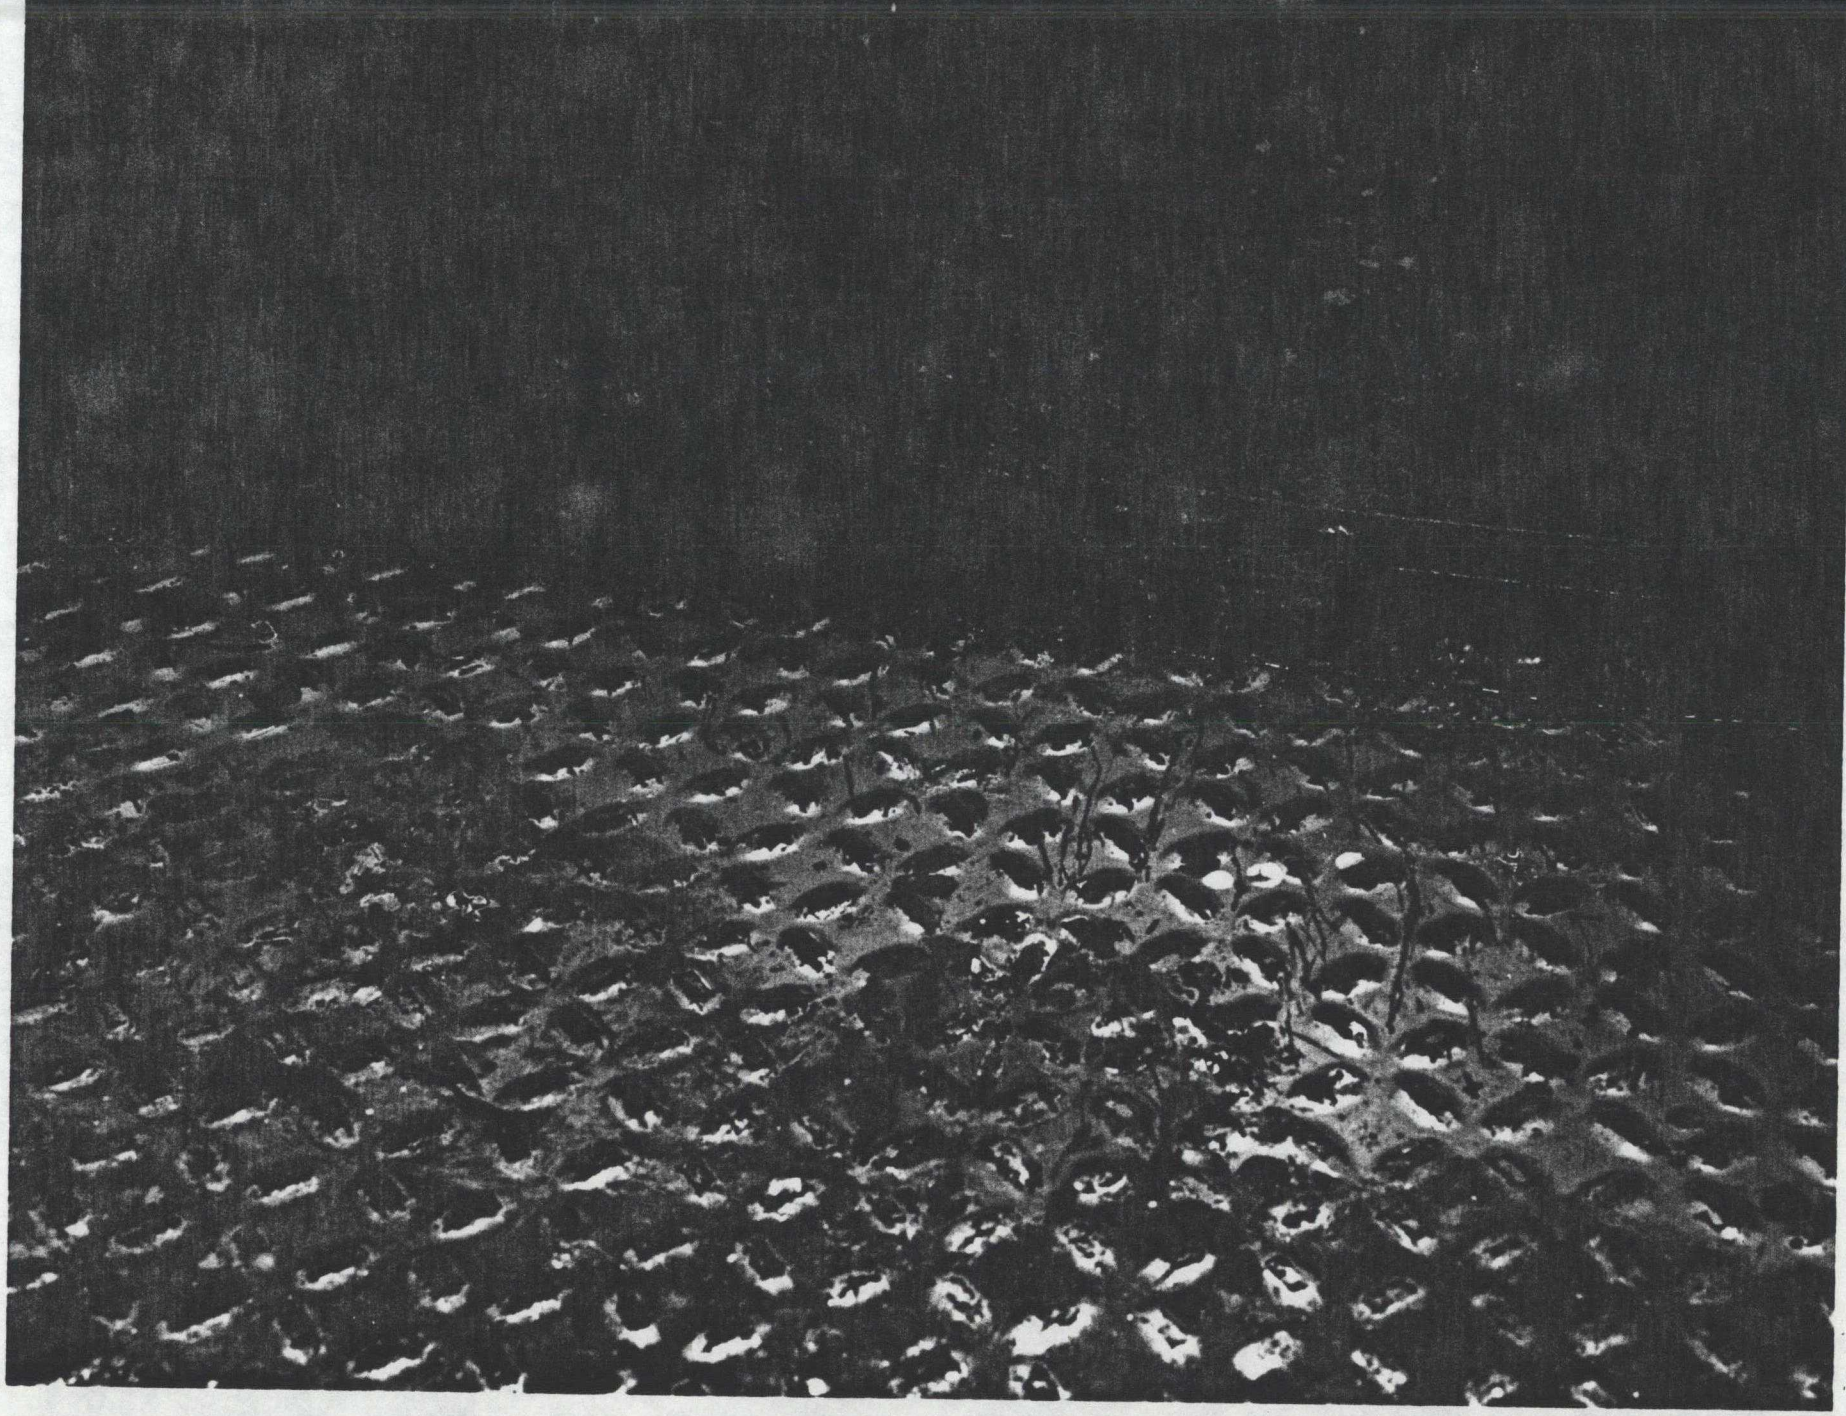
DATE: 11.15.86 NAME: Schmit #23

at #6417574. Note leaked material collecting at base of transformer. Visible color differentiation on deck marks extent of IT clean-up activity.

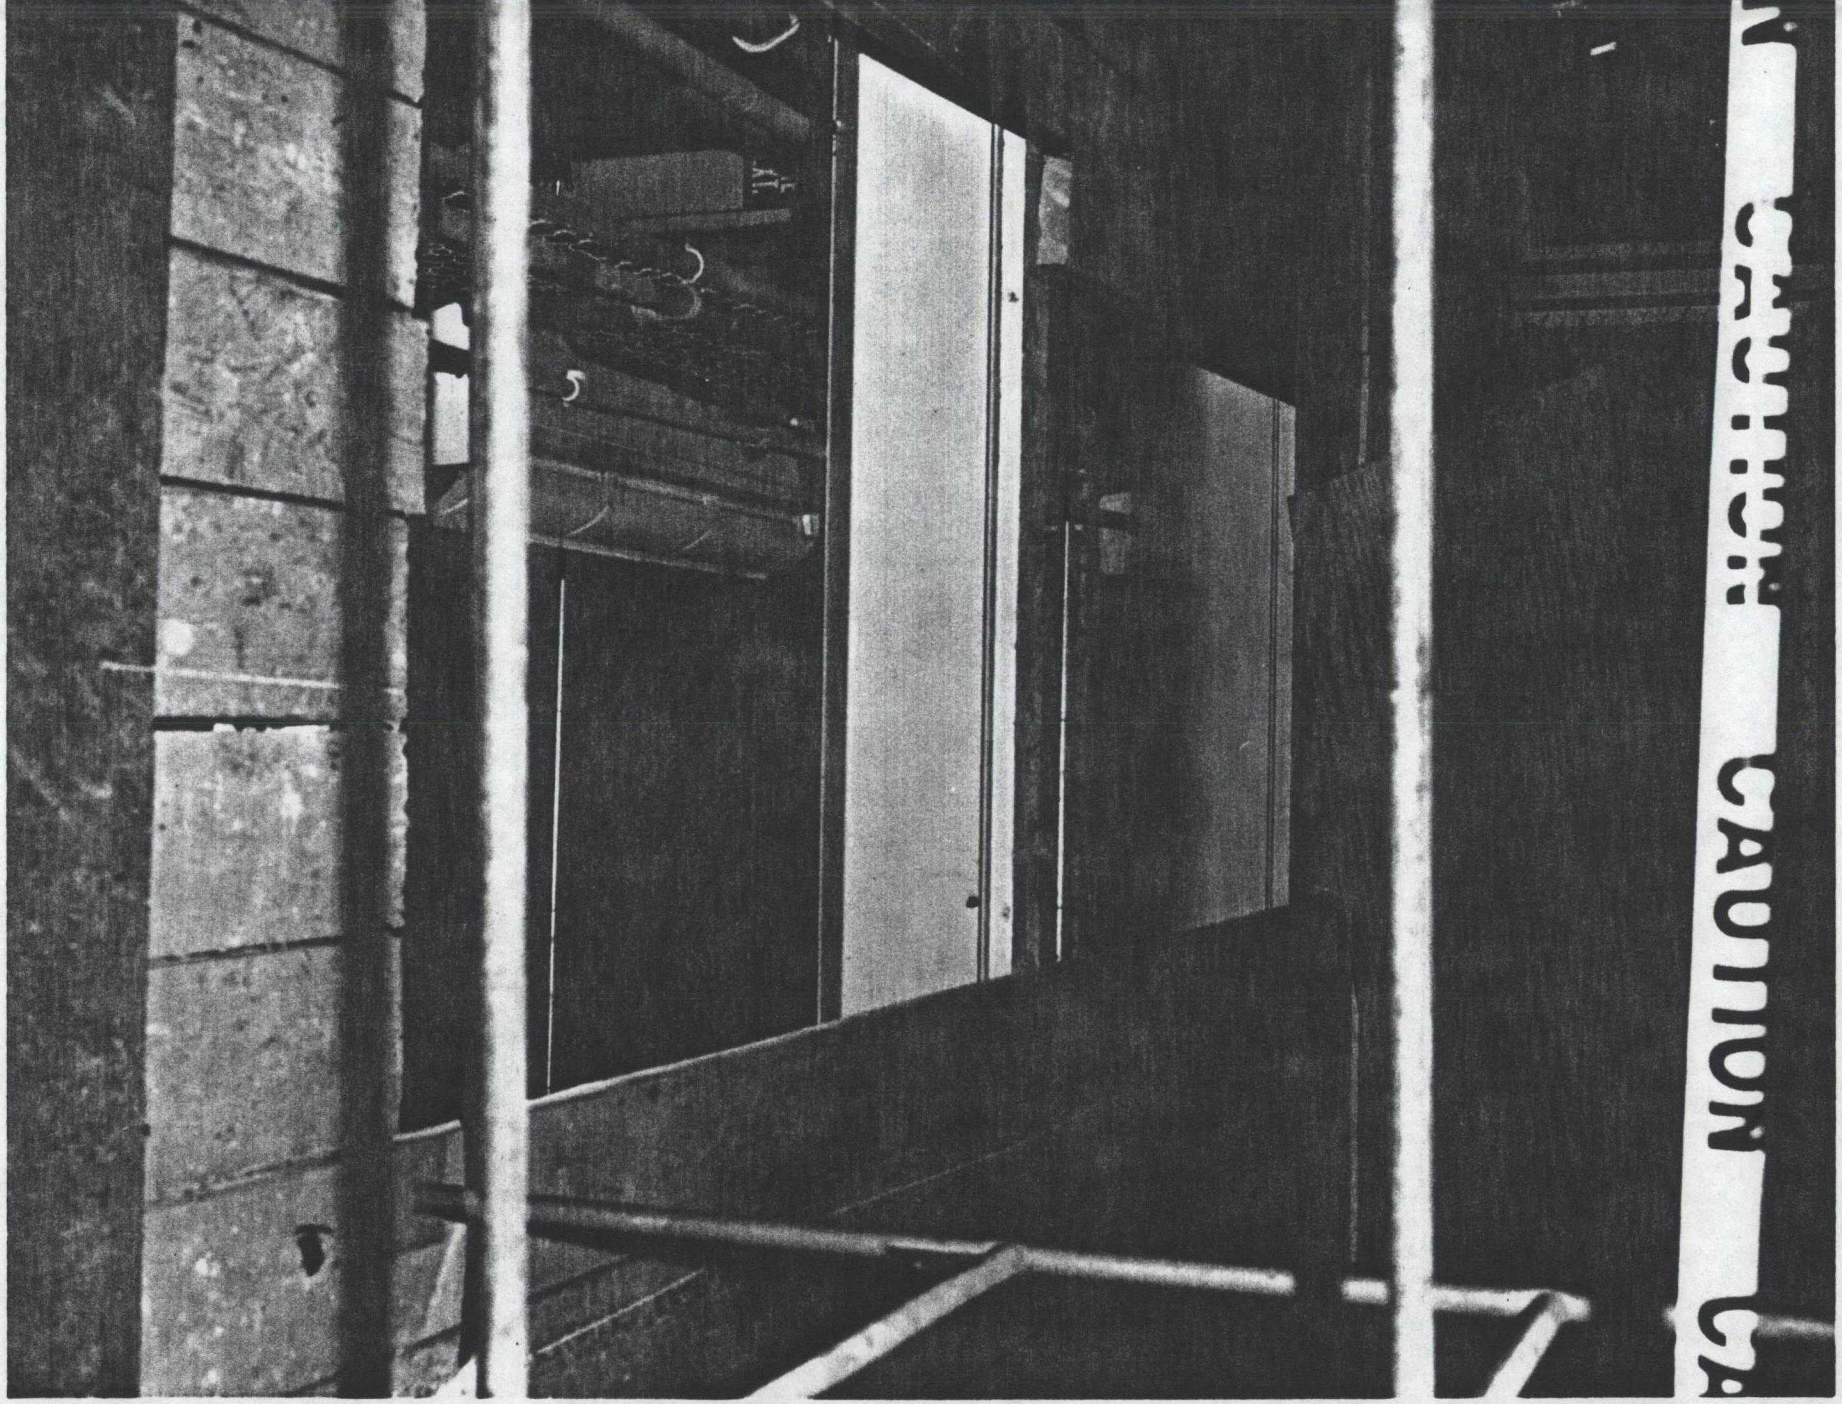
DESCRIPTION: Gen Dyn - Bldg 1
2nd Mezzanine floor beneath GE #6417574 transformer deck. Note new spillage on lighter colored replacement flooring.

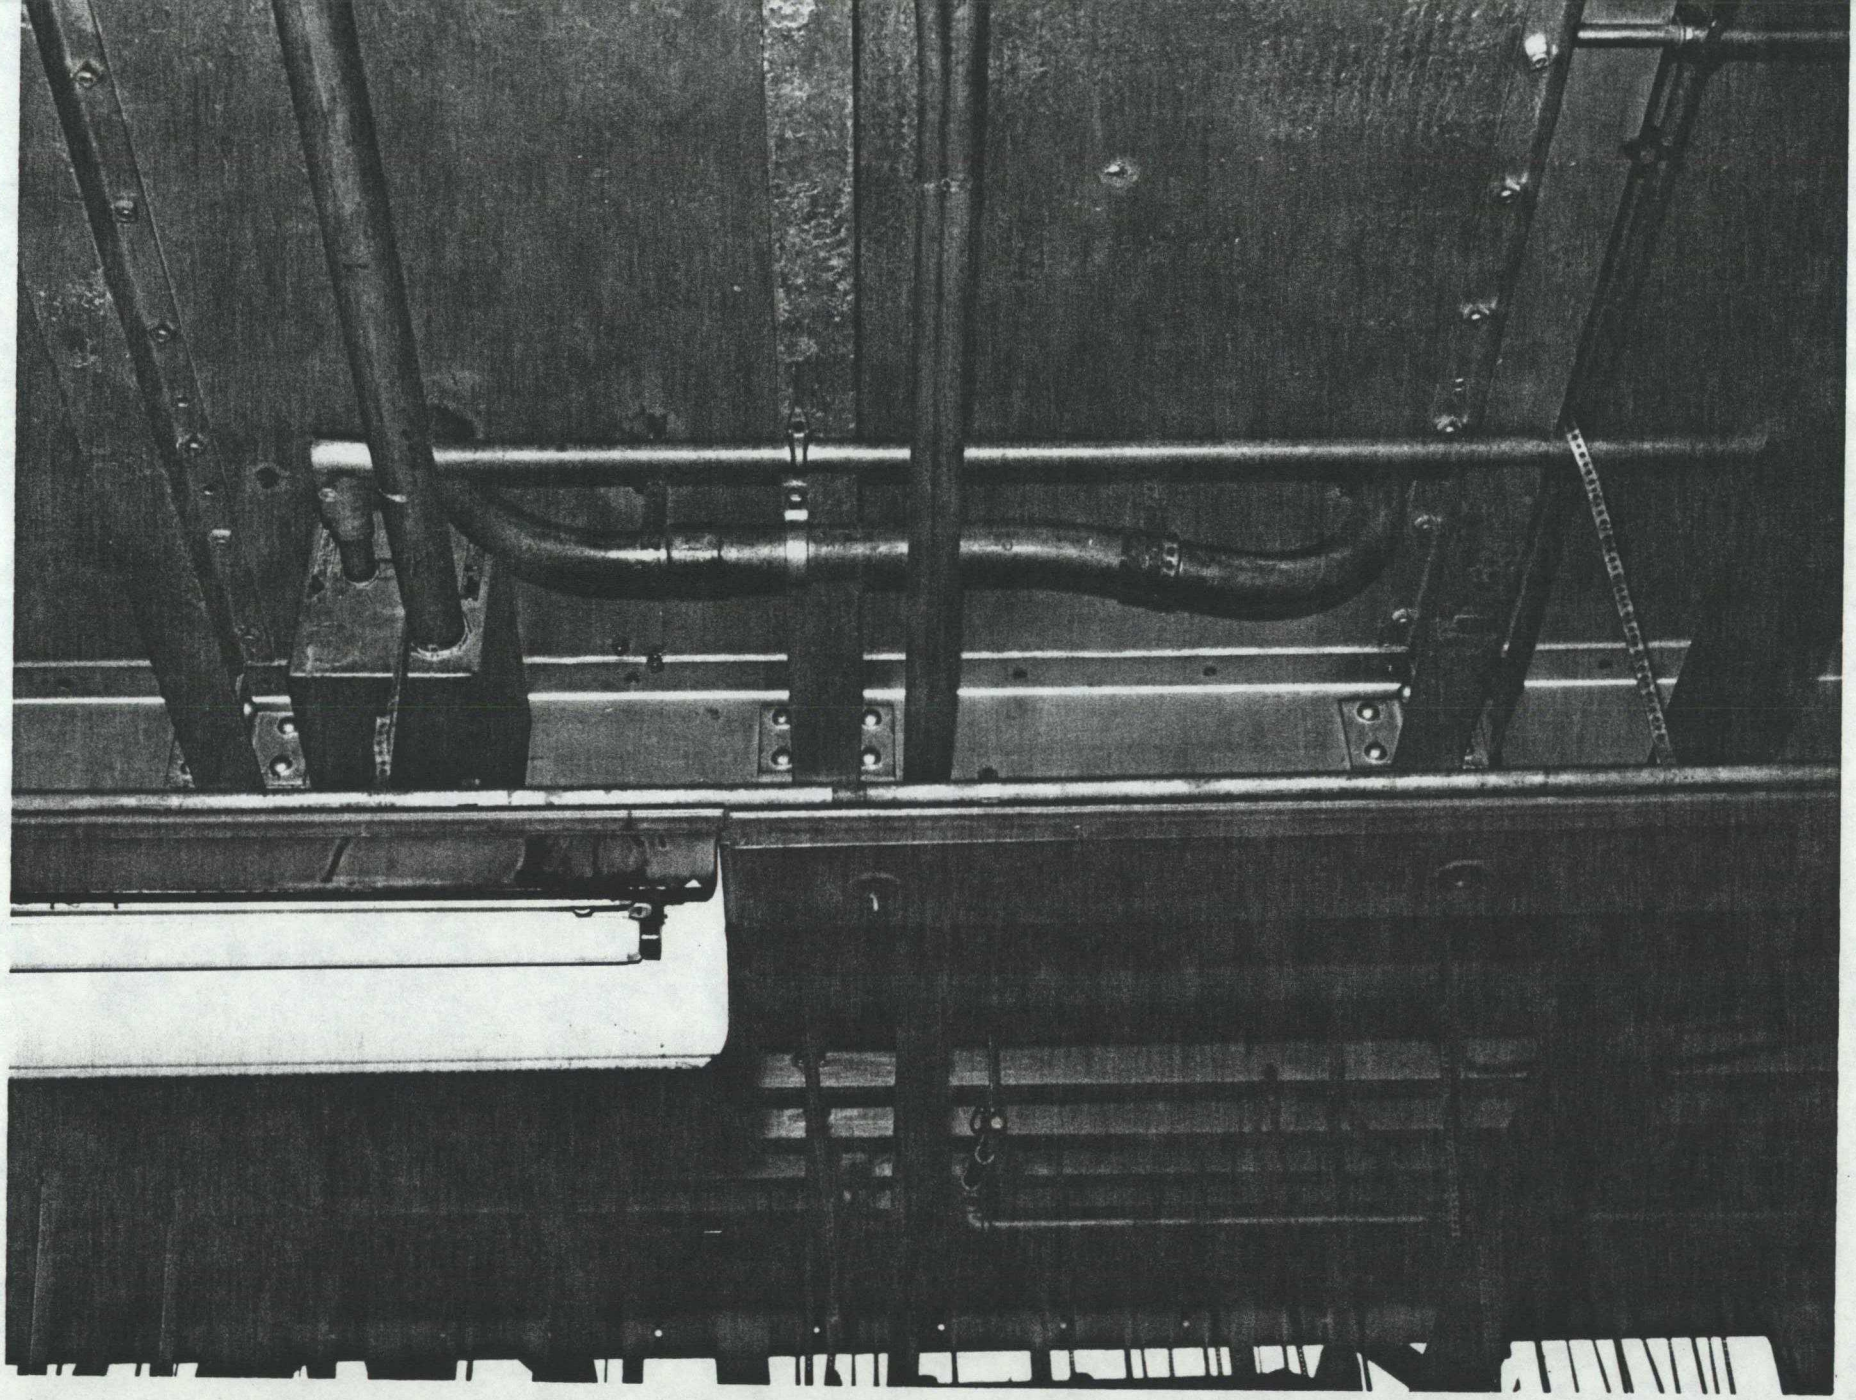
DATE: 11.15.86 NAME: Schmit #26

Piping below floor of transformer deck shown in #23. Note drips from pipe support area & evidence of spilled material on fluorescent light ballast & hood.

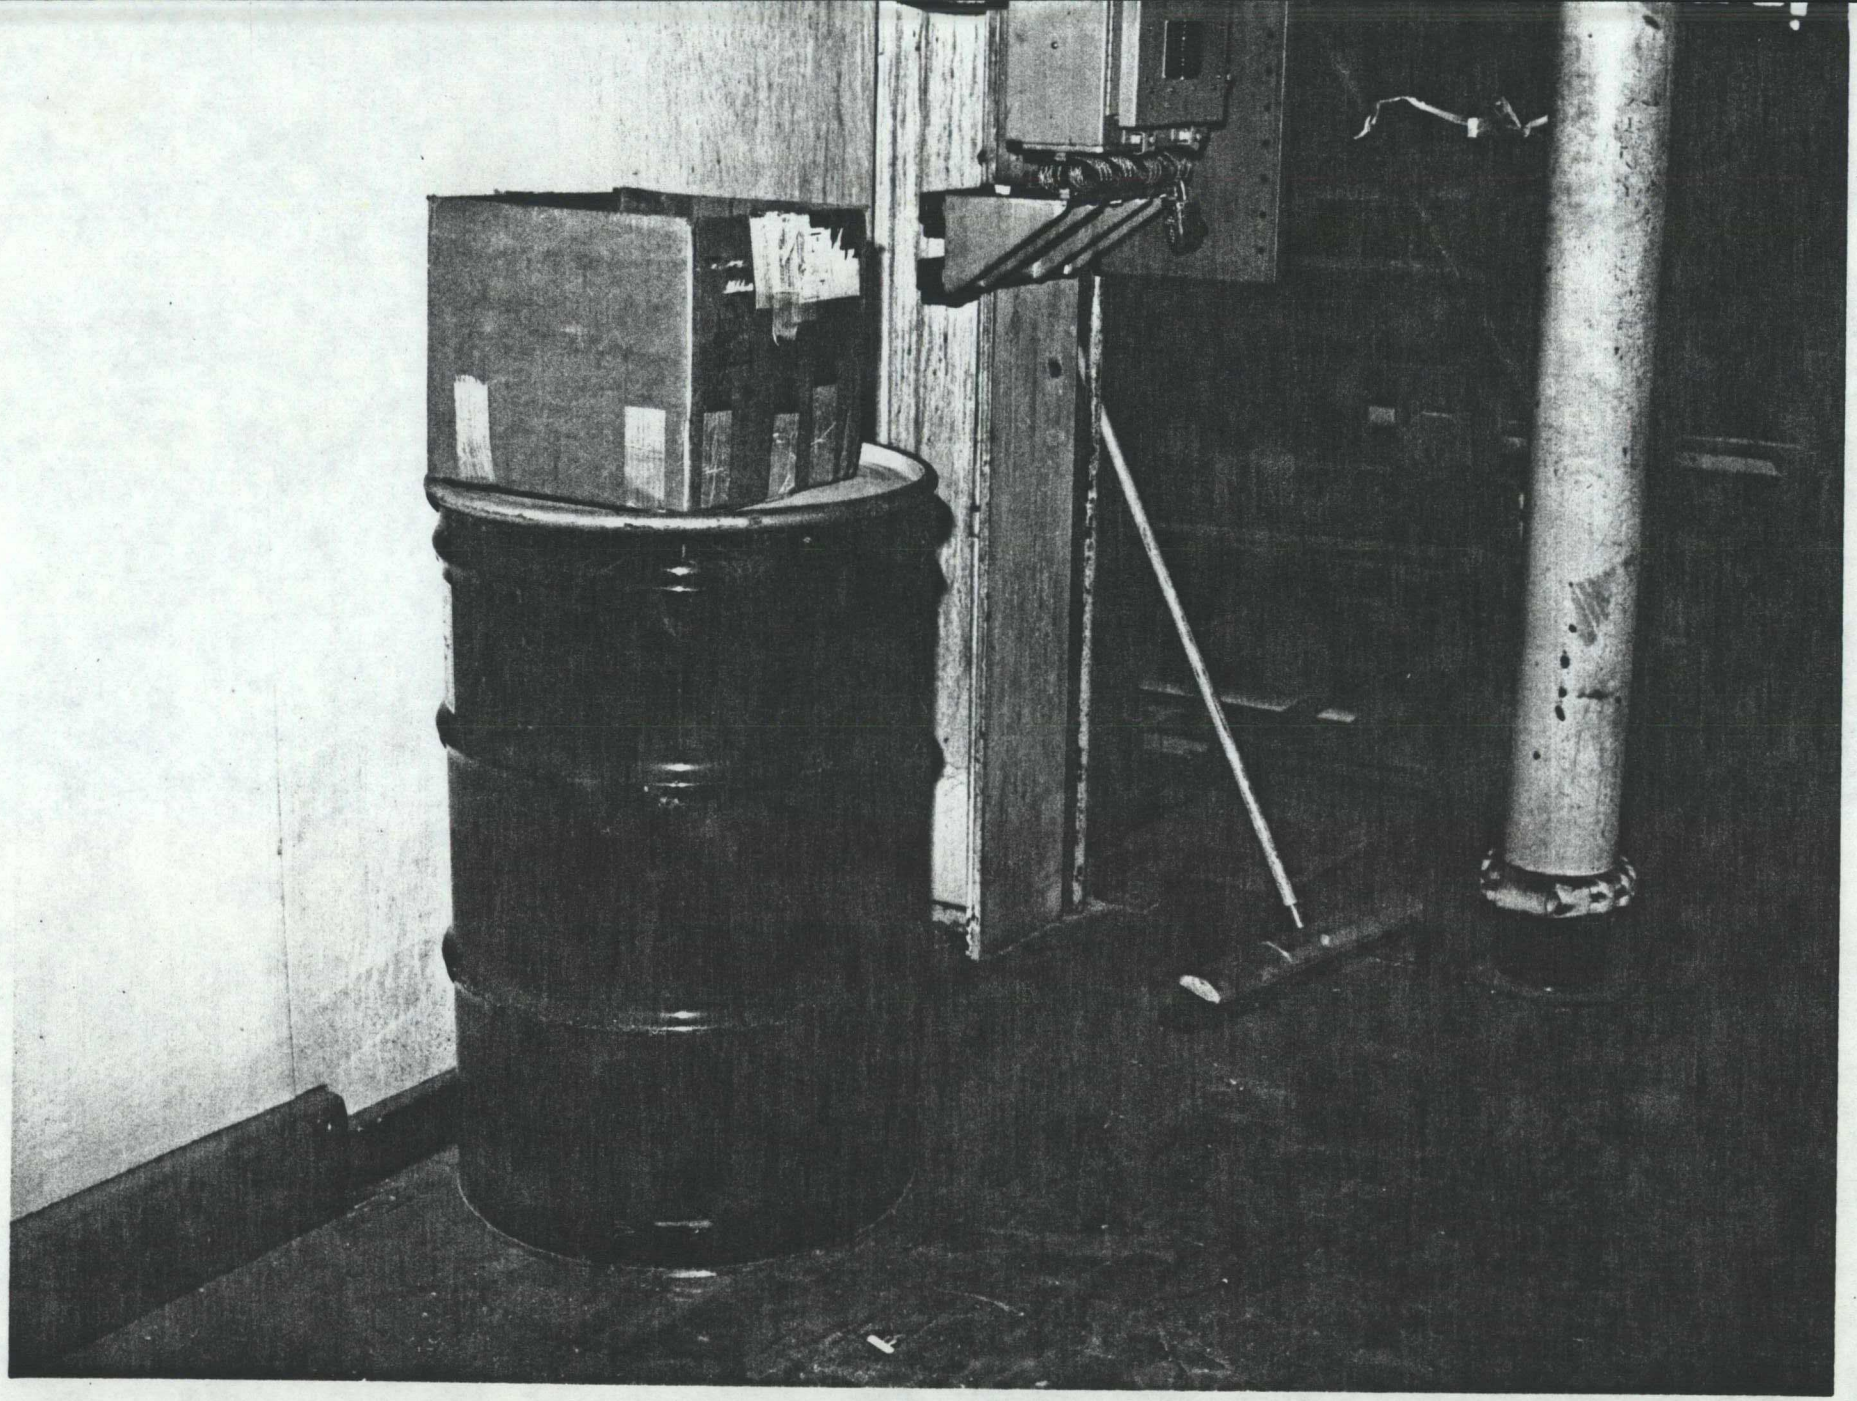
DATE: 11-15-86 NAME: Schmit #27

Drum of clean-up materials used by IT. Ladder to transformer deck is visible at right of center. Drum was dated 10-10-85 but did not have MR. Also note push broom.

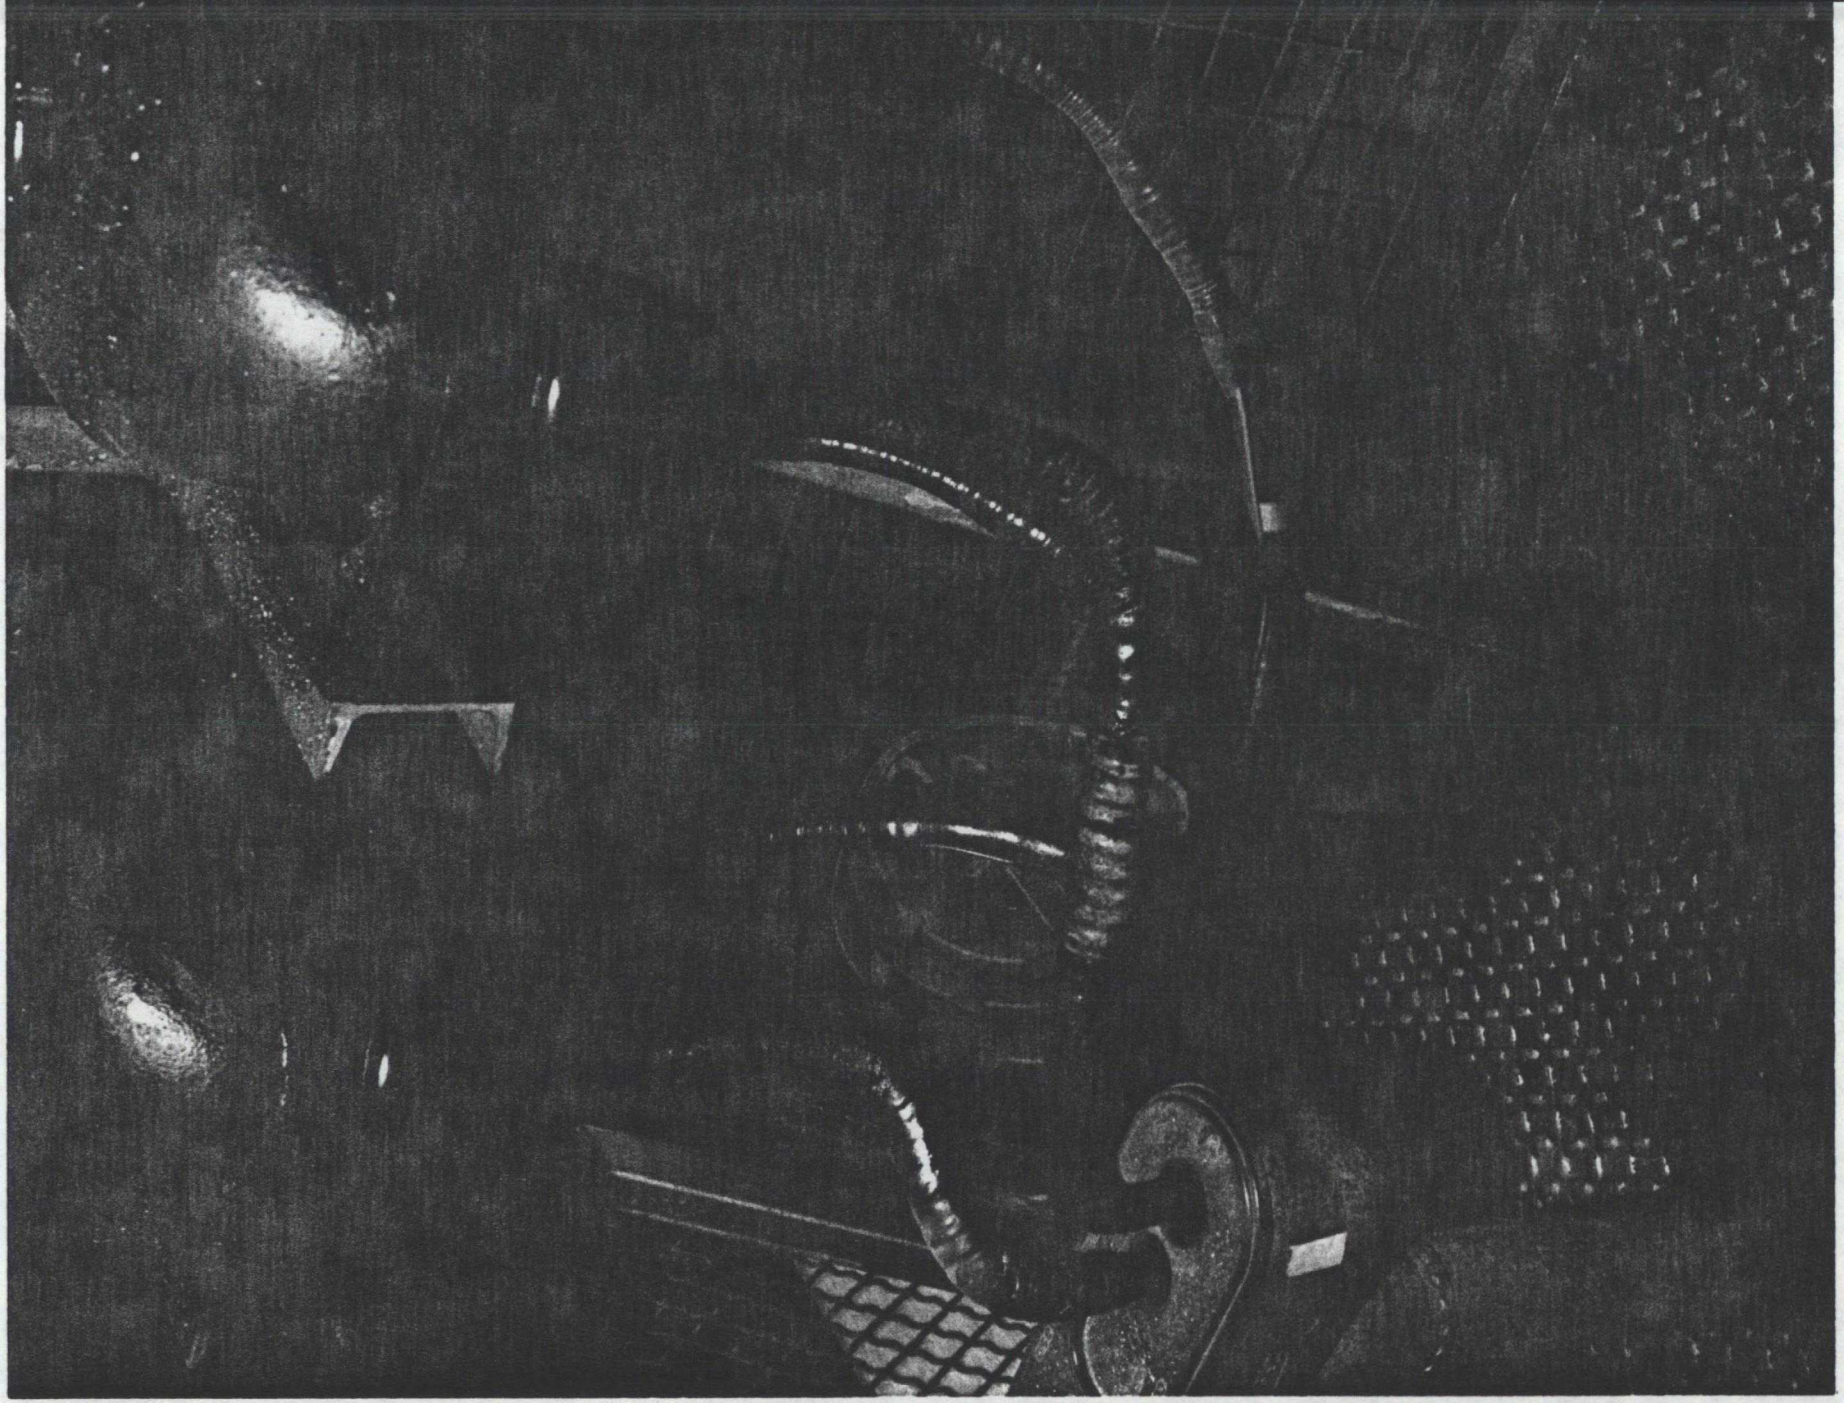
DATE: 11-15-86 NAME: Schmit #28

Leaking oil fuse cutout switches located on the 2nd Mezz. transformer deck at Col. C-16. Note oily material on cables, switch supports, & substation deck

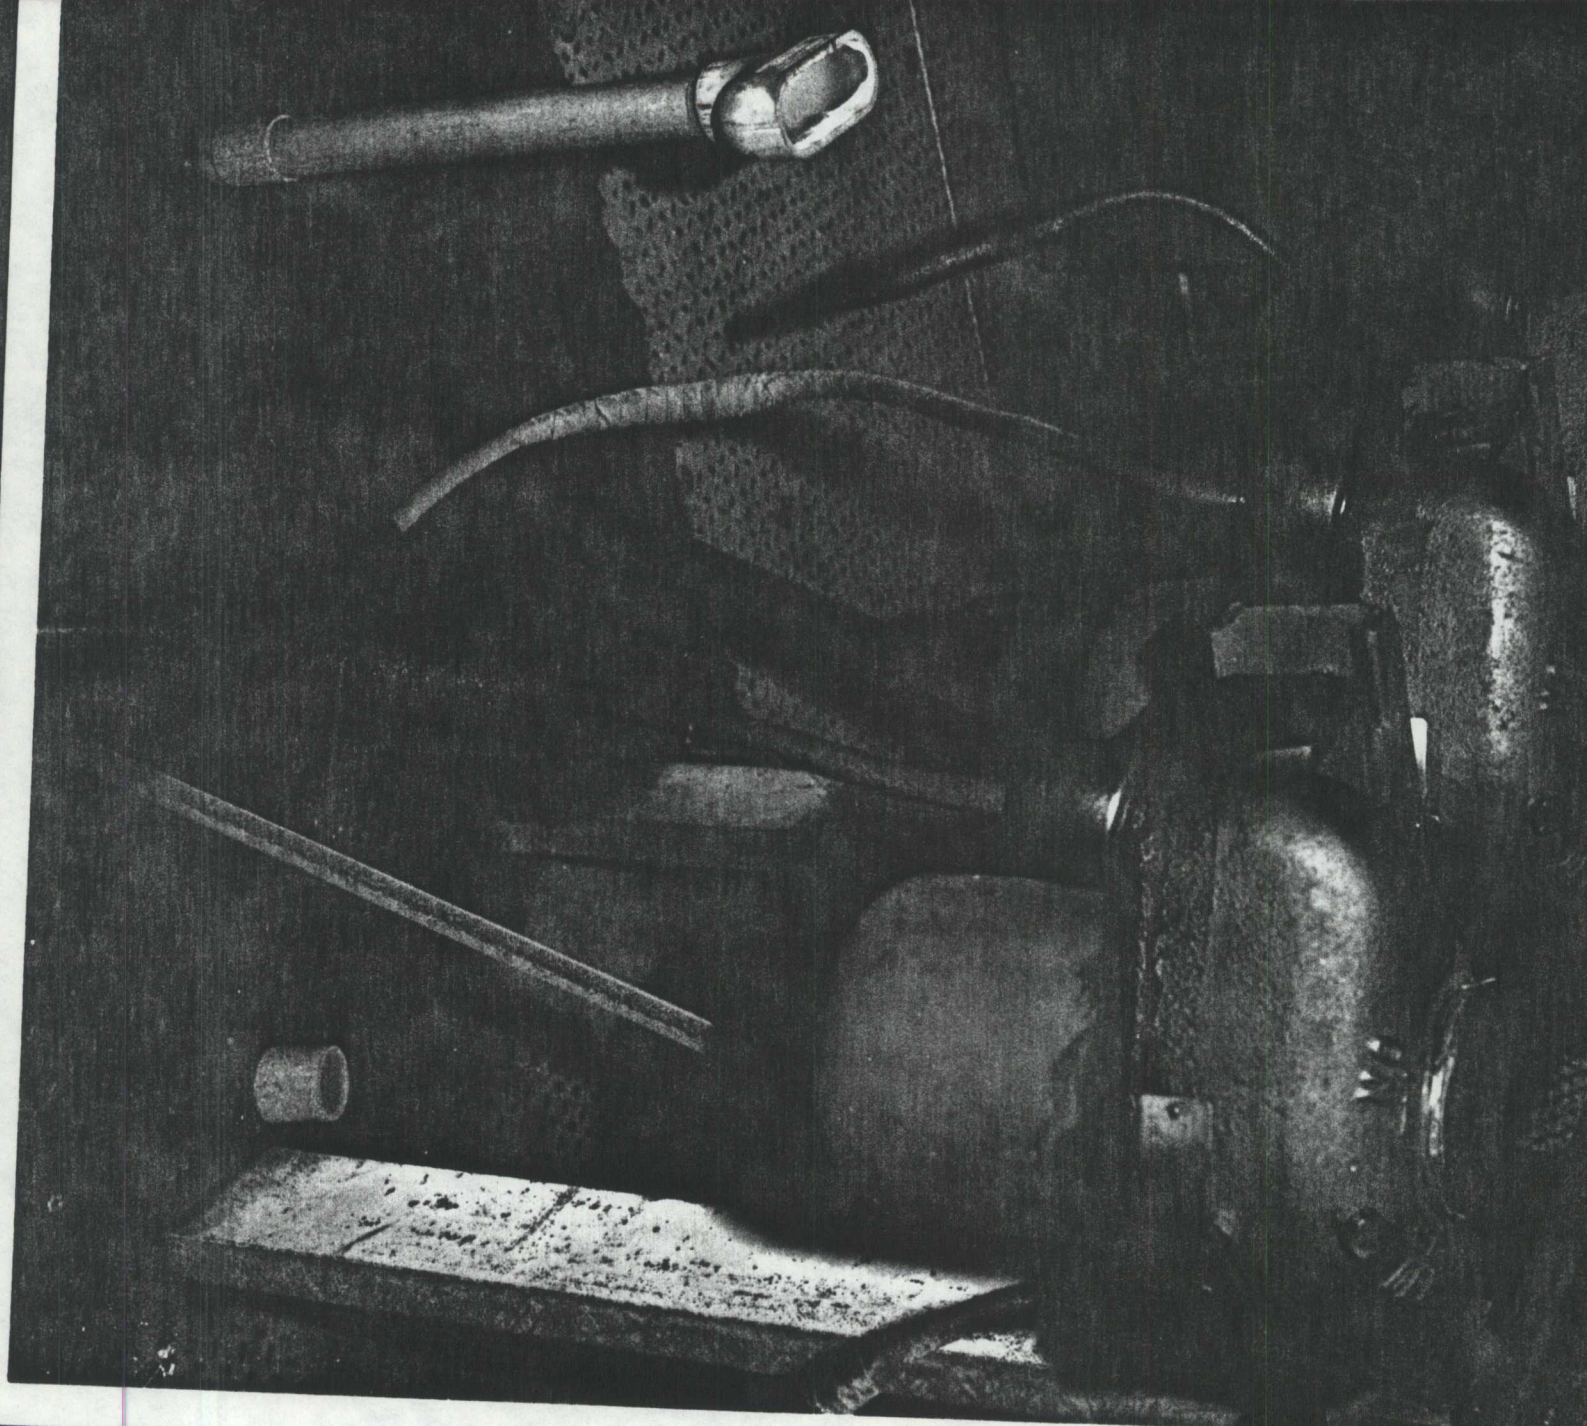
DATE: 11-15-86 NAME: Schmit #29

Another set of locking off switches, located on the 2nd Mezz. transformer deck at Col. C-22.
