SFUND RECORDS CTR
2385815

DATE: 11·14·85 NAME: Schmit #1
DESCRIPTION: GenDyn-Bldg 1
Ground floor substation w/ 3 retrofilled Westinghouse transformers, #3011134 → #3011136.

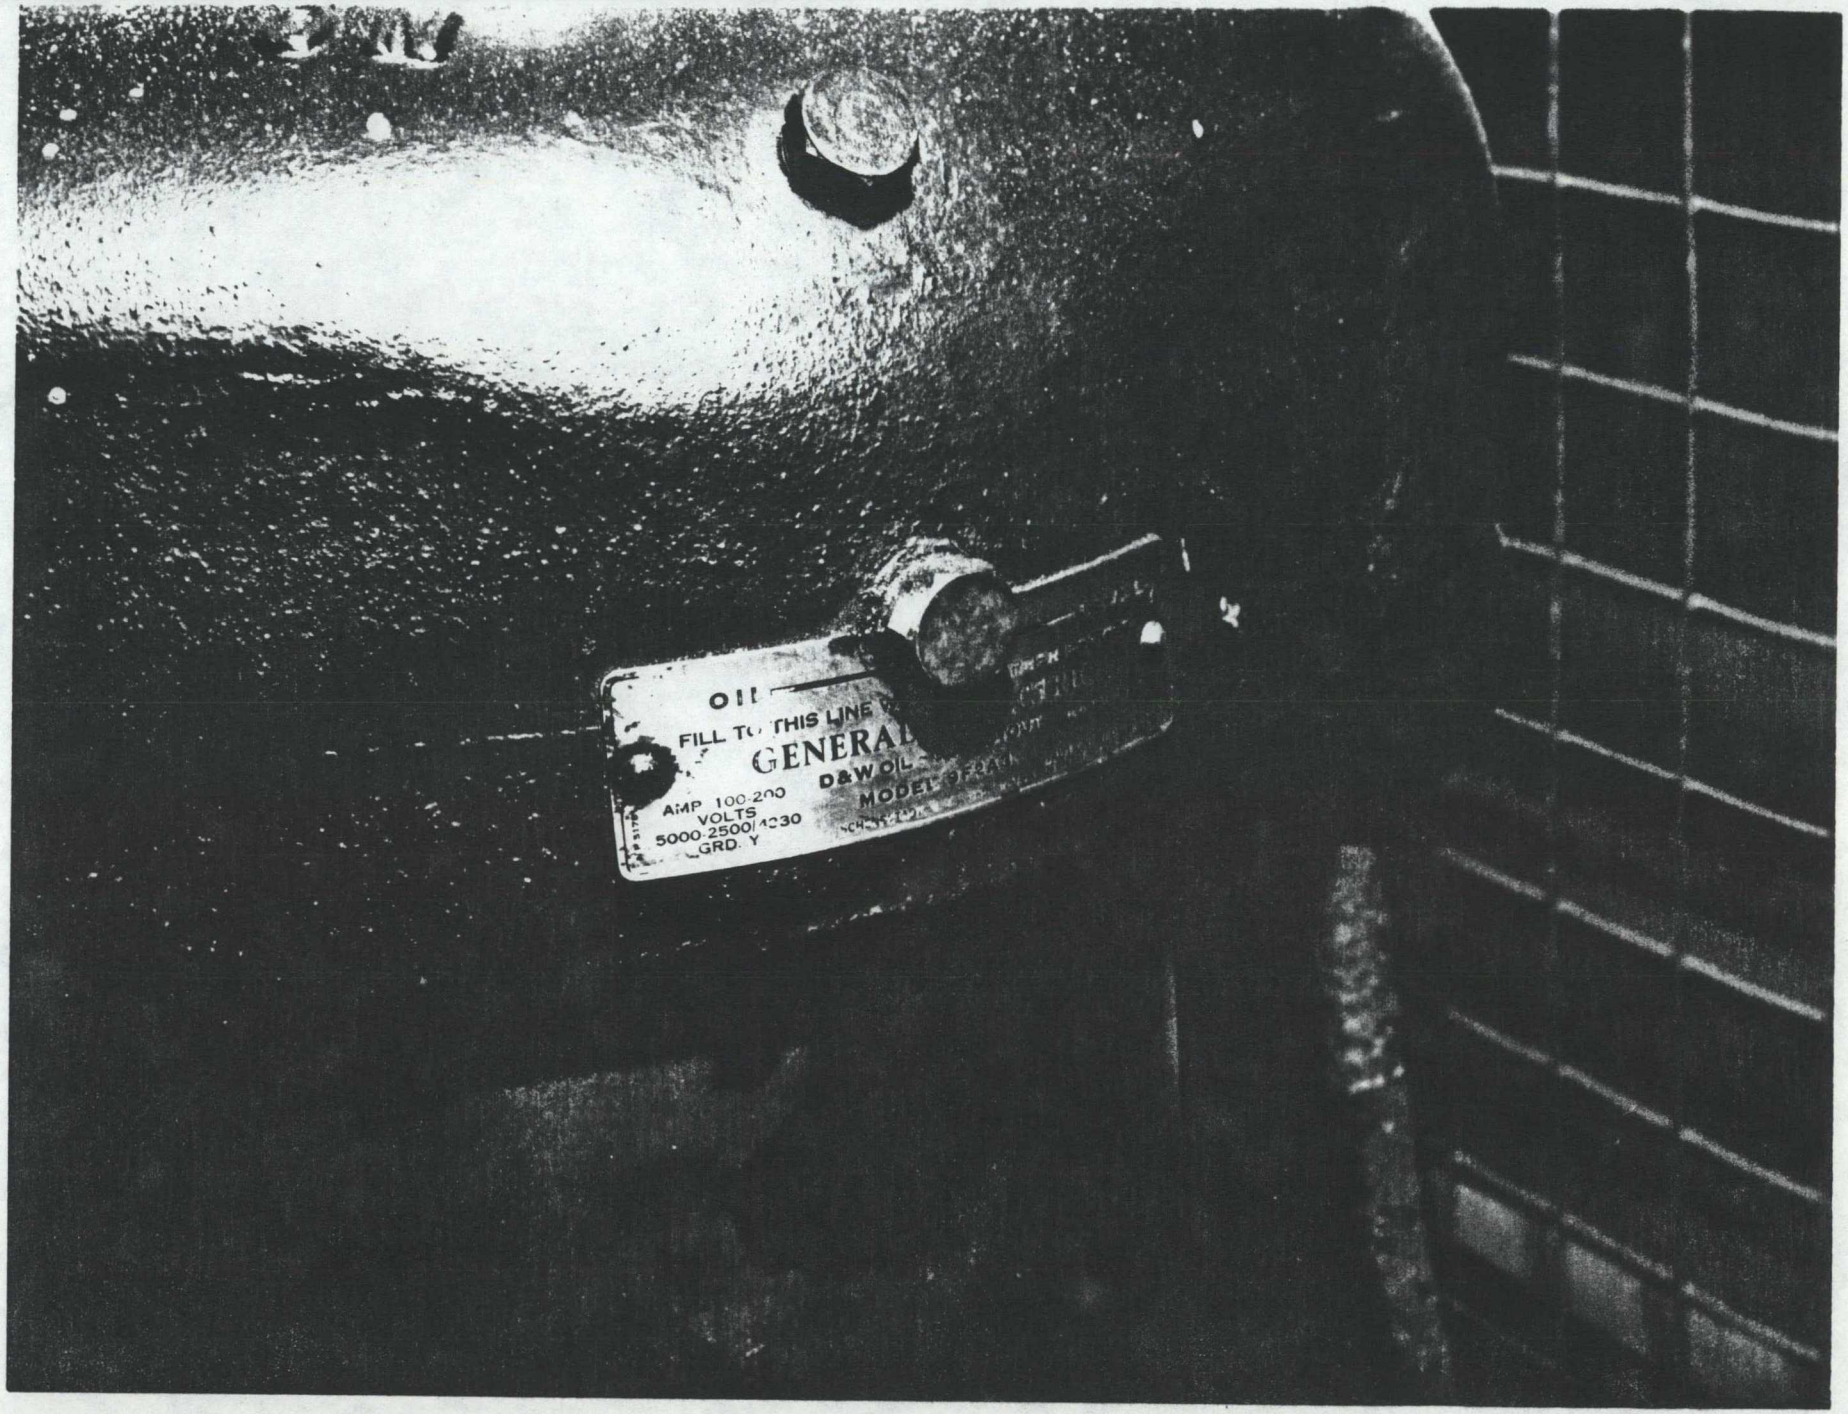
DATE: 11.15.86 NAME: Schmit #50

Close-up of an oil fuse cutout switch typical of those which were found to be leaking throughout Plant 19.

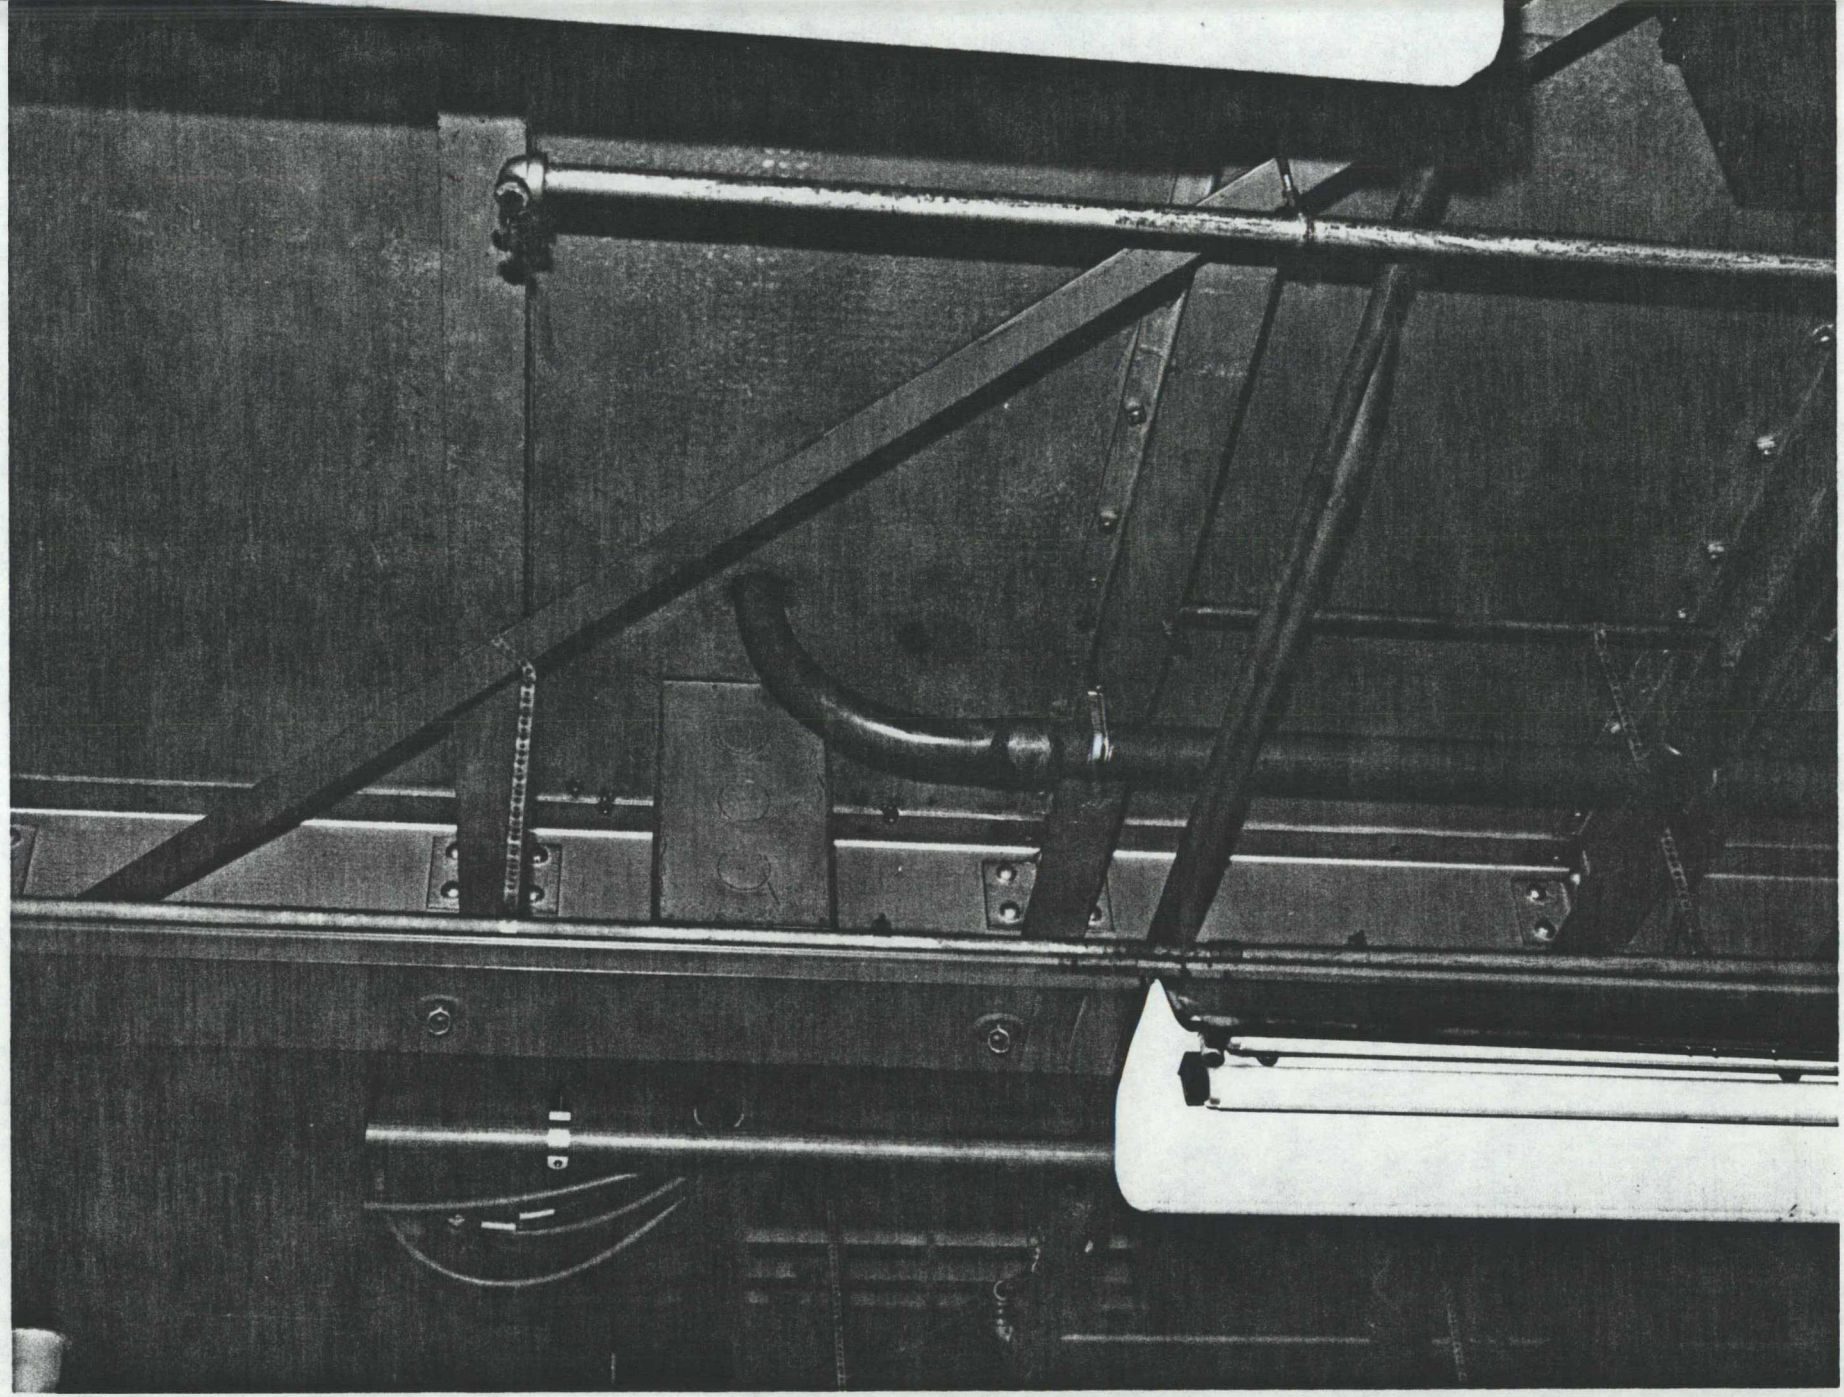
DATE: 11-15-86 NAME: Schmit #32

Leaks from Col. C-22 substation deck.

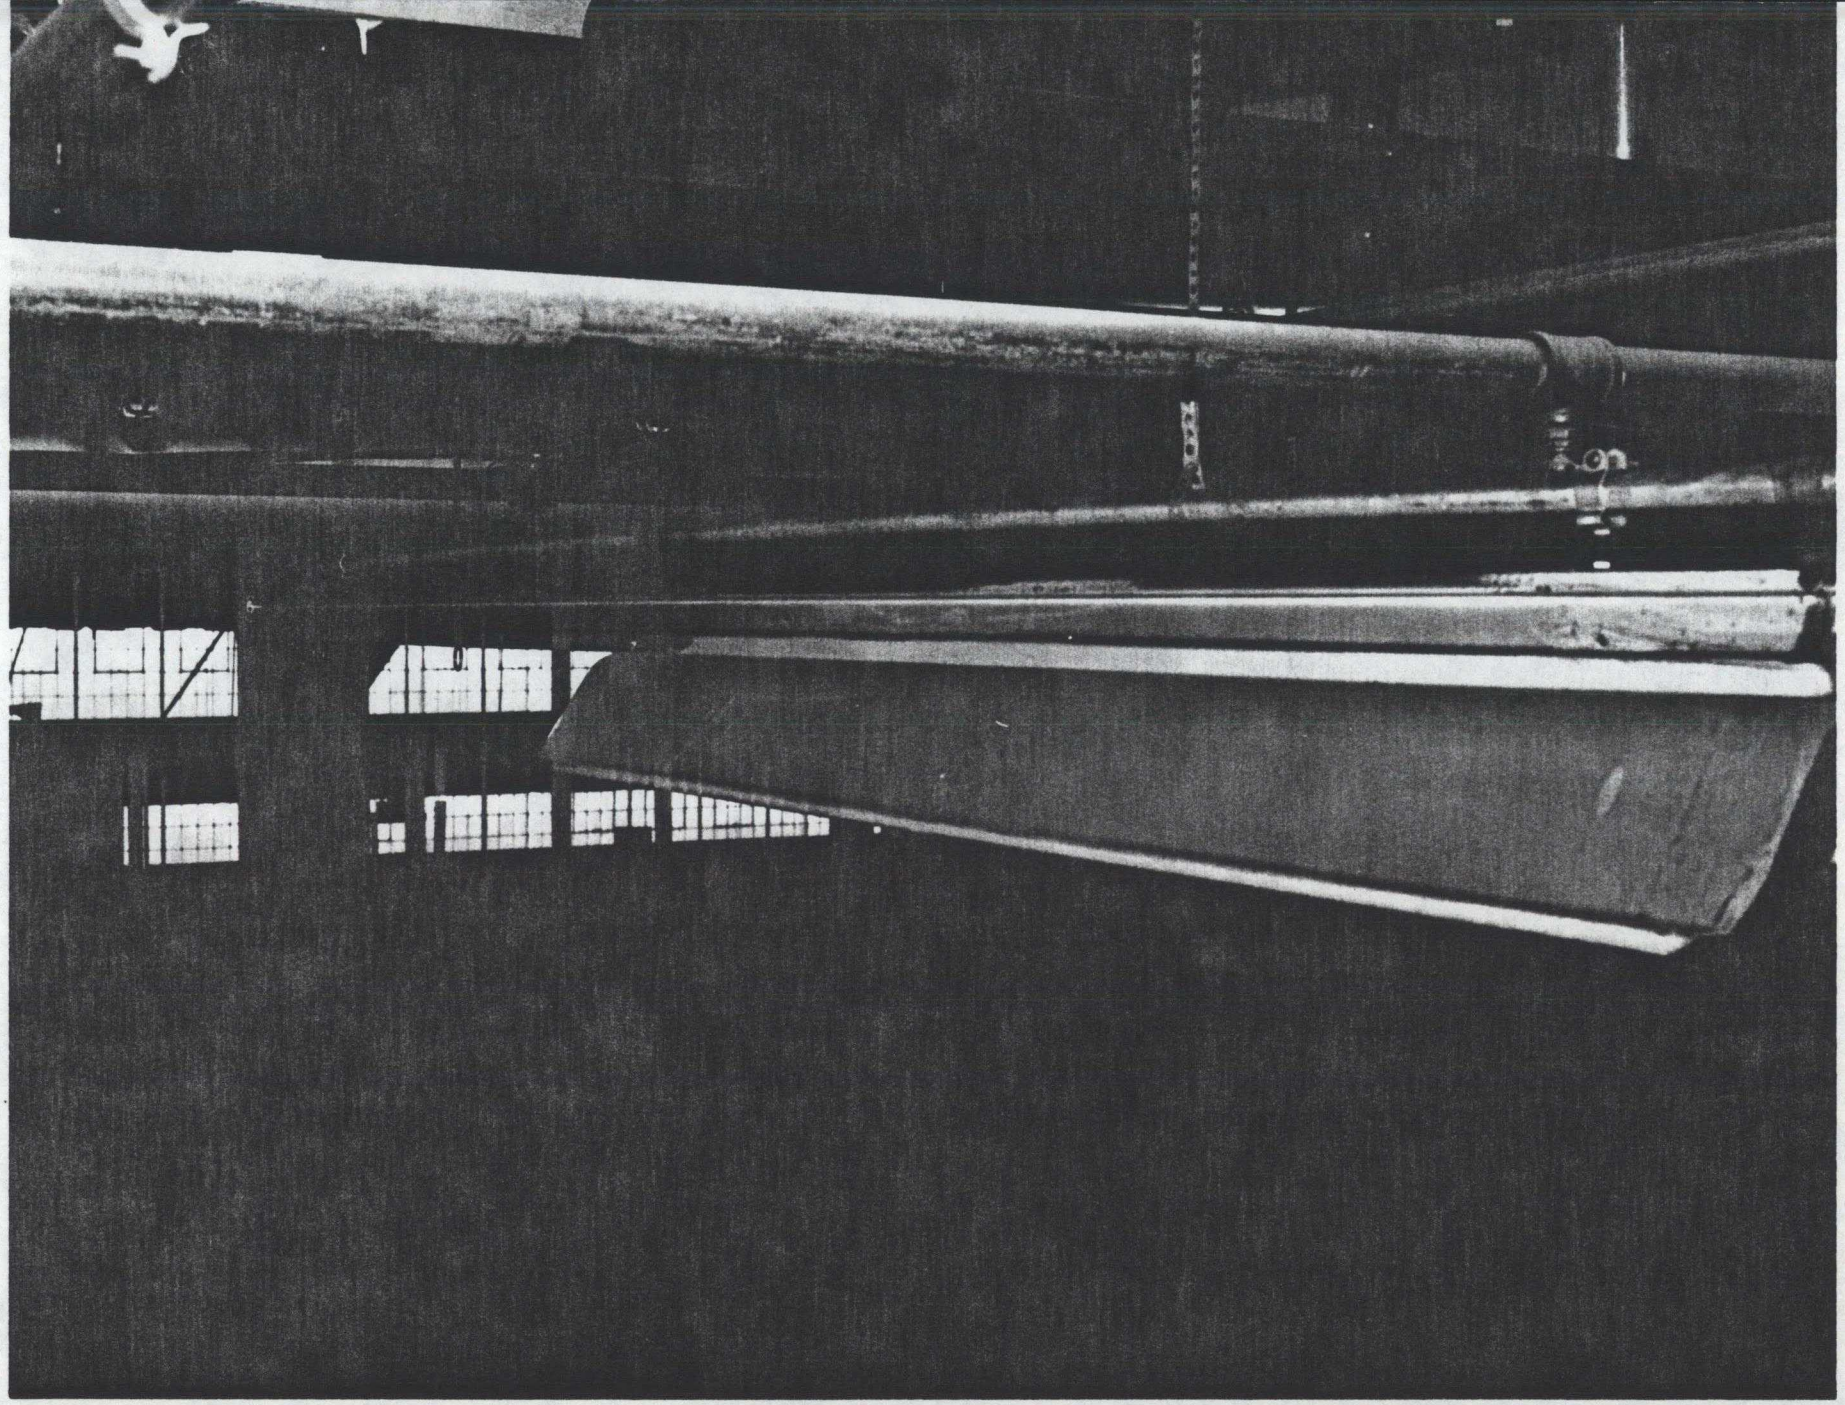
DATE: 11.15.86 NAME: Schmit #33

Contamination of pipe & ballast resulting from leaks from Col. Ct 22 substation.

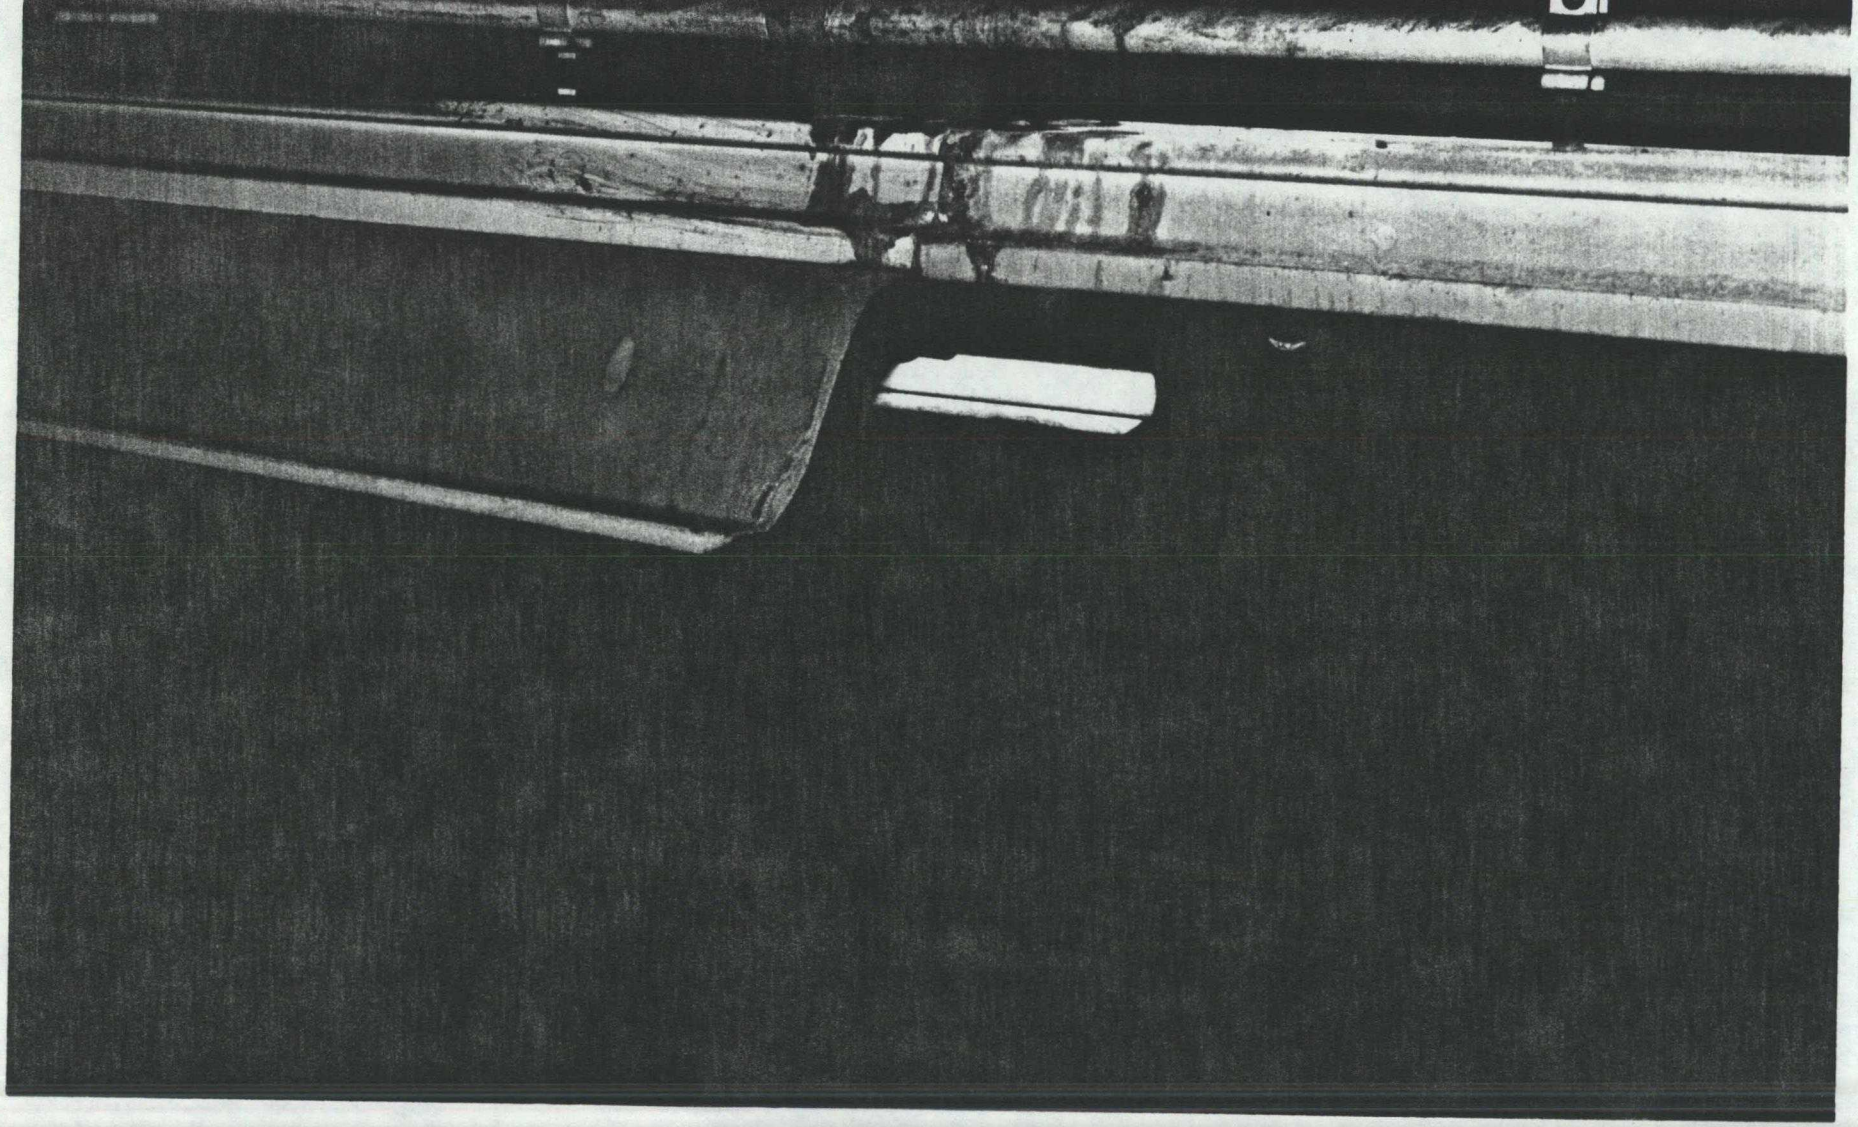
DATE: 11.15.86 NAME: Schmit #34
DESCRIPTION: GenDyn-Bldg 1
Contamination on light ballast from fats from
Col. C-22 substation

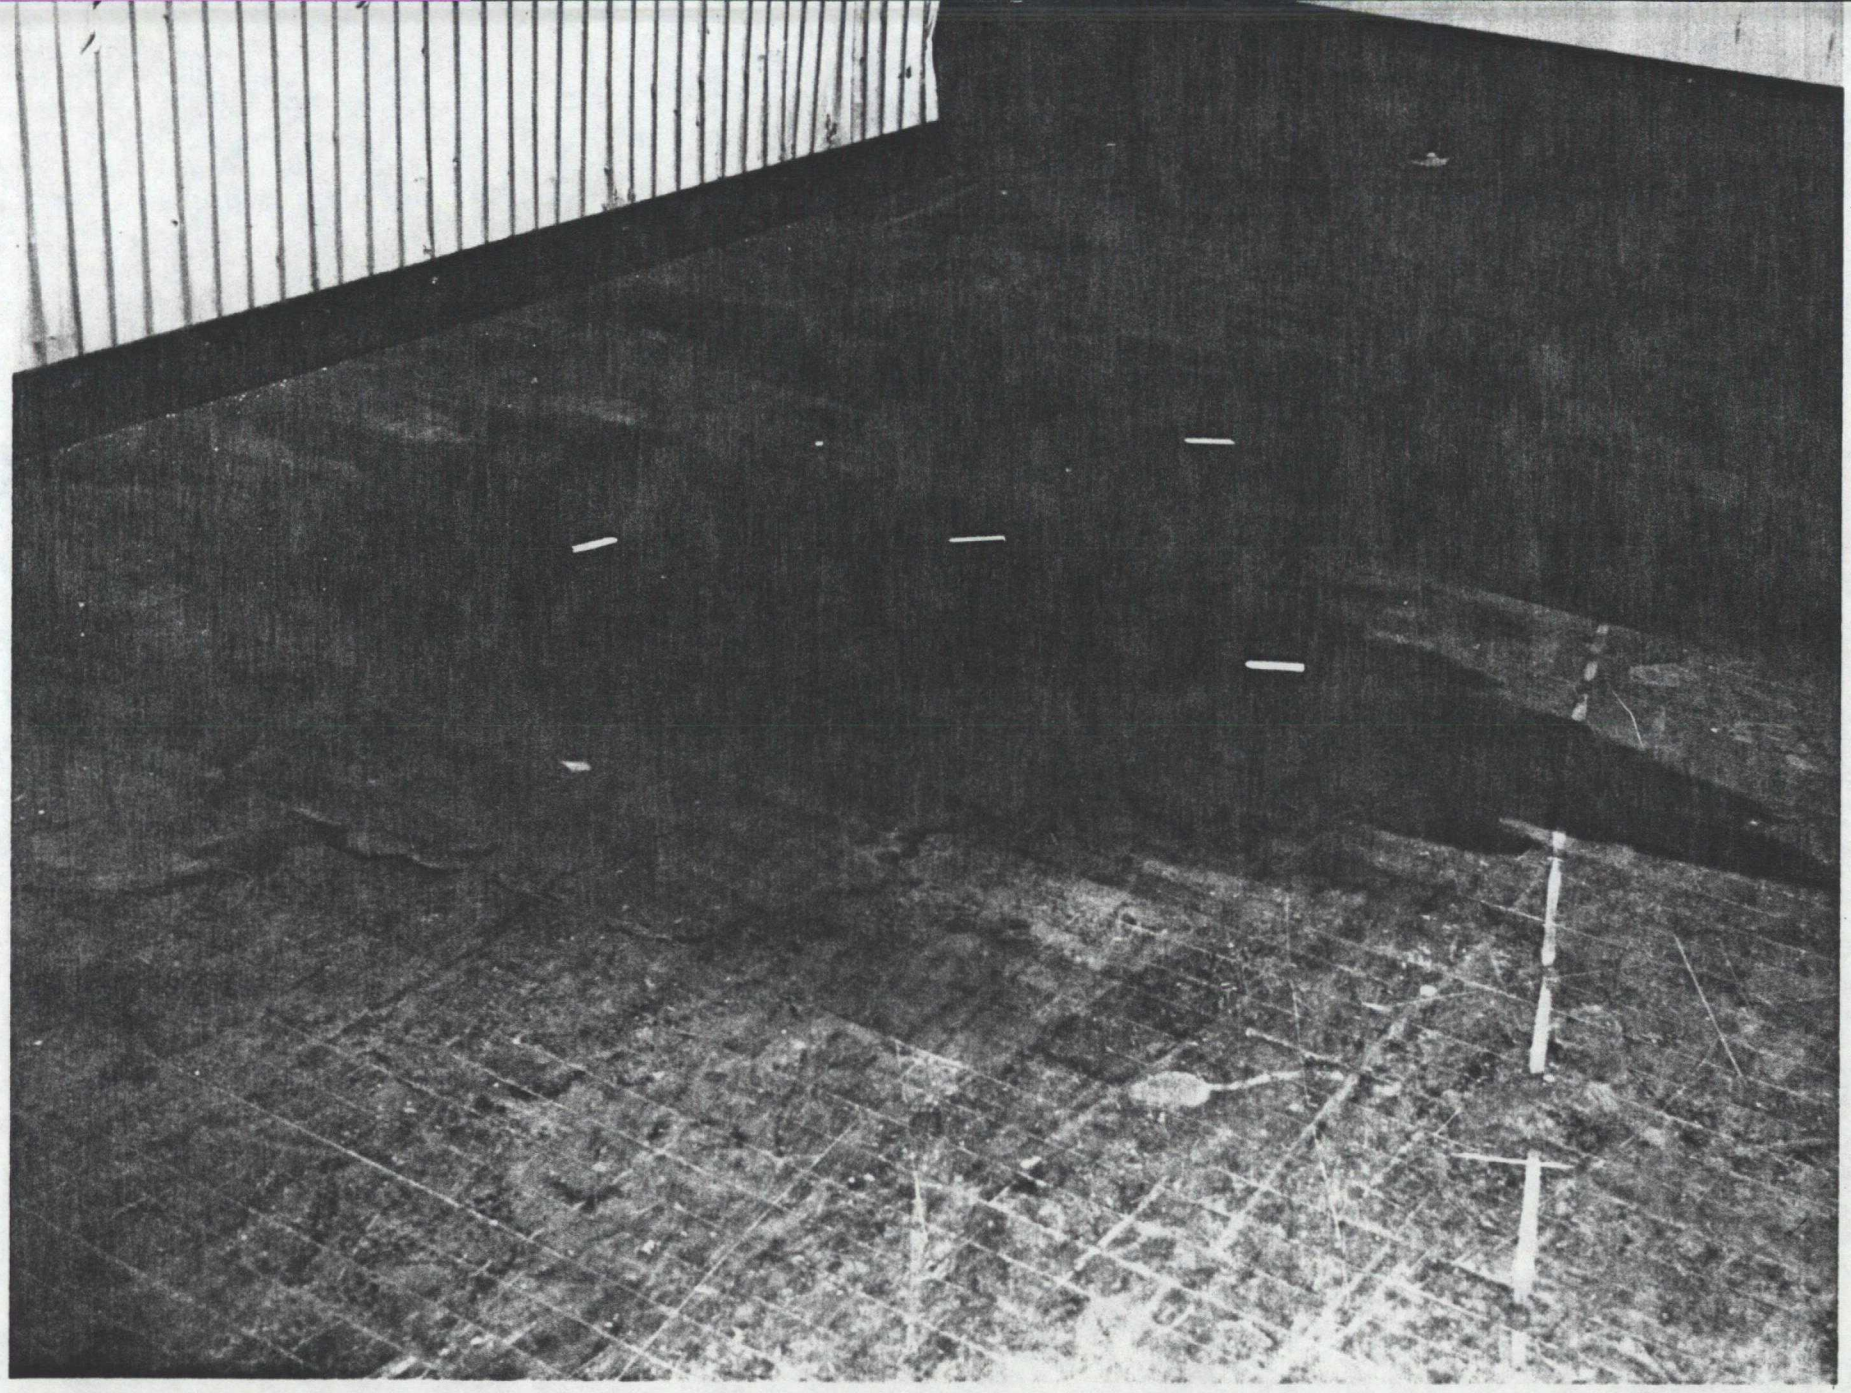
DATE: 11.15.86 NAME: Schmit #35

Floor beneath col. C-22 substation saturated with dielectric fluid.

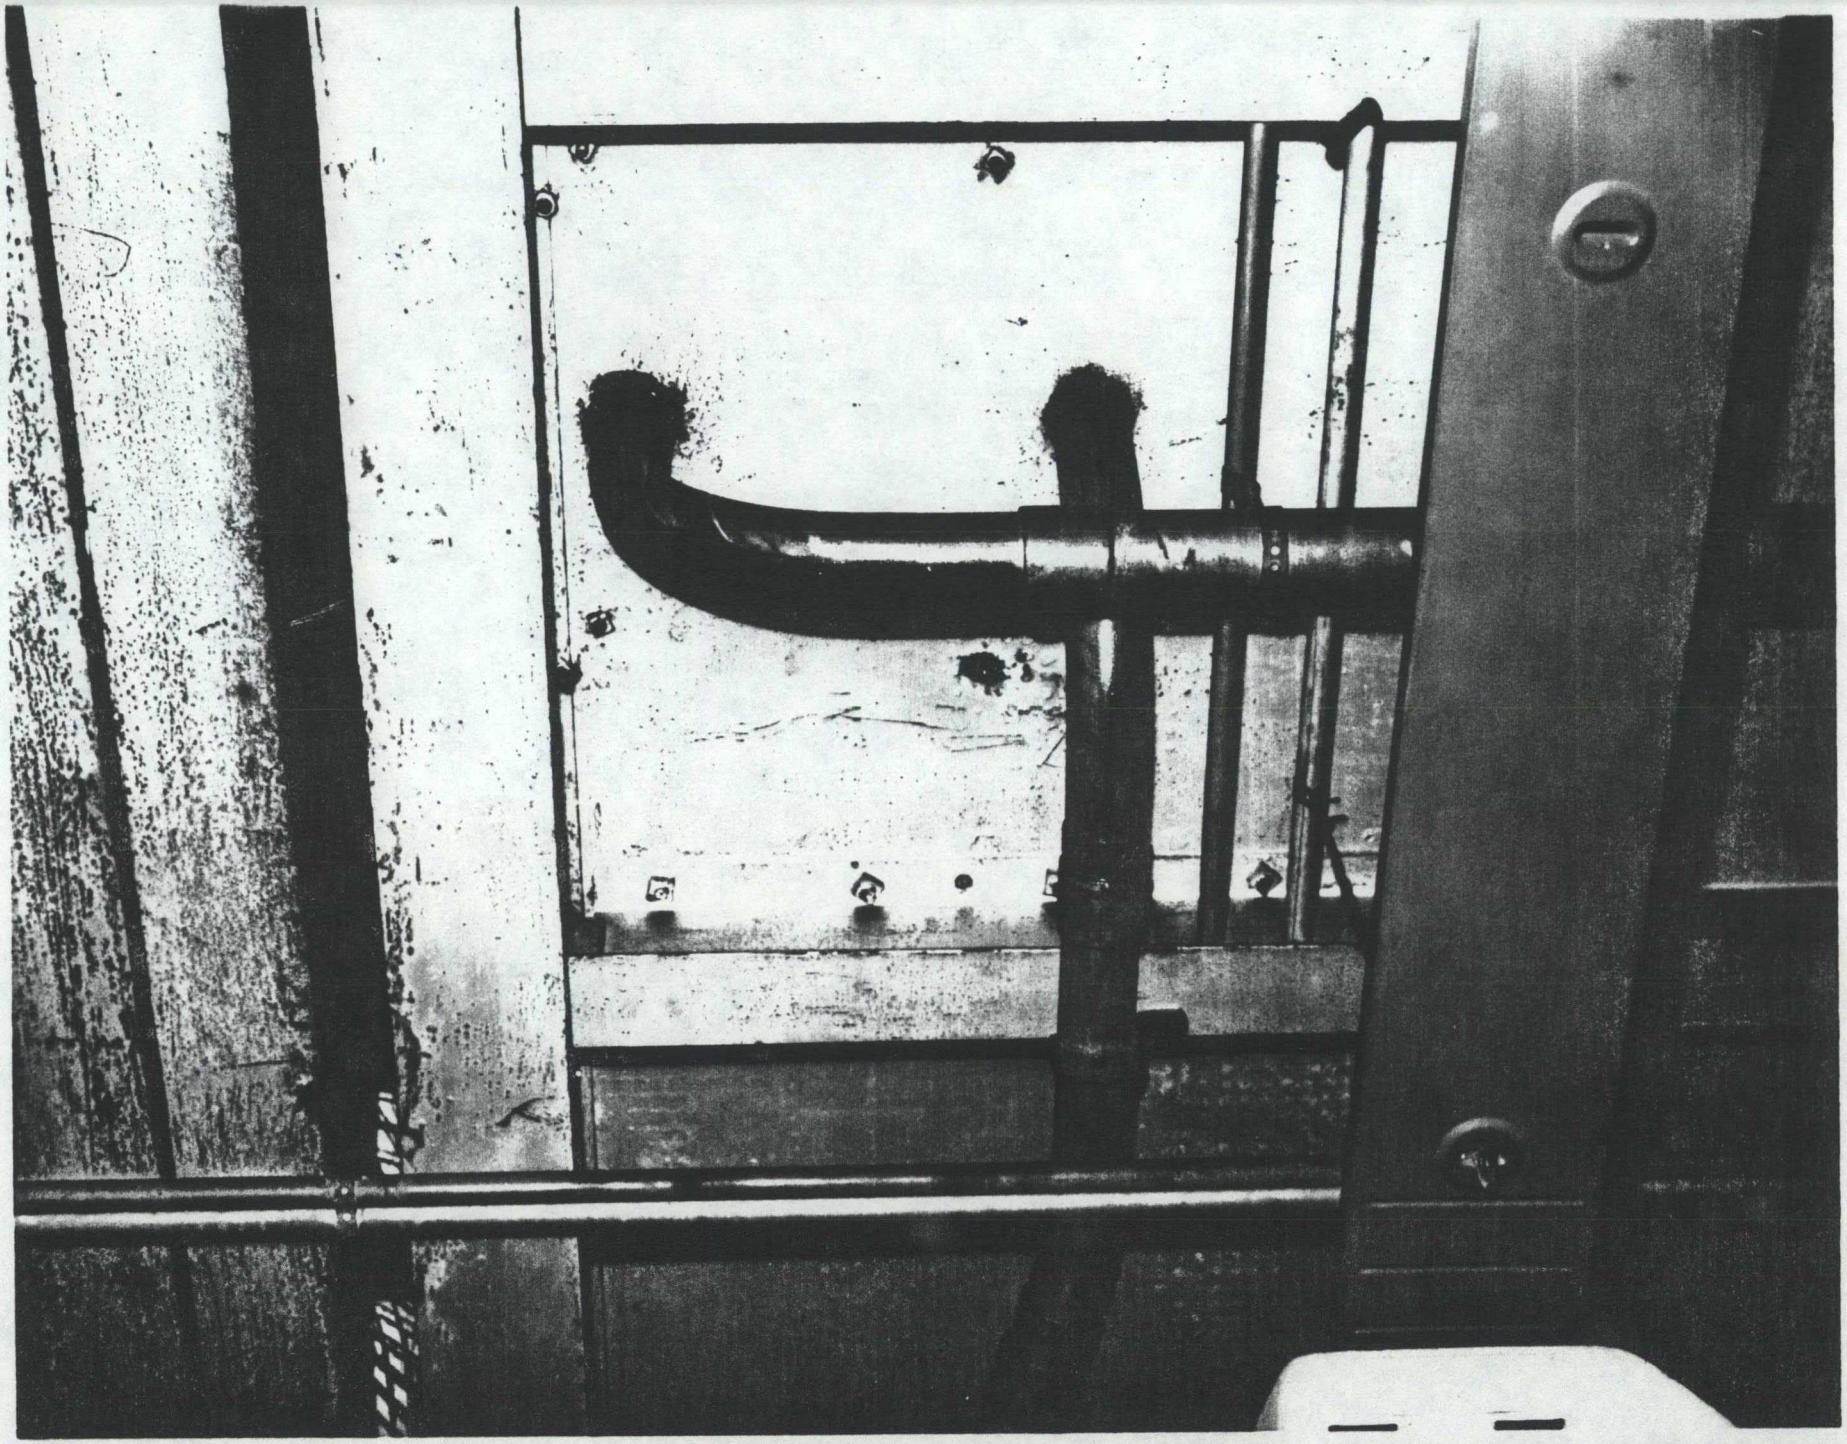
DATE: 11·15·86 NAME: Schmit #38

Material leaking from deck of substation at Col. C-10.

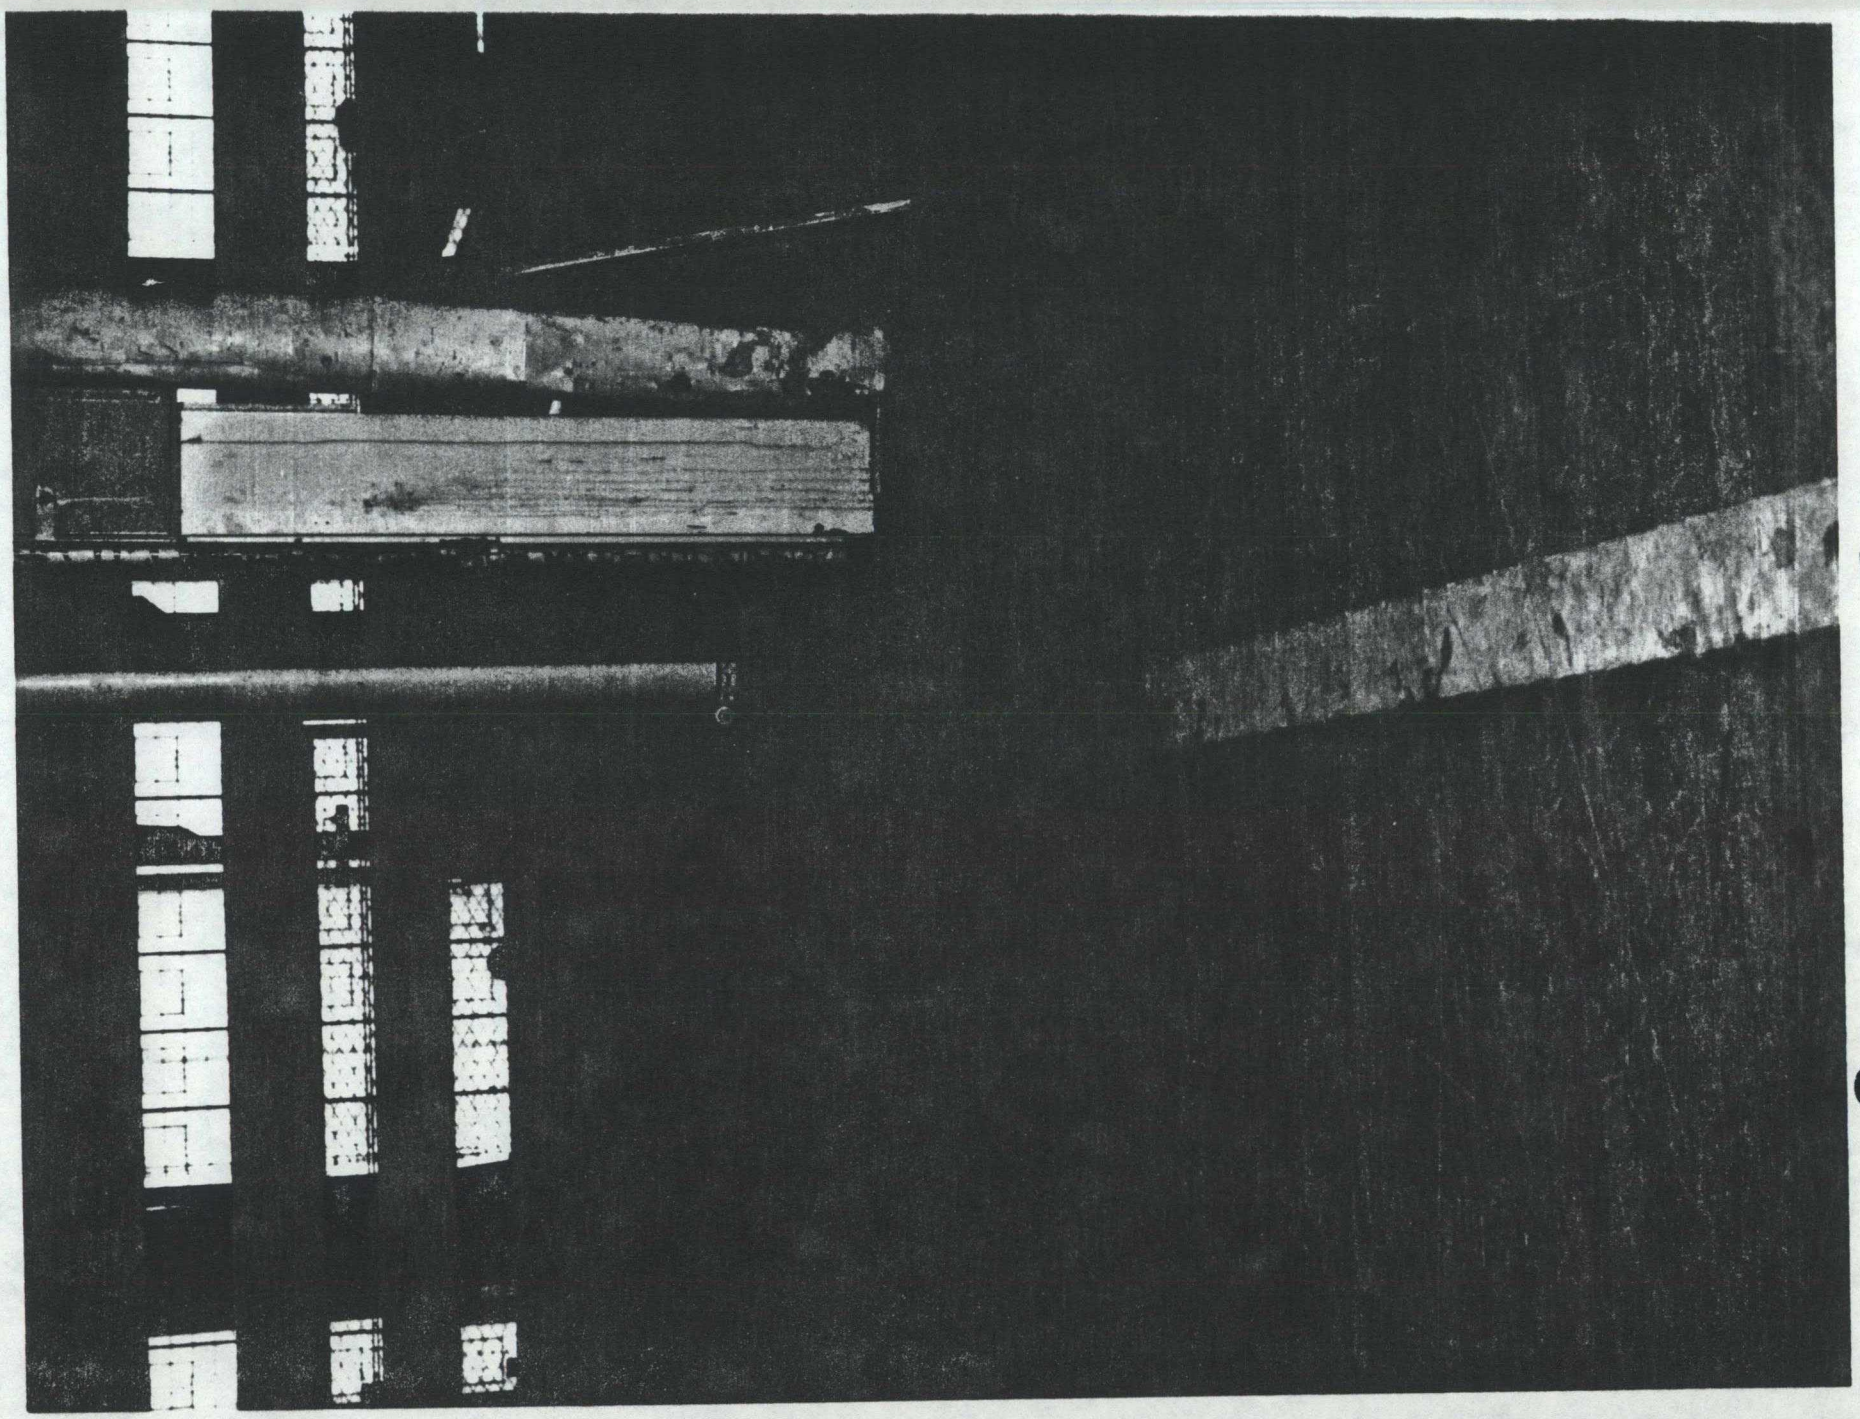
DATE: 11·15·86 NAME: Schmit #39

Stained area beneath Col. C-10 substation

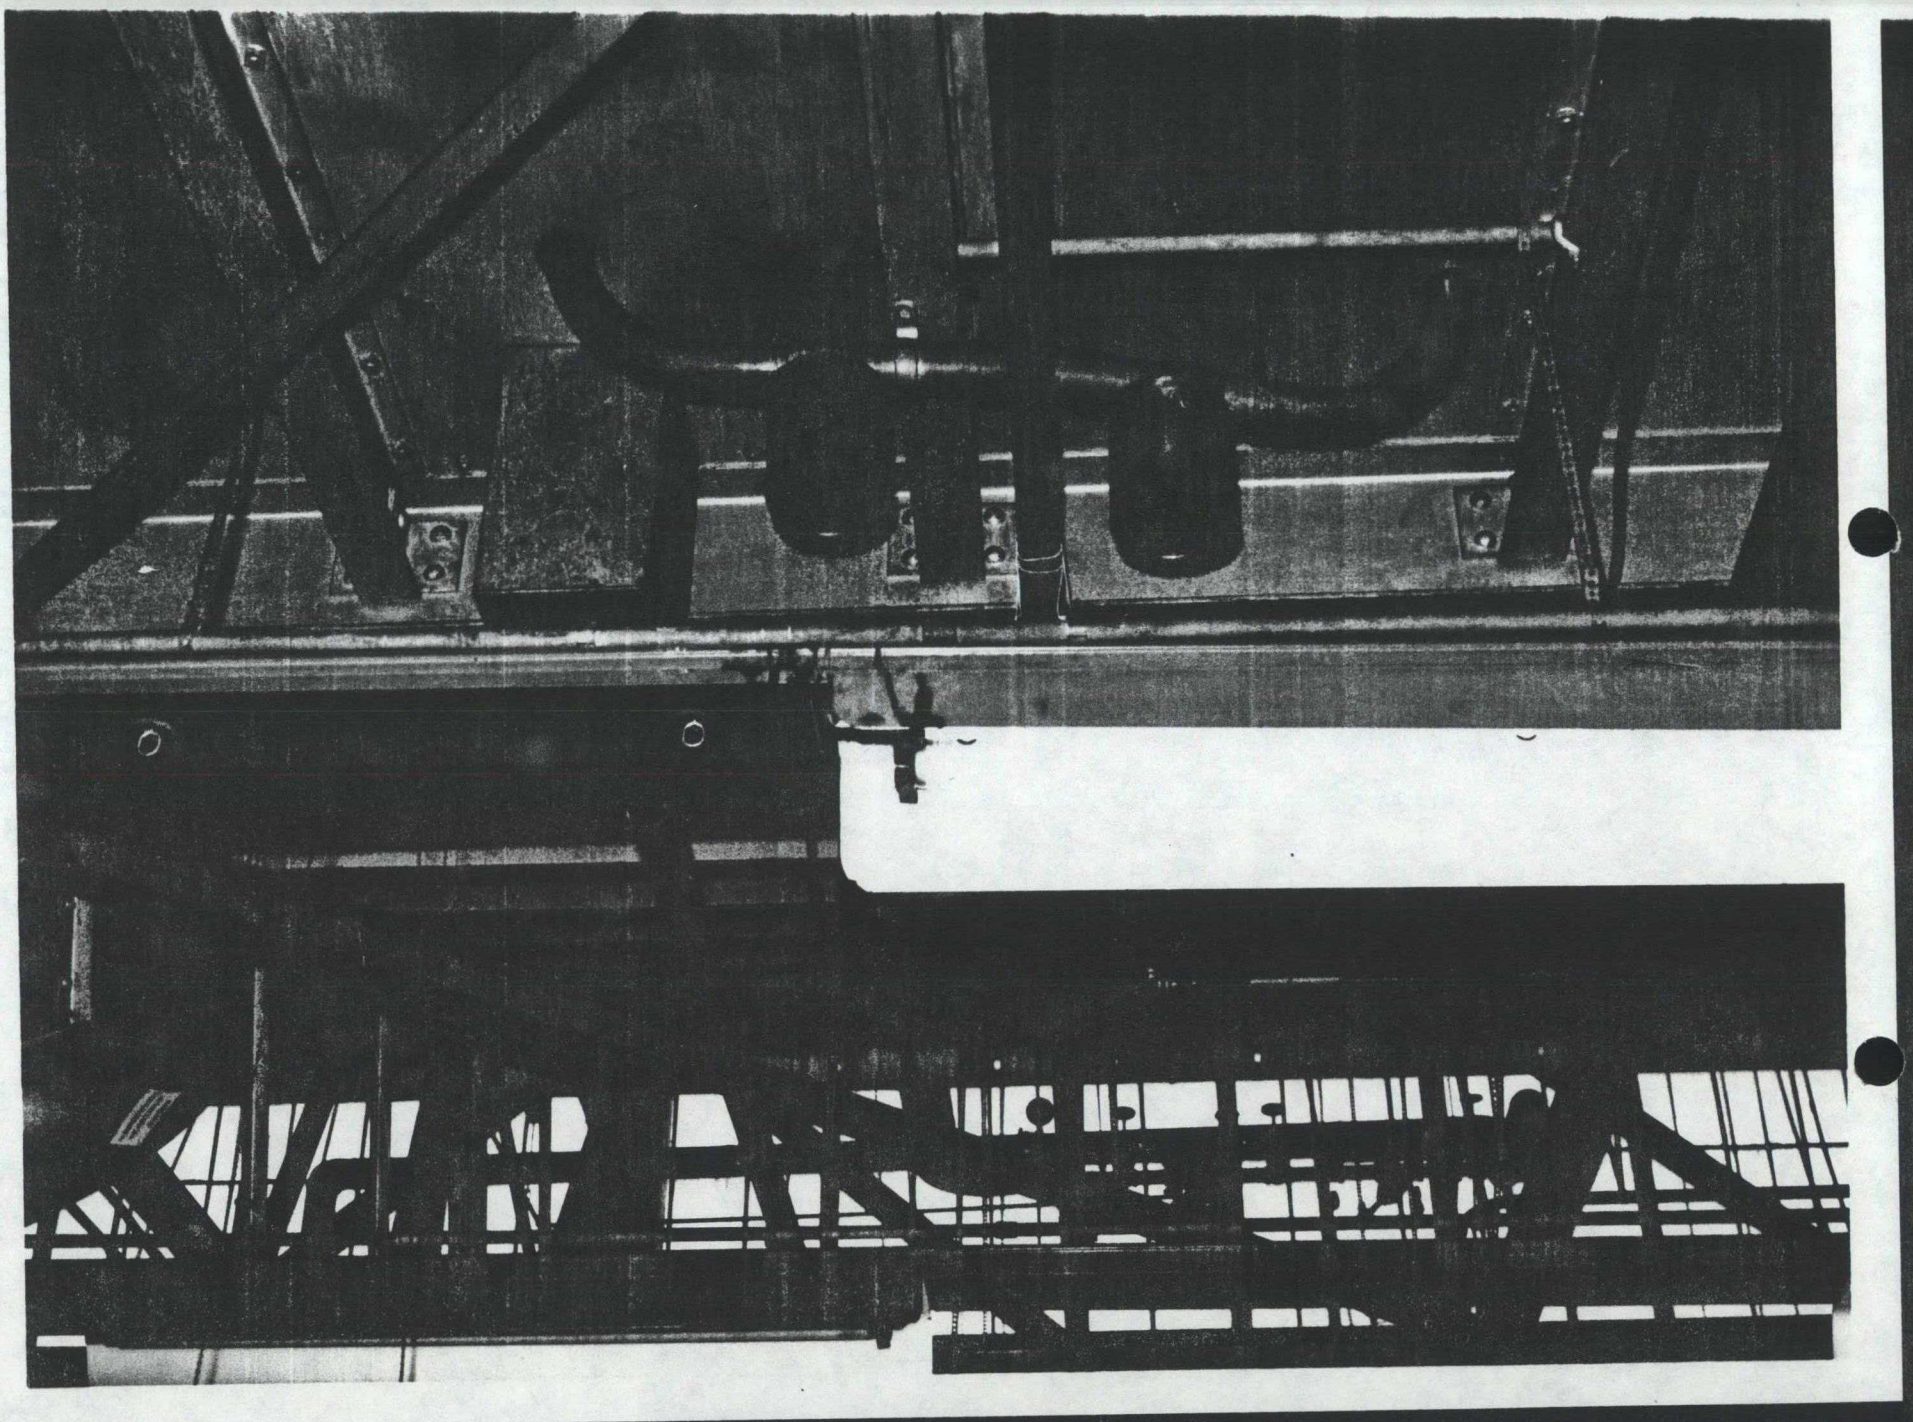
DATE: 11·15·86 NAME: Schmit #41
DESCRIPTION: GenDyn-Bldg 1
Leakage from rivet on deck @ Col. C-4 substation.
Buckets were placed to catch drips from pipe.
Note also contamination on ballast/scaffolding.

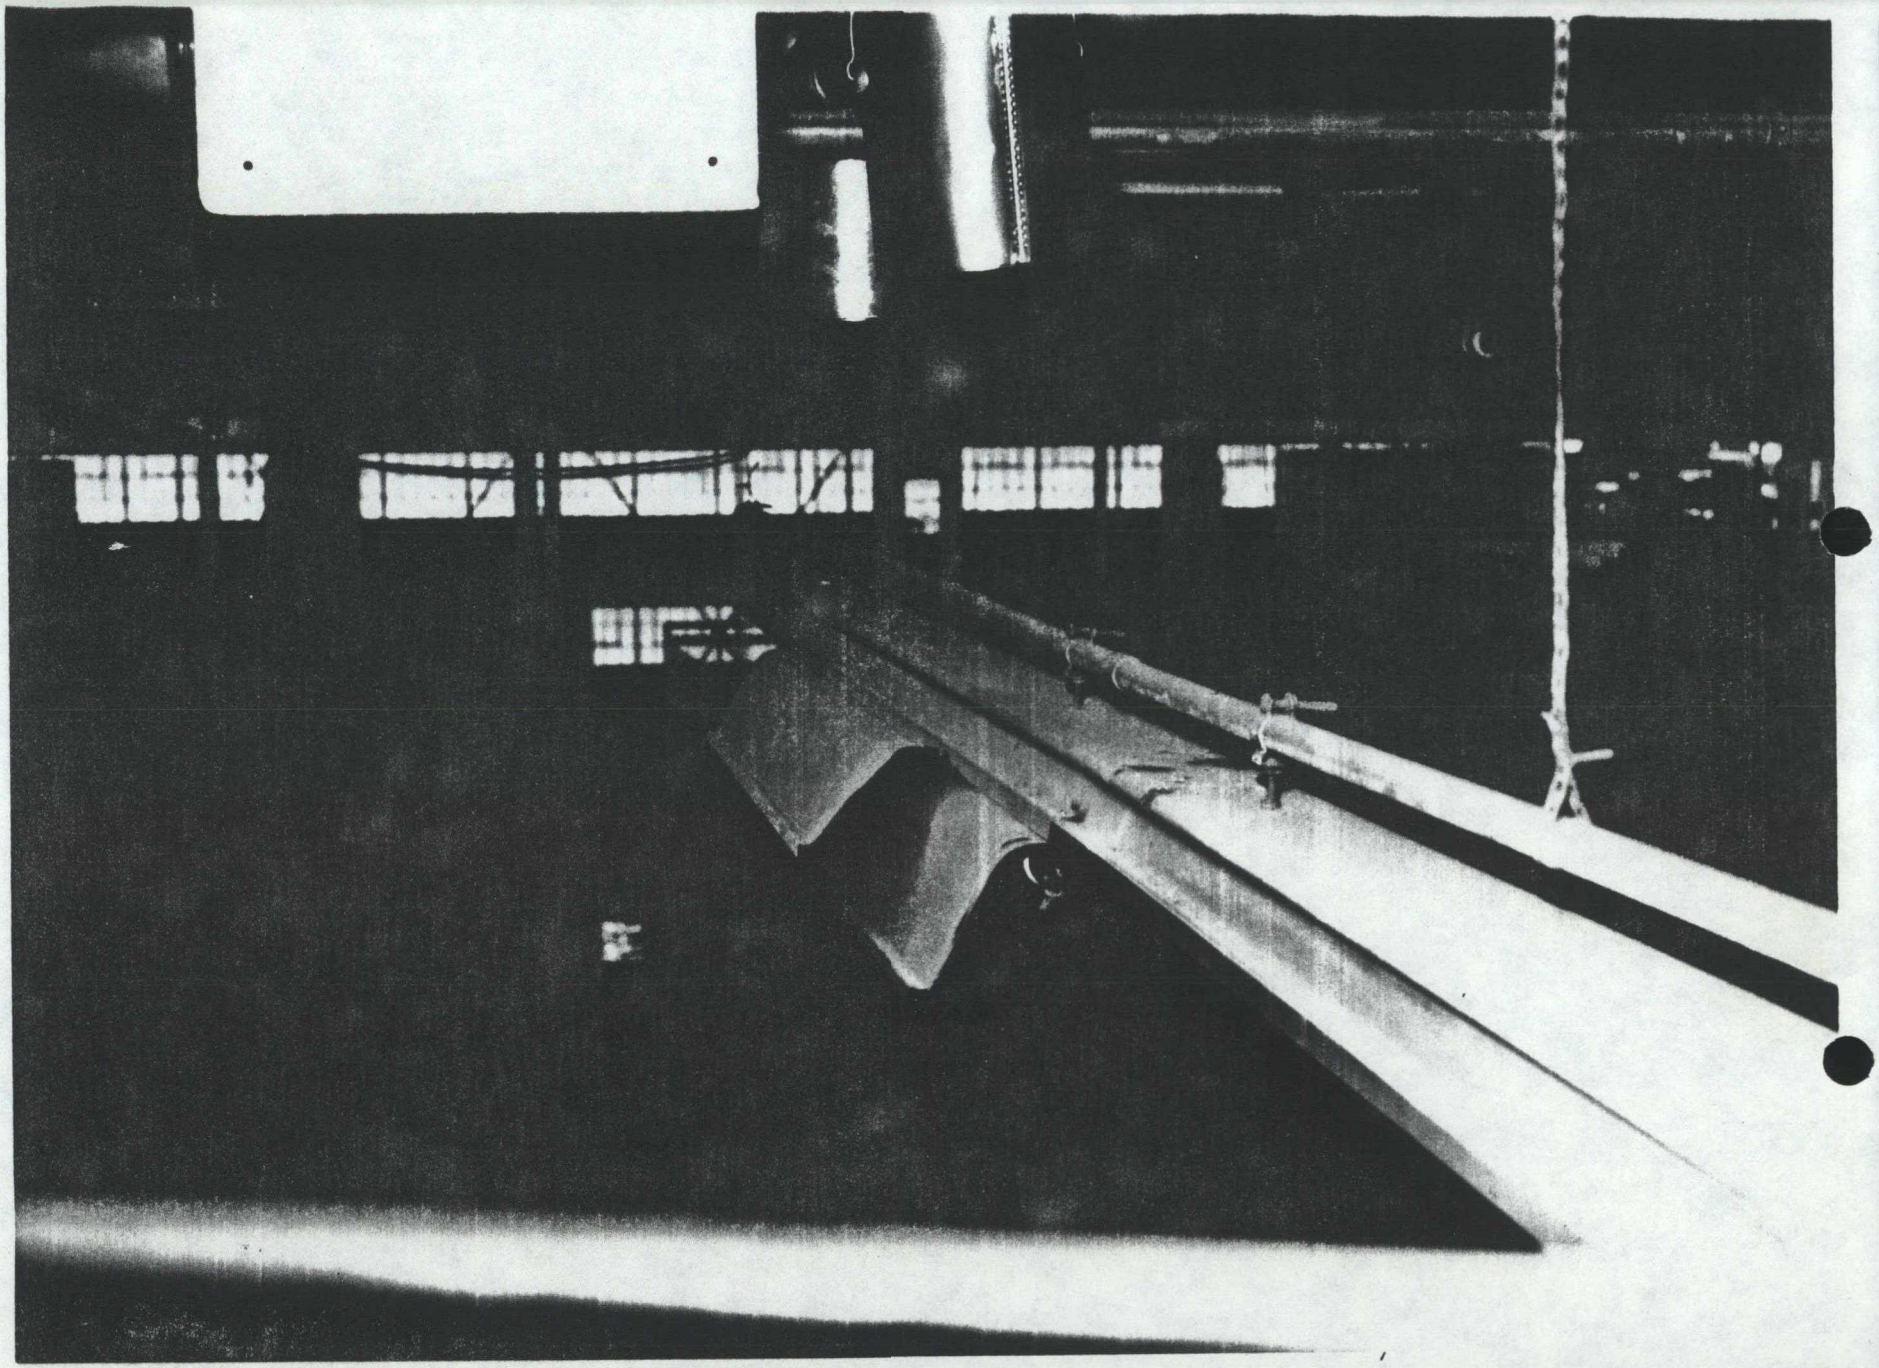
DATE: 11·15·86 NAME: Schmit #42
DESCRIPTION: GenDyn-Bldg 1
Buckets catching leakage from Col. C-4 substation.
Note spillage on fluorescent light hood.

New stain on replacement flooring beneath Col. C-4 substation
