SFUND RECORDS CTR
2385815

DATE: 11·14·85 NAME: Schmit #1
DESCRIPTION: GenDyn-Bldg 1
Ground floor substation w/ 3 retrofilled Westinghouse transformers, #3011134 → #3011136.

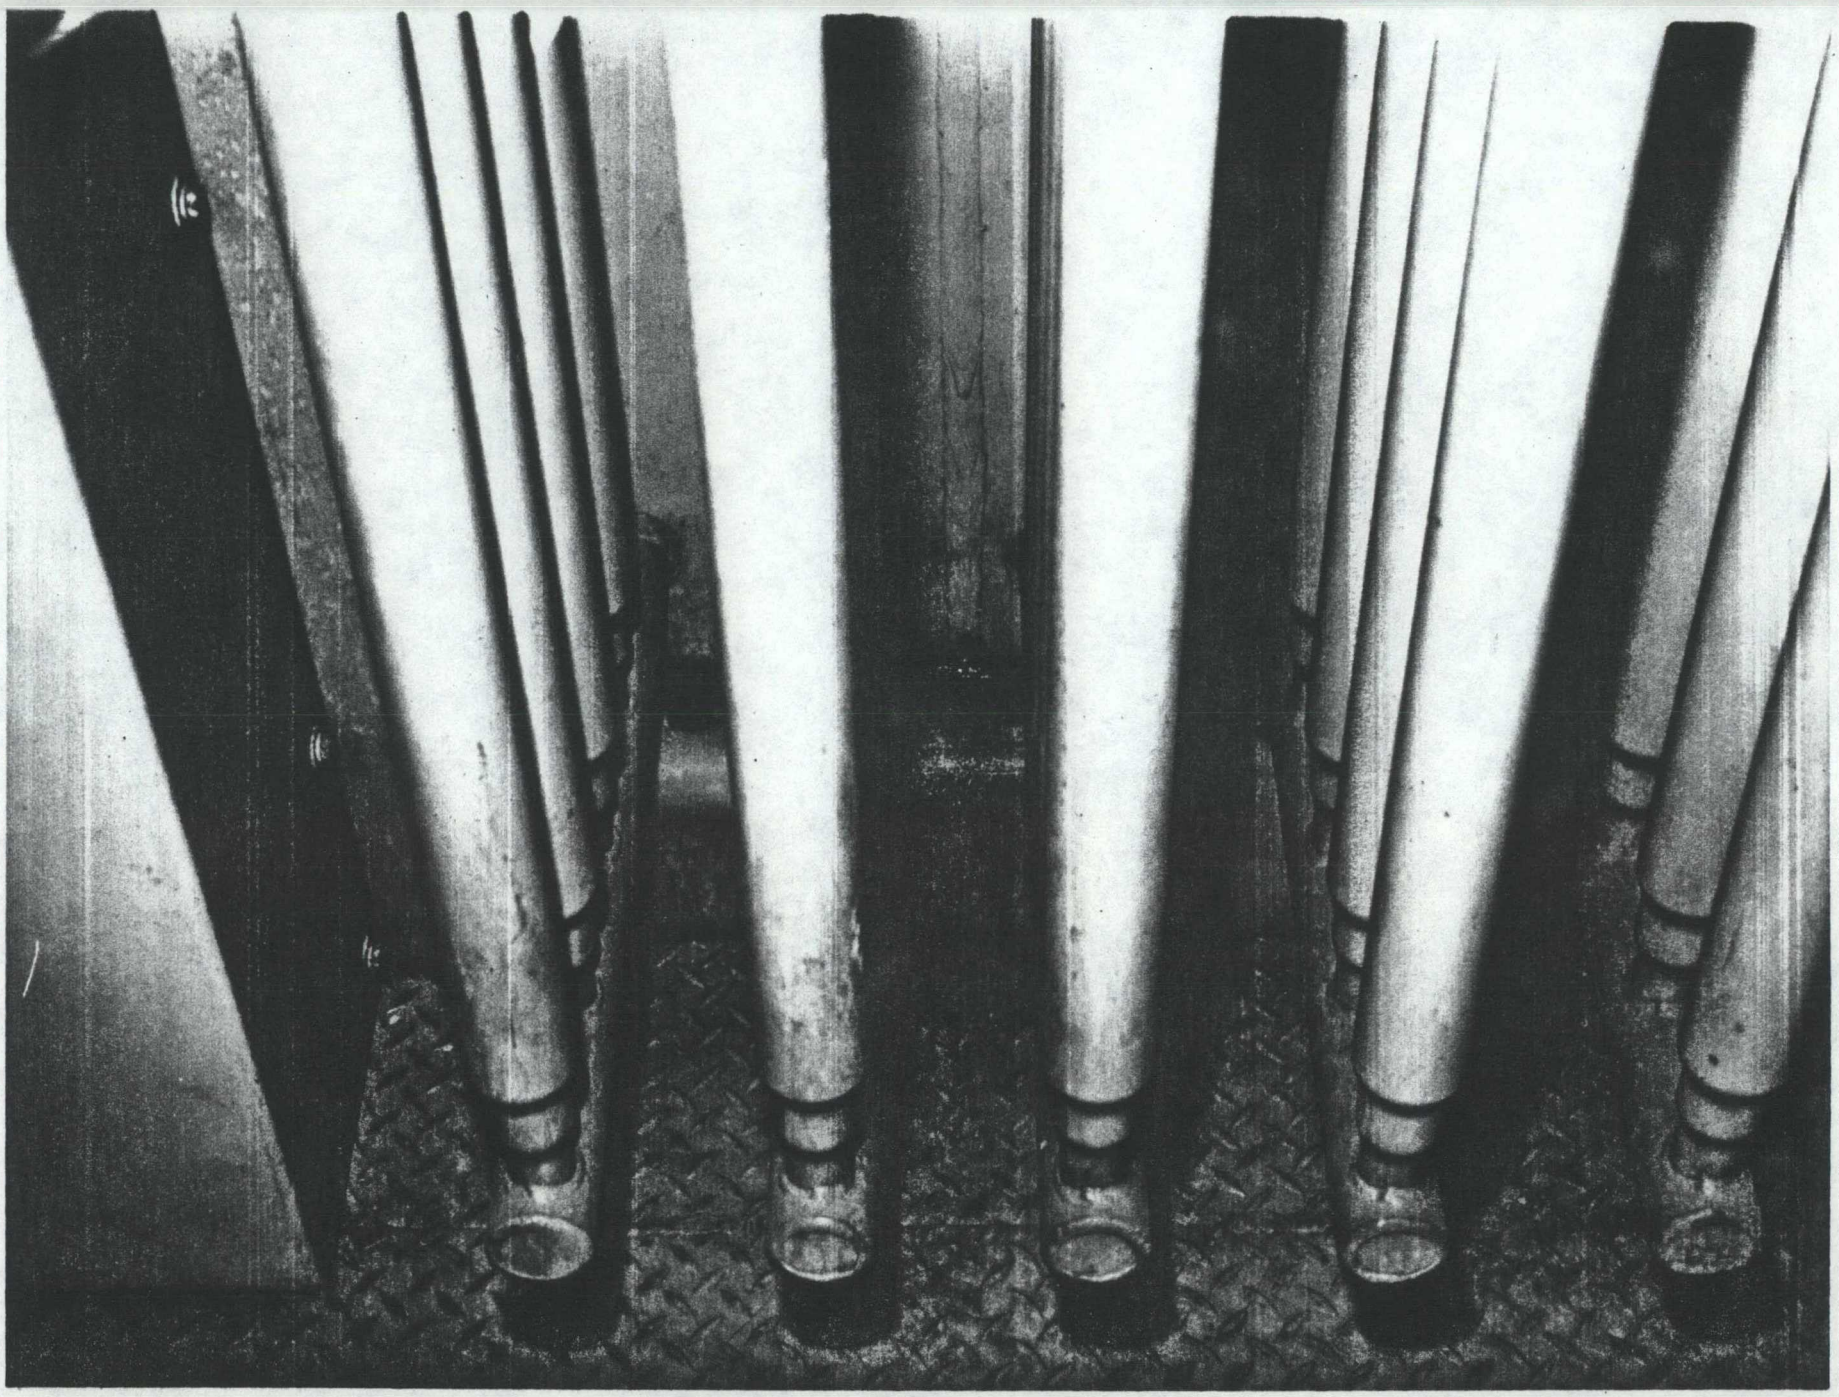
DATE: 11-15-86 NAME: Schmit #47

Leak at base weld on #GEC 503430

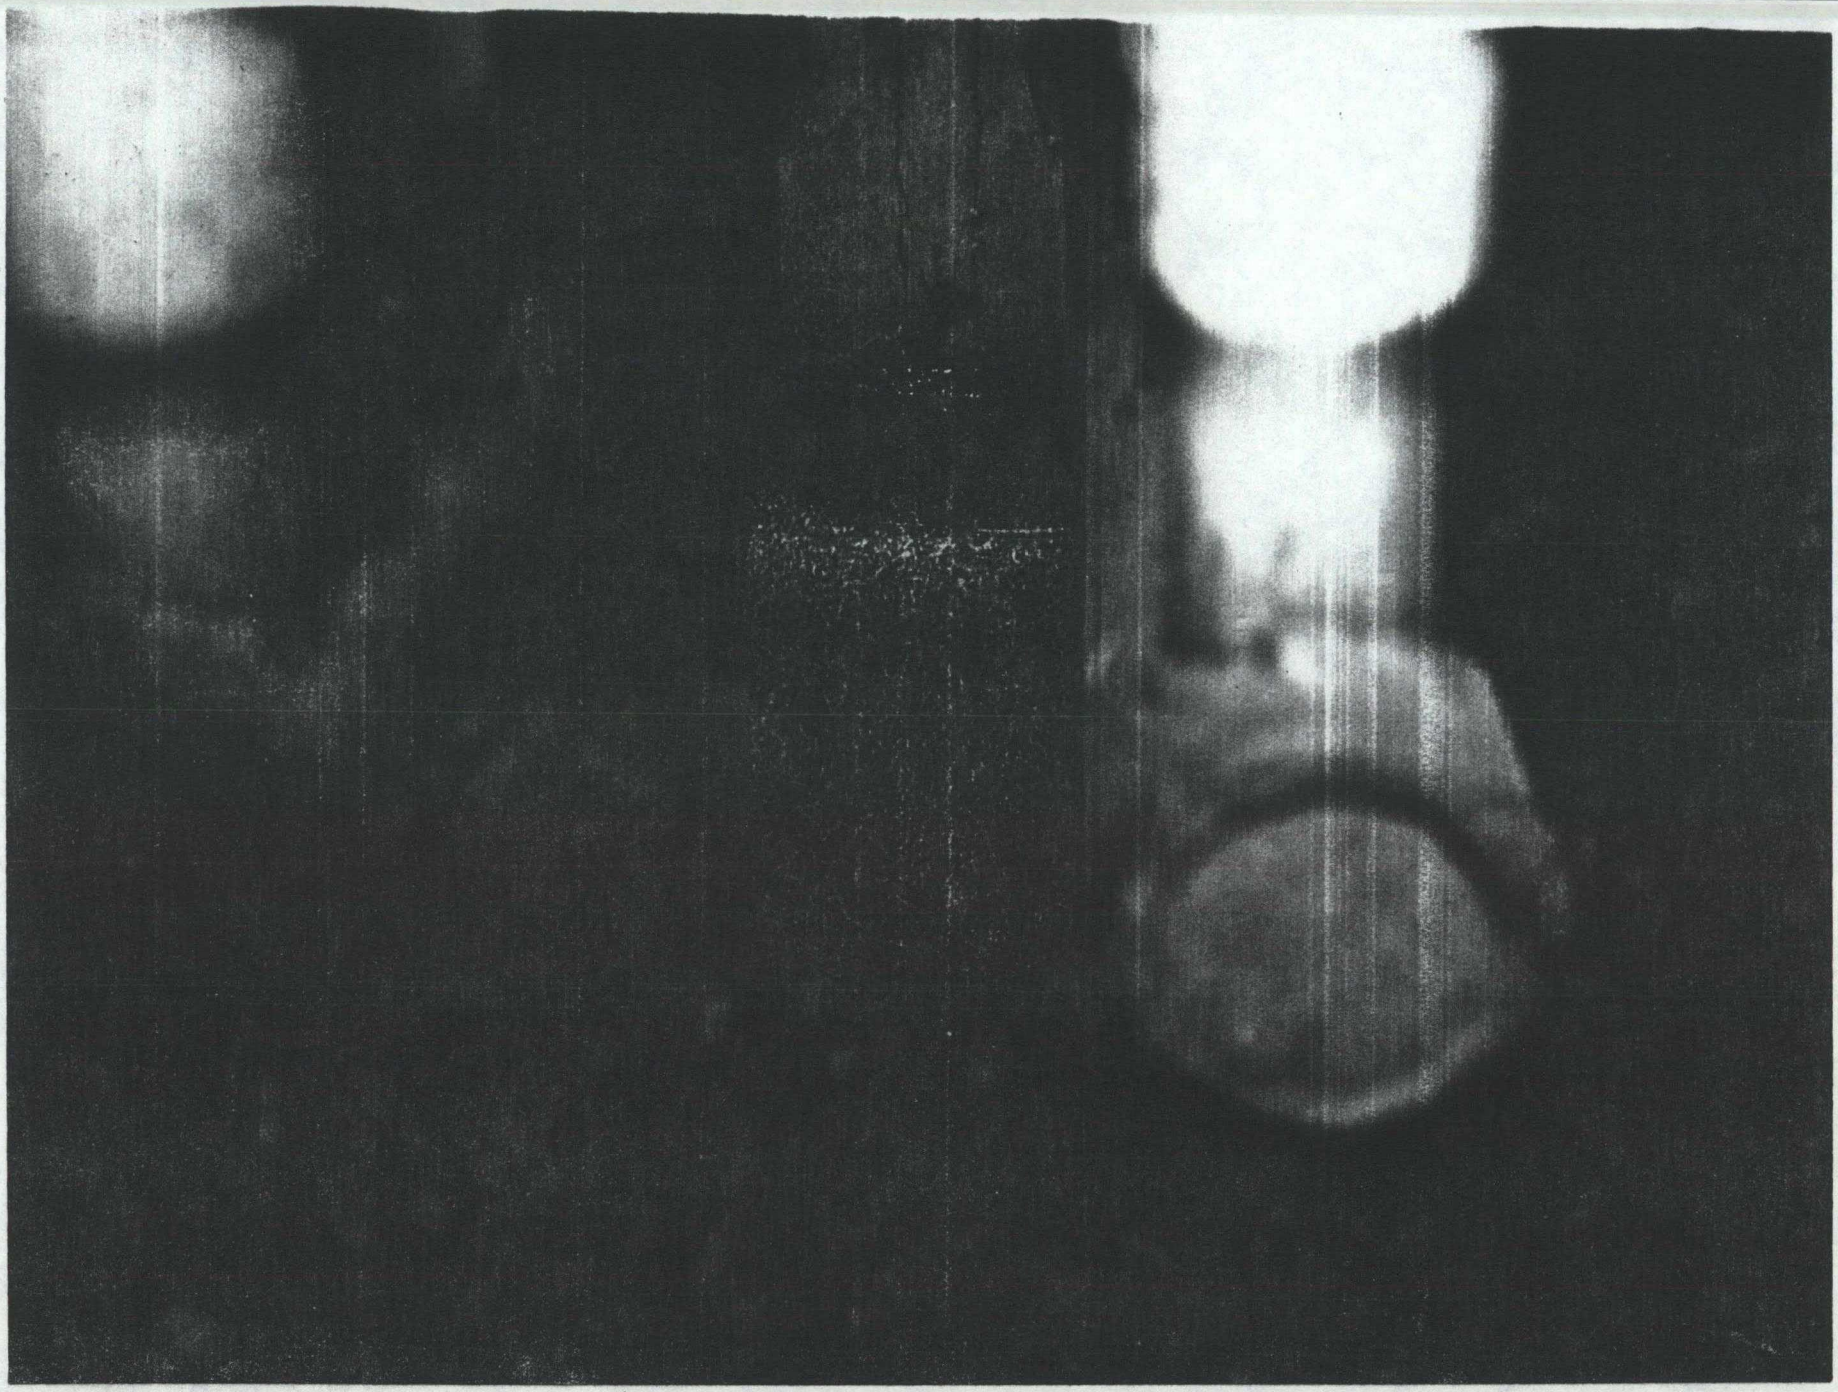
DATE: 11.15.86 NAME: Schmit #48

Close-up of leak. #GE C-503430.

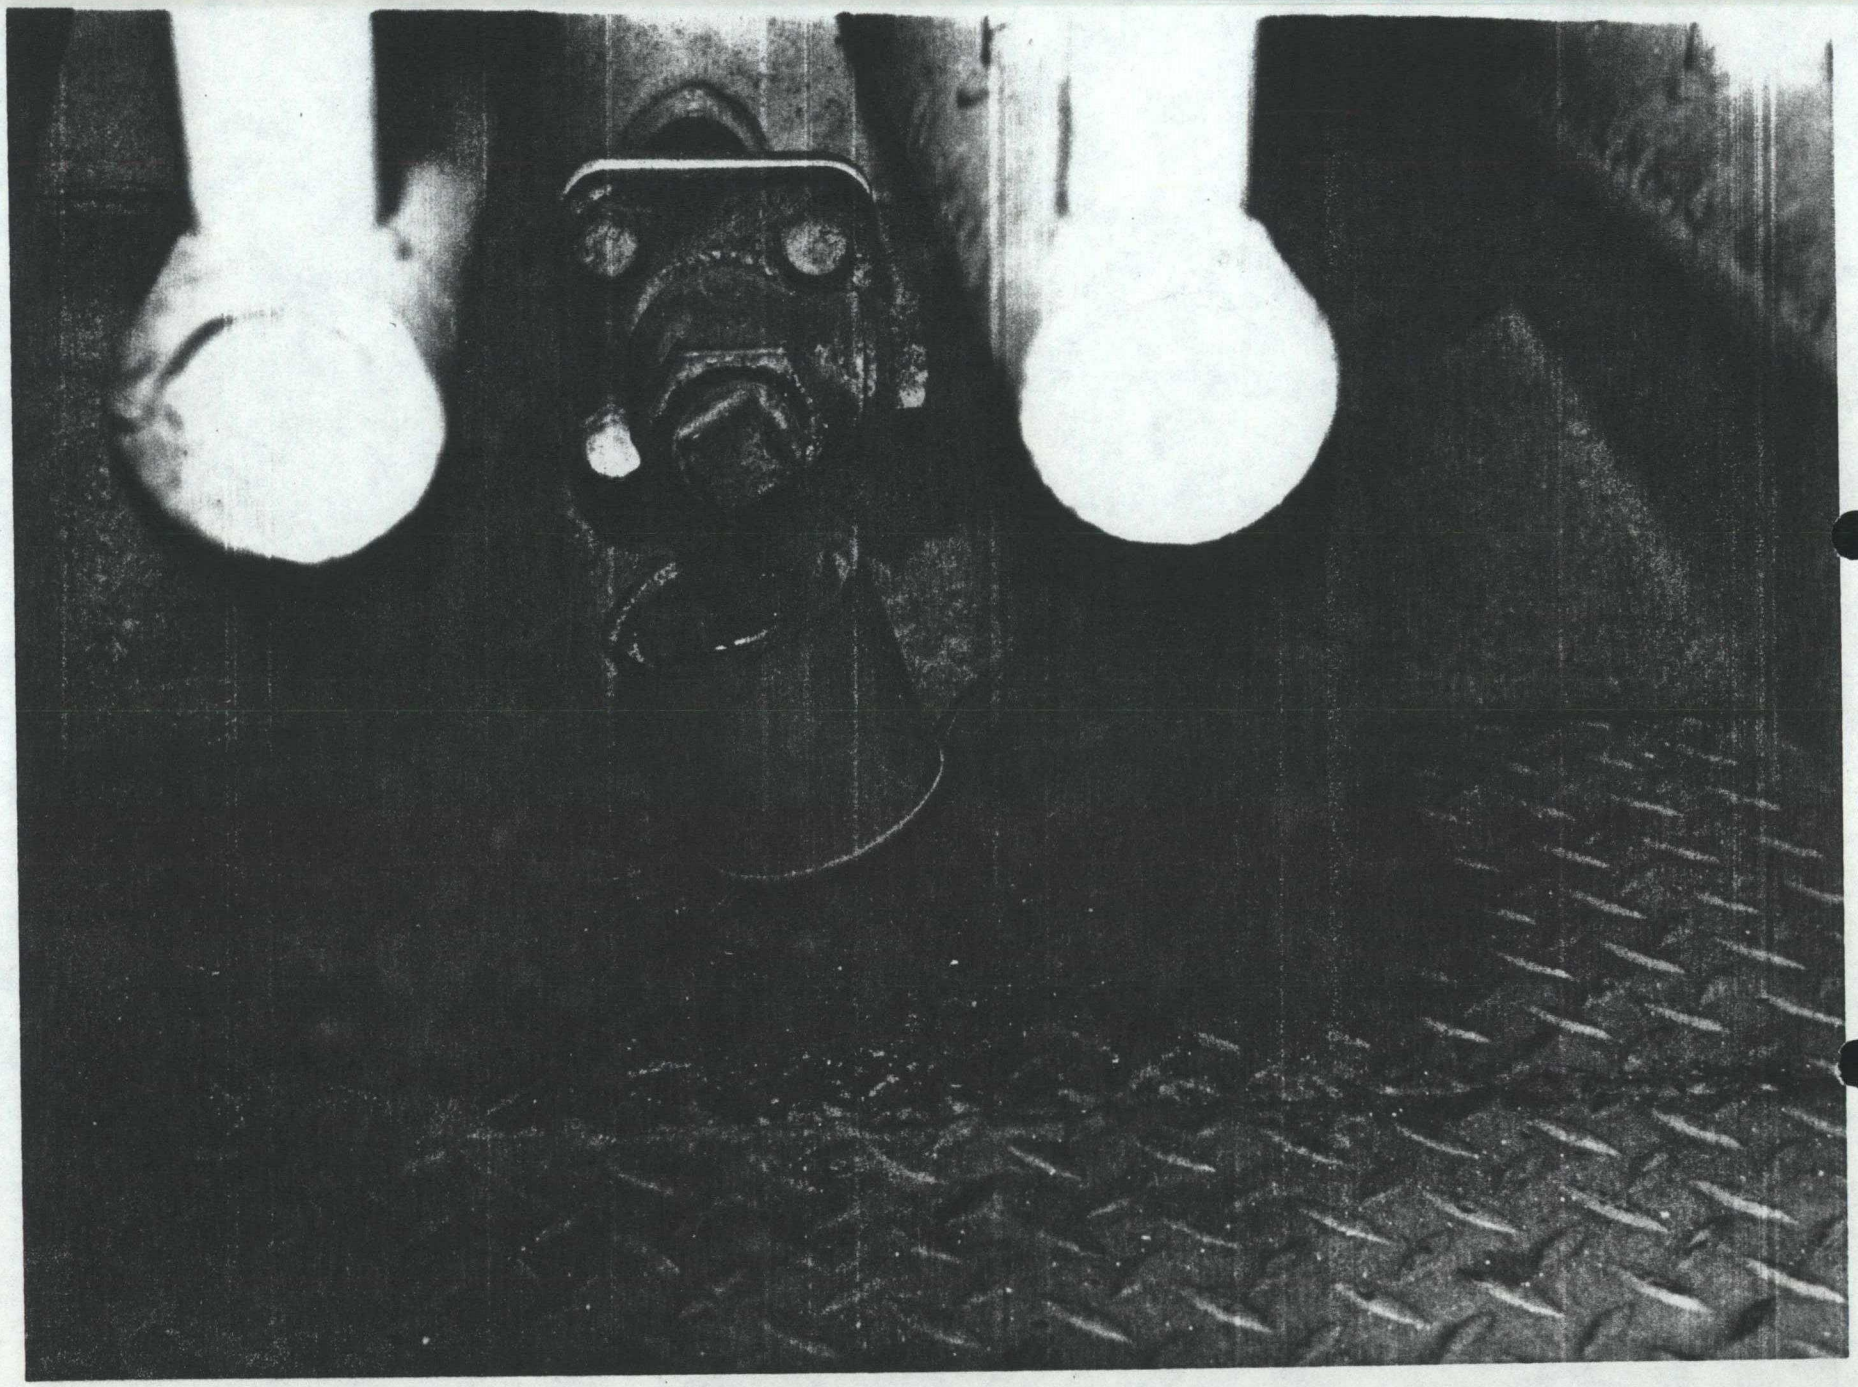
DATE: 11-15-86 NAME: Schmit #49

Historic leak from drain tap. #GE C-503430.

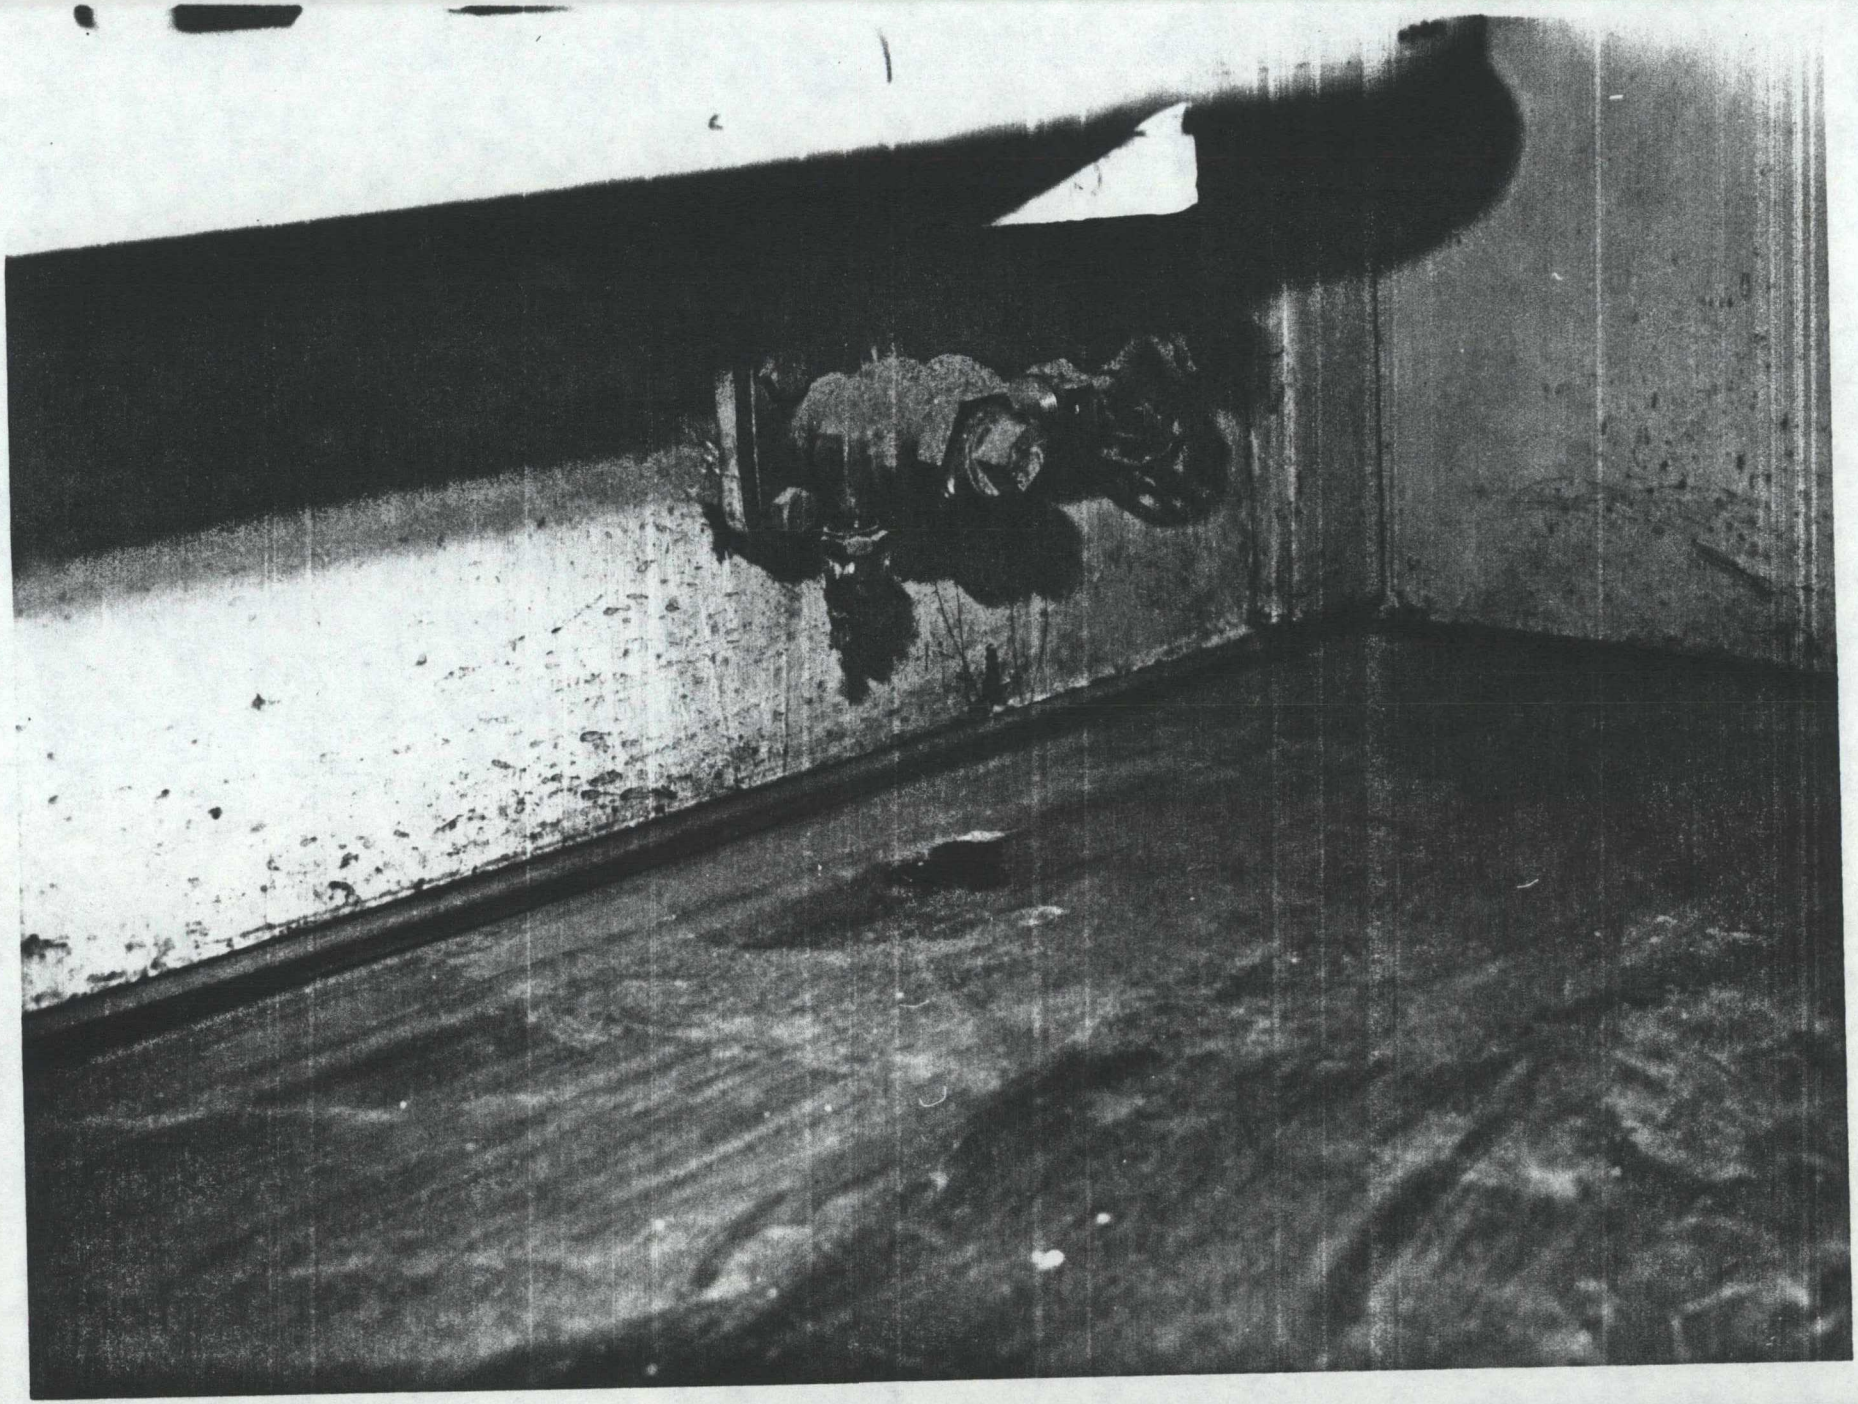
DATE: 11-15-86 NAME: Schmit #51
DESCRIPTION: GenDyn Bldg 3
GE #C583472. Leak from drain tap

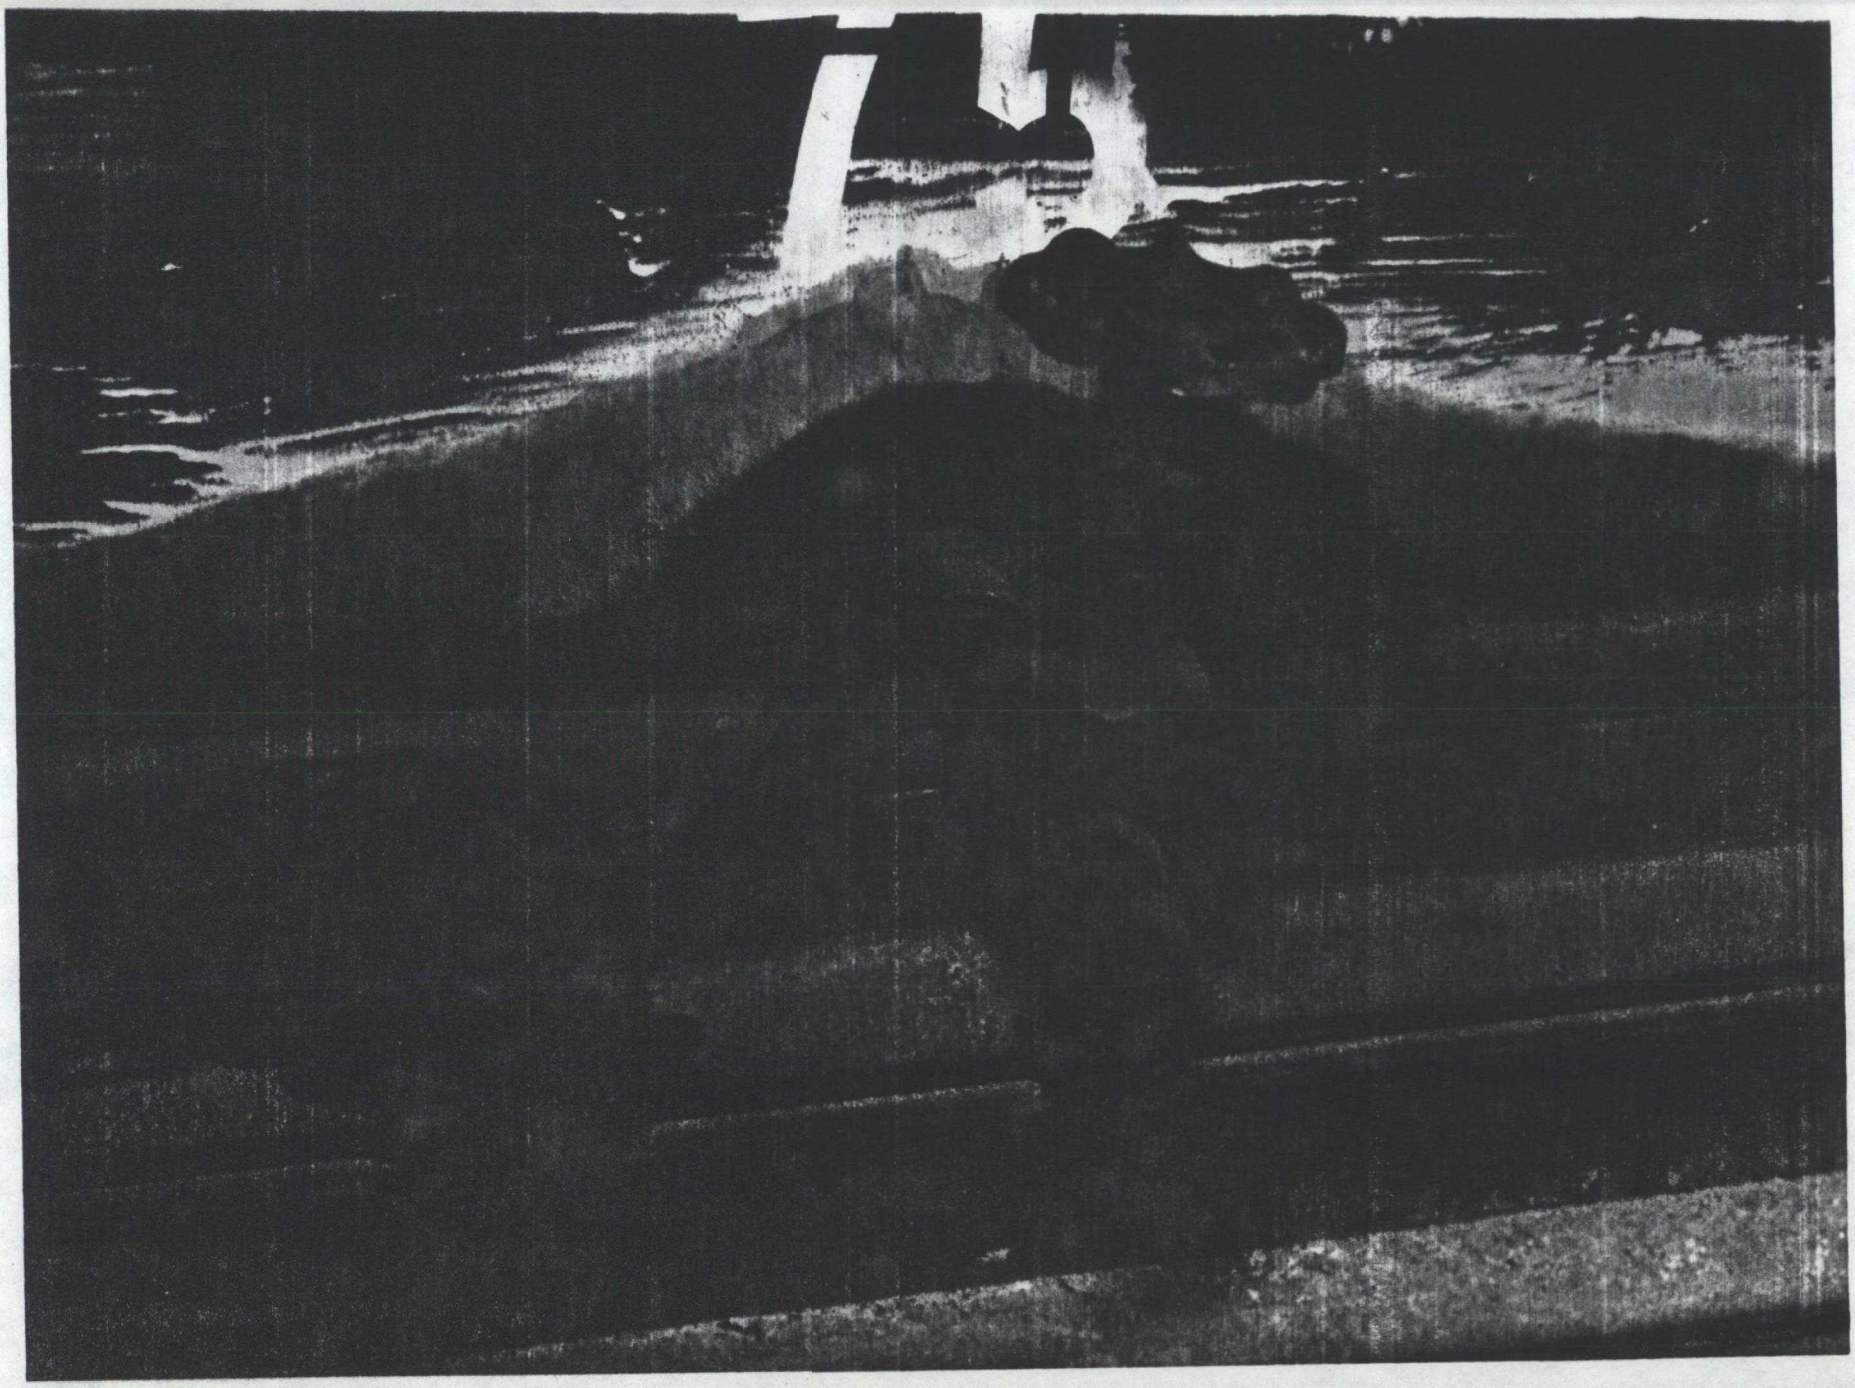
DATE: 11-15-86 NAME: Schmit #54

Leak at valve stem of Lino Materials Co # 1408449

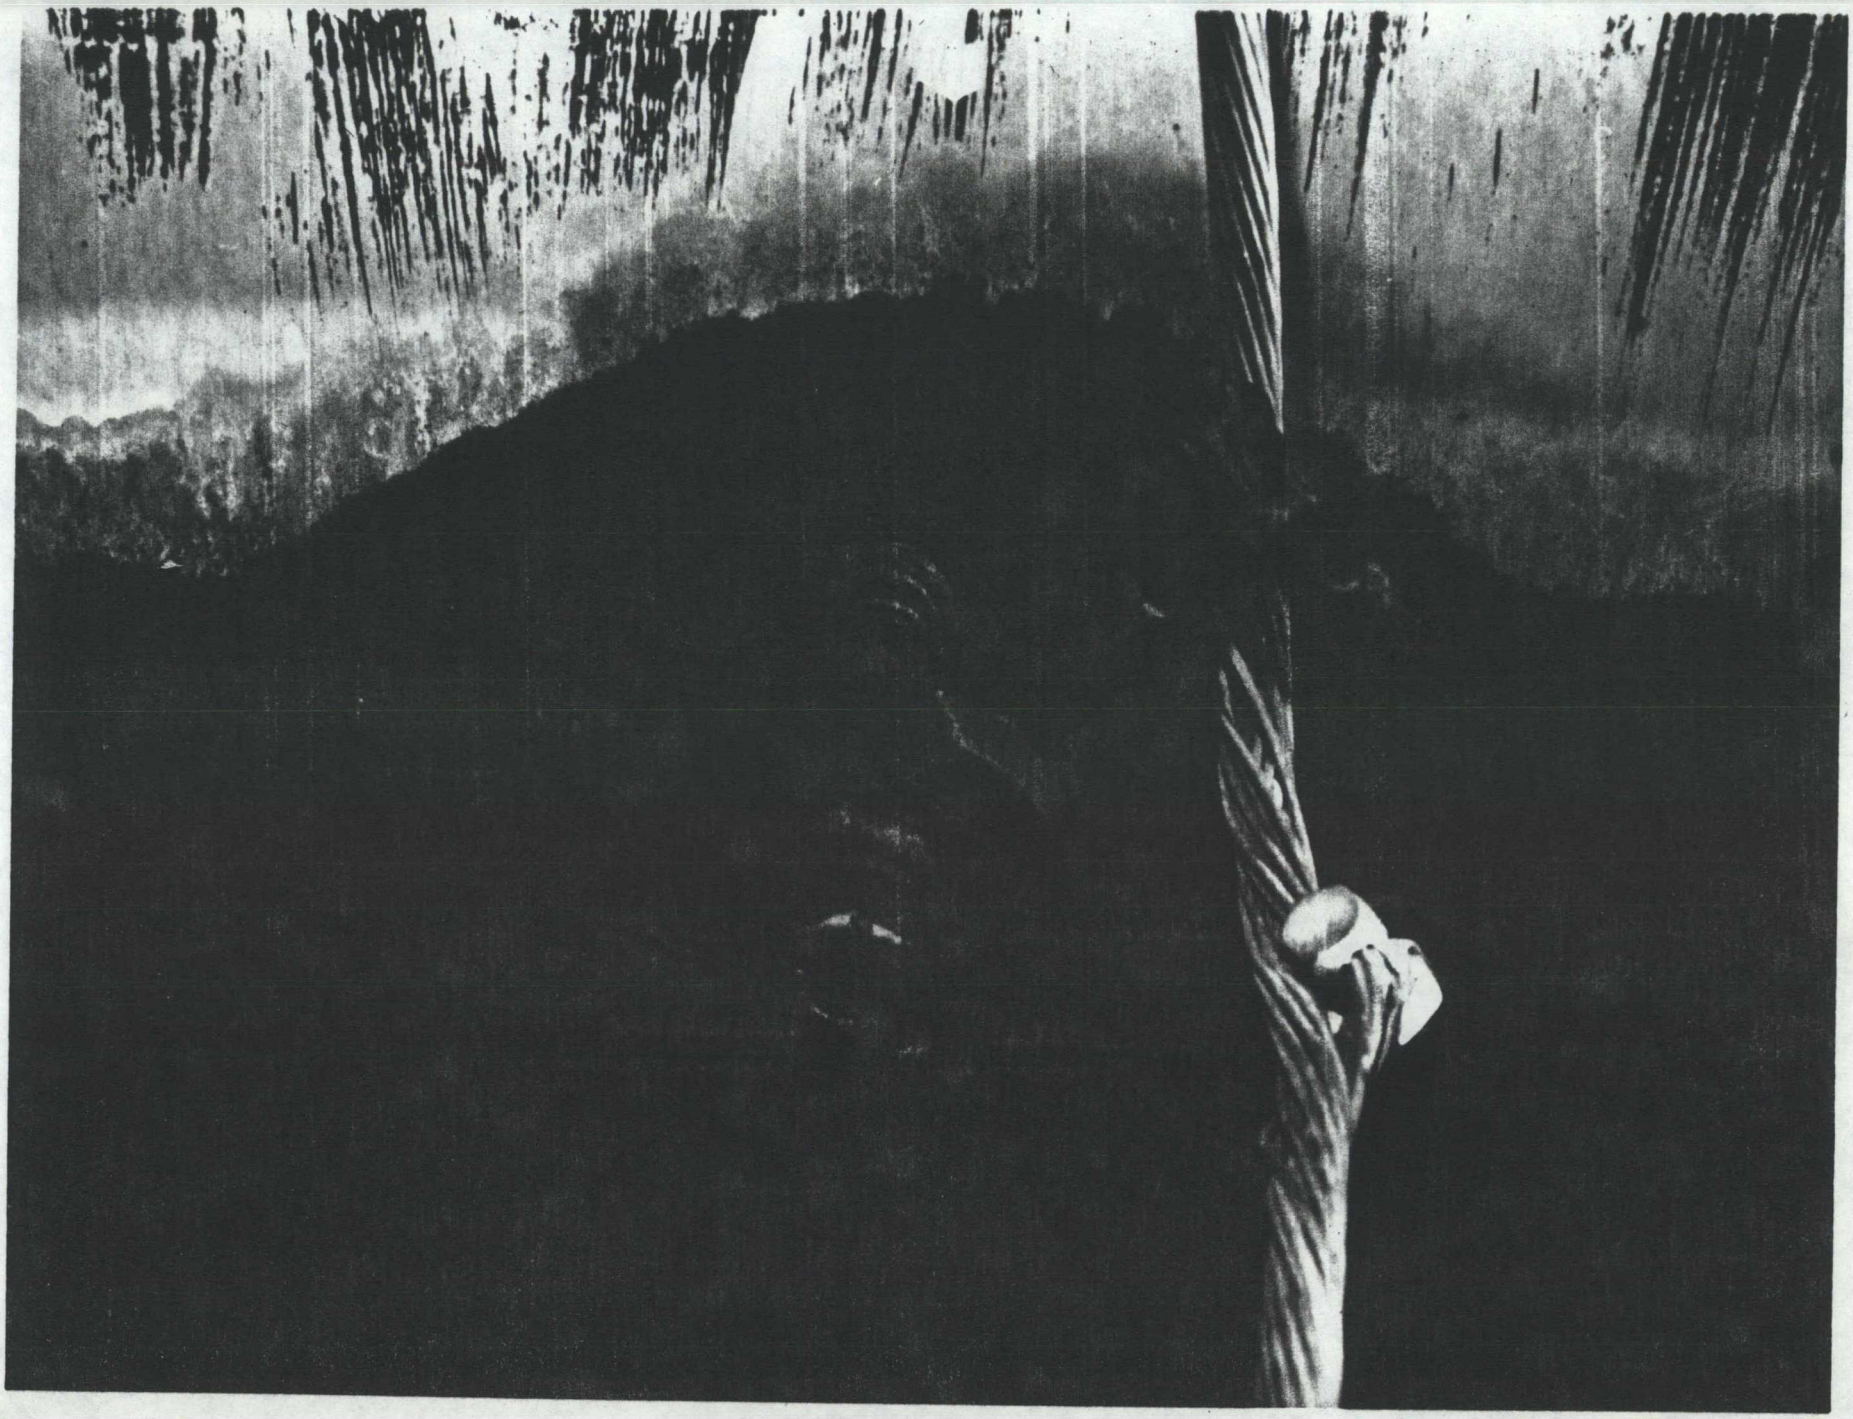
DATE: 11.15.86 NAME: Schmit #56
DESCRIPTION: GenDyn - Bldg 9 Roof
Leak at valve stem of Line Material Co. #1408447.

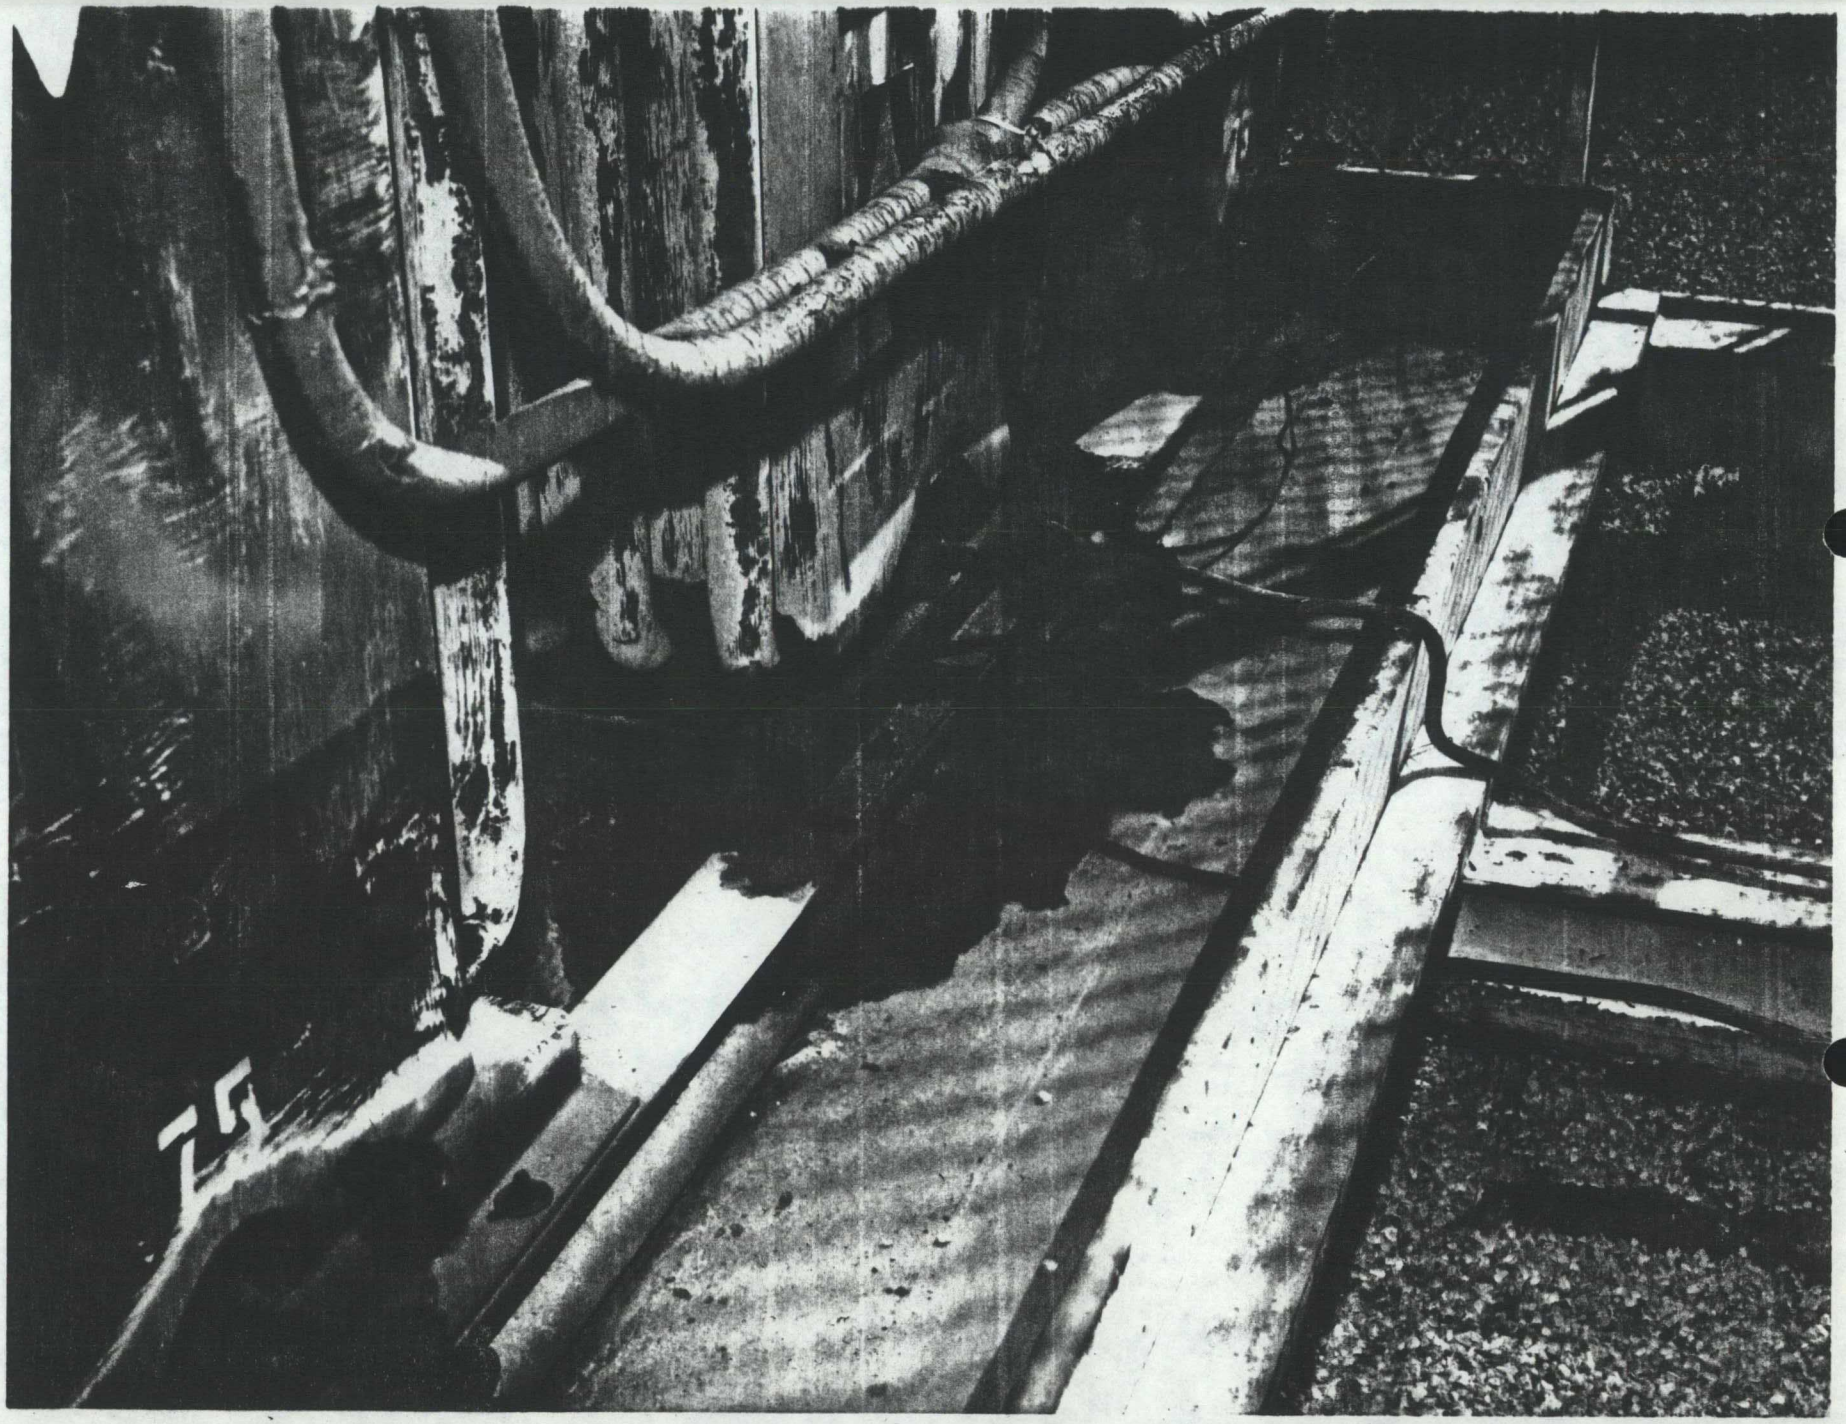
DATE: 11.15.86 NAME: Schmit #57
DESCRIPTION: GenDyn-Bldg 4 Roof
Overview of leaks from Line Material Co #1408448 and #1408447. #1408448 (PCB) is at left.

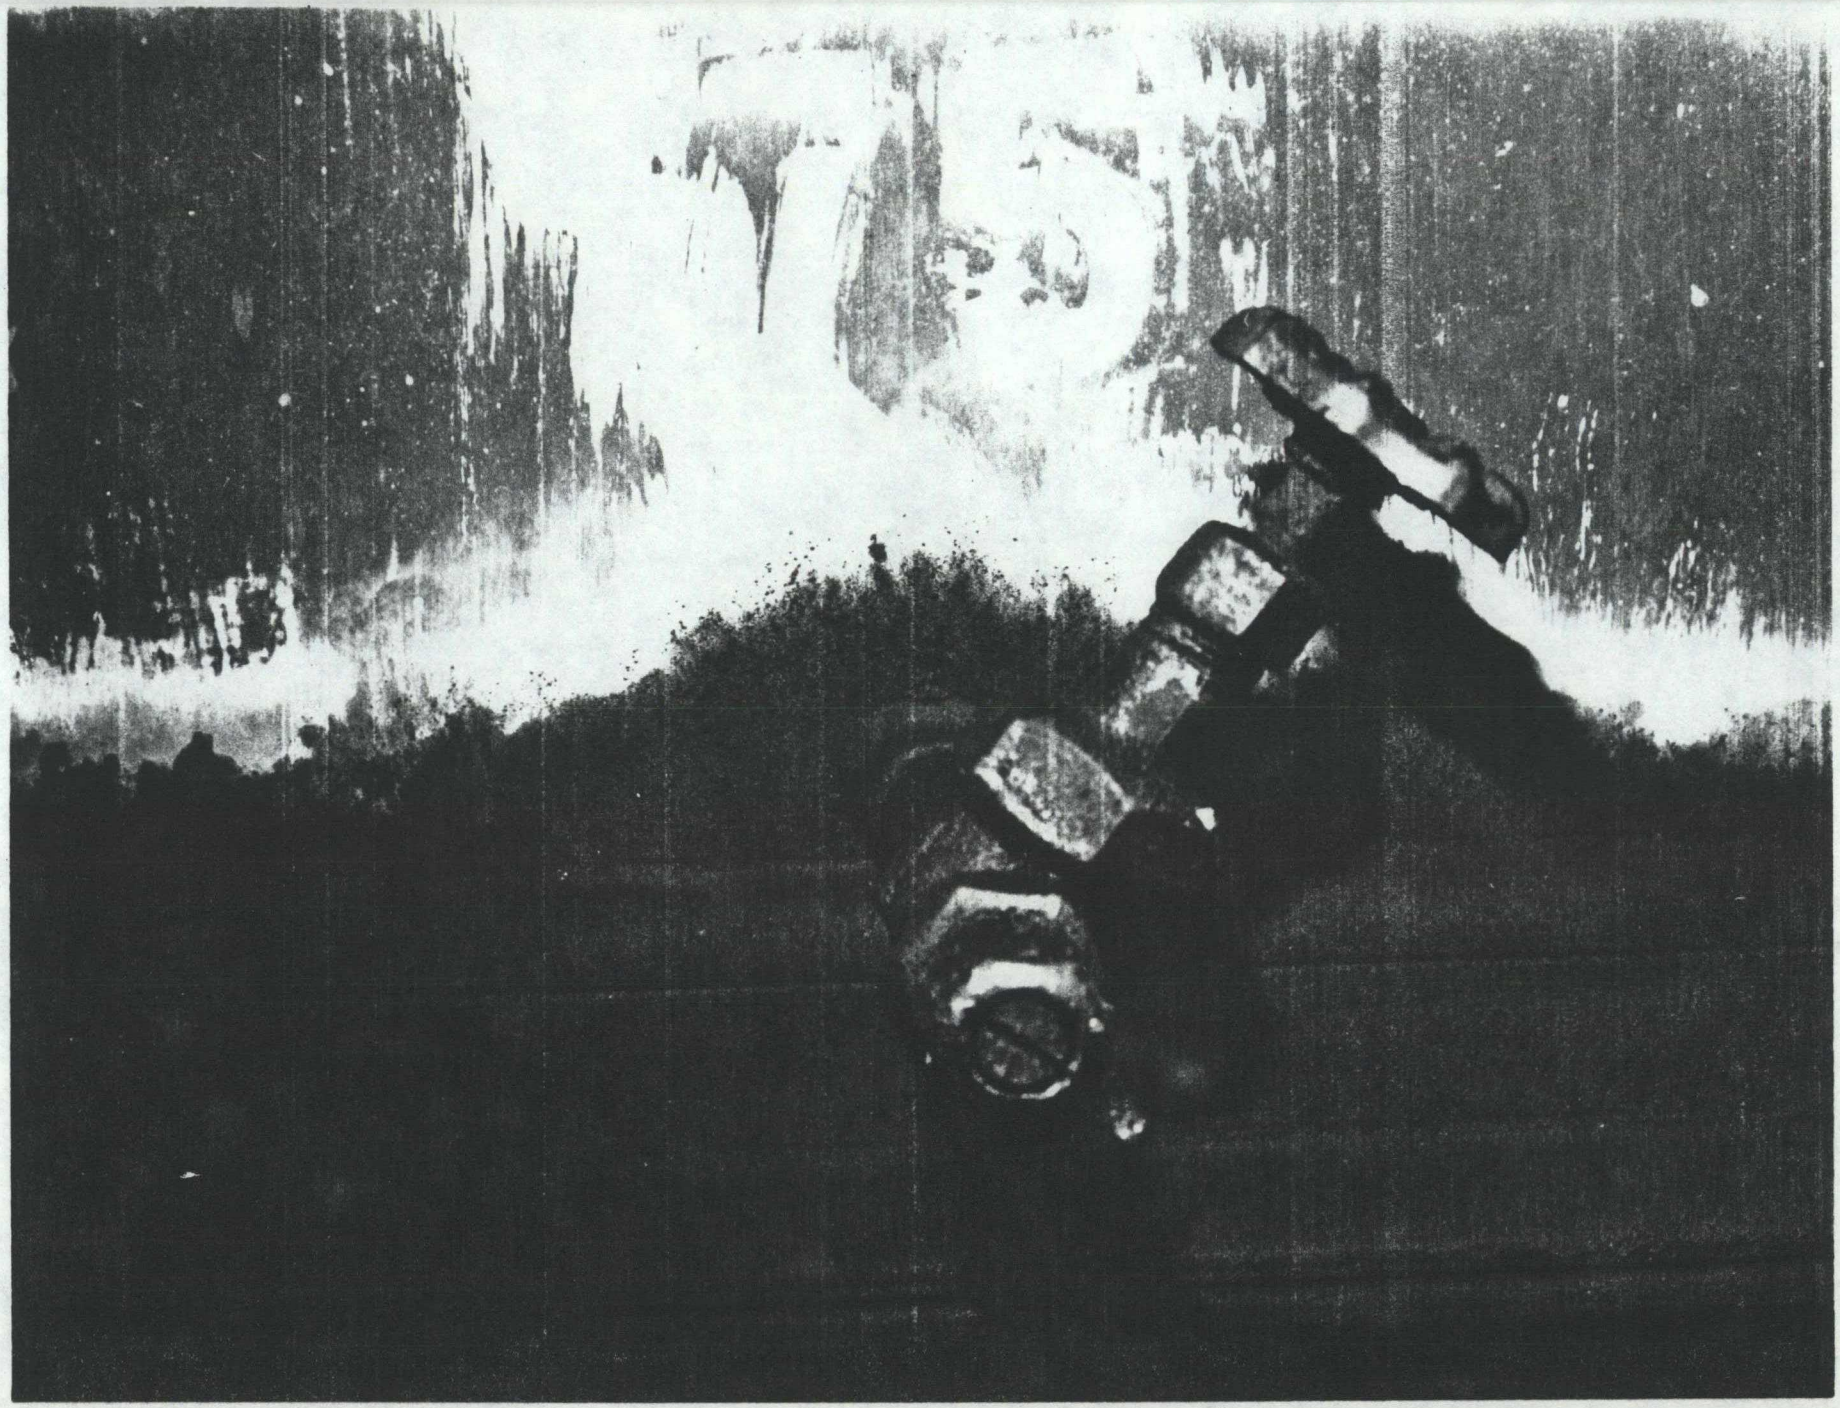
DATE: 11-15-86 NAME: Schmit #59
DESCRIPTION: GasDyn-Bldg 4 Roof
Leak at valve stem of Line Material Co. # 1408448.
