SFUND RECORDS CTR
2385815

DATE: 11·14·85 NAME: Schmit #1
DESCRIPTION: GenDyn-Bldg 1
Ground floor substation w/ 3 retrofilled Westinghouse transformers, #3011134 → #3011136.

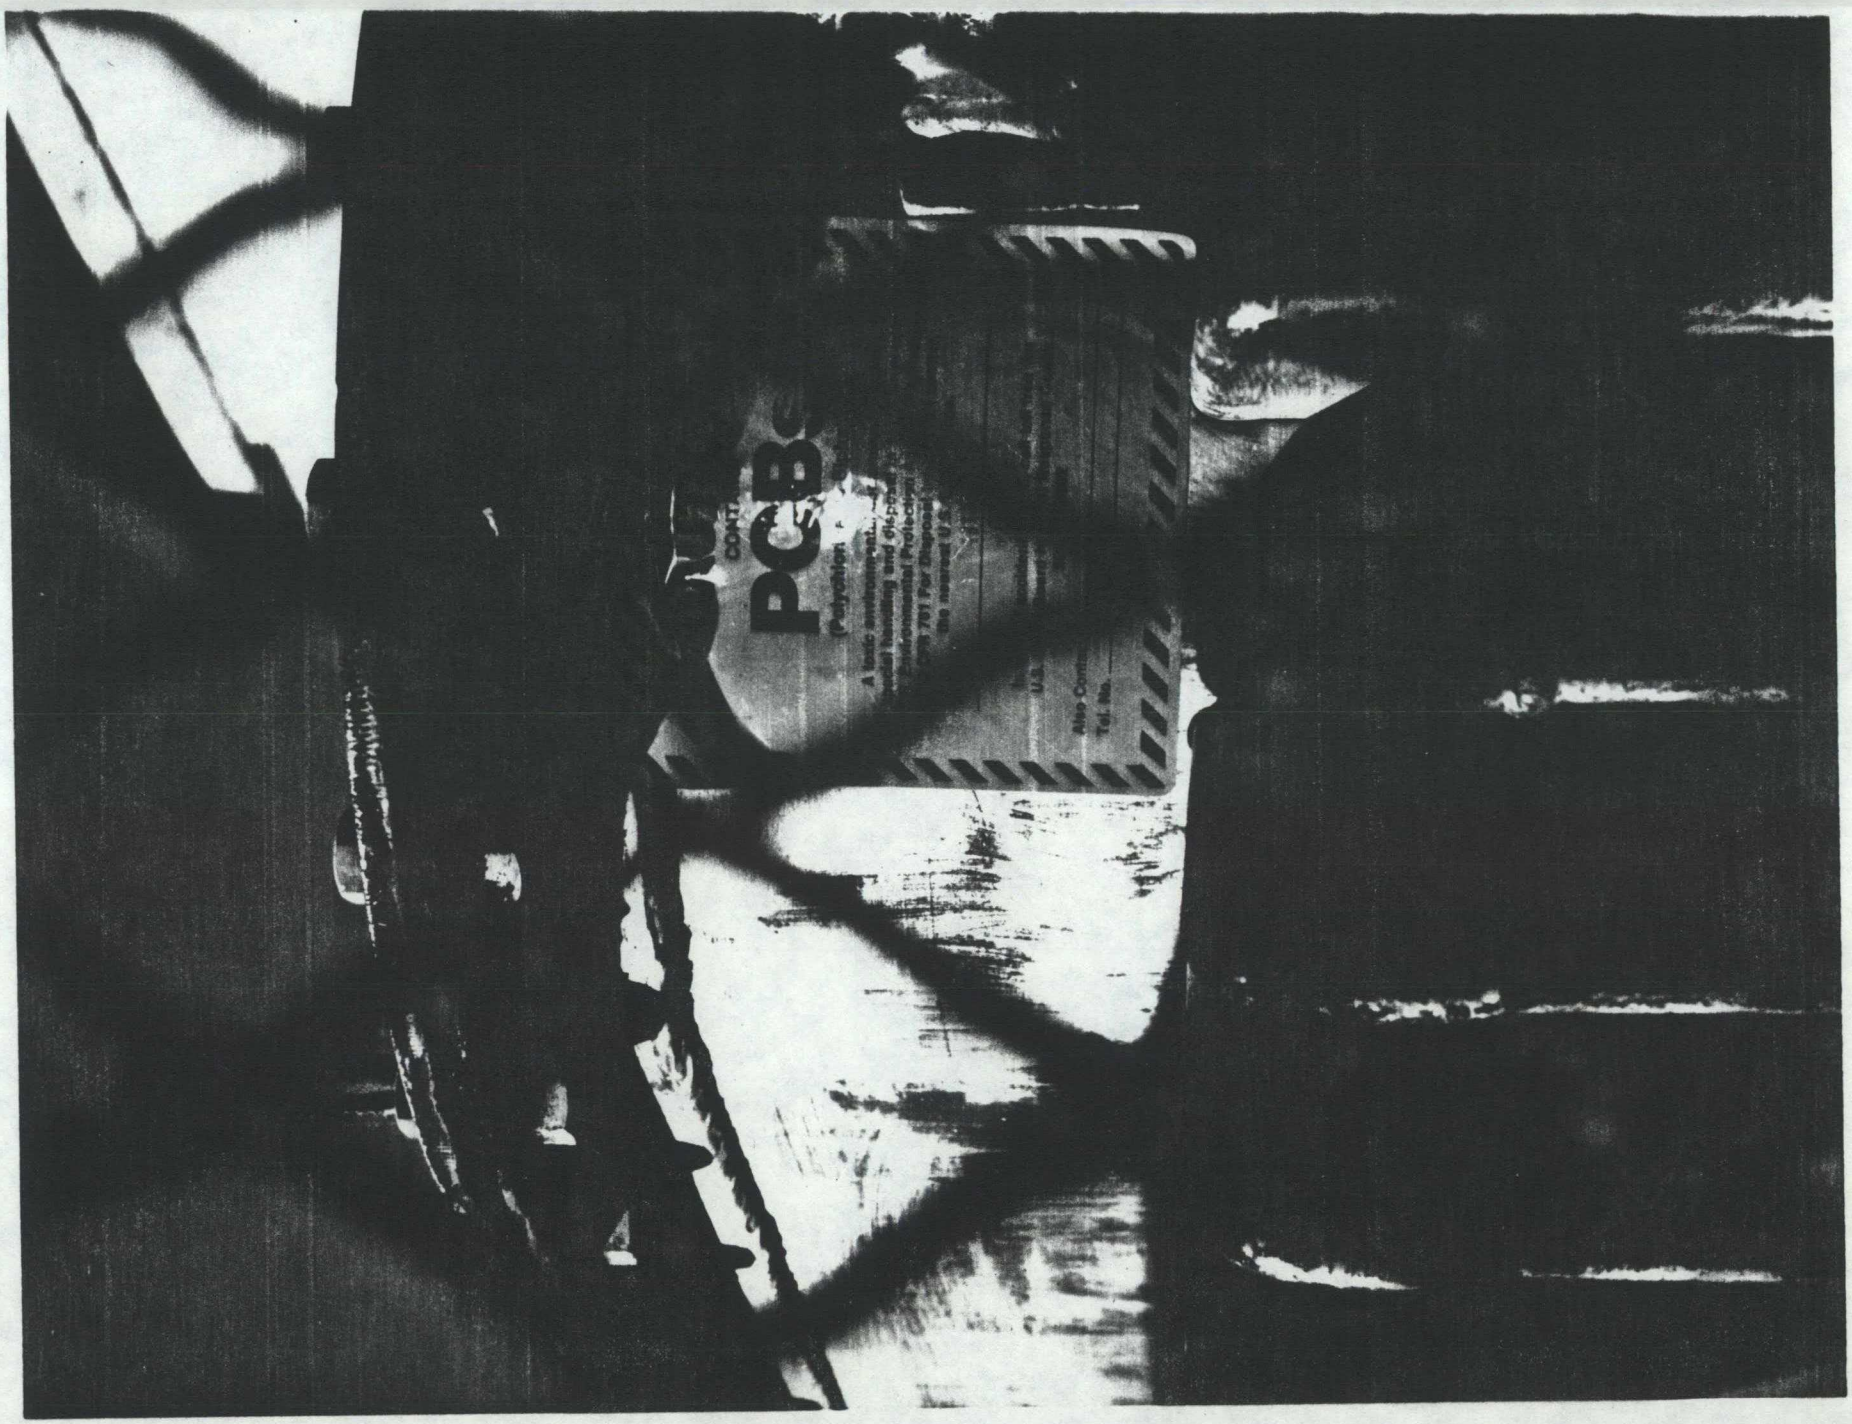
DATE: 11·15·86 NAME: Schmit #61
DESCRIPTION: Genlyn-Bldg 7
Leak along top flange on S side of GE #659308.

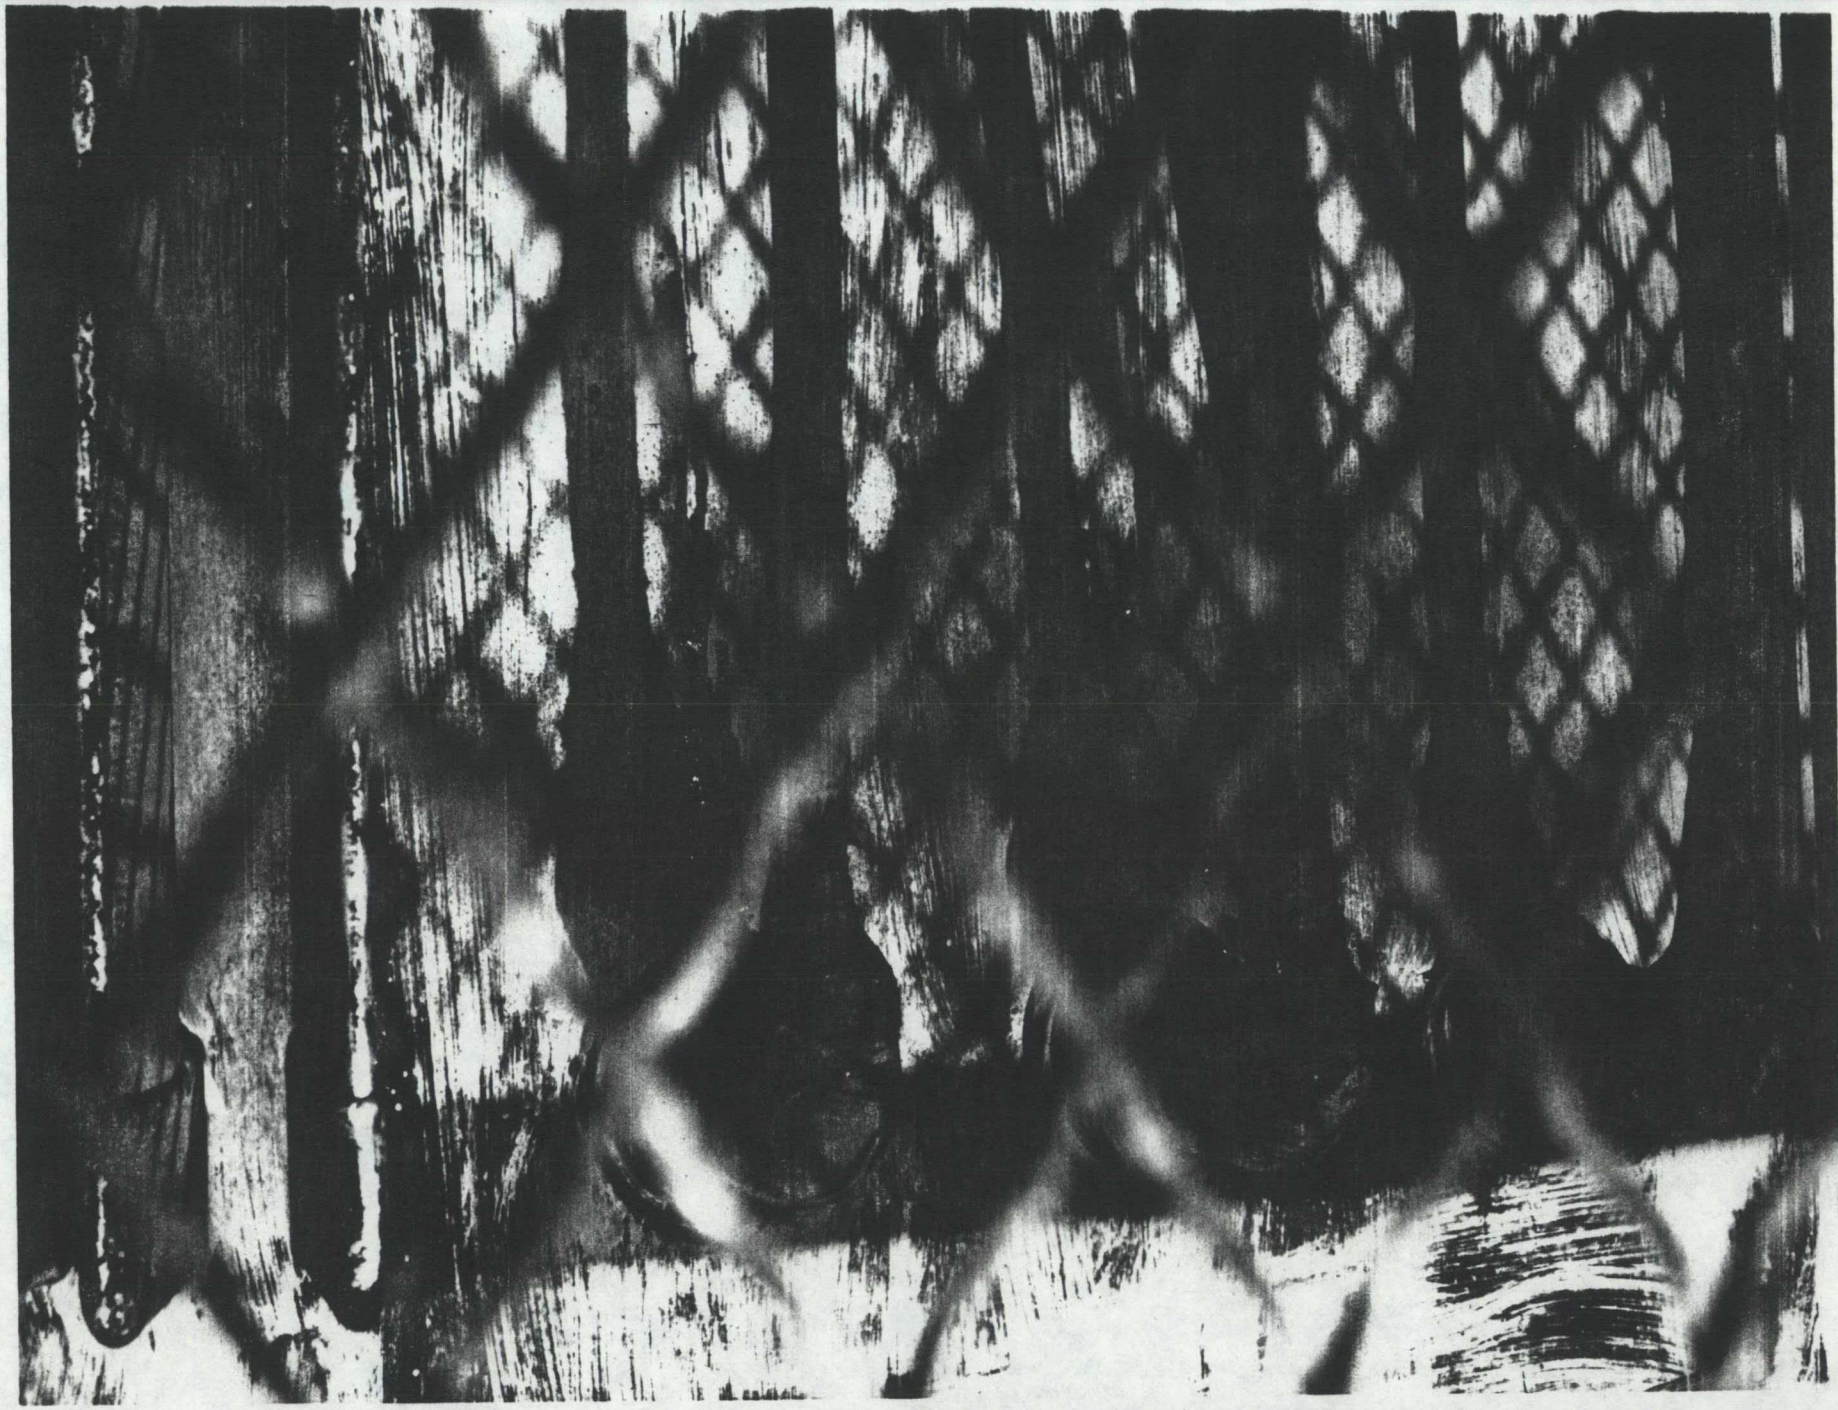
DATE: 11-15-86 NAME: Schmit #62

Leak from bushings of GE #6579308.

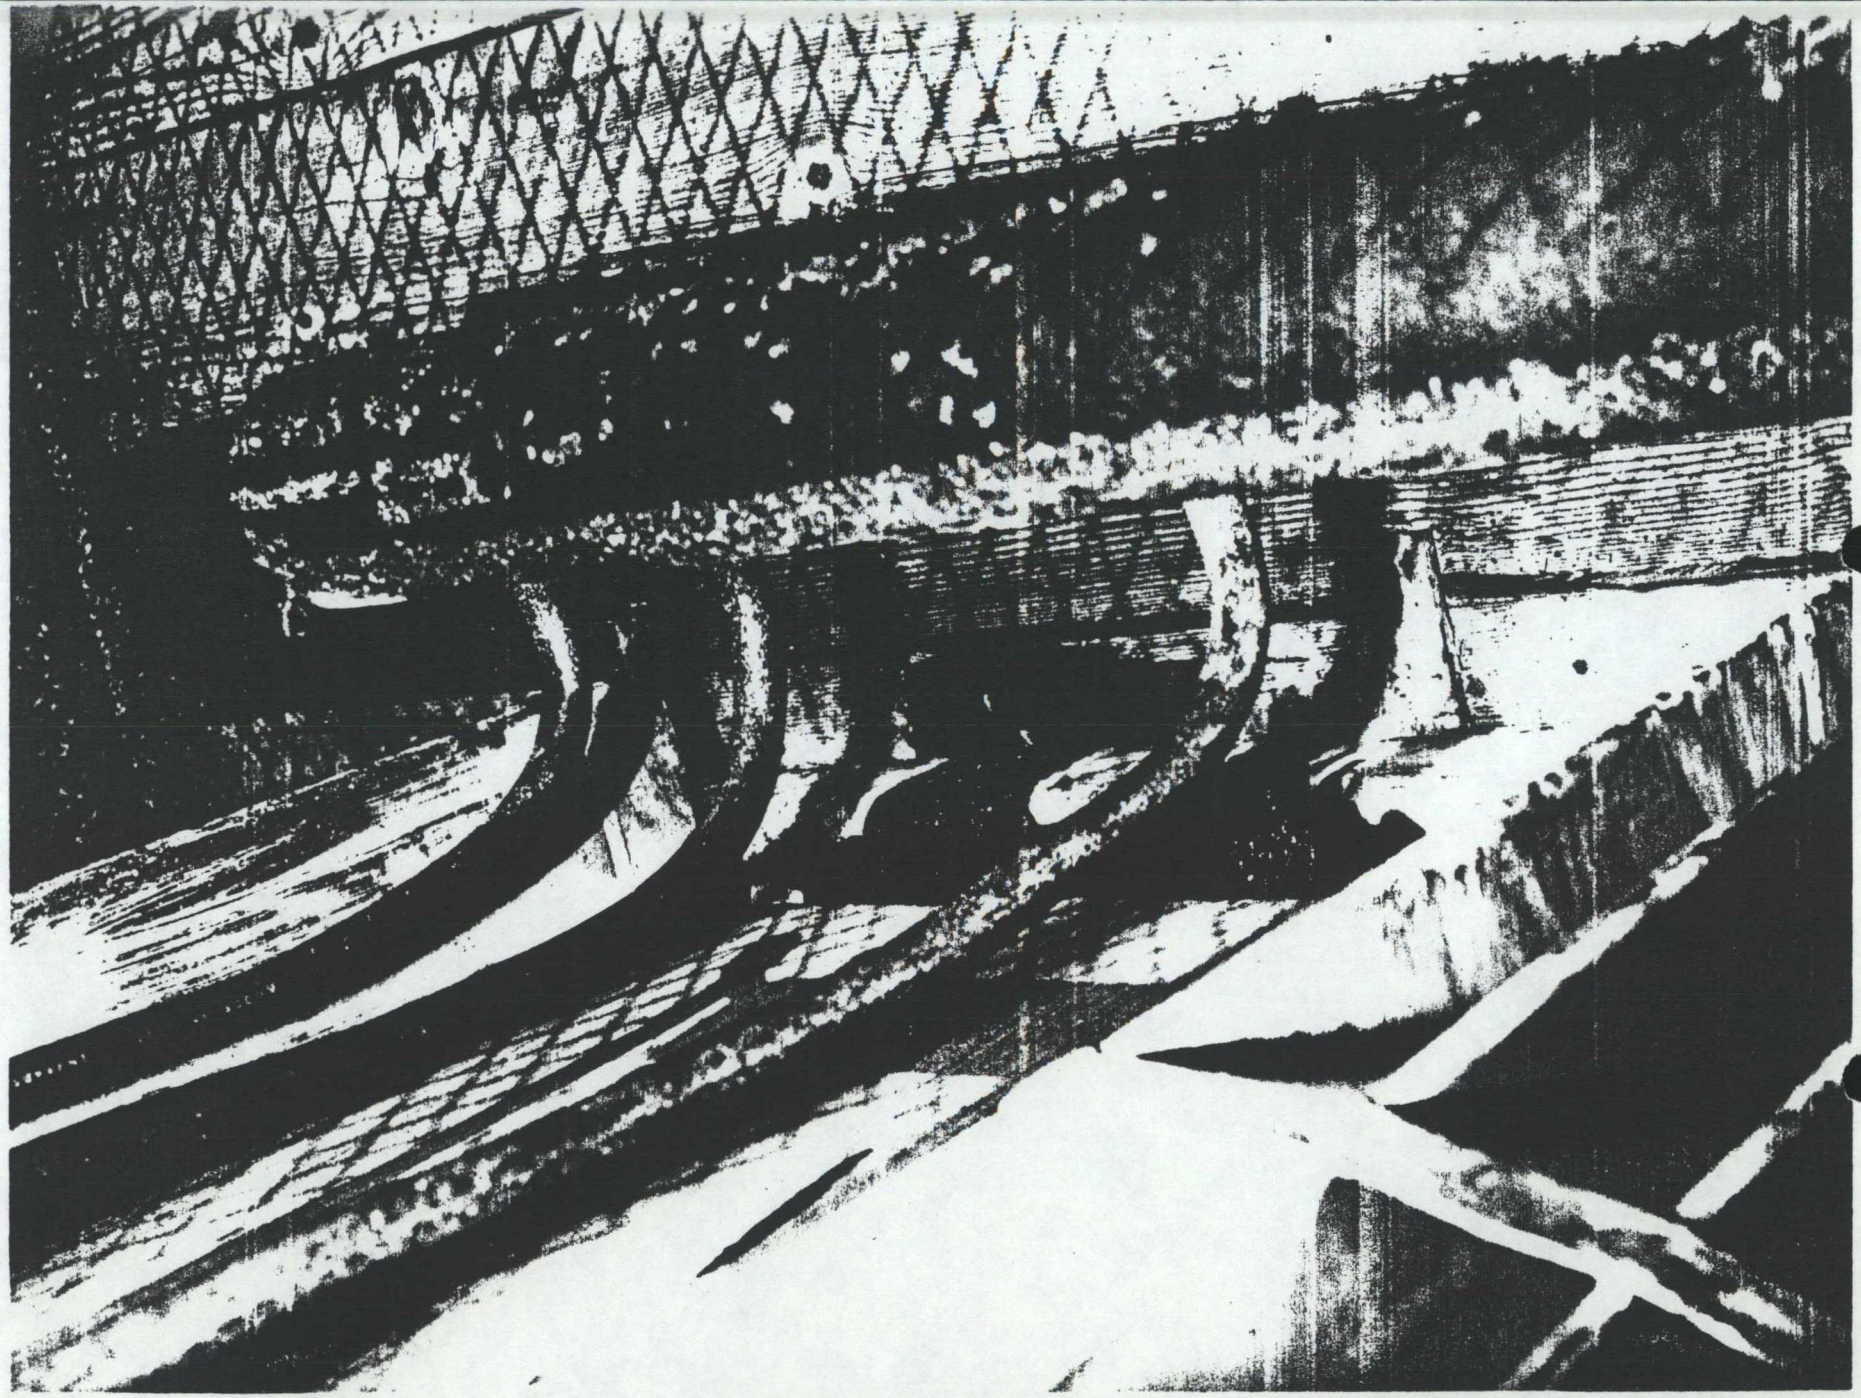
DATE: 11·15·86 NAME: Schmit #63

Material leaked from bushings onto base of GE

#6519308

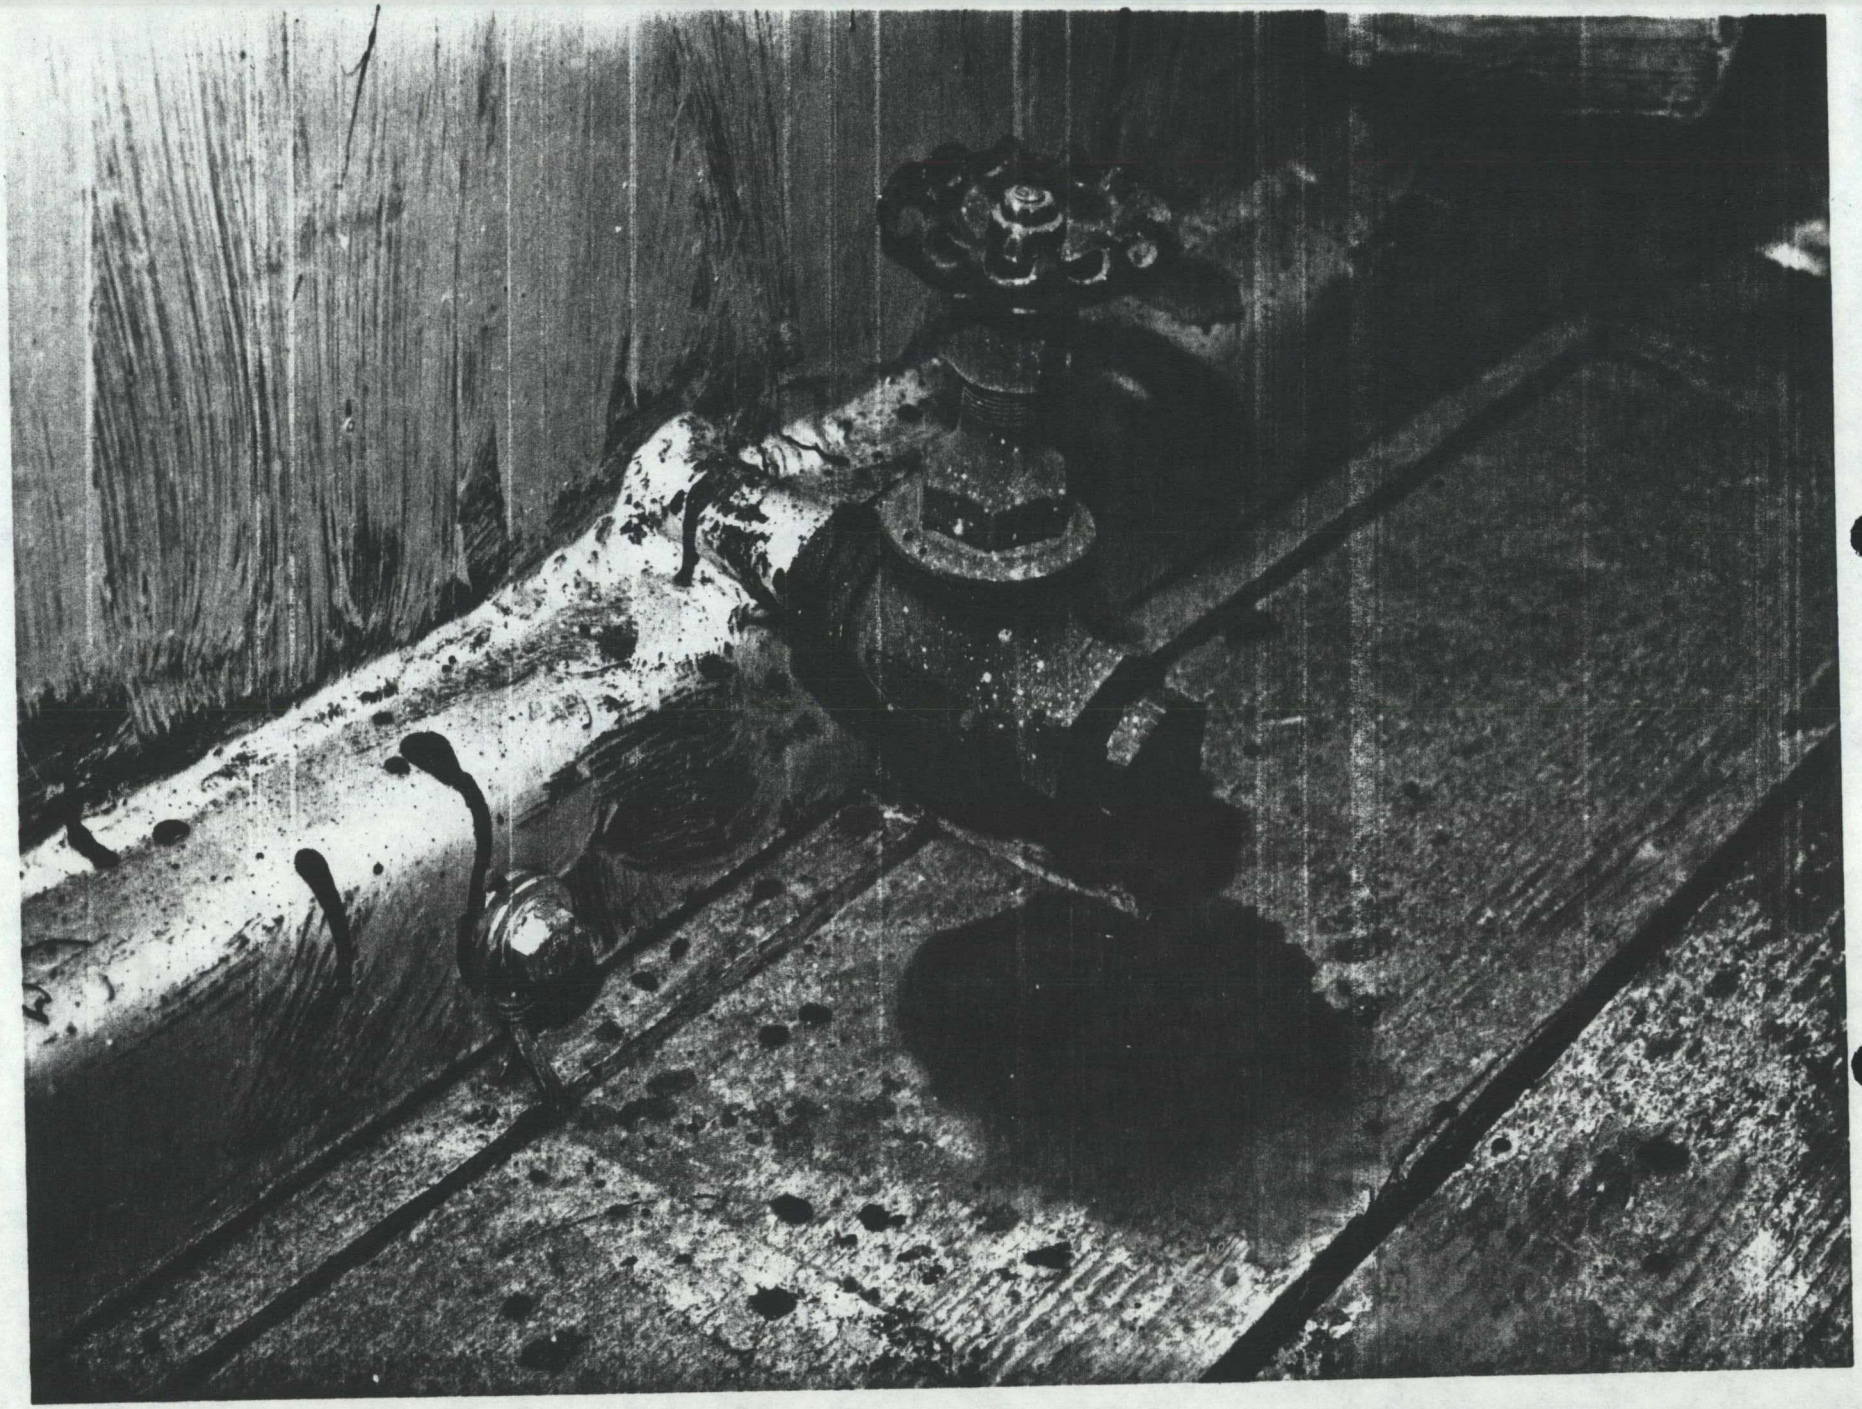
DATE: 11-15-86 NAME: Schmit #64

Leak from drain valve of GE #6519308.

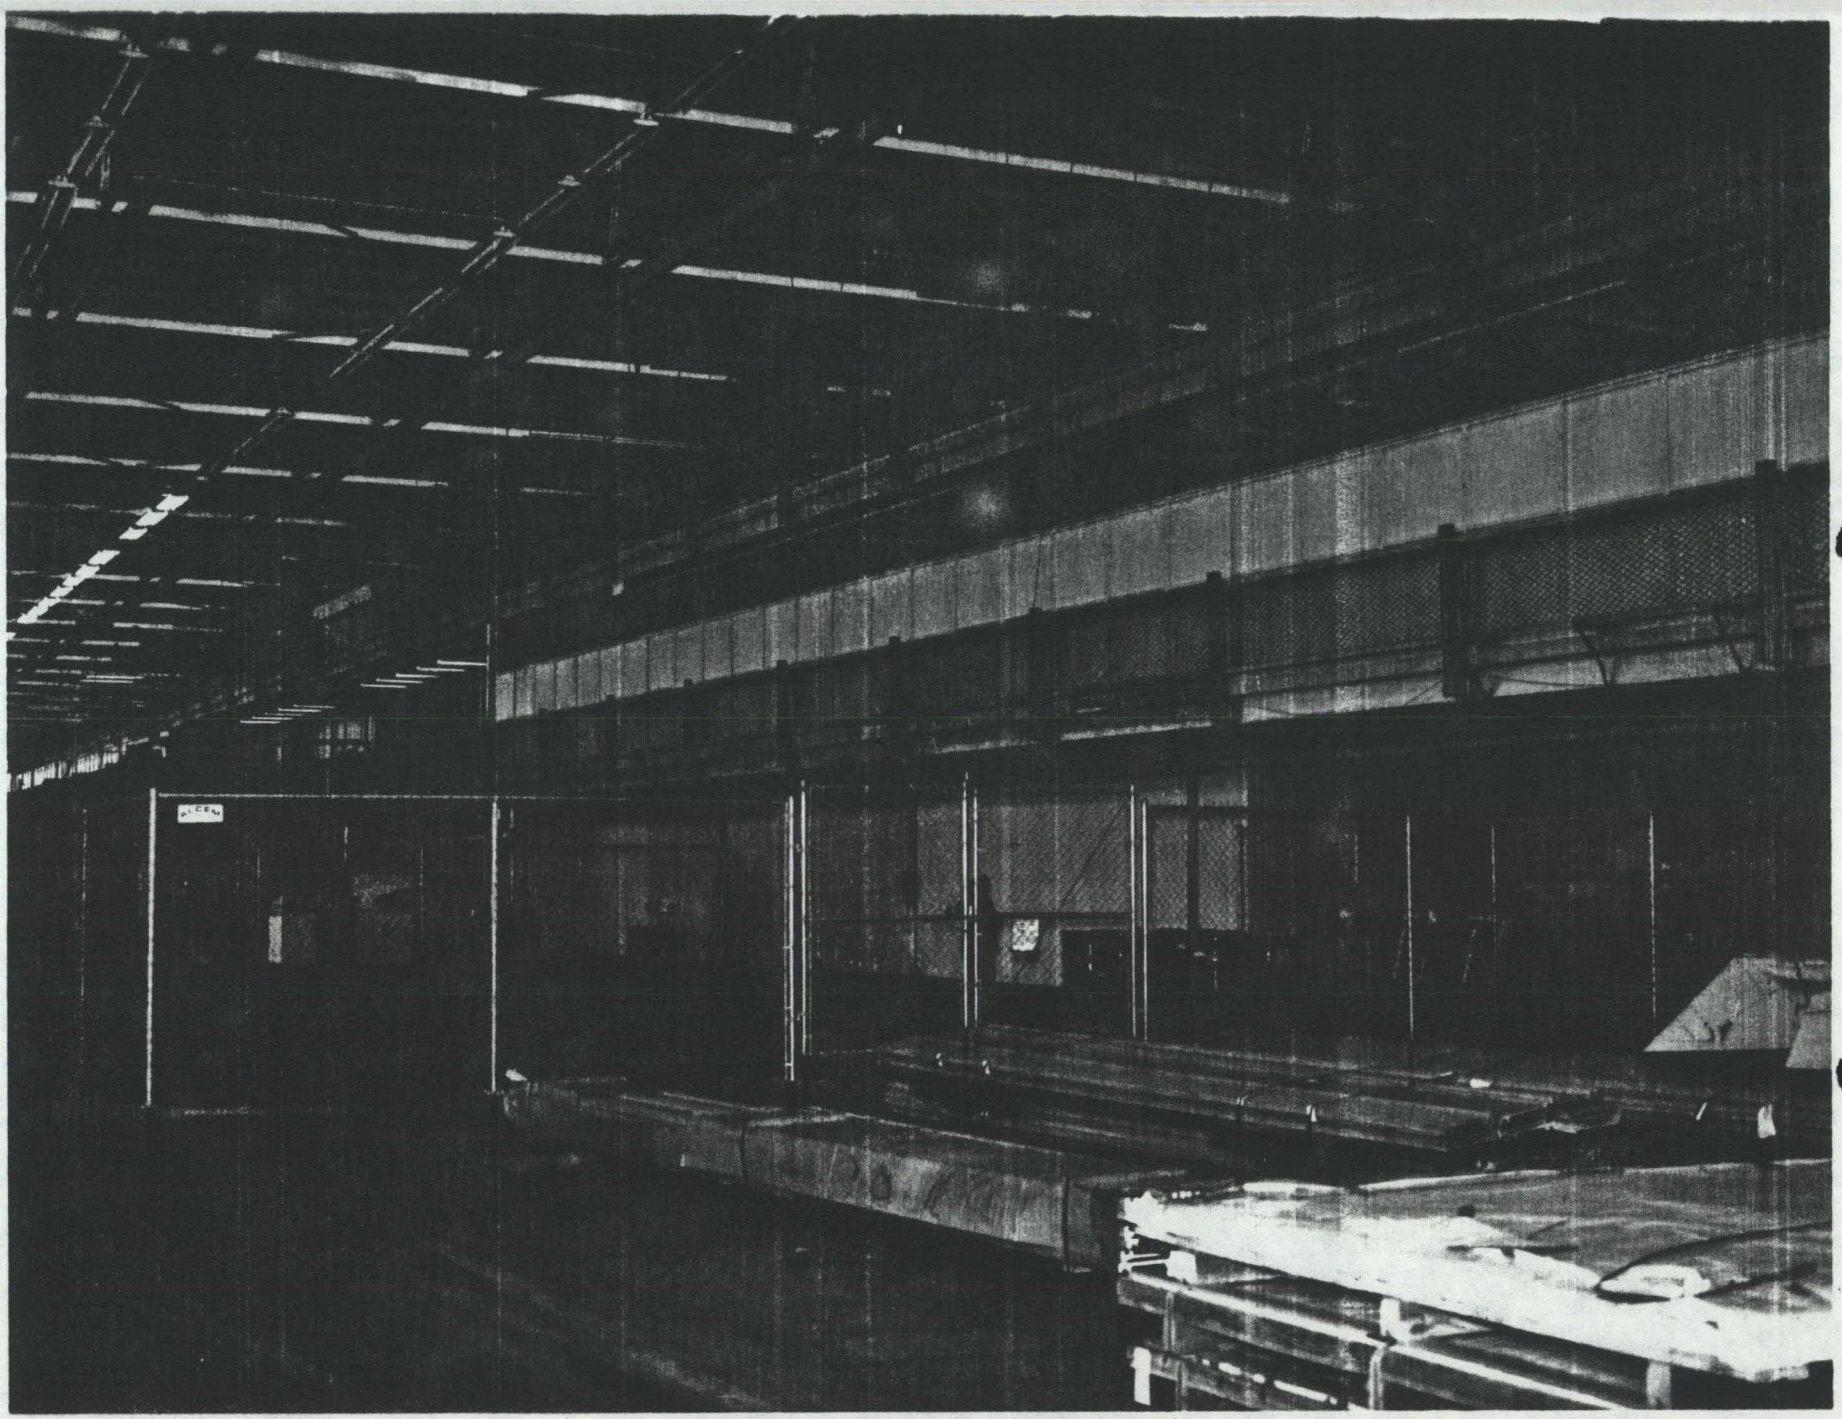
DATE: 11-15-86 NAME: Schmit #65

PCB storage for disposal facility. Note lack of Mu.
