ANALYTICAL RESULTS REPORT
RICHARDSON FLAT TAILINGS
SUMMIT COUNTY, UTAH

TDD R8-8508-07

DATE SUBMITTED: OCTOBER 25, 1985

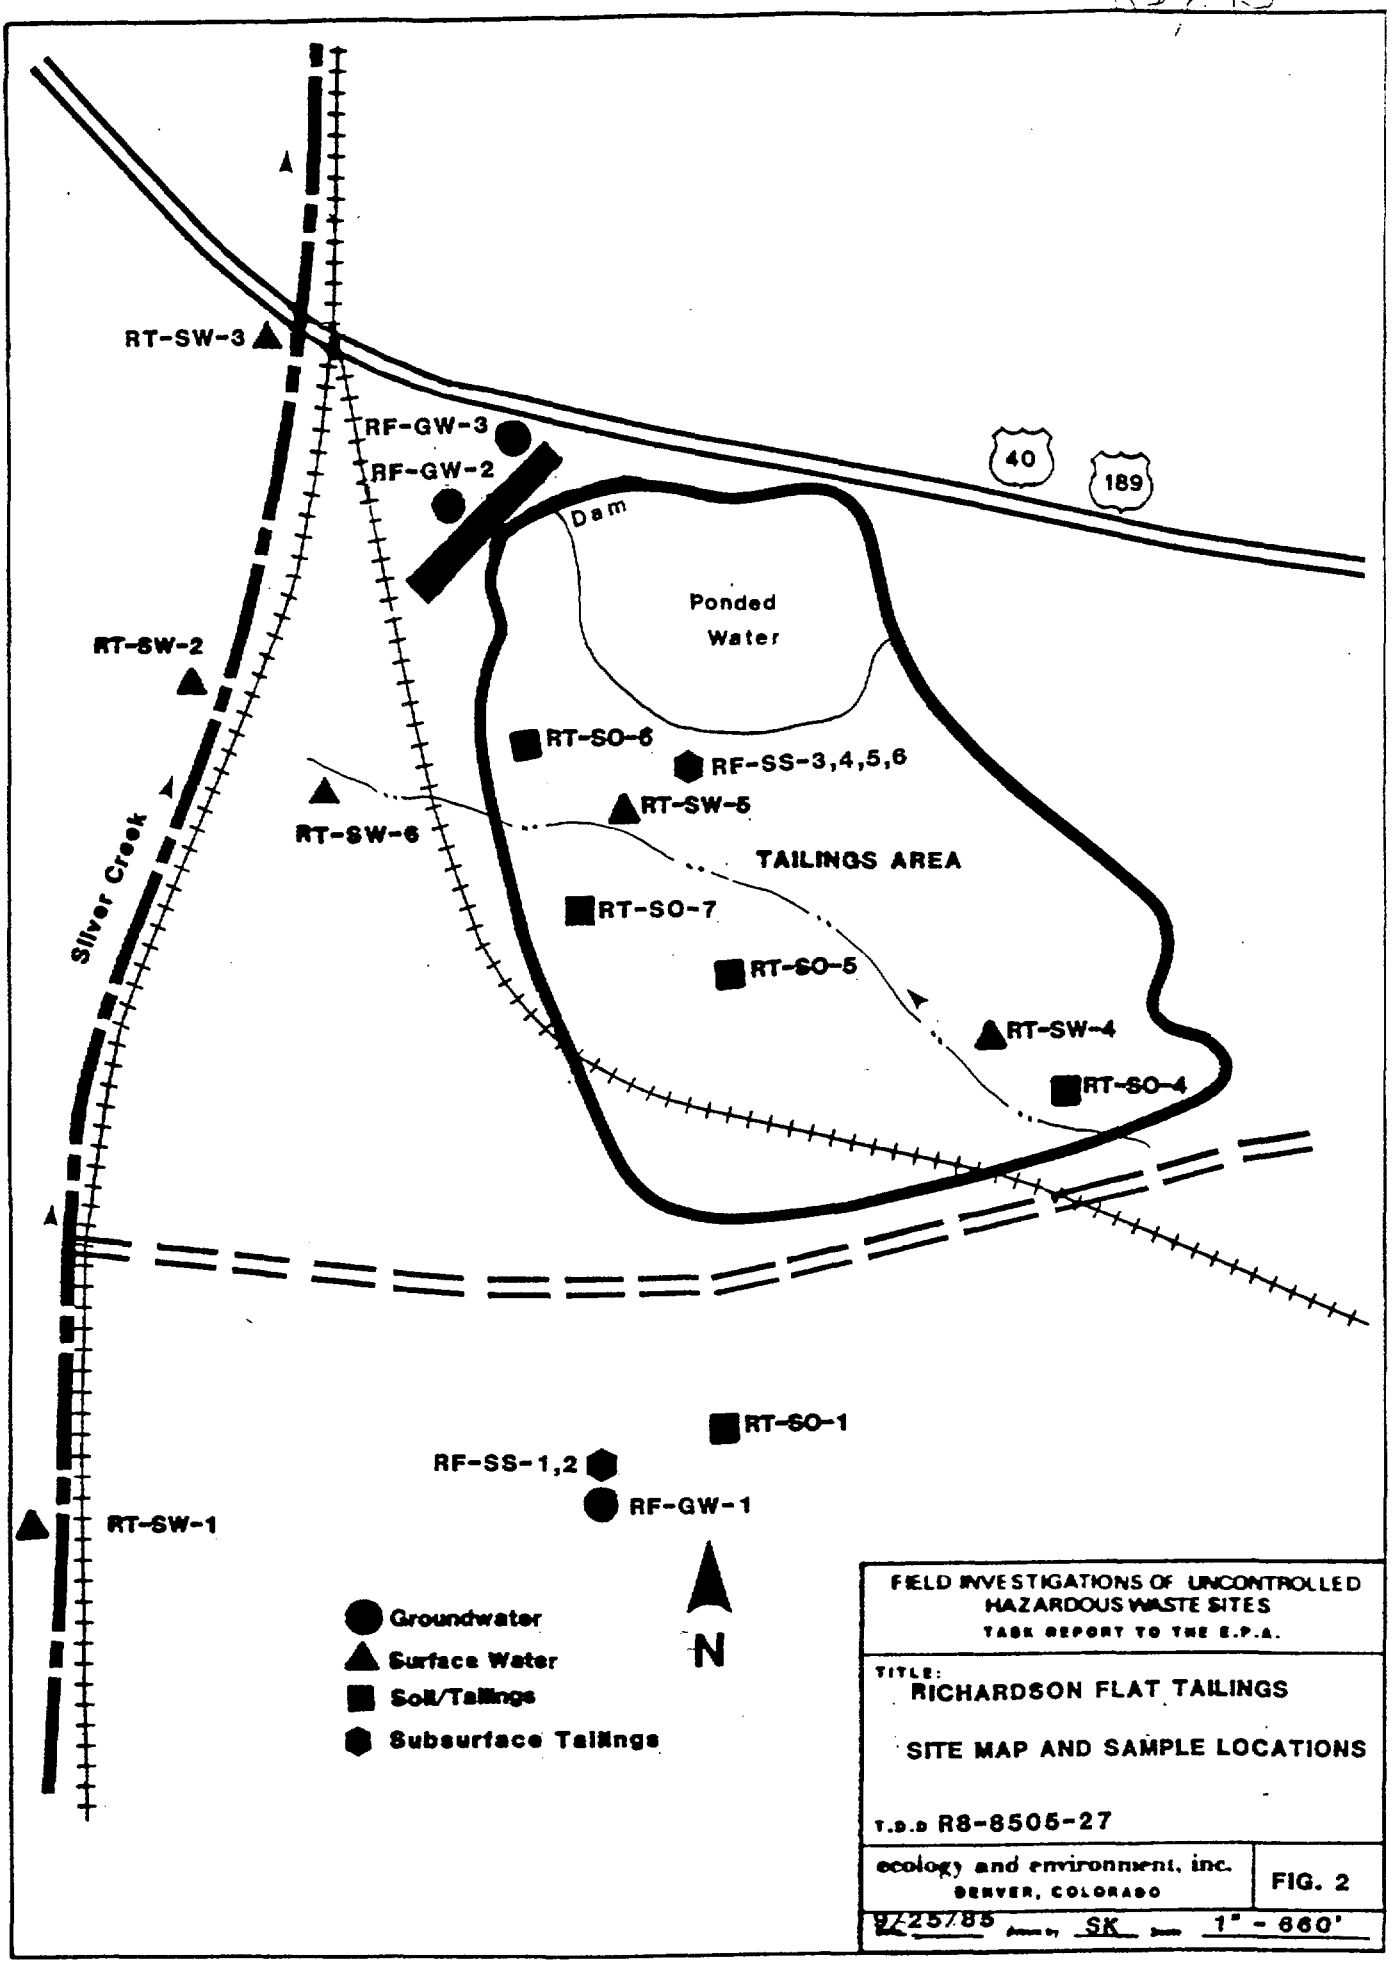
Analytical results for the 1985 sampling effort at Richardson Flat Tailings have been compiled in Tables 1, 2, 3, 4 and 5. Corresponding sample locations are illustrated in Figure 2. The raw data are attached as Appendix B.

RT-SW-3
RF-GW-3
RF-GW-2
40
189
Dam
Ponded
Water
RT-SW-2
RT-SO-6
RF-SS-3,4,5,6
RT-SW-5
RT-SW-6
TAILINGS AREA
Silver Creek
RT-SO-7
RT-SO-5
RT-SW-4
RT-SO-4
RT-SO-1
RF-SS-1,2
RF-GW-1
RT-SW-1
Groundwater
Surface Water
Soil/Tailings
Subsurface Tailings
N
FIELD INVESTIGATIONS OF UNCONTROLLED HAZARDOUS WASTE SITES
TASK REPORT TO THE E.P.A.
TITLE:
RICHARDSON FLAT TAILINGS
SITE MAP AND SAMPLE LOCATIONS
T.D.# R8-8505-27
ecology and environment, inc.
DENVER, COLORADO
FIG. 2
9/25/85
SK
1" = 660'
