FINAL REPORT
RICHARDSON FLATS TAILINGS
SUMMIT COUNTY, UTAH

TDD #T08-9204-015 and #T08-9210-050
PAN EUT0039SBA and EUT0039SDA

Scott Keen
Ecology and Environment, Inc.
Technical Assistance Team

DATE SUBMITTED: February 19, 1993

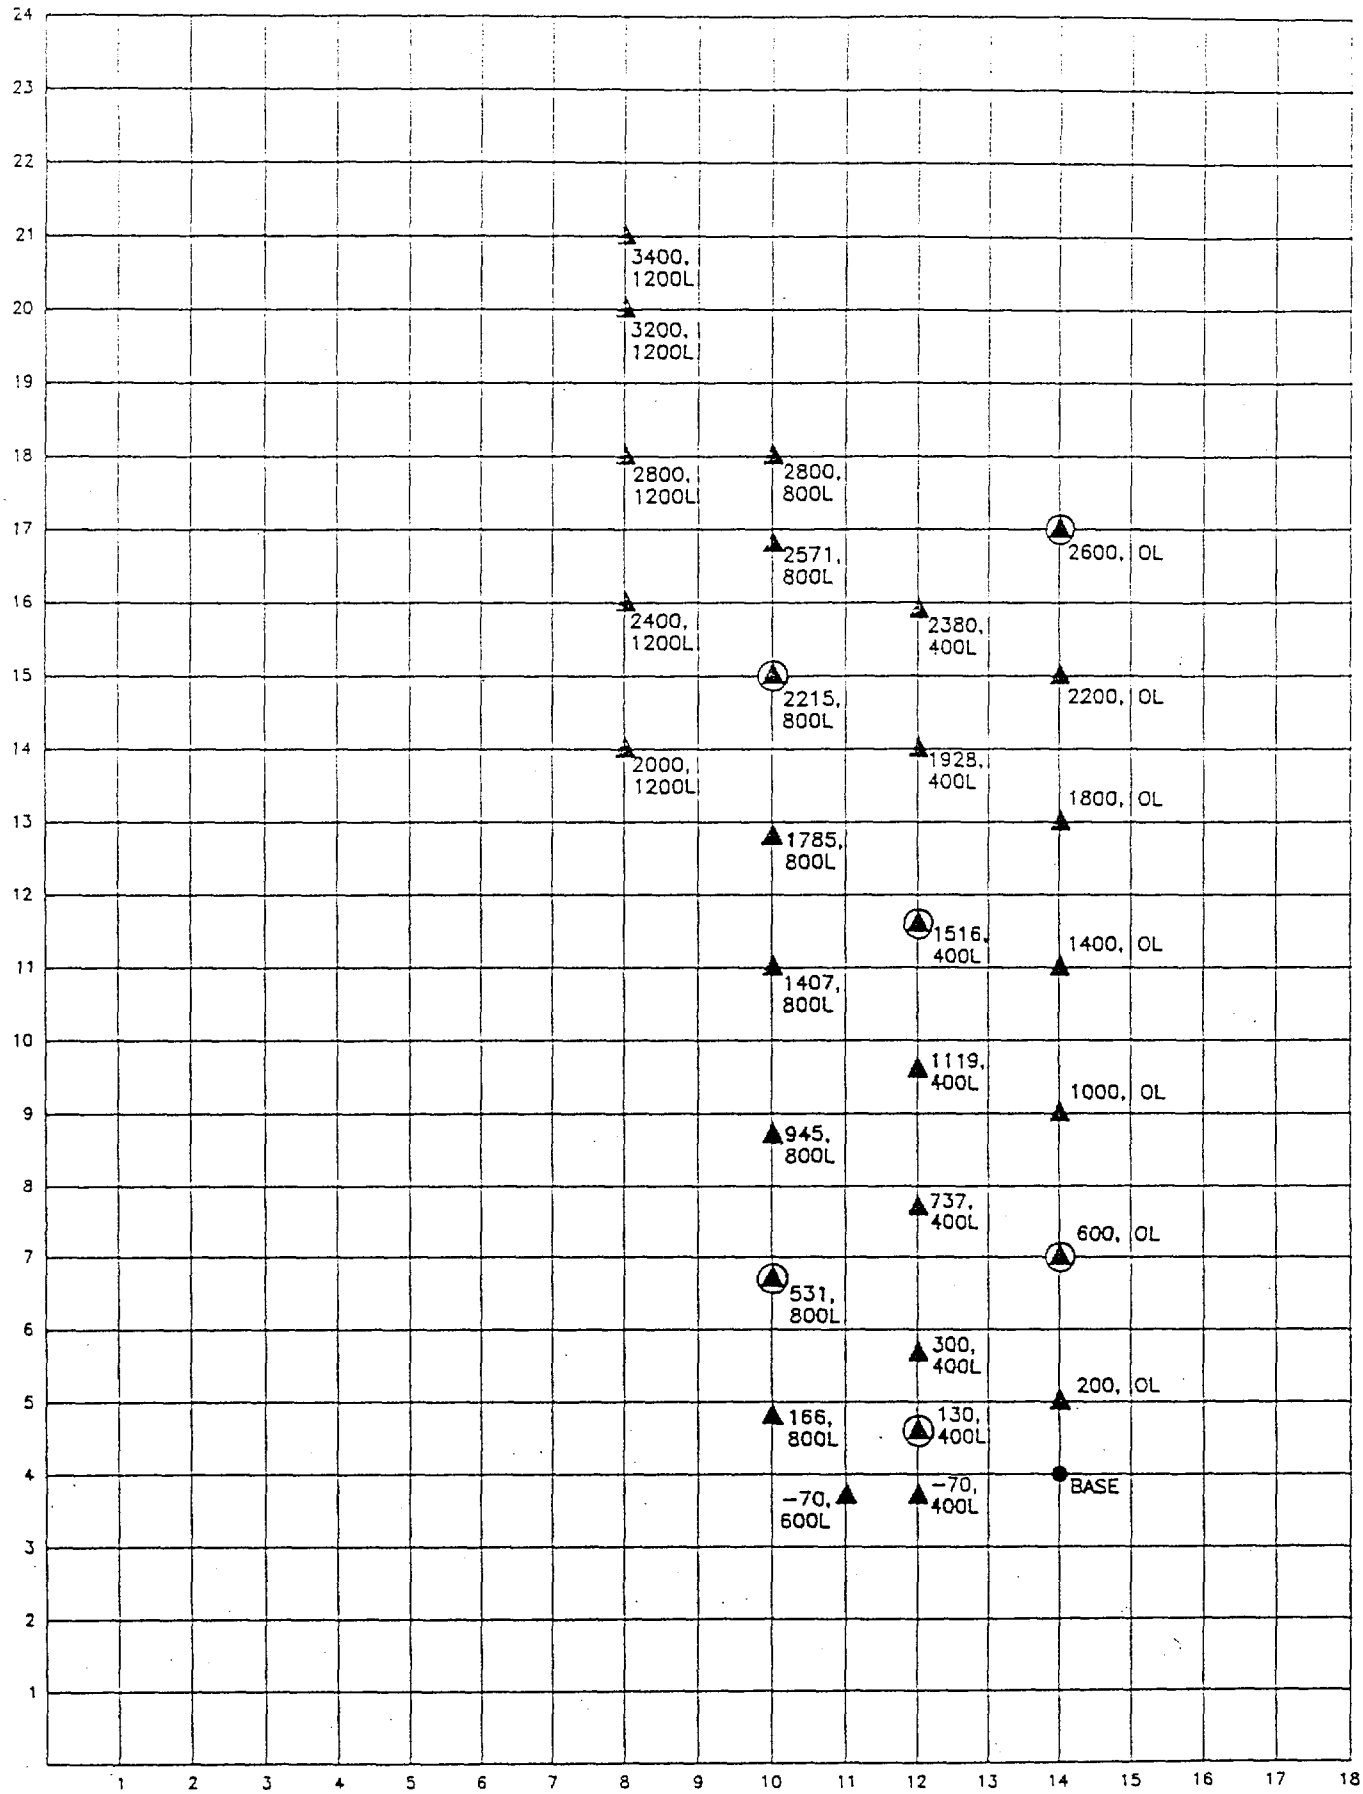
Figure 2
RICHARDSON FLATS
August 4, 5, 6, 1992

Depth of cover was determined at 29 locations over the tailings area. These locations are depicted on Figure 2. Locations were determined by first establishing a reference line in an approximate direction of northwest to southeast through the tailings area (Figure 1). This reference line includes and is a continuation of a straight portion of the tailings containment structure as shown in Figure 1. Points were marked along this reference line at 200 or 400 foot intervals. At 2800 feet from the base point a second reference line was established in a perpendicular direction to the first reference line. This second reference line extended in an approximate direction from southwest to northeast. For the purpose of sampling or soil cover measurements, all locations within the tailings area were identified relative to these two reference lines. For example, a sample location identified as 1900, 800L would be 1900 feet from the base point (using the first reference line) and 800 feet to the left (northeast) using the second reference line.

The grid pattern shown in Figure 2 represent much of the entire tailings area. Of the 29 points on this grid only 1 point had no cover soil and no salt grass present. Nine of the 29 points (approximately 30 percent) had no cover soil present. At the 20 points where cover soil was present, the cover soil was 6 inches thick or less at 6 points and greater than 6 inches in thickness at 14 points.

Figure 2 shows the location of six soil samples collected on August 6, 1992. Each of these samples, except sample RF-SO-3, was taken from soil that was added by UPCM as cover to the site. Table 2 contains analytical results for these samples and the normal ranges for these elements in soils of the western United States. Sample RF-SO-3 was collected within an area covered by salt grass. As discussed, where salt grass is currently established soil cover has not been added by UPCM. This soil sample is more likely to be representative of tailings material.
