Subject: Preliminary Assessment Report Richardson Flat Tailings, Summit County Utah

POTENTIAL HAZARDOUS WASTE SITE
PRELIMINARY ASSESSMENT
PART 1 - SITE INFORMATION AND ASSESSMENT

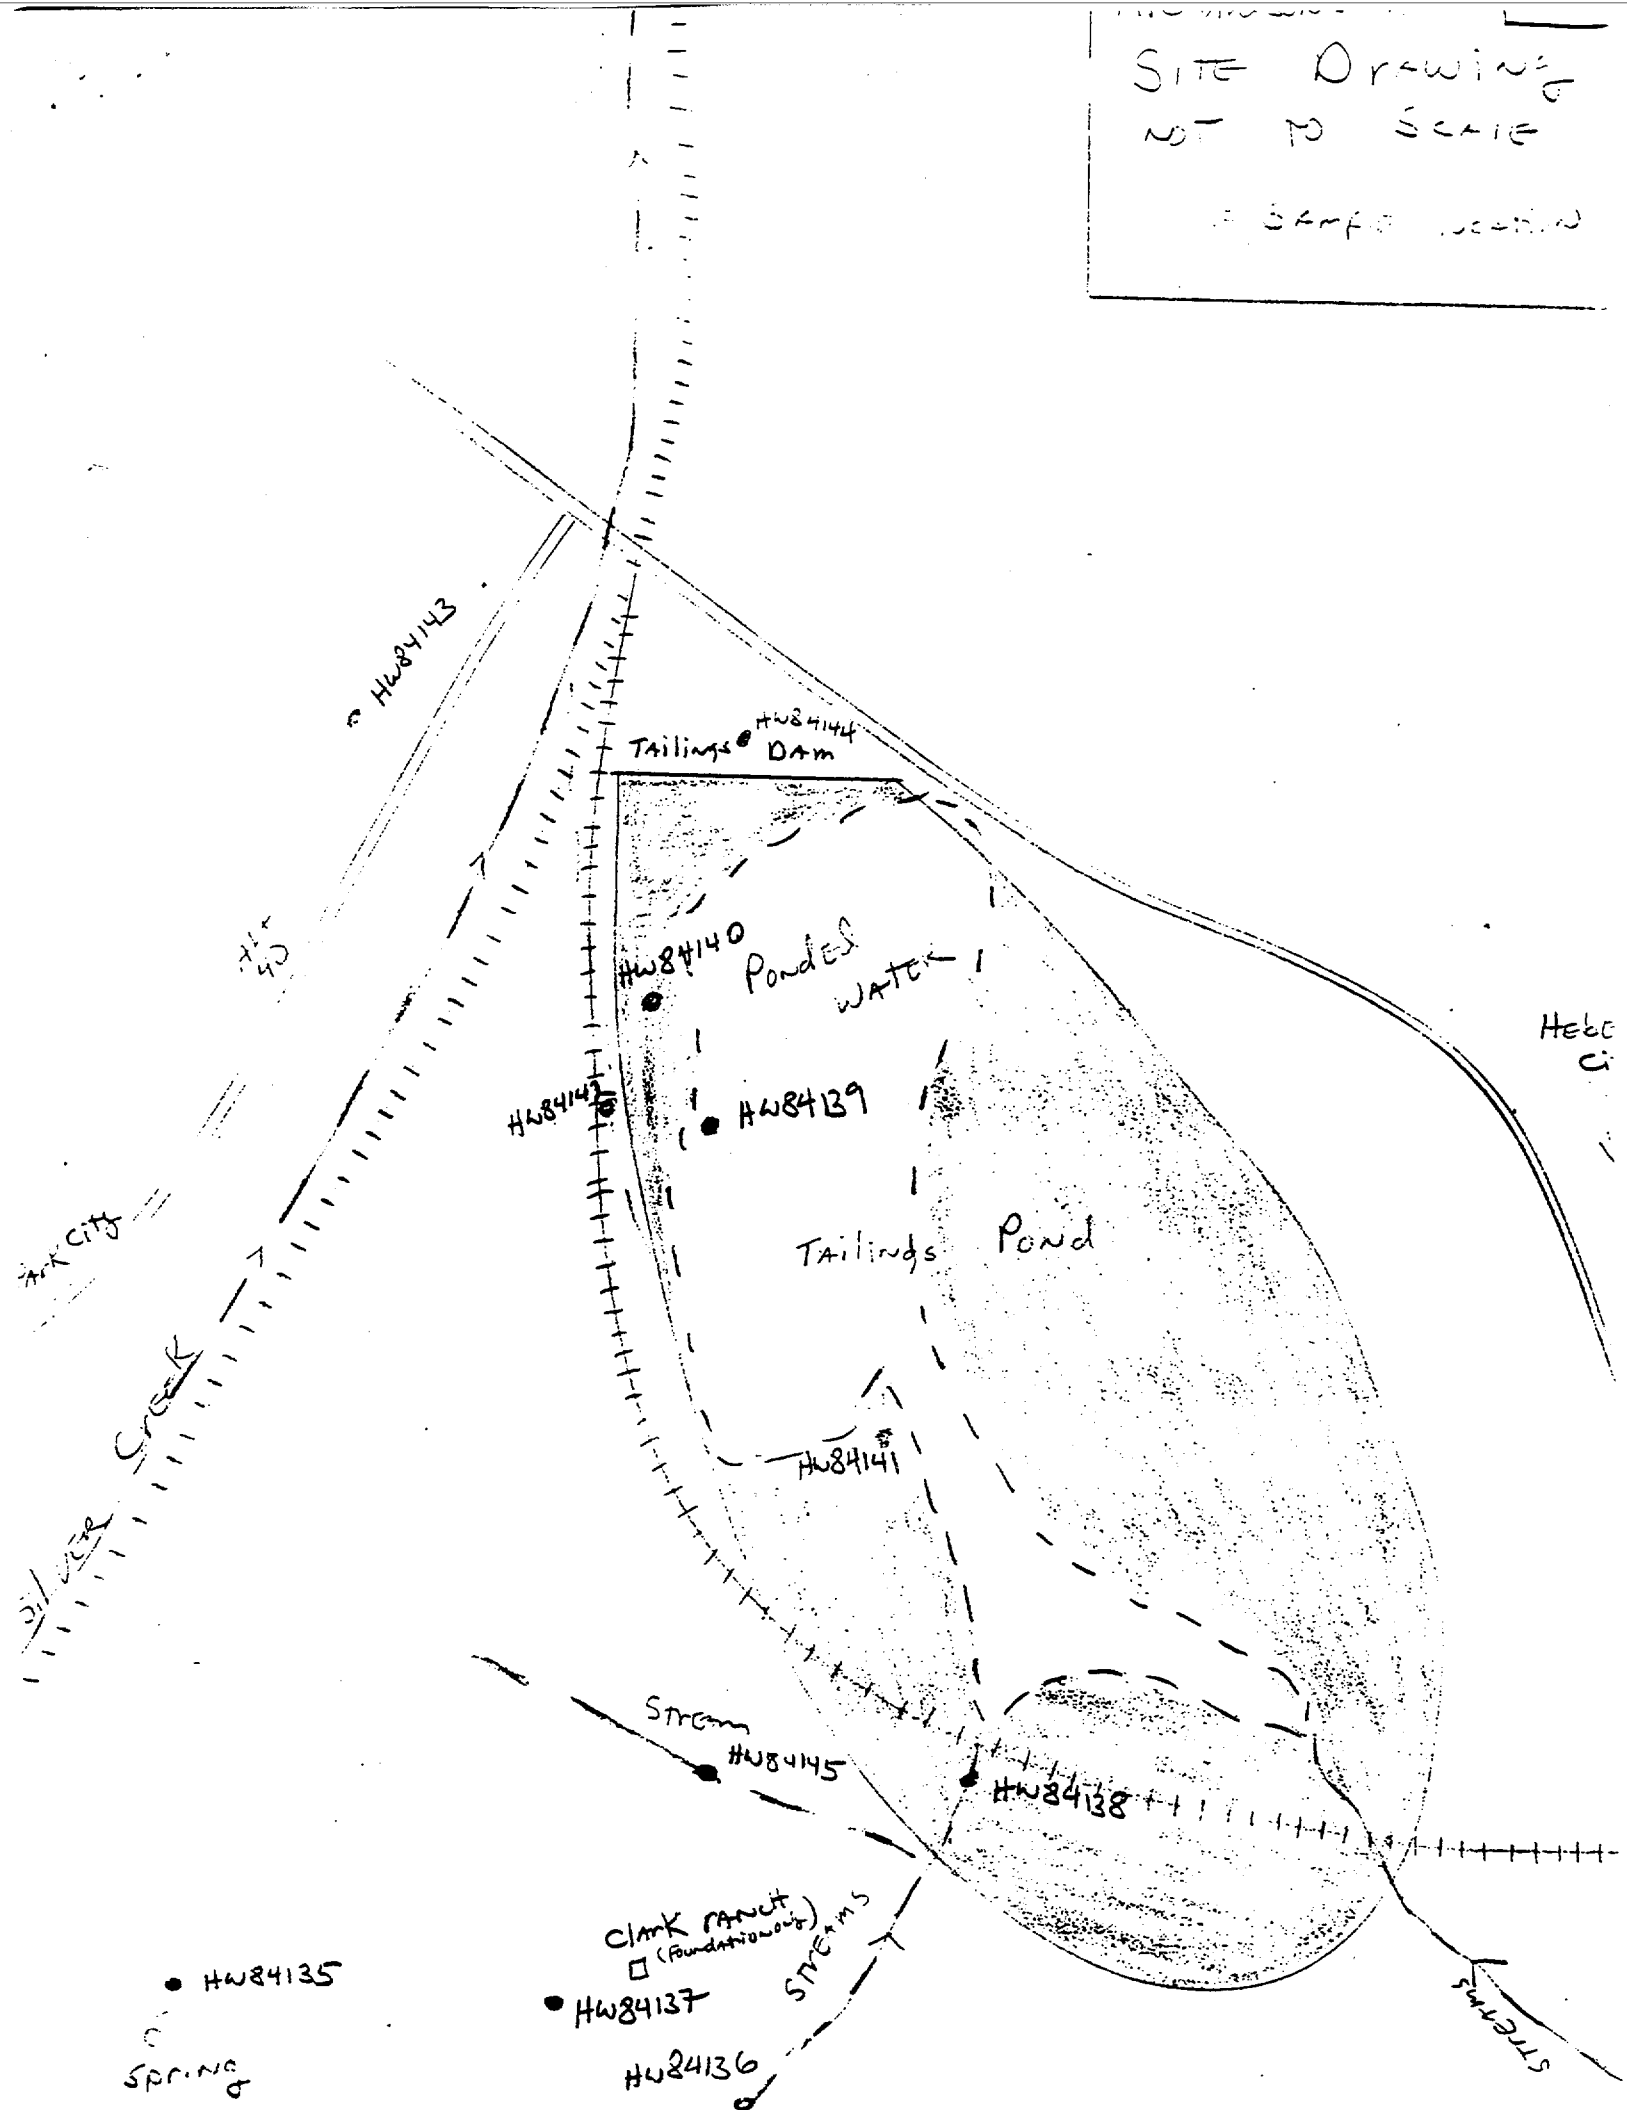
SITE DRAWING
NOT TO SCALE
HW84143
Tailings
HW84144
DAM
HW84140
Ponded
WATER
HW84142
HW84139
Tailings Pond
HW84141
Silver Creek
Stream
HW84145
HW84138
Clark Ranch
(Foundations)
STREAMS
HW84135
HW84137
HW84136
SPRING
STREAMS
