Re: PCB Groundwater Quality Assessment Program
1st Quarter 2015 Data Report
Solutia Inc., W. G. Krummrich Plant, Sauget, IL

GROUNDWATER MONITORING REPORT

PCB GROUNDWATER QUALITY ASSESSMENT PROGRAM
SOLUTIA INC., W.G. KRUMMRICH FACILITY
SAUGET, ILLINOIS

April 2015 **140-3345**

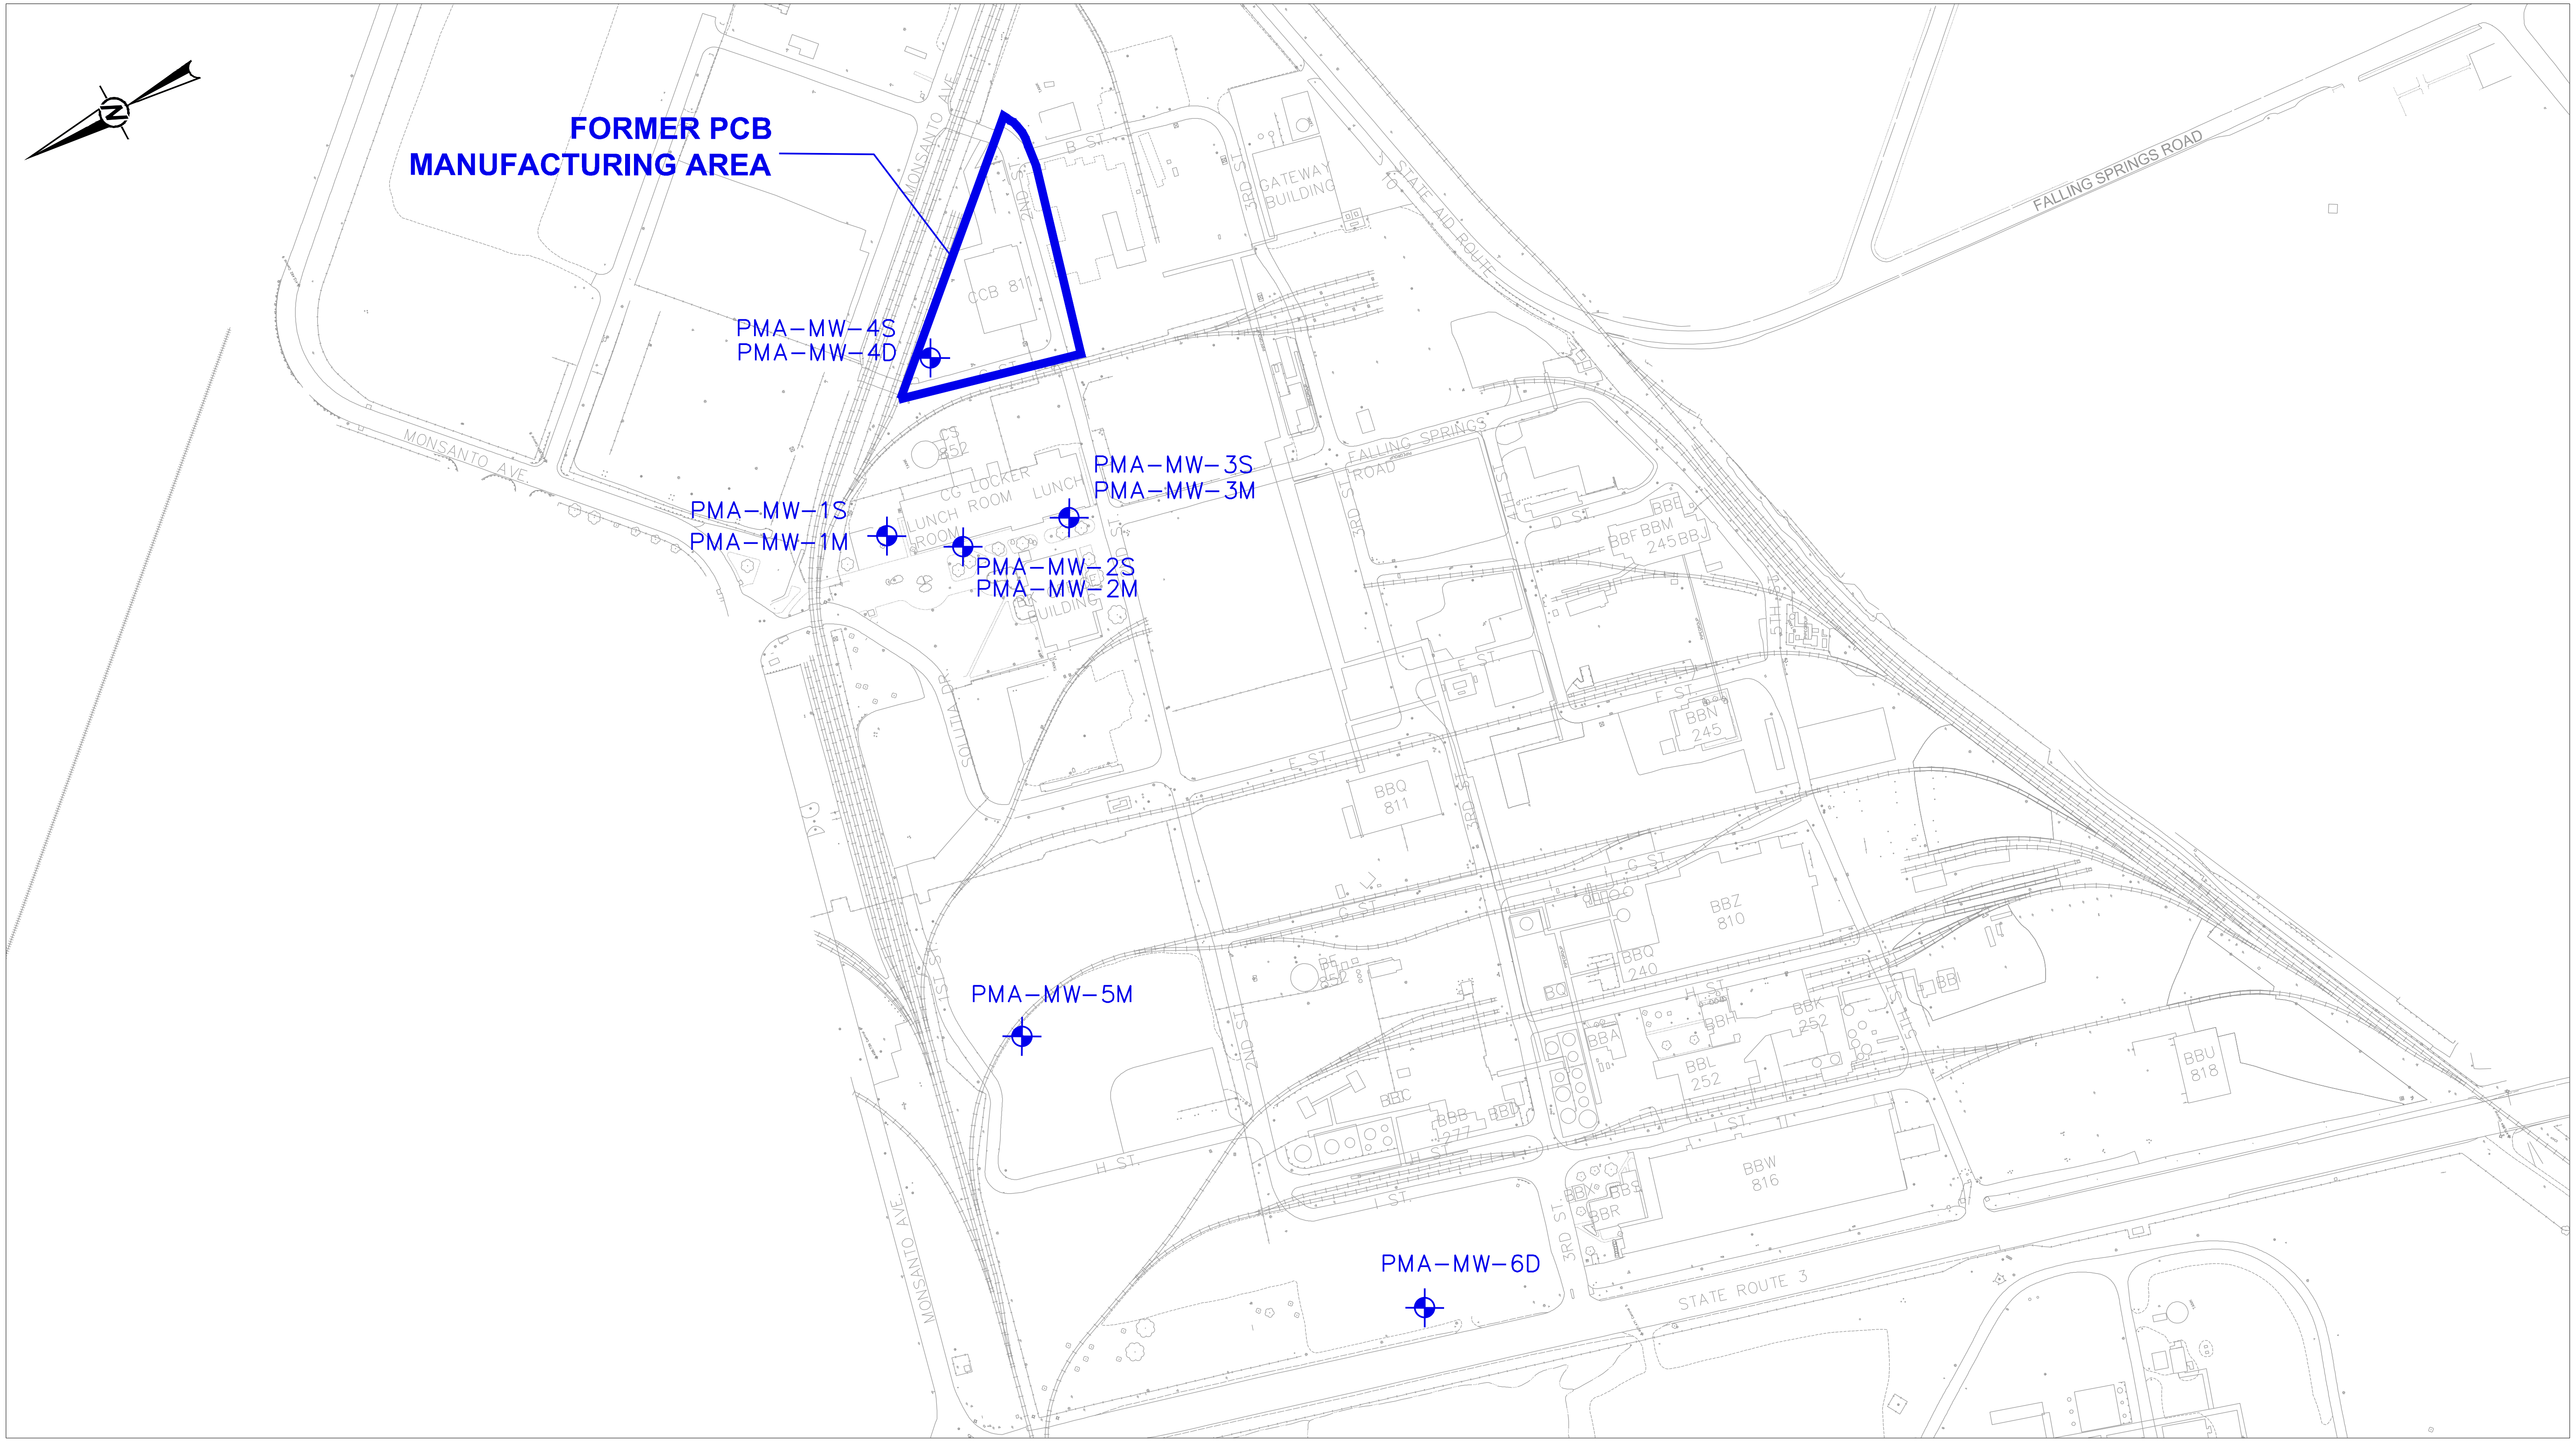
TITLE
FORMER PCB MANUFACTURING AREA
MONITORING WELL LOCATIONS

Ten (10) monitoring wells are sampled during the PCB event. The locations of the monitoring wells are shown on Figure 2 and the sample locations are included in the table below.

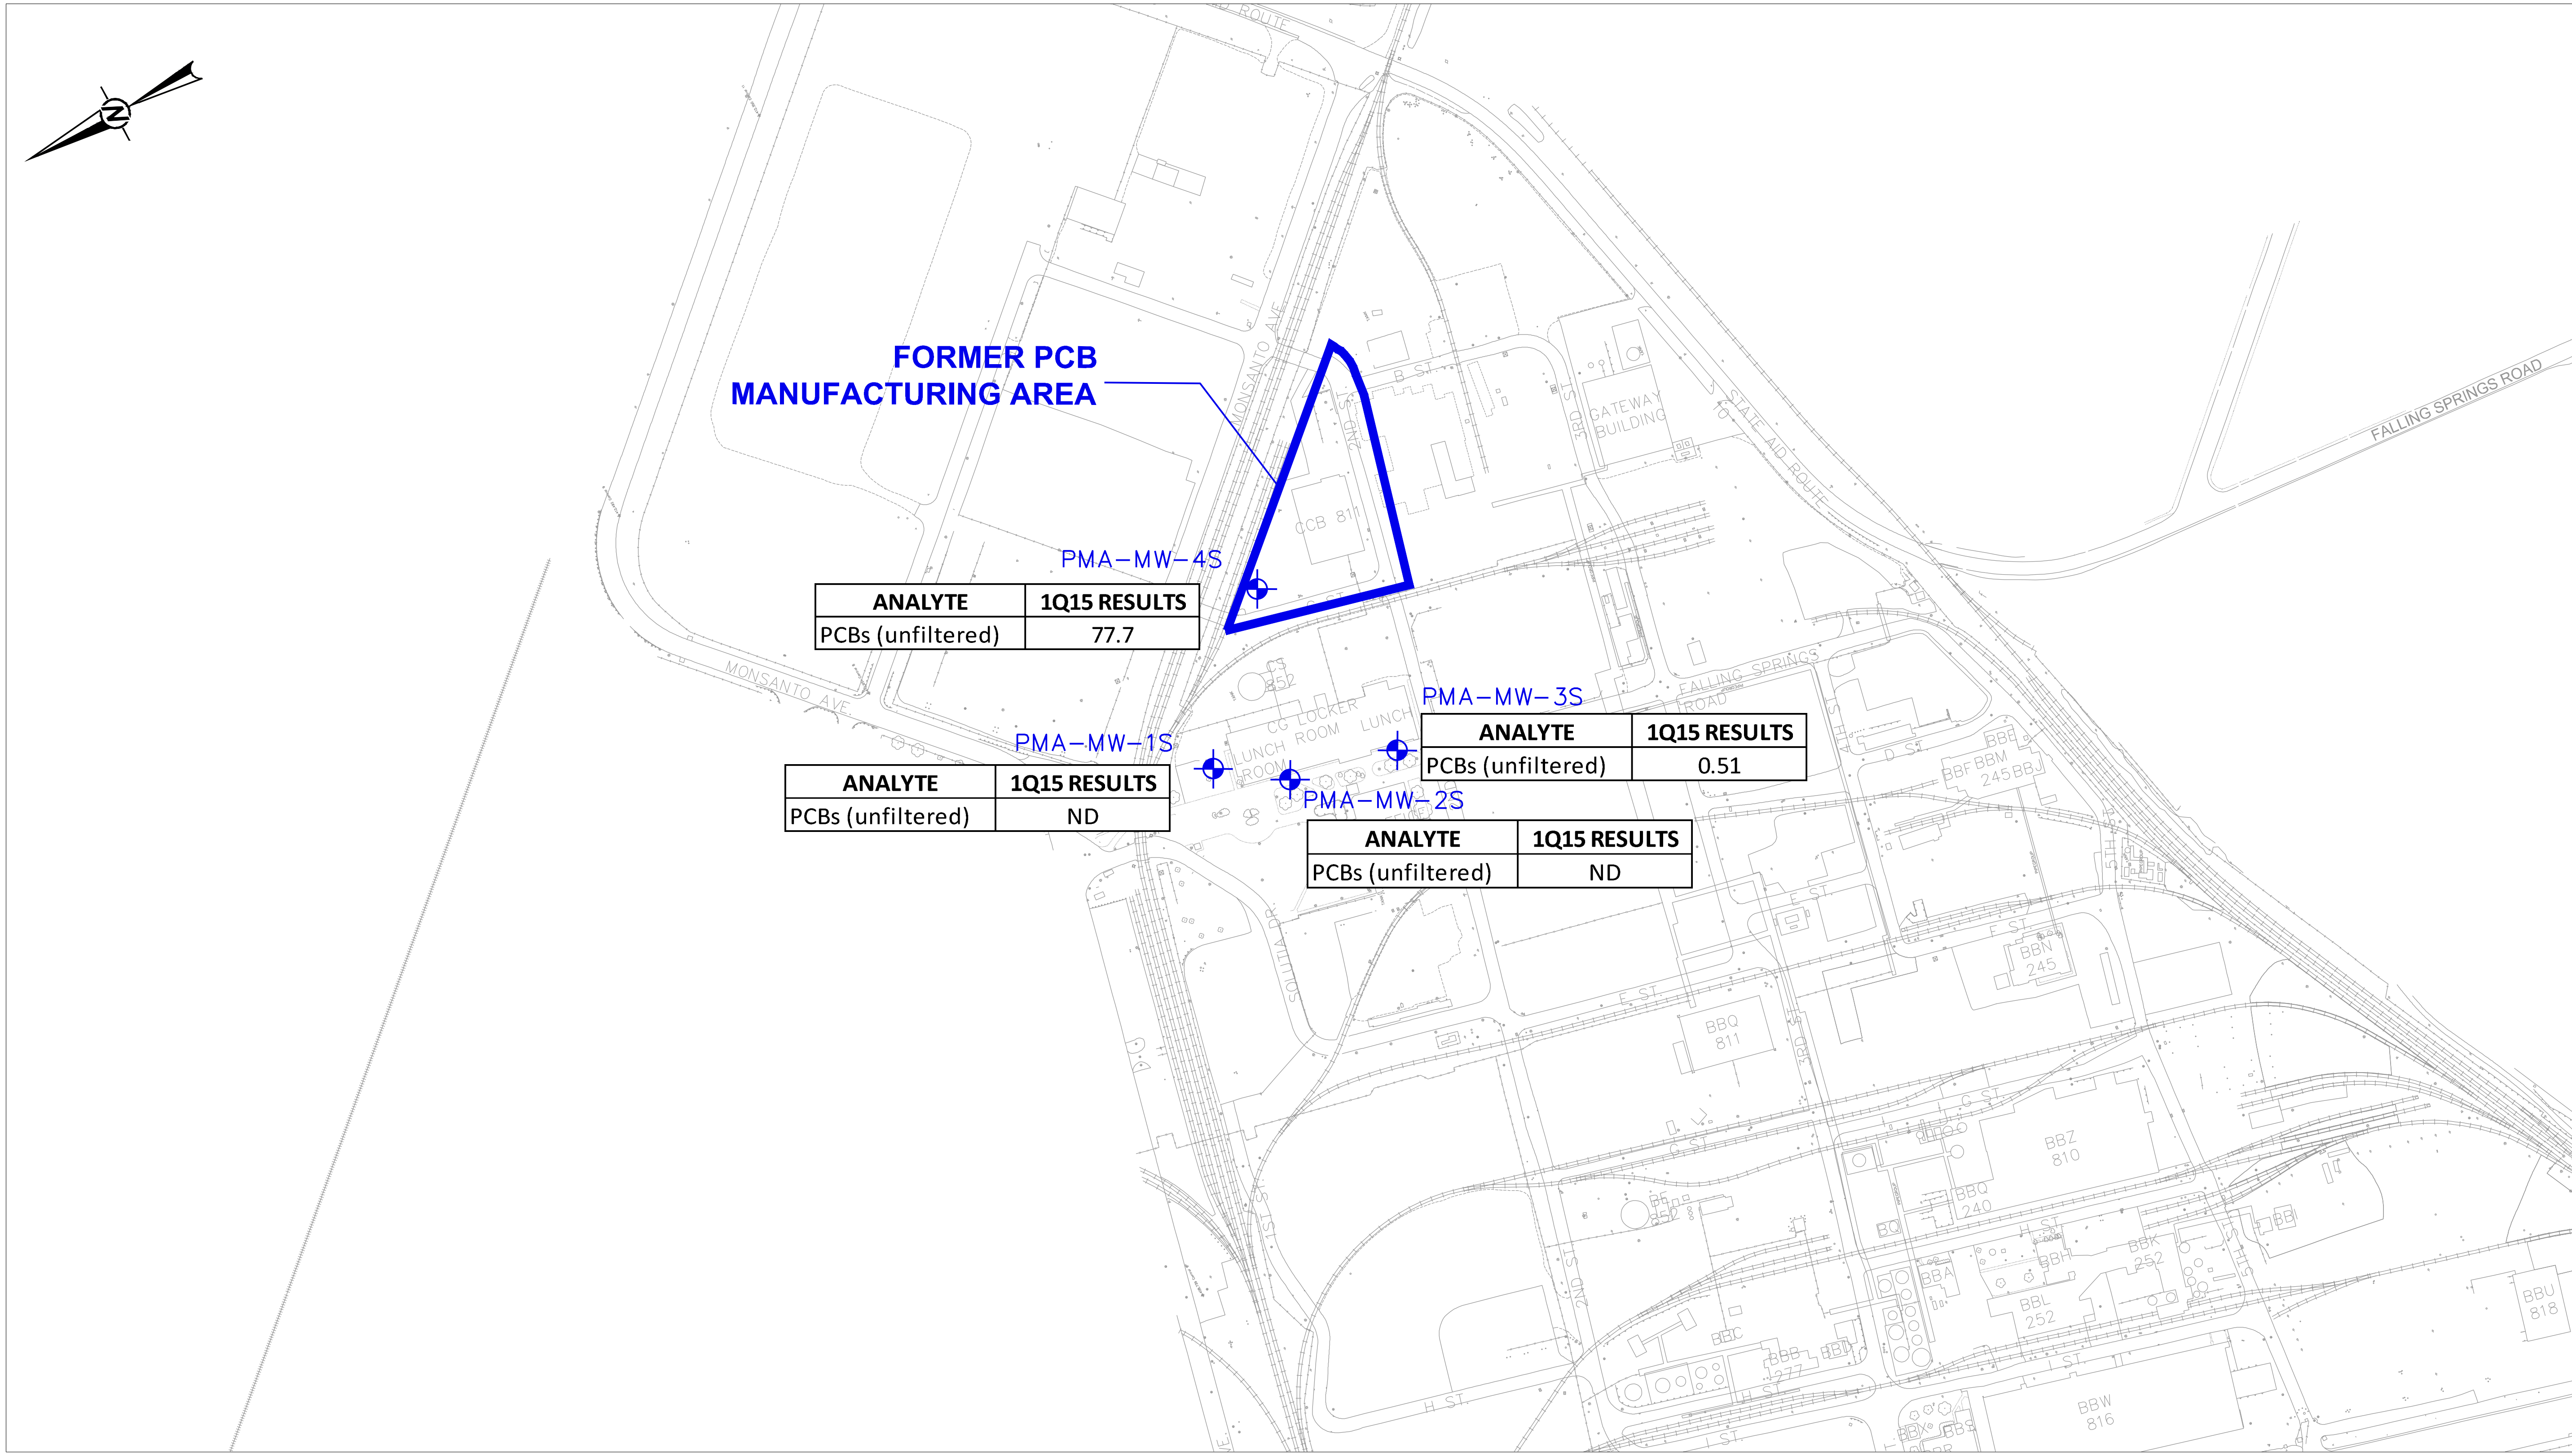
TITLE
PCB RESULTS
SHALLOW HYDROGEOLOGIC UNIT

Groundwater analytical data for the 1Q15 PCB event is discussed below and presented in Table 2. Sample results are also shown for the SHU and the MHU/DHU in Figures 4 and 5, respectively.

Historically dense non-aqueous phase liquid (DNAPL) has been periodically detected in PMA-MW-4S, located in the former PCB Manufacturing Area. DNAPL was not detected in PMA-MW-4S during the 1Q15 event. A groundwater sample was collected at PMA-MW-4S and PCBs were detected at a concentration of 77.7 µg/L. PCBs were not detected in two (2) of three (3) monitoring wells in the SHU downgradient of the former PCB Manufacturing Area (PMA-MW-1S and PMA-MW-2S).

ANALYTE	1Q15 RESULTS
PCBs (unfiltered)	77.7

ANALYTE	1Q15 RESULTS
PCBs (unfiltered)	0.51

ANALYTE	1Q15 RESULTS
PCBs (unfiltered)	ND

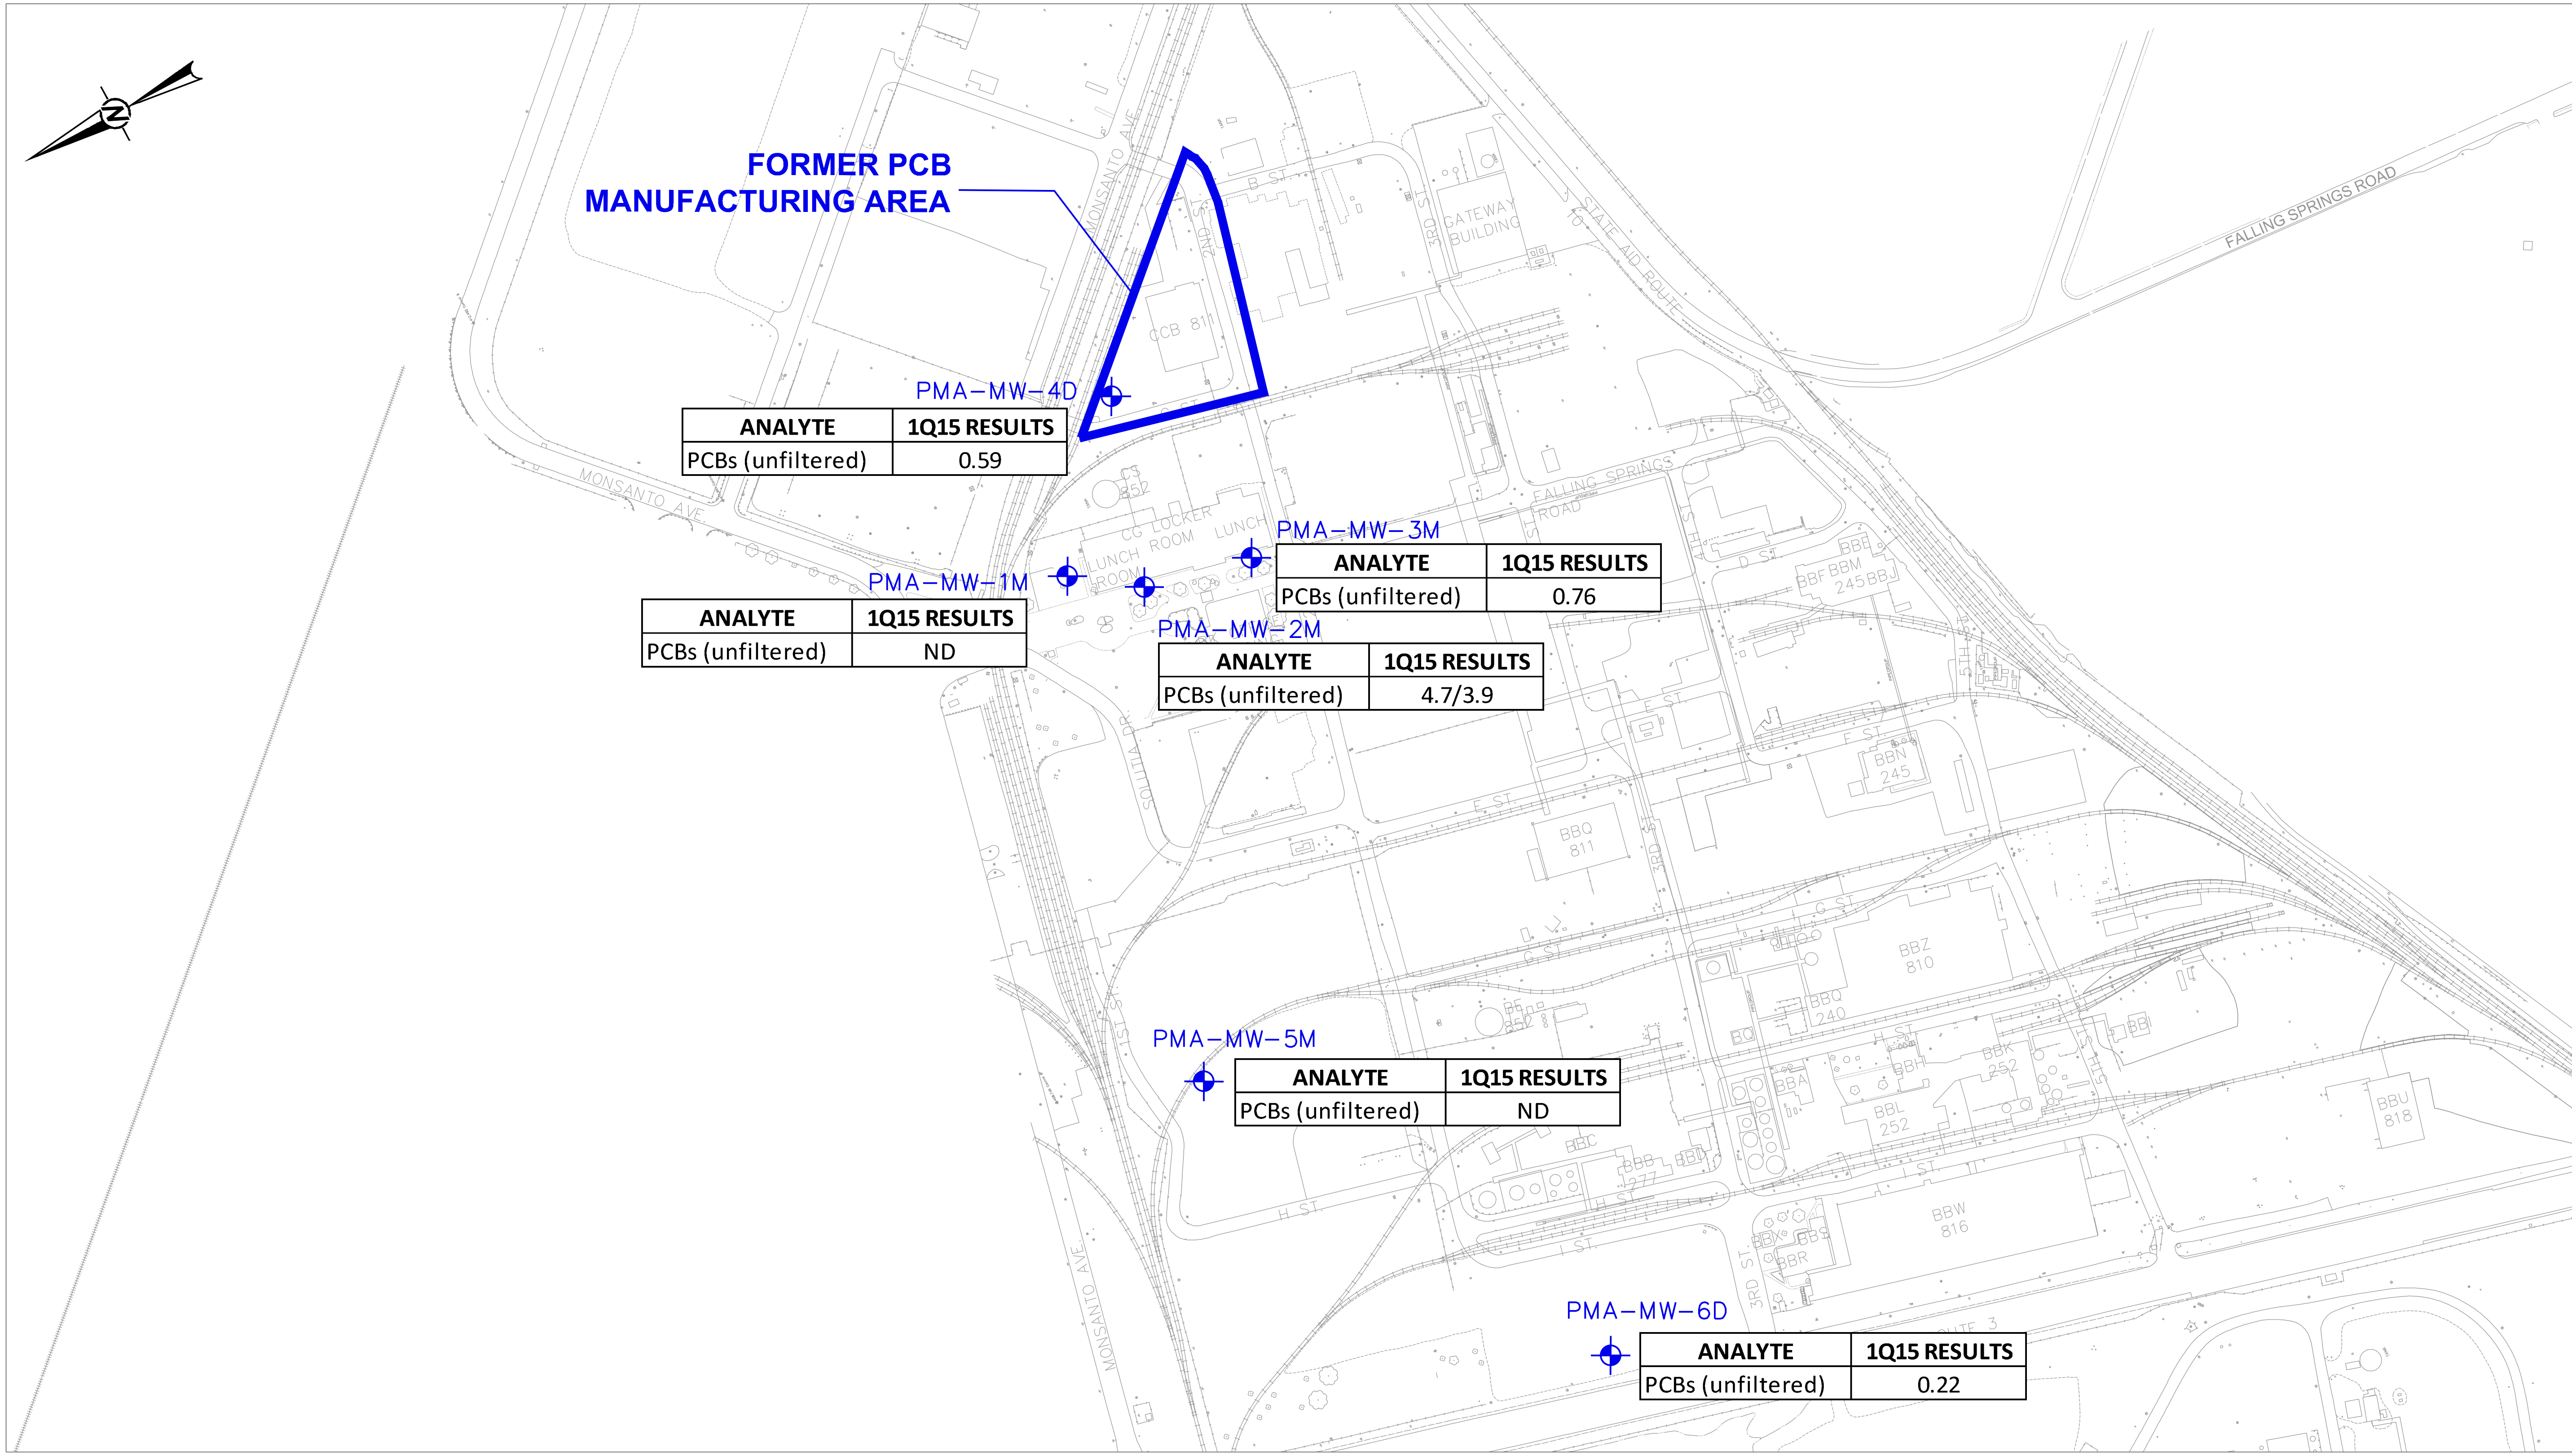
TITLE
PCB RESULTS
MIDDLE/DEEP HYDROGEOLOGIC UNIT

PCBs were detected in four (4) of the six (6) monitoring wells located in the MHU and DHU. Results are summarized below.

- Former PCB Manufacturing Area: PCBs were detected at a concentration of 0.59 µg/L in PMA-MW-4D.
- Downgradient of Former PCB Manufacturing Area: PCBs were detected in three (3) of five (5) monitoring wells downgradient of the former PCB Manufacturing Area at concentrations of 4.7 µg/L / 3.9 µg/L (PMA-MW-2M and AD), and 0.76 µg/L (PMA-MW-3M) and 0.22 µg/L (PMA-MW-6D). PCBs were not detected in PMA-MW-1M, and PMA-MW-5M.

ANALYTE	1Q15 RESULTS
PCBs (unfiltered)	0.59

ANALYTE	1Q15 RESULTS
PCBs (unfiltered)	0.76

ANALYTE	1Q15 RESULTS
PCBs (unfiltered)	4.7/3.9

ANALYTE	1Q15 RESULTS
PCBs (unfiltered)	0.22
