Re: PCB Groundwater Quality Assessment Program
4th Quarter 2011 Data Report
Solutia Inc., W. G. Krummrich Plant, Sauget, IL

4TH QUARTER 2011
DATA REPORT

PCB GROUNDWATER QUALITY ASSESSMENT PROGRAM

SOLUTIA INC.
W.G. KRUMMRICH FACILITY
SAUGET, ILLINOIS

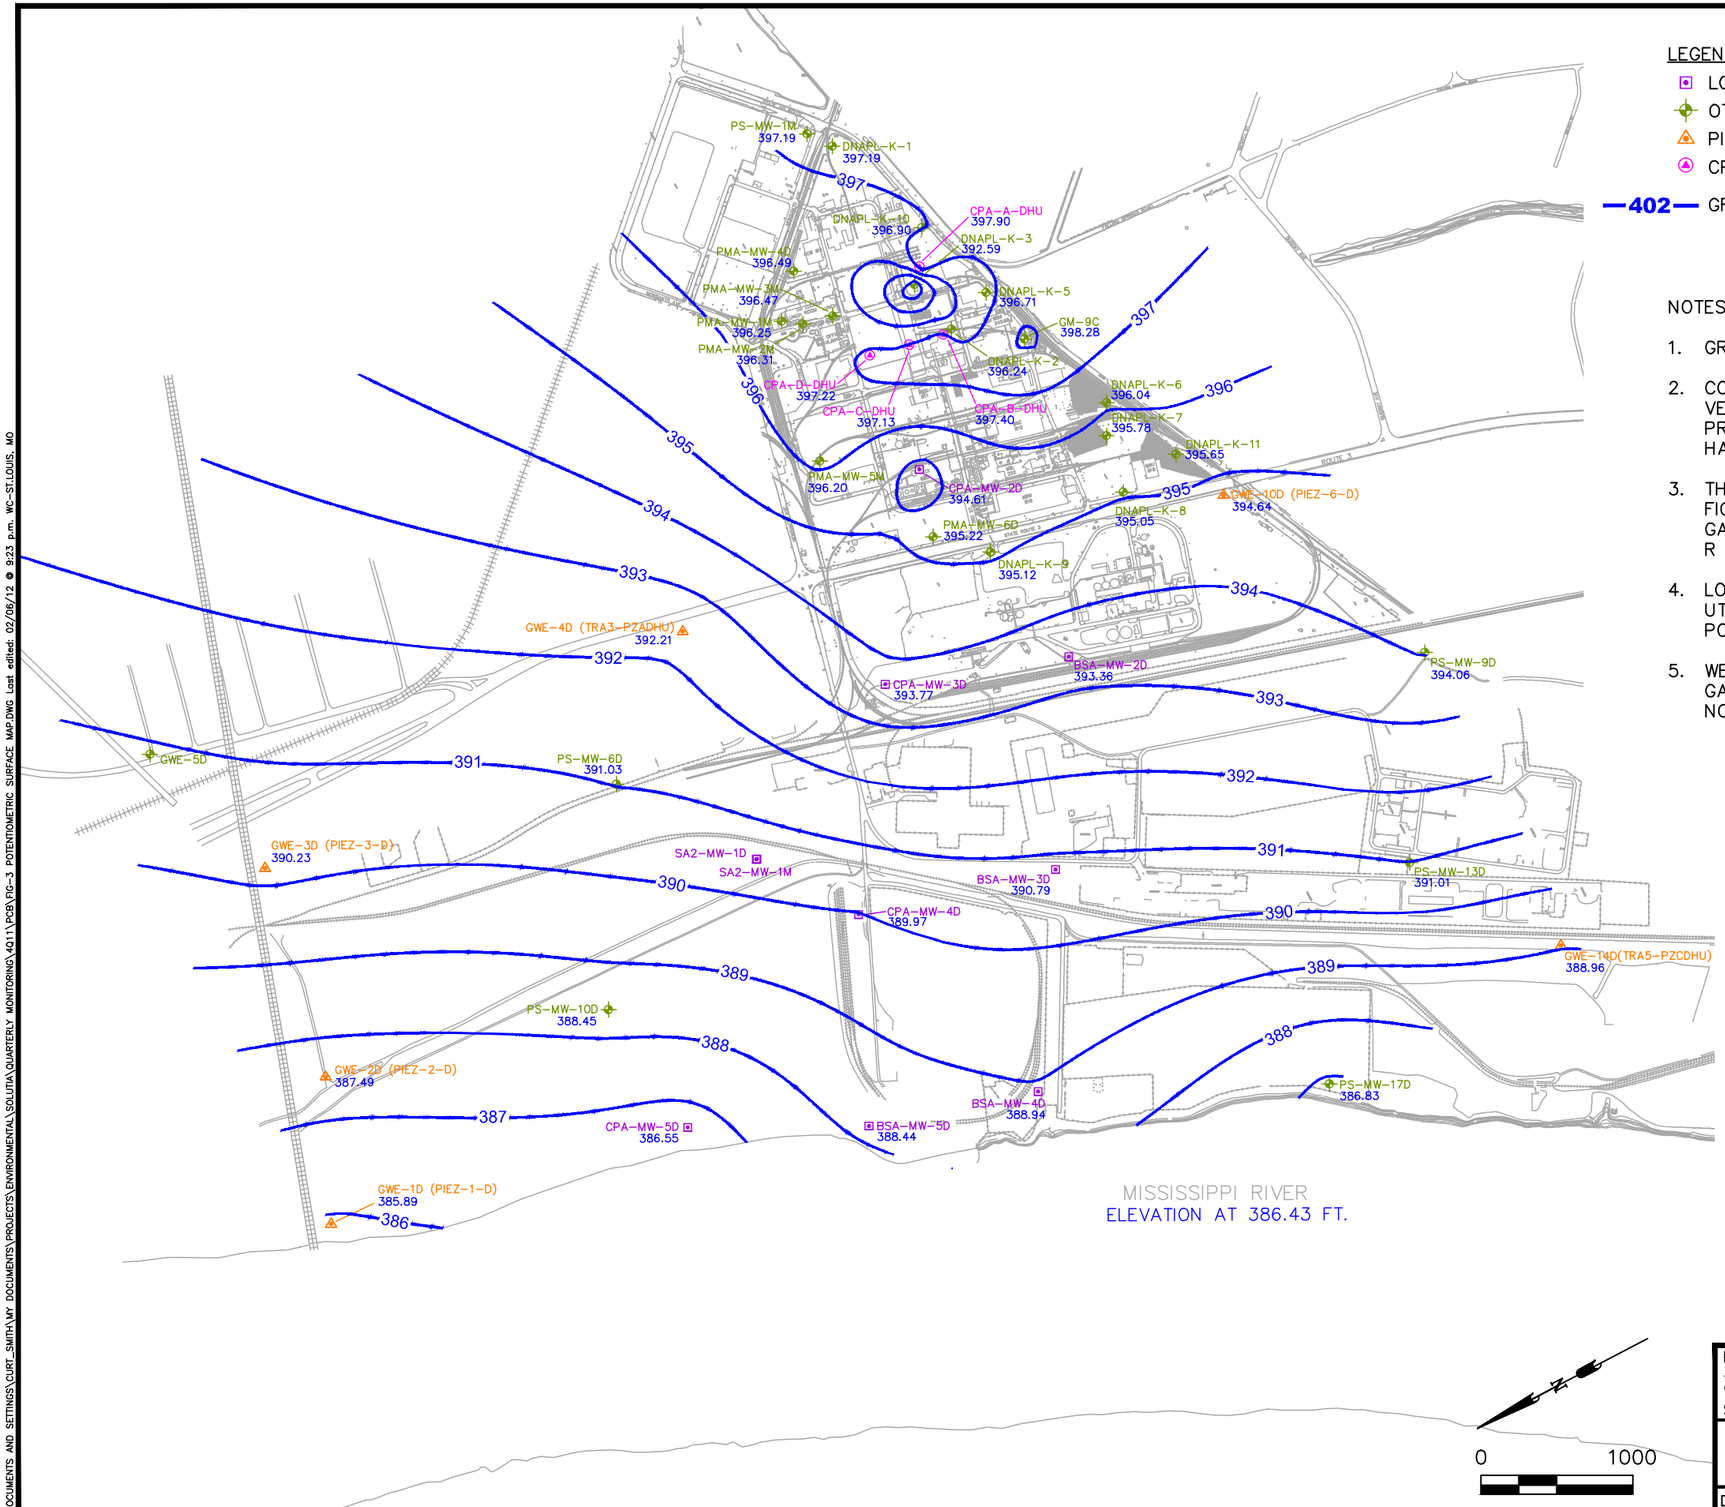
Well gauging information for the 4Q11 event is presented in **Table 1**. As the middle and deep hydrogeologic units are the primary migration pathway for constituents present in groundwater at the WGK Facility, a groundwater potentiometric surface map based on water level data from wells screened in the MHU and DHU is presented as **Figure 3**.

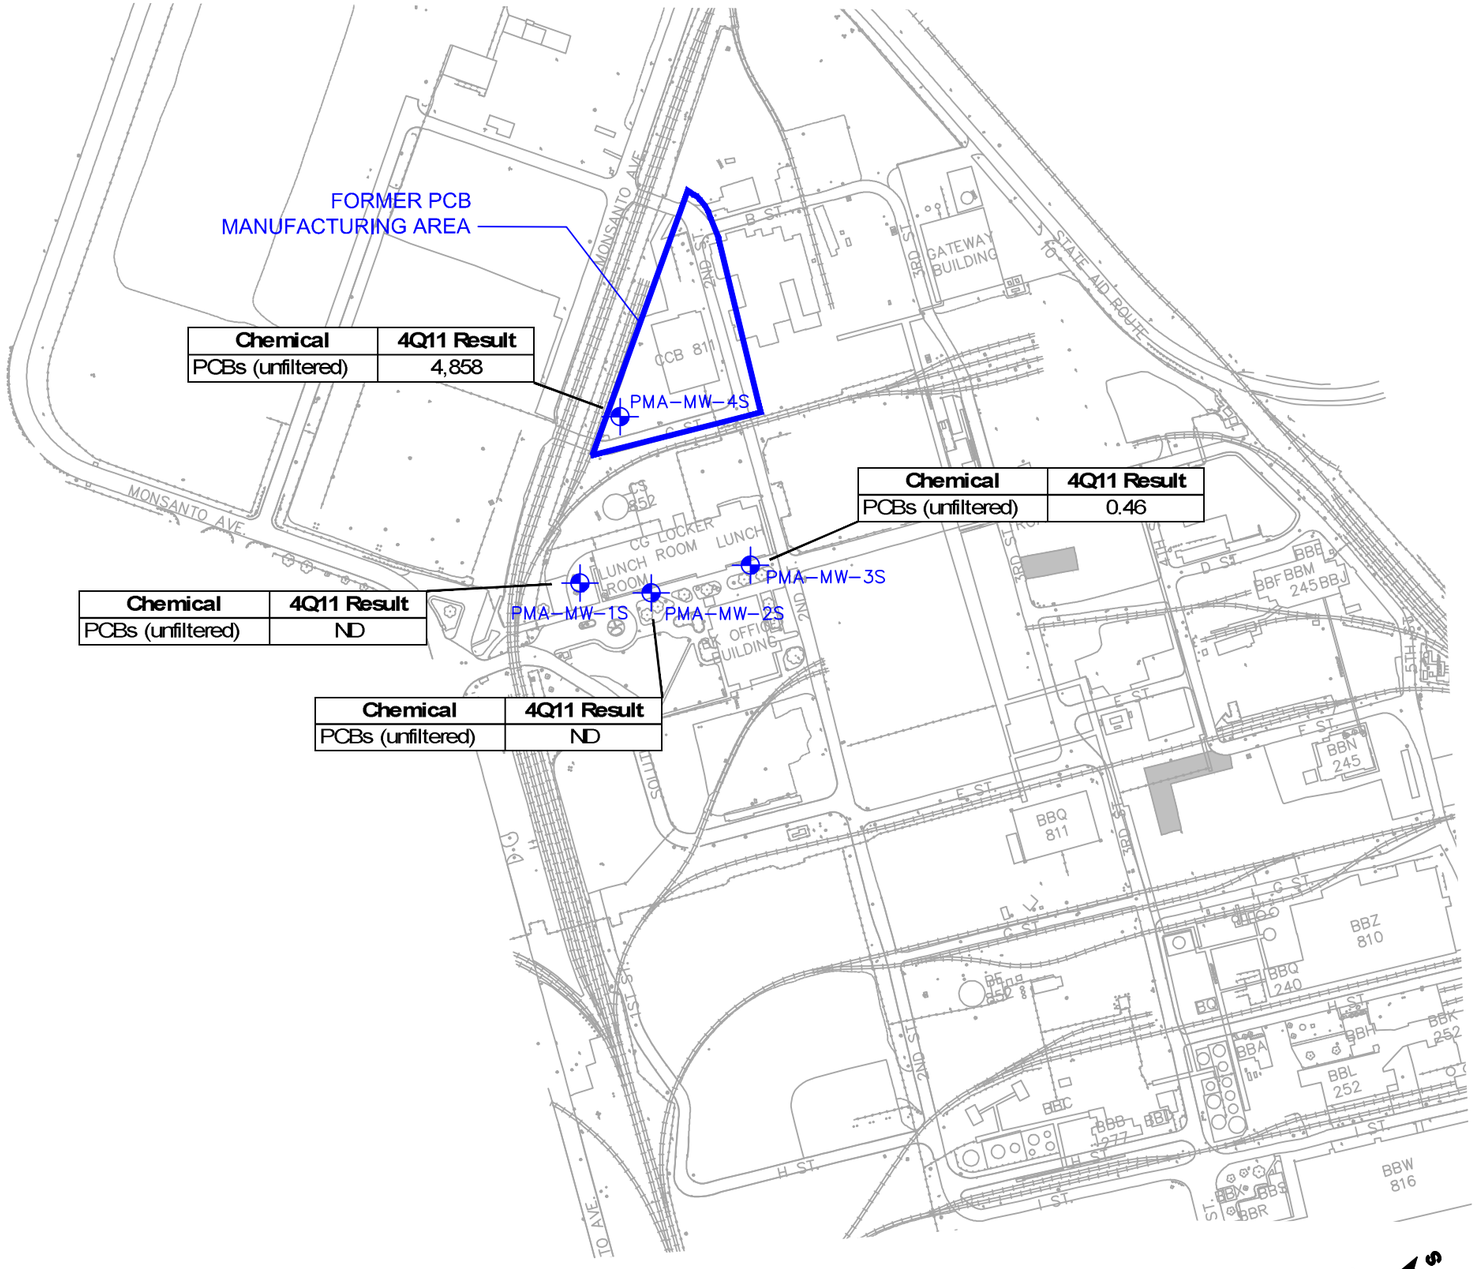
FIG. NO. 4

Historically, measurable DNAPL has been periodically observed in the source area SHU monitoring well PMA-MW-4S during previous sampling events. DNAPL was not detected in PMA-MW-4S by the oil/water interface probe during the 4Q11 event. As a result, a water sample was collected, and total PCBs were detected at a concentration of 4,858 µg/L. PCBs were detected in one of the three down-gradient PCB Groundwater Quality Assessment Program SHU monitoring wells (PMAMW-3S) at a concentration of 0.46 µg/L. Such data indicate that PCBs in the SHU are attenuating over the 300 to 400 ft distance between PMA-MW-4S and the three downgradient monitoring wells. PCB sampling results for the SHU are presented on **Figure 4**.

Chemical	4Q11 Result
PCBs (unfiltered)	4,858

Chemical	4Q11 Result
PCBs (unfiltered)	0.46

Chemical	4Q11 Result
PCBs (unfiltered)	ND

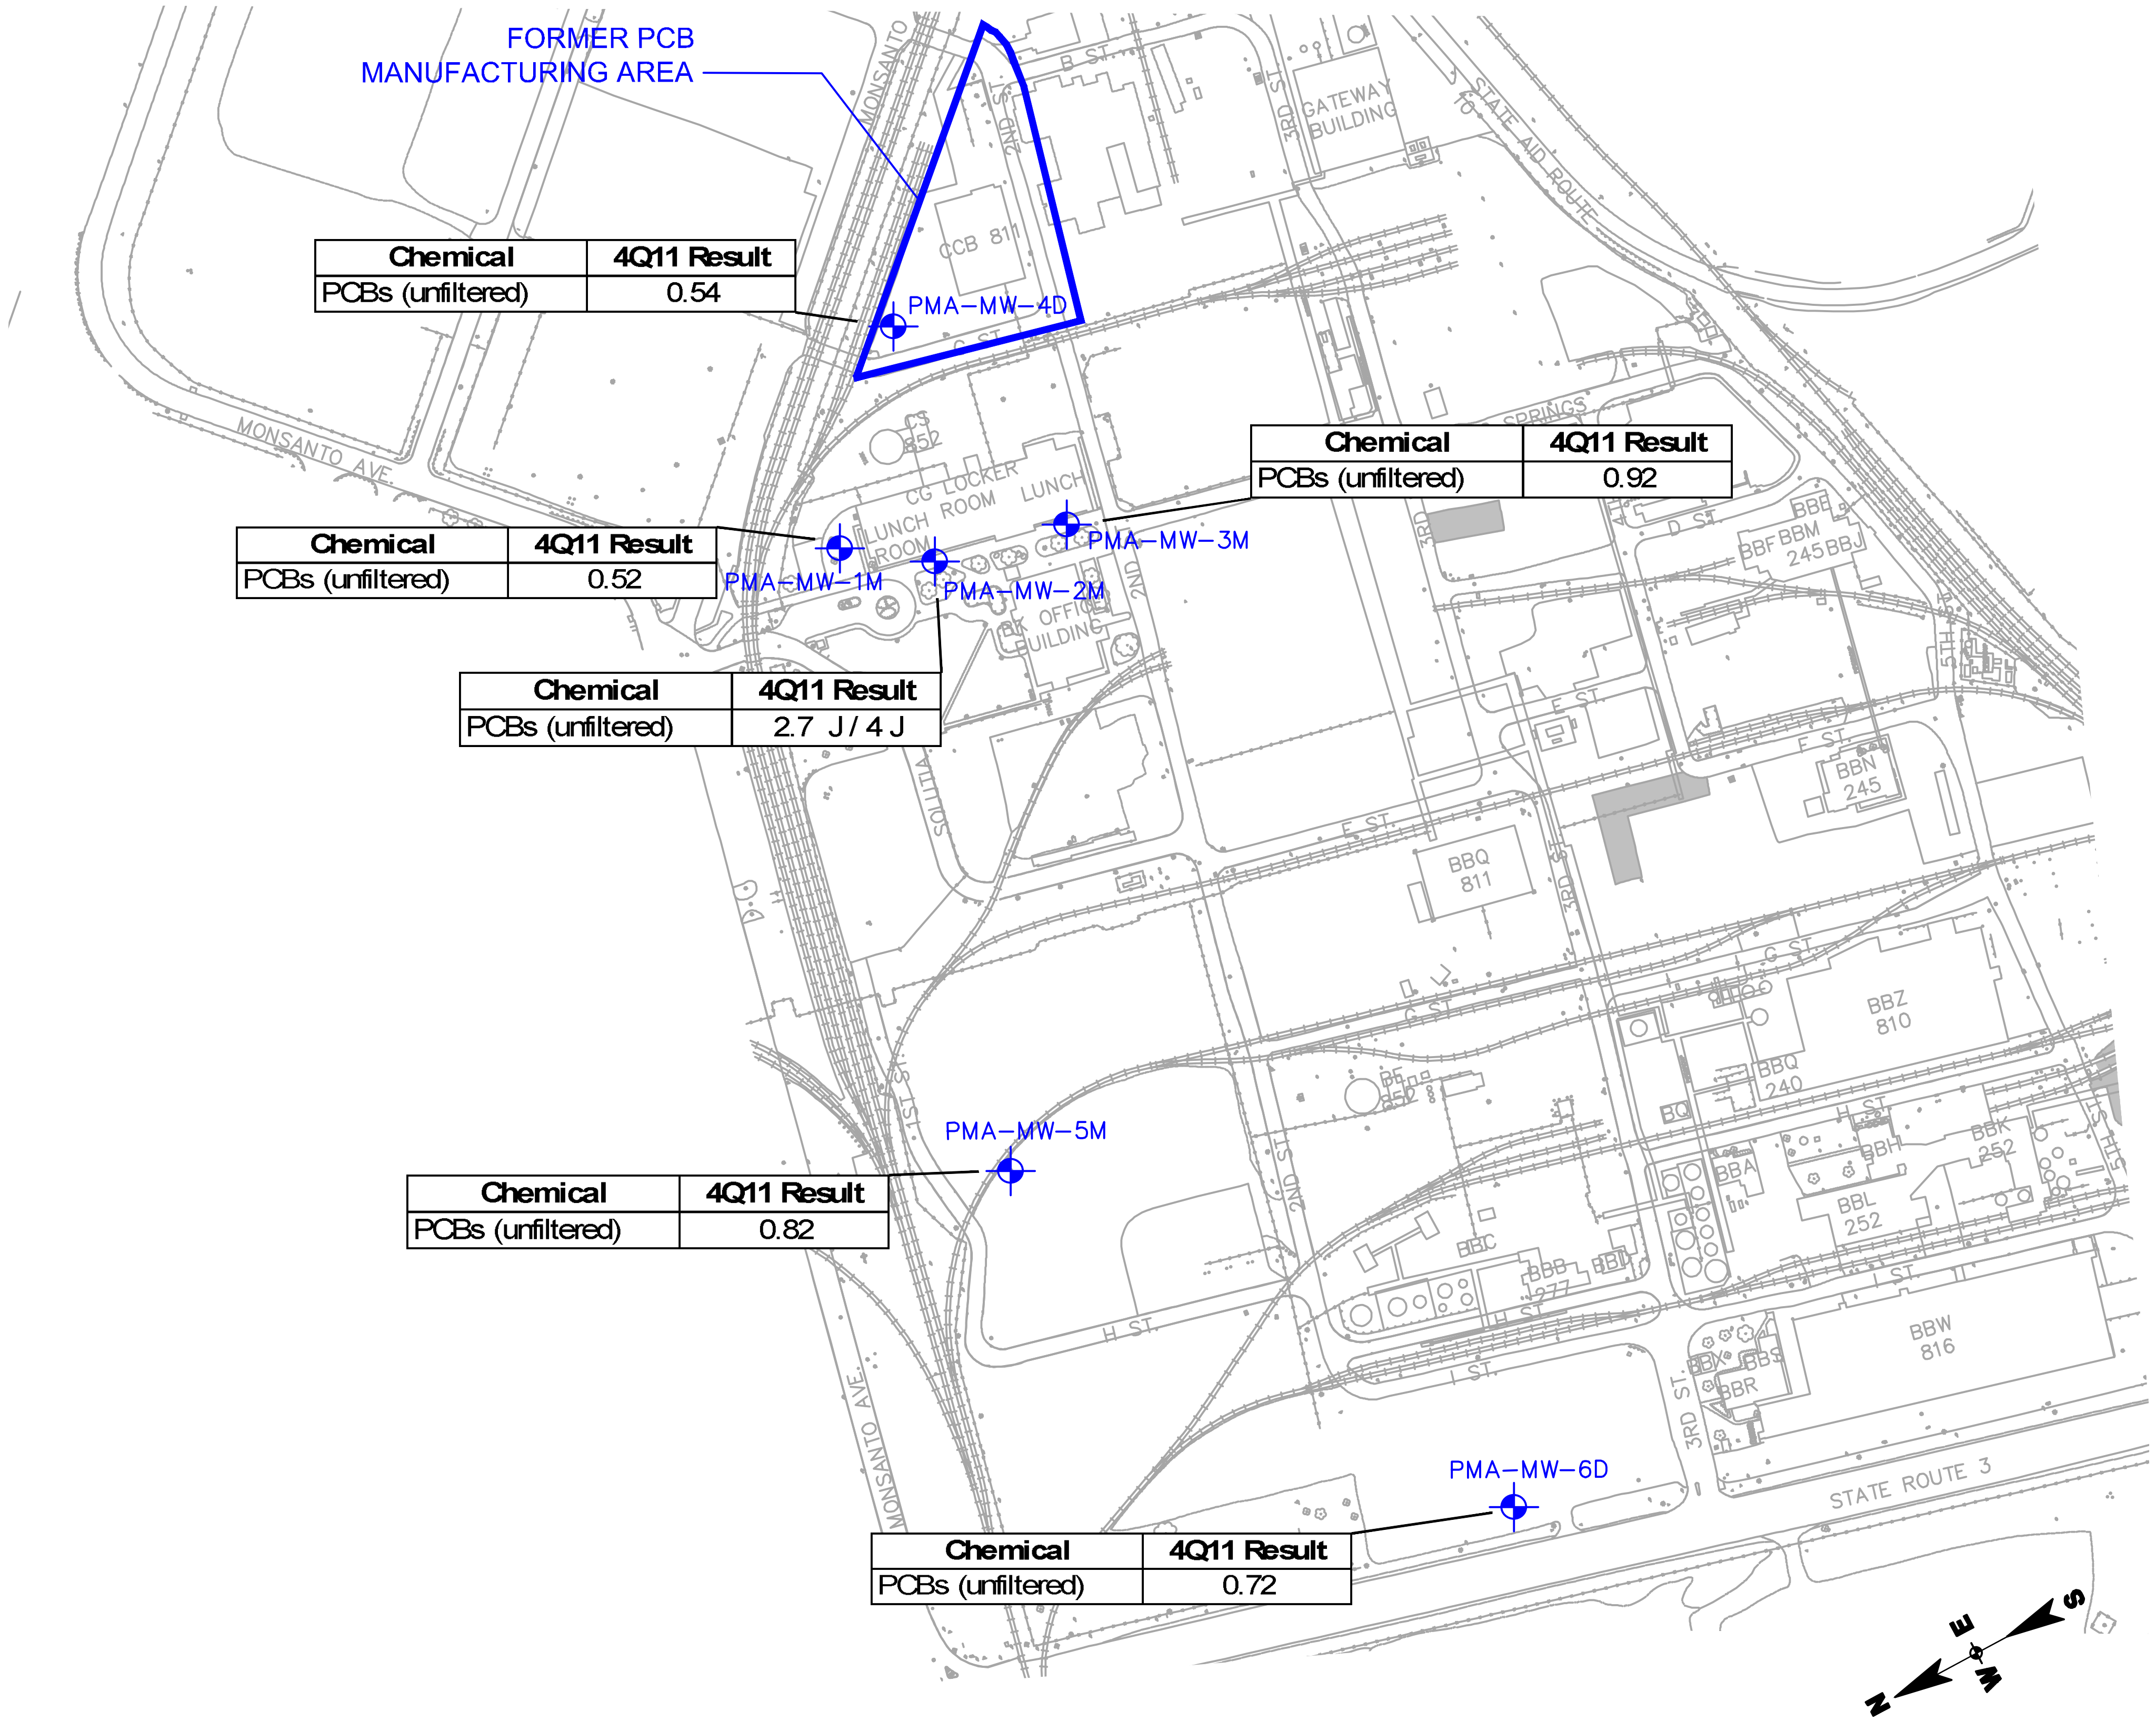
PCB GROUNDWATER QUALITY ASSESSMENT PROGRAM 4TH QUARTER 2011 DATA REPORT W.G. KRUMMRICH FACILITY SAUGET, ILLINOIS	PROJECT NO. 21562682
URS	
DRN. BY: chs January 2012 DSGN. BY: dp CHKD. BY:	PCB Results – MHU/DHU Wells
FIG. NO.	5

Laboratory analytical results for monitoring well PMA-MW-4D, located in the Former PCB Manufacturing Area, indicated a total PCB concentration of 0.54 µg/L for the 4Q11 sampling event. PCBs were also detected in all five downgradient monitoring wells at concentrations of 0.52 µg/L (PMA-MW-1M), an estimated 2.7 µg/L and estimated 4 µg/L (PMA-MW-2M and

duplicate), 0.92 µg/L (PMA-MW-3M), 0.82 µg/L (PMA-MW-5M) and 0.72 µg/L (PMA-MW-6D). **Figure 5** displays the 4Q11 PCB sampling results for the MHU/DHU.

Chemical	4Q11 Result
PCBs (unfiltered)	0.54

Chemical	4Q11 Result
PCBs (unfiltered)	0.92

Chemical	4Q11 Result
PCBs (unfiltered)	0.52

Chemical	4Q11 Result
PCBs (unfiltered)	2.7 J / 4 J

Chemical	4Q11 Result
PCBs (unfiltered)	0.82

Chemical	4Q11 Result
PCBs (unfiltered)	0.72
