Third Five-Year Review Report

Arkwood, Inc. Site
Boone County
Omaha, Arkansas

July 2011

THIRD FIVE-YEAR REVIEW
Arkwood, Inc.
ARD084930148
Boone County, Arkansas

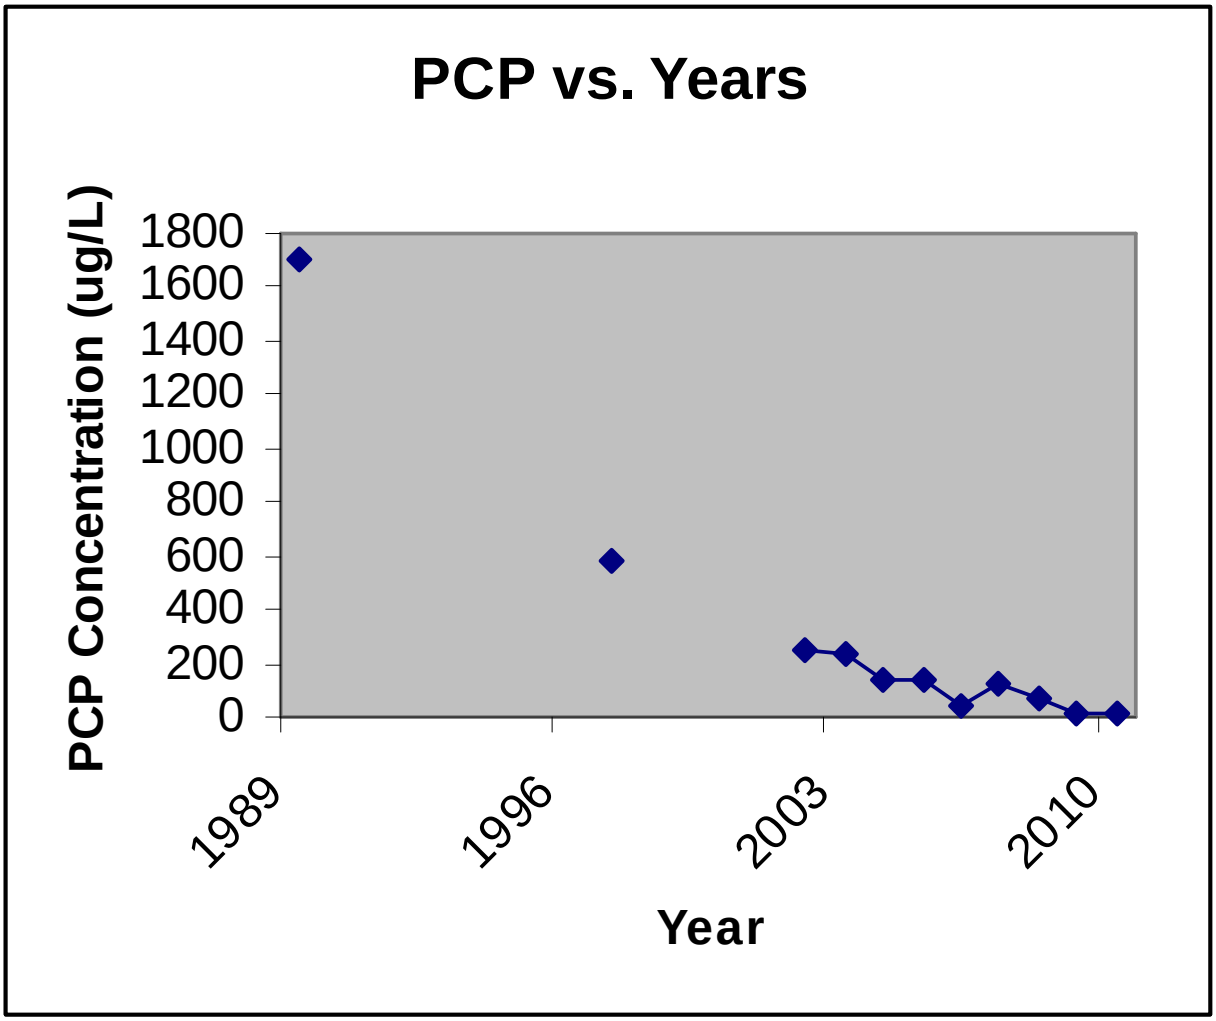
Figure 2a
New Cricket Spring
PCP Concentrations
1989-2010

1989/1990≅1700	2006≅39
1996/1998≅581	2007≅123
2002≅255	2008≅76
2003≅237	2009≅13
2004≅134	2010≅18
2005≅132

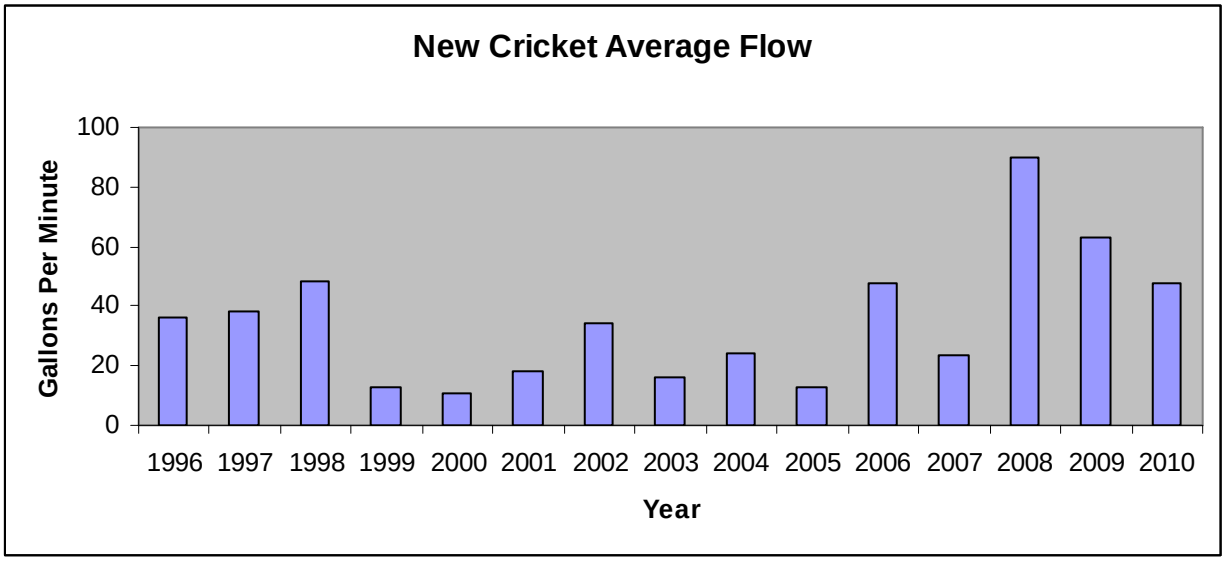
Figure 3

The volume of water flow at New Cricket Spring has been measured over the past fifteen years. Flows vary from less than 1/2 gallon per minute (gpm) to over 1,000 gpm.
