AN ASSEMBLAGE OF ANALYTICAL DATA

REILLY CHEMICAL AND TAR PROPERTY

ST. LOUIS PARK, MINNESOTA

Prepared by the
St. Louis Park Health Department

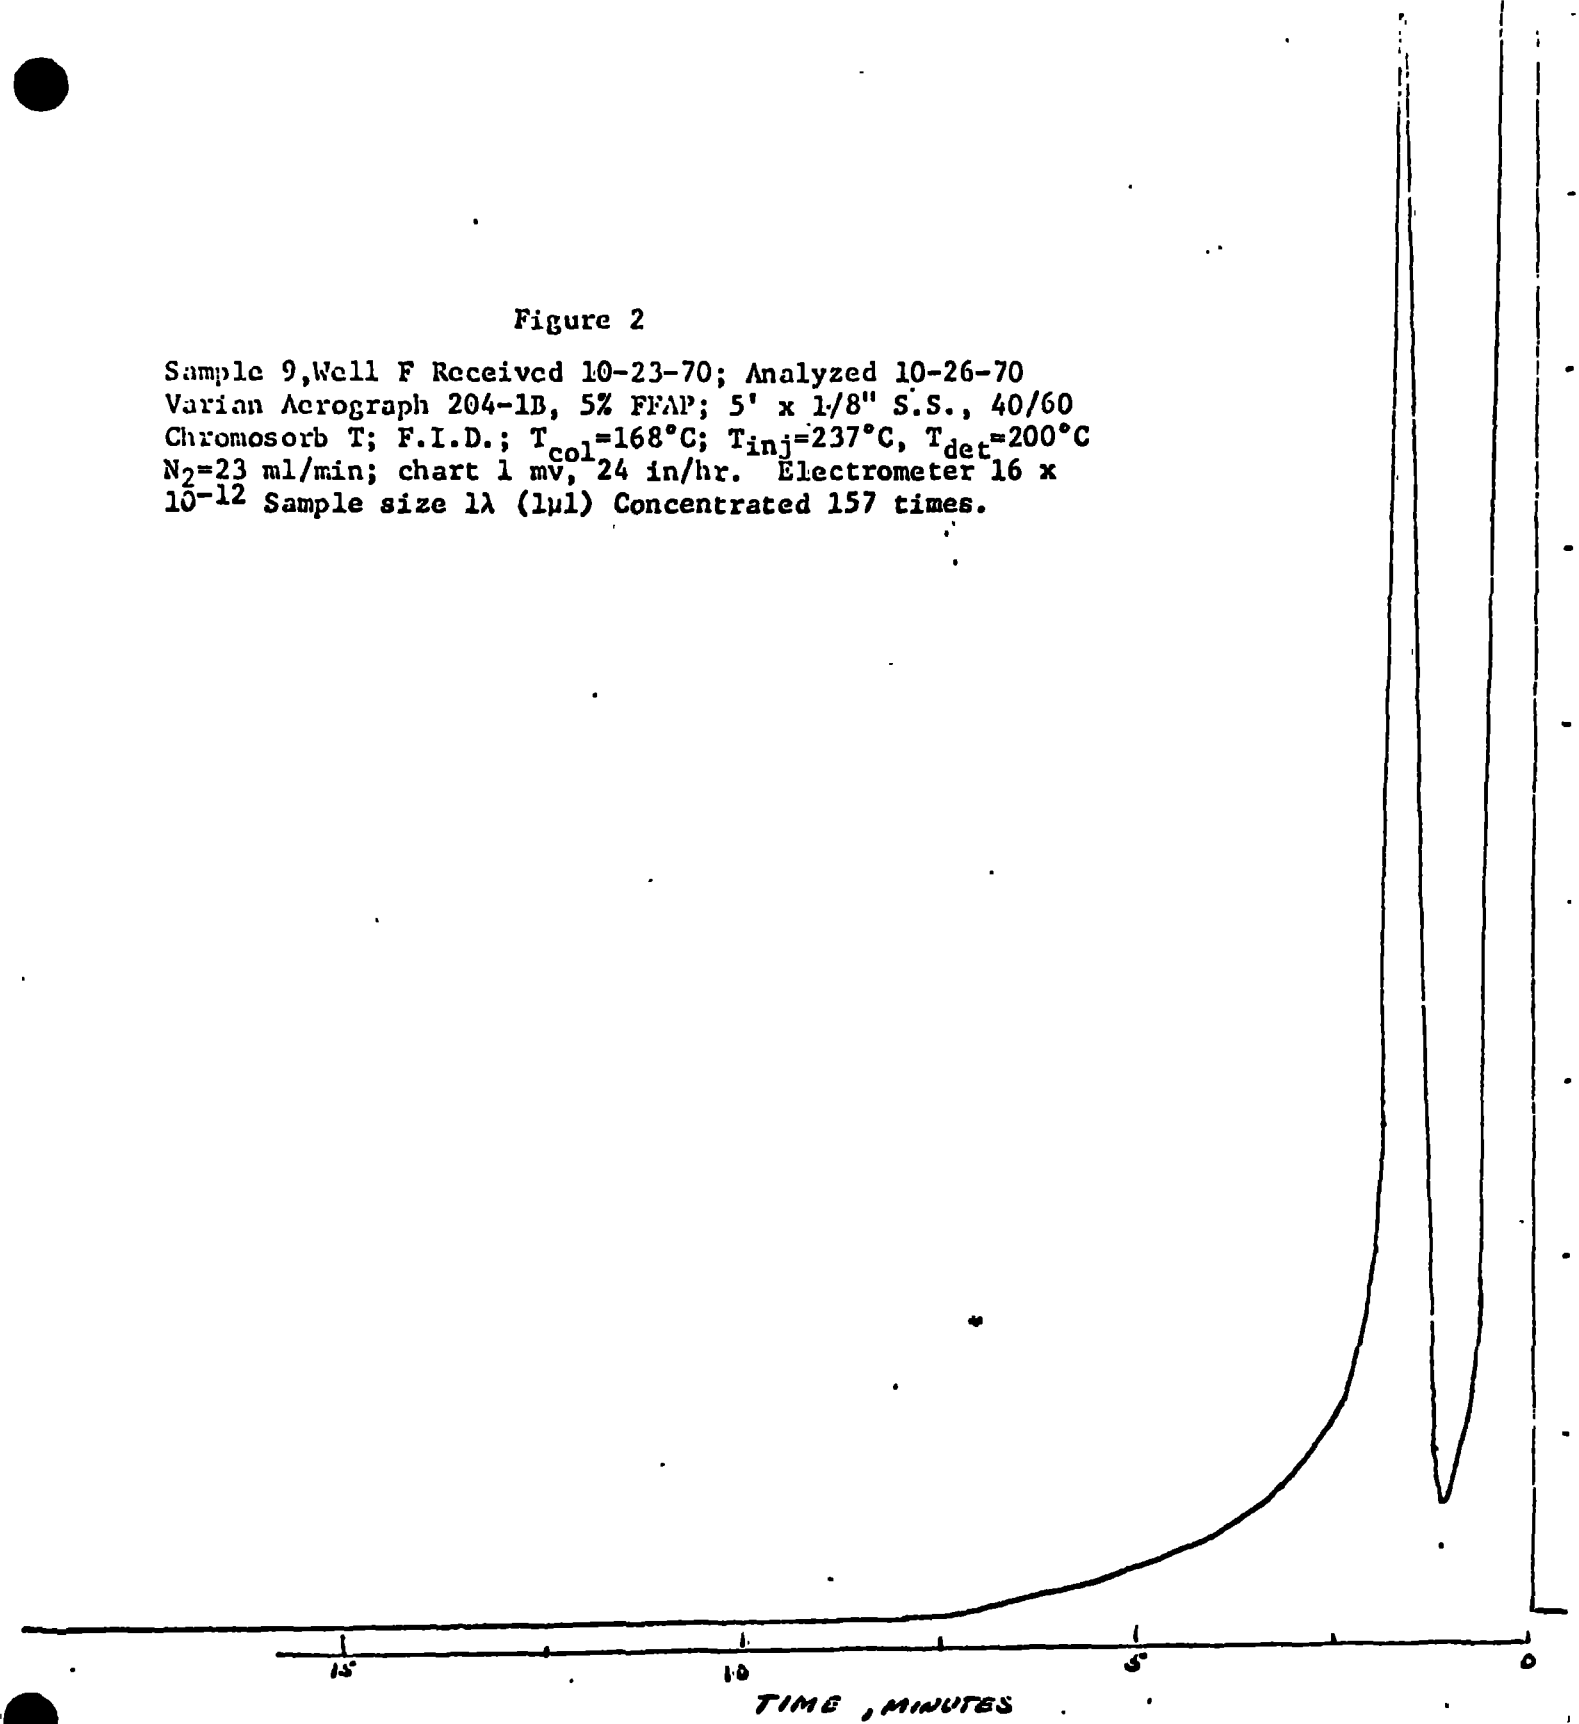
Except for the effluent sample, Dr. Baker was unable to find any phenols or phenolic compounds in any of the waters. A comparison of the typical chromatograms shown in Figures 1 and 2 demonstrates this point quite clearly. Figure 2 is a chromatogram of the water from the Flame Industries well. Analysis of this sample in the RICE laboratory revealed the presence of 0.001 mg/l of phenol. Table 1 lists the location, odor, phenol concentration and the area of the rapidly eluting peak presumably due to sulfur containing compounds. (A sulfide odor was noted during collection of many of the well waters.) Dr. Baker estimates his limit of detection as 1 to 3 µg/l (0.001 to 0.003 mg/l) for organic materials, although recovery at this level may be influenced by the total dissolved salt content of the waters during concentration.

Sample 9, Well F Received 10-23-70; Analyzed 10-26-70
Varian Aerograph 204-1B, 5% FFAP; 5' x 1/8" S.S., 40/60
Chromosorb T; F.I.D.; T_{col}=168°C; T_{inj}=237°C, T_{det}=200°C
N_2=23 ml/min; chart 1 mv, 24 in/hr. Electrometer 16 x
10^{-12} Sample size 1λ (1μl) Concentrated 157 times.
