# REMEDIAL ACTION CONSTRUCTION AND COMPLETION REPORT

## LANDFARM REMEDY

**Prewitt Refinery Site**
**Prewitt, NM**

**February 1997**

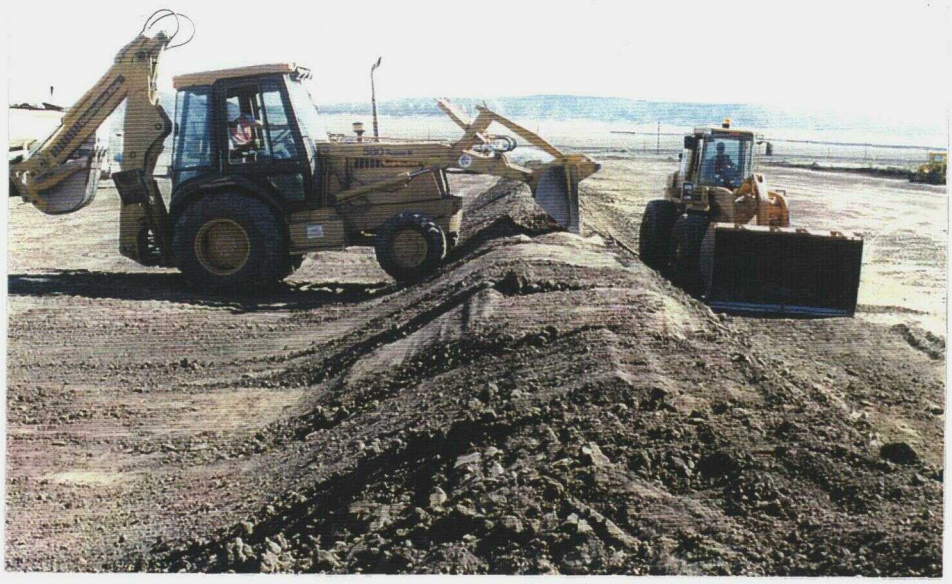
Photo 3-13. Construction of Run-on/Run-off Protection Berm

Photo 3-14. Installation of HDPE Liner in Run-off Collection Basin

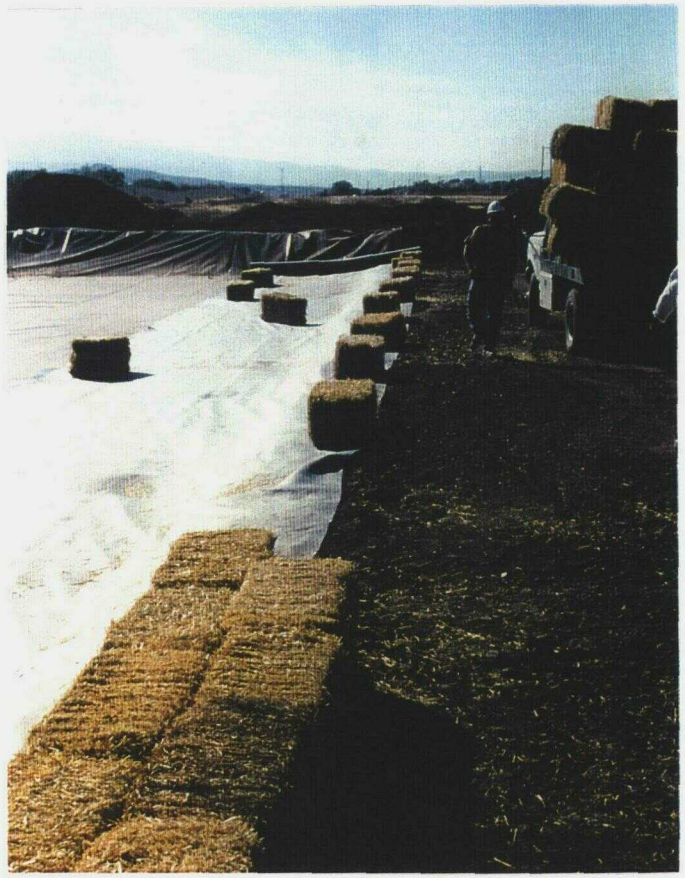
Photo 3-15. Hay Berm Installation at Toe of Landfarm Treatment Cell

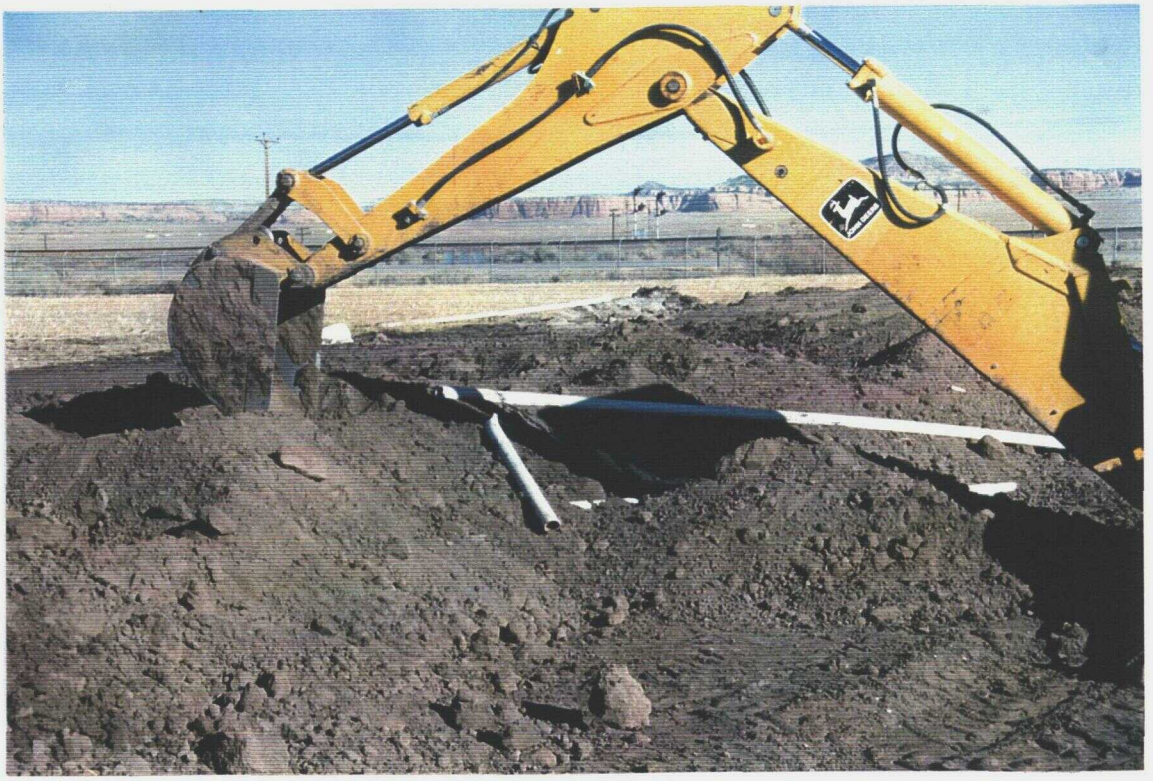
Photo 8-1. Sprinkler System Piping Removal.

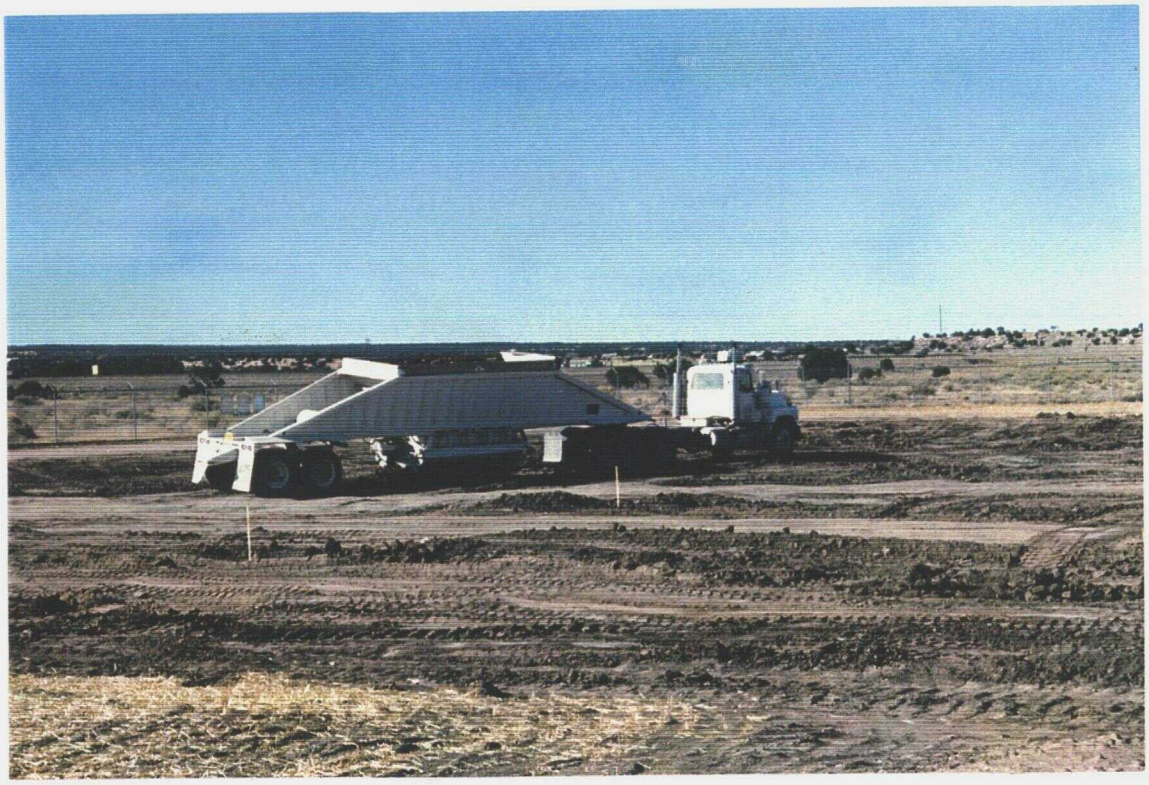
The cap was constructed in lifts, and the soil was spread and compacted using a dozer. Photo 8-2 shows the cap soil hauled from the borrow area being placed over the treated soils. Photo 8-3 shows the cap soil dozing and compaction activities. Cut stakes which had been used for the subgrade preparation, were also used as fill stakes for cap placement. The cap placement was completed on November 21, 1996. Grading of the entire former landfarm area was performed using a grader, and was completed on November 22, 1996.

Photo 8-2. Cap Soil Placement
