# WETLAND SURFACE WATER SAMPLE LOCATIONS

REPORT: PRELIMINARY SITE CHARACTERIZATION REPORT

SITE: GULFCO MARINE MAINTENANCE
FREEPORT, BRAZORIA COUNTY, TEXAS

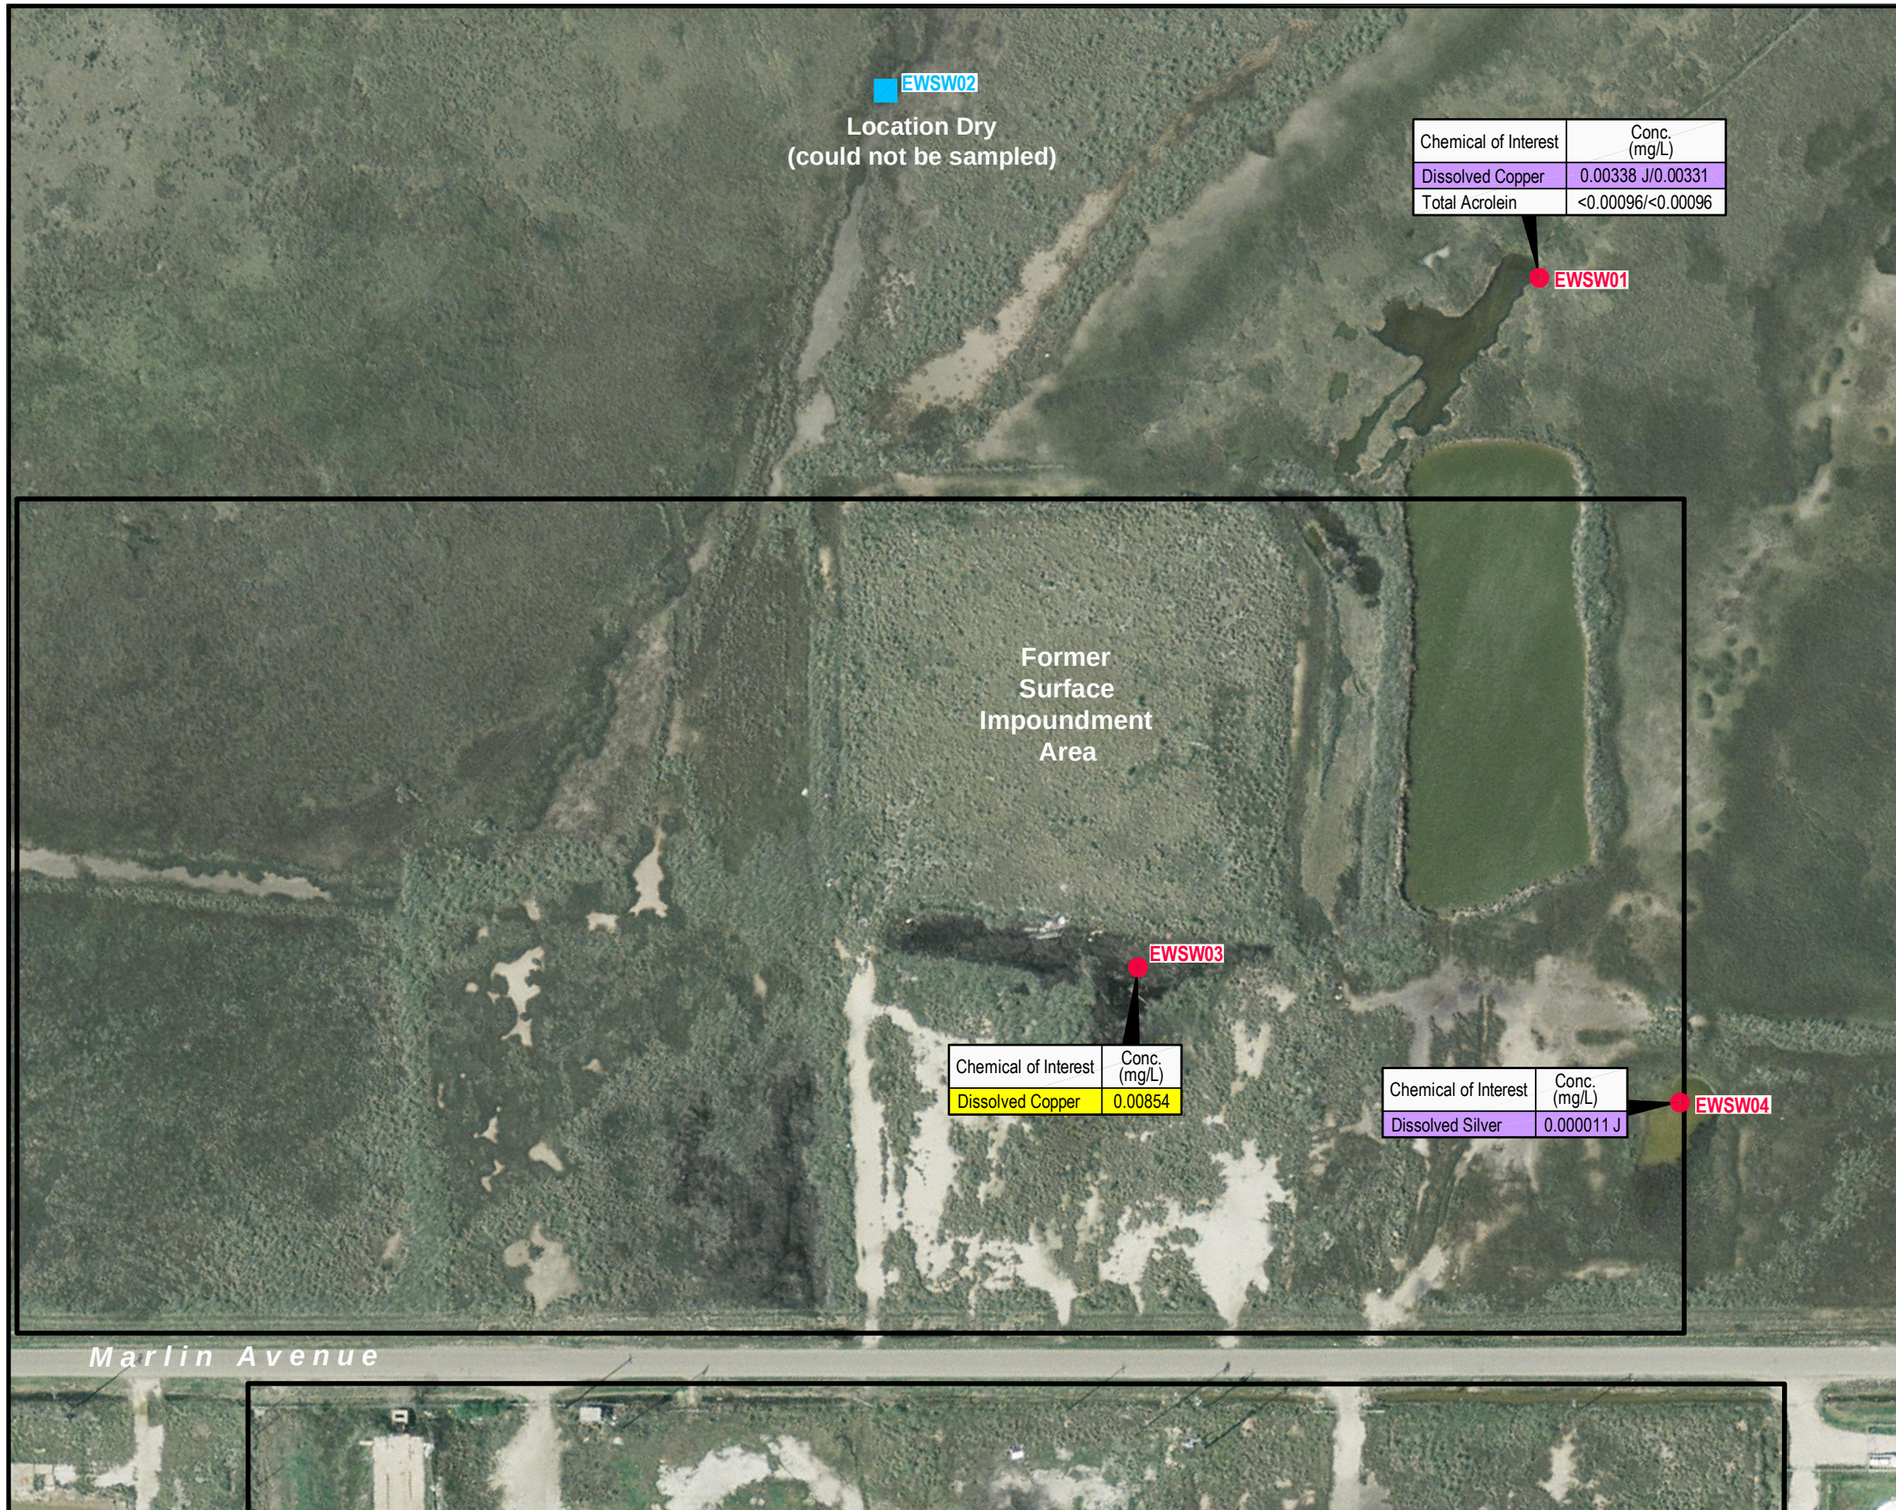
| Chemical of Interest | Conc. (mg/L) |
|---|---|
| Dissolved Copper | 0.00338 J/0.00331 |
| Total Acrolein | <0.00096/<0.00096 |

| Chemical of Interest | Conc. (mg/L) |
|---|---|
| Dissolved Copper | 0.00854 |

| Chemical of Interest | Conc. (mg/L) |
|---|---|
| Dissolved Silver | 0.000011 J |

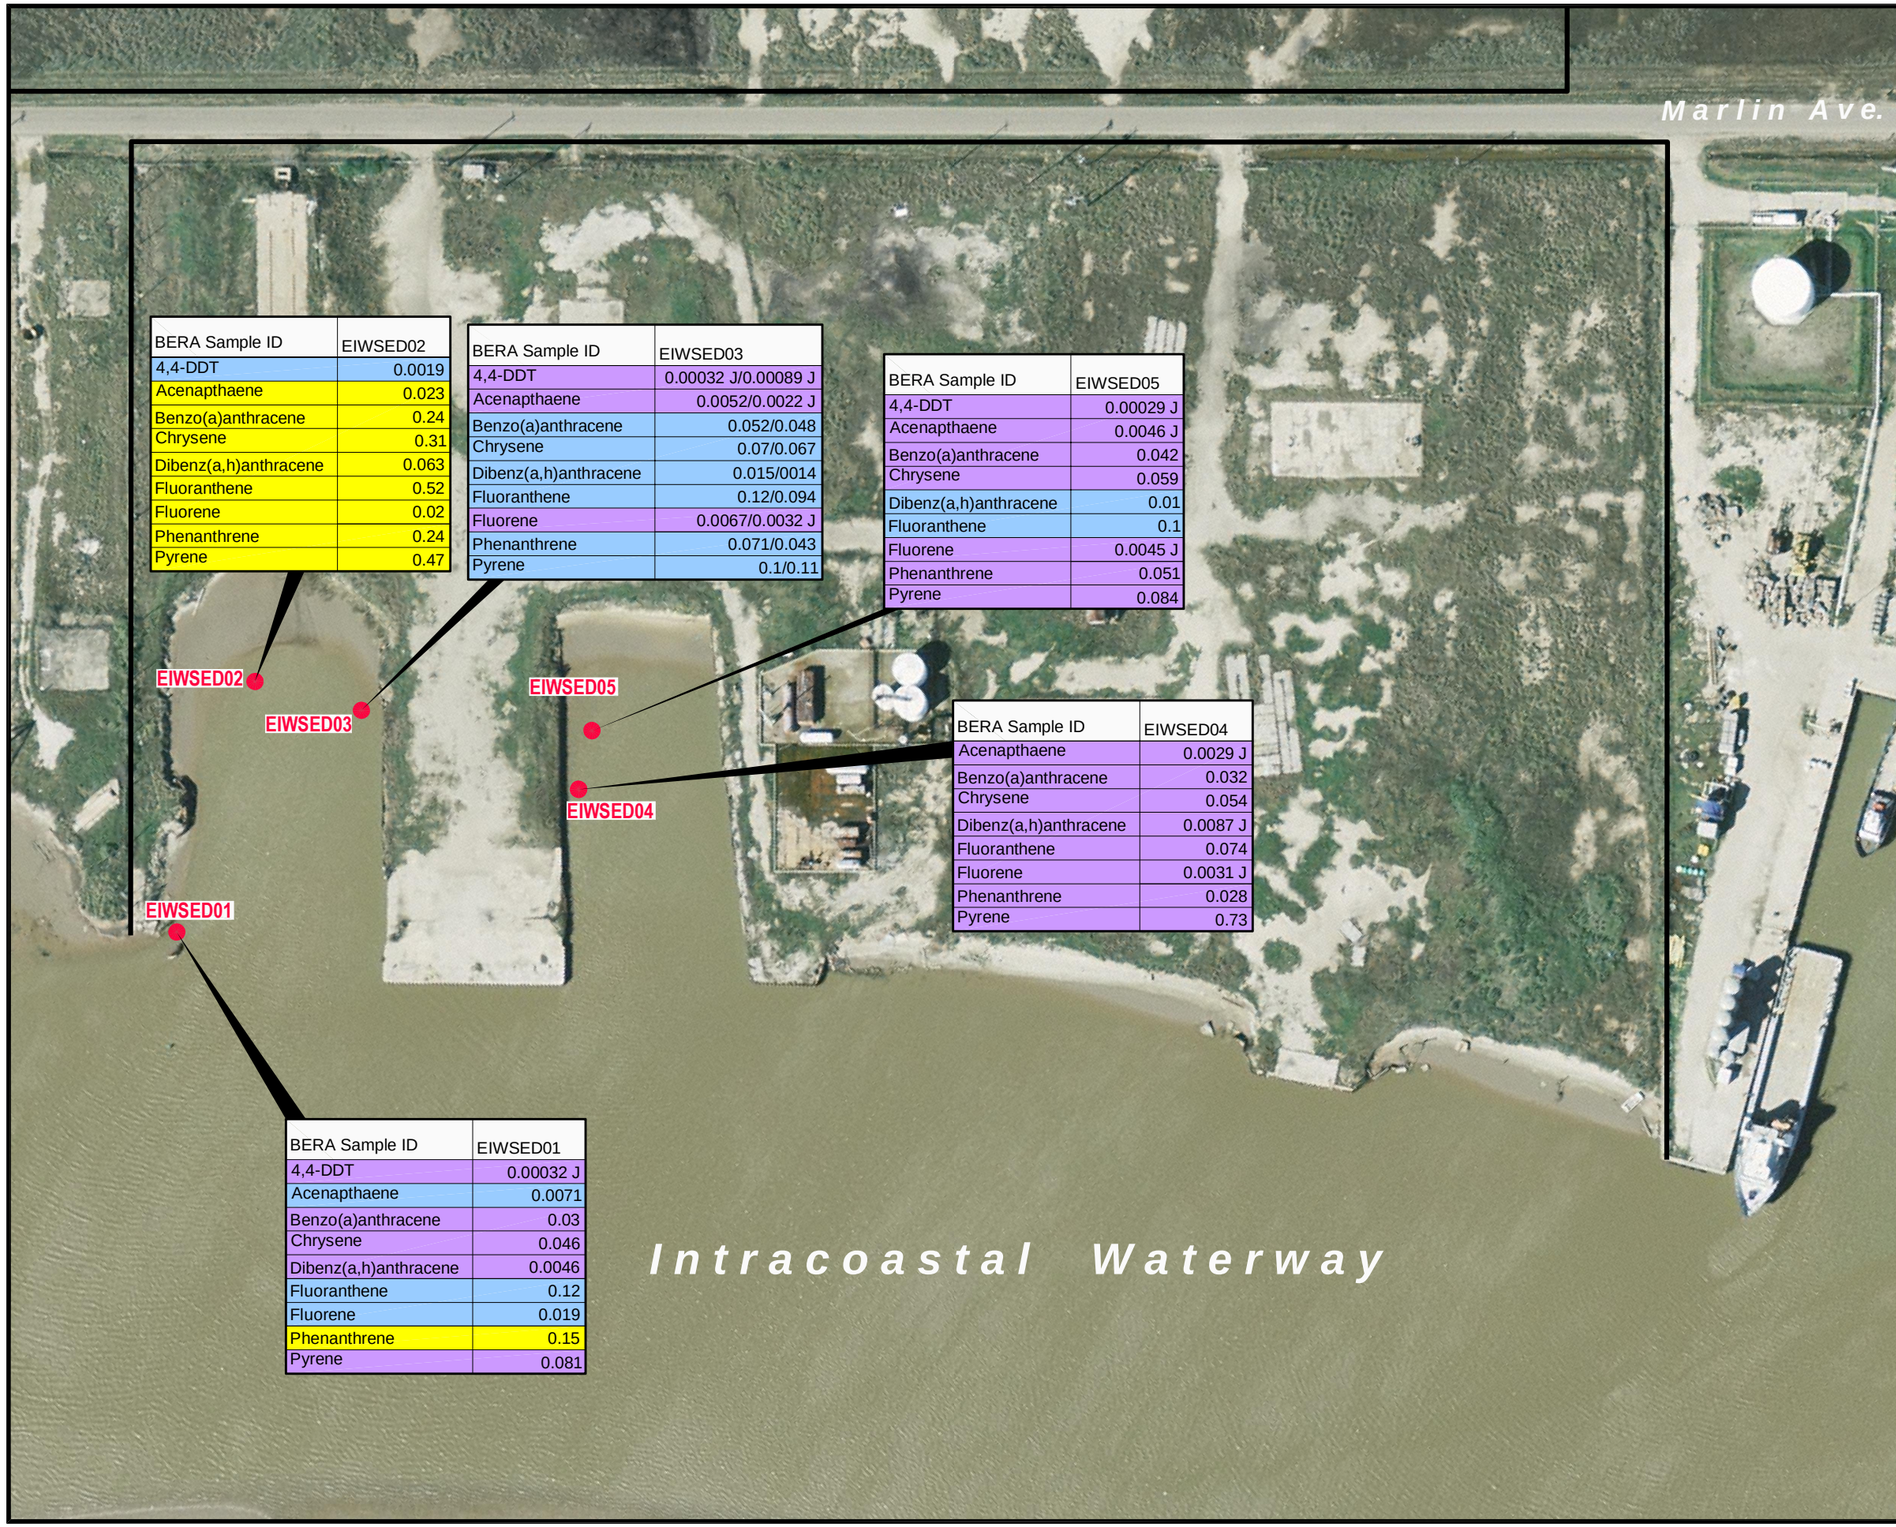
**INTRACOASTAL WATERWAY SEDIMENT SAMPLE LOCATIONS**

| BERA Sample ID | EIWSED02 |
| 4,4-DDT | 0.0019 |
| Acenapthaene | 0.023 |
| Benzo(a)anthracene | 0.24 |
| Chrysene | 0.31 |
| Fluoranthene | 0.52 |
| Pyrene | 0.47 |
