UNITED STATES ENVIRONMENTAL PROTECTION AGENCY
REGION 6
1445 ROSS AVENUE, SUITE 1200
DALLAS, TEXAS 75202-2733

February 5, 2014

SUBJECT: Quarterly cap inspection at the San Jacinto River Waste Pits superfund site

FROM: Valmichael Leos, Federal On-Scene Coordinator
Emergency Readiness Team (6SF-PE)

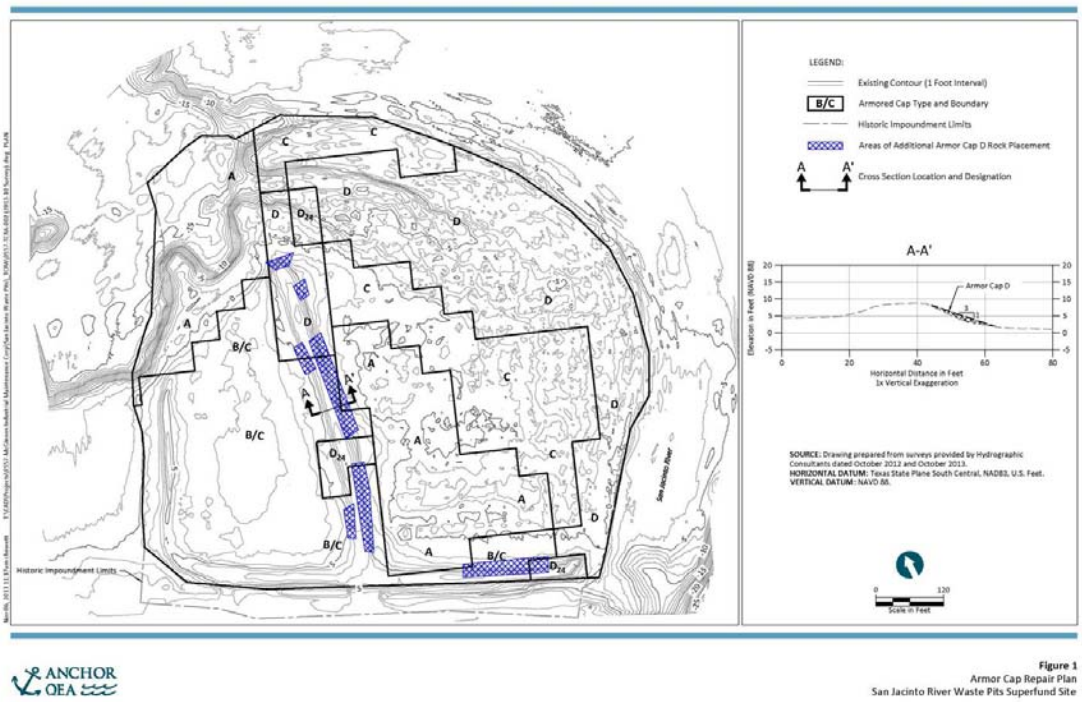
In addition to inspecting the overall integrity of the armor cap, seven additional areas (see Figure One) were inspected where additional rock was placed and the slopes flattened to provide more stability and strength per the enhancement work plan dated November 2013. The section of the armor cap located above water level was also observed to be intact with no areas of cap erosion evident.

Figure 1- Areas to be covered with additional rock and flatten slopes from November 2013 Armor Cap Enhancement plan
