GATEWAY EASEMENT

Project Name: ~~Leong St~~

Project: CITY OF MOUNTAIN VIEW

Pipe Segment Reference:
Upstream MH: F5-54
Downstream MH: F5-52
Direction of Survey: Upstream
Material: Vitrified Clay Pipe

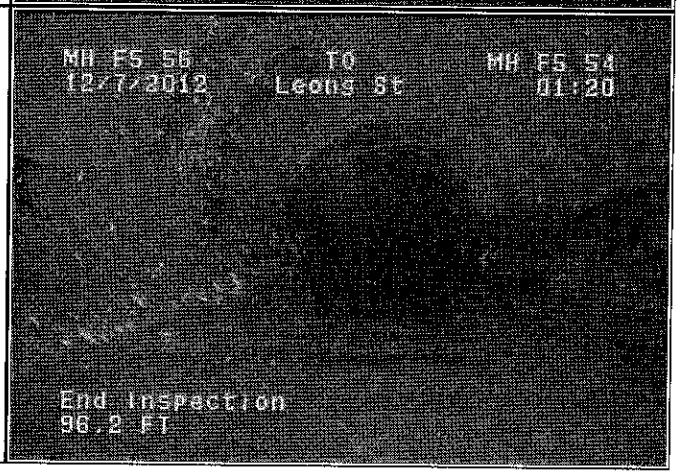
96.2	End Inspection Severity: None	20:39

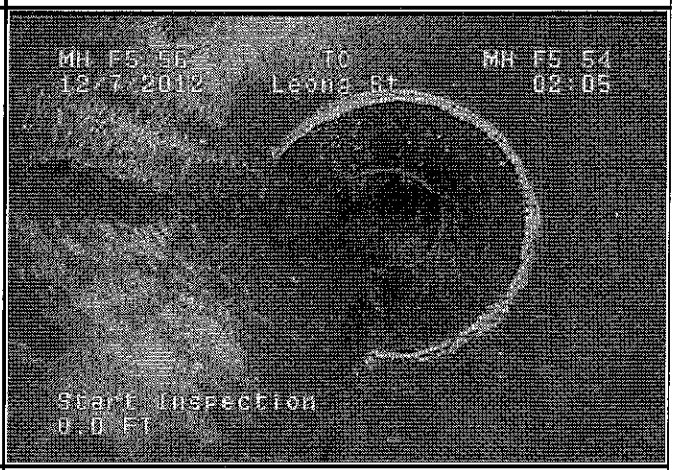
Distance	Fault Observation	Time	Picture
0.0	Start Inspection Severity: None	13

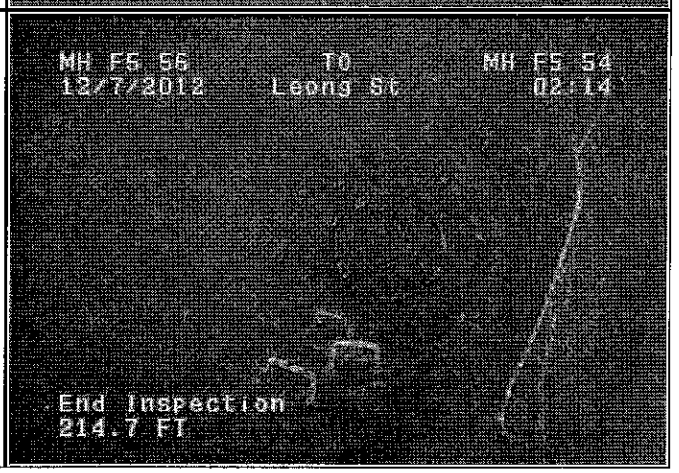
214.7	End Inspection Severity: None	09:02

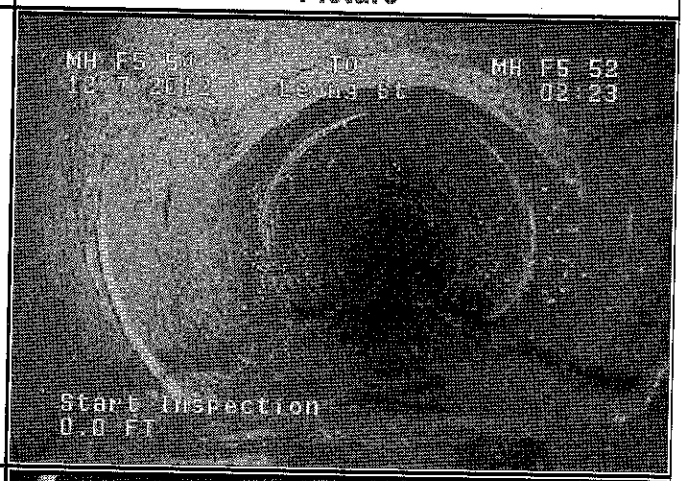
Distance	Fault Observation	Time	Picture
0.0	Start Inspection Severity: None	23

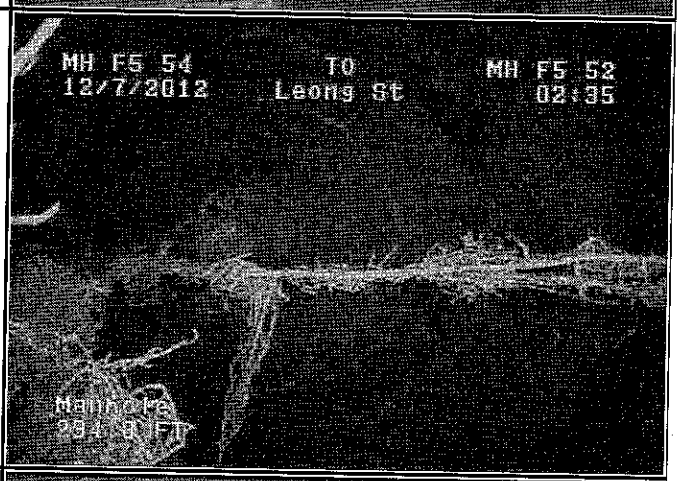
294.8	Manhole Severity: None	12:07

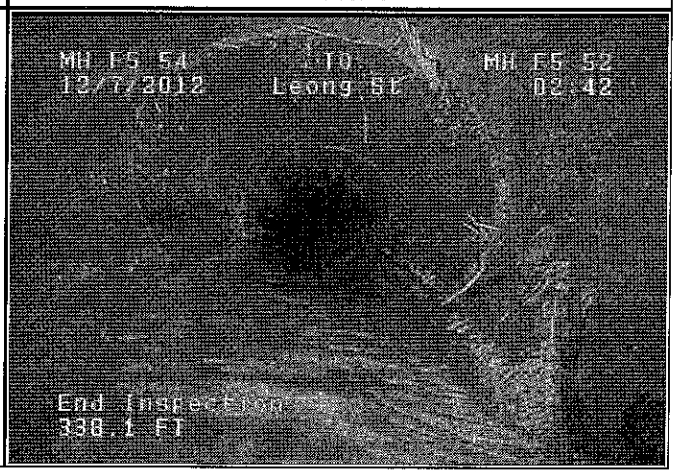
338.1	Broken Severity: None	18:27

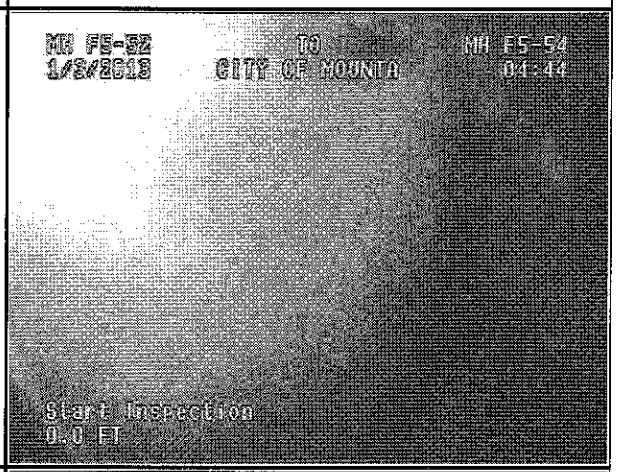
Distance	Fault Observation	Time	Picture
0.0	Start Inspection Severity: None Remarks: start	31

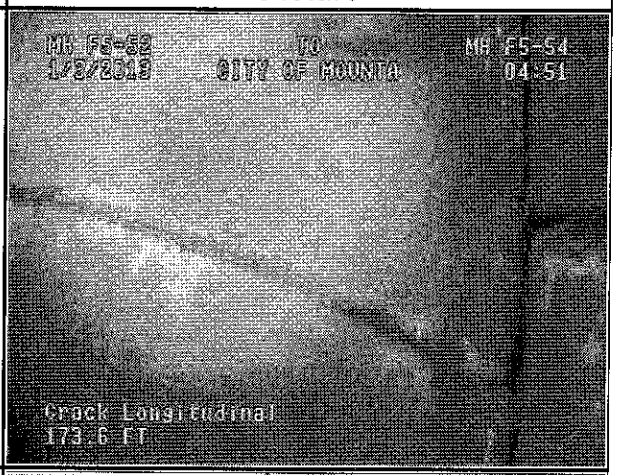
Distance	Fault Observation	Time	Picture
173.6	Crack Longitudinal Position: 2 Severity: None Struct Weight: 2	07:33

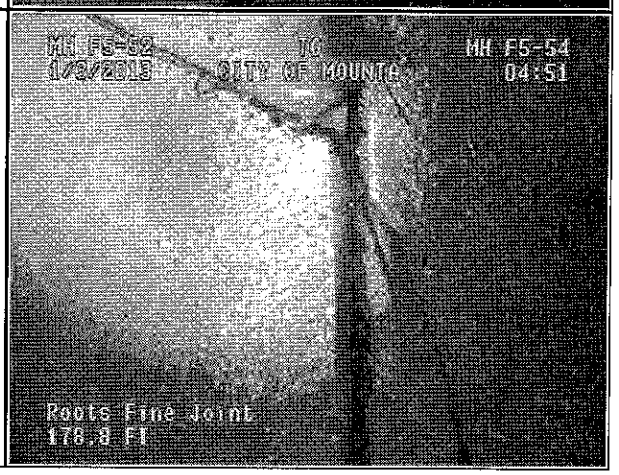
173.6	Infil Runner Position: 3 Severity: None Maint Weight: 4	07:50	
178.8	Roots Fine Joint Position: 1 Severity: None Joint Maint Weight: 1	08:14

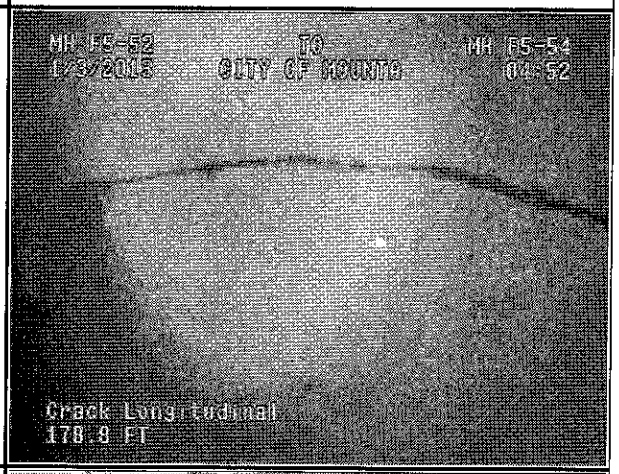
Distance	Fault Observation	Time	Picture
178.8	Crack Longitudinal Position: 1 Severity: None Struct Weight: 2	08:30

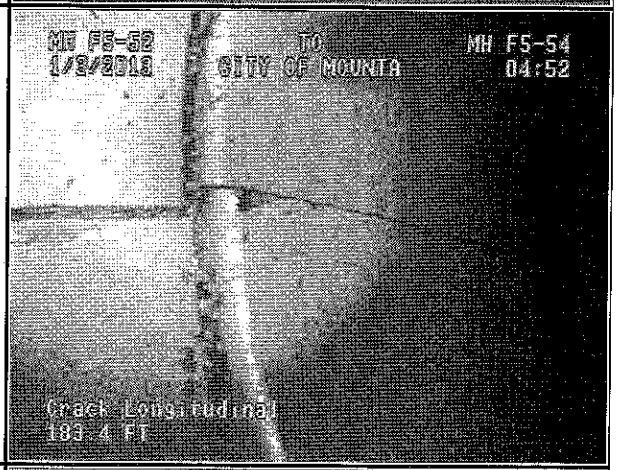
183.4	Crack Longitudinal Position: 12 Severity: None Struct Weight: 2	08:56

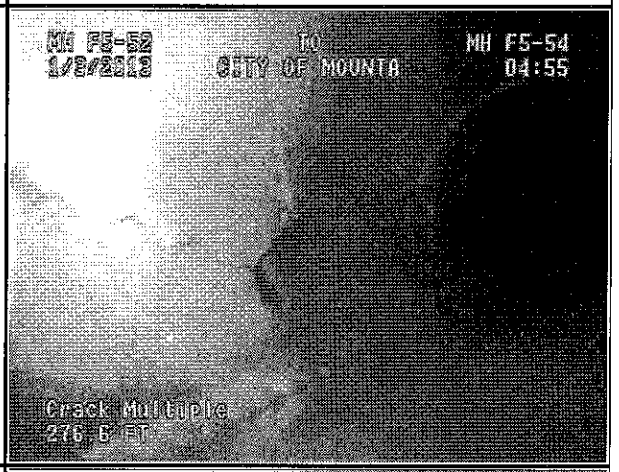
Distance	Fault Observation	Time	Picture
276.6	Crack Multiple Position: 6 To 9 Severity: None Struct Weight: 3	12:03

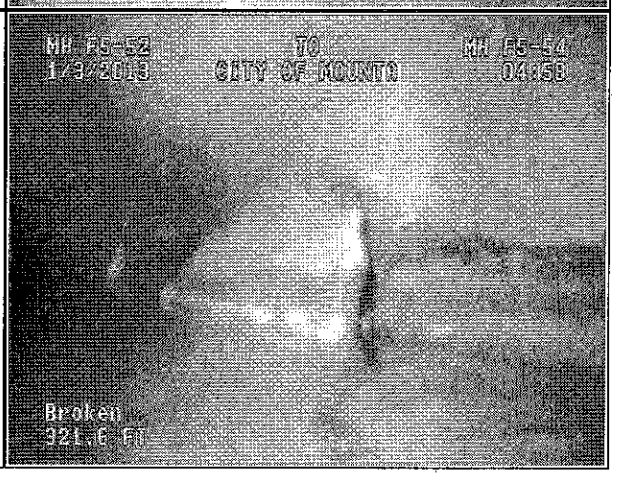
290.0	General Observation Severity: None Remarks: Pipe looks egg shaped	13:02	
321.6	Broken Position: 9 Severity: None Struct Weight: 3	14:32

Distance	Fault Observation	Time	Picture
322.6	End Inspection Severity: None Remarks: cannot pass break at 6 ocklock.	15:21

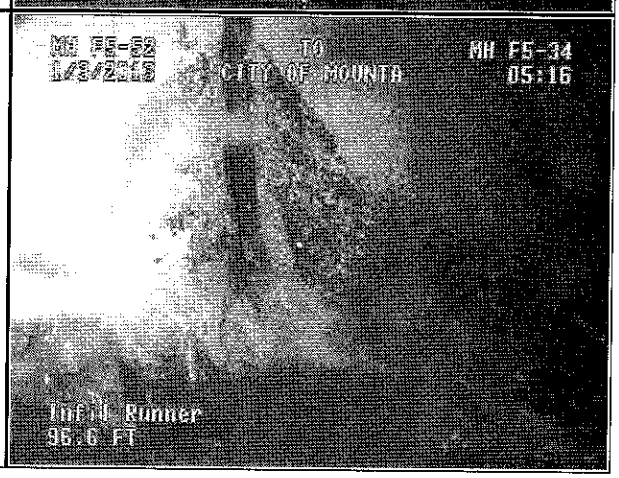
Distance	Fault Observation	Time	Picture
0.0	**Start Inspection** **Severity: None** **Remarks: start**	26	
92.5	**Infil Dripper** **Position: 12** **Severity: None** **Maint Weight: 3**	03:25	
96.6	**Infil Runner** **Position: 9** **Severity: None** **Maint Weight: 4**	03:47

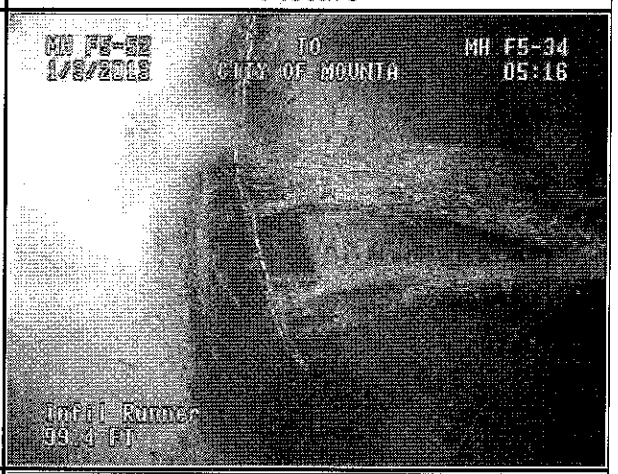
Distance	Fault Observation	Time	Picture
99.4	Infil Runner Position: 11 Severity: None Maint Weight: 4	04:05

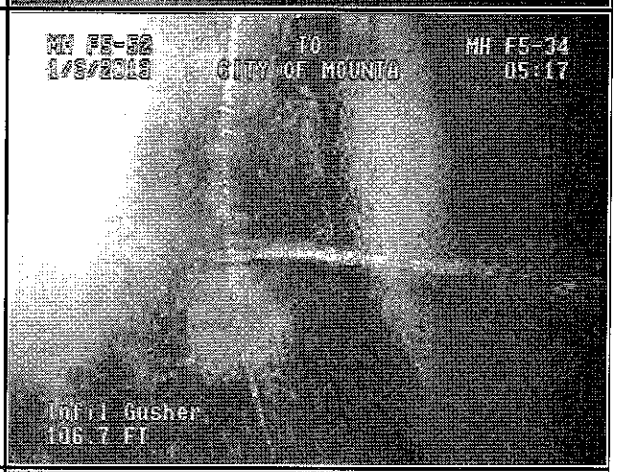
106.7	Infil Gusher Position: 10 Severity: None Maint Weight: 5	04:32

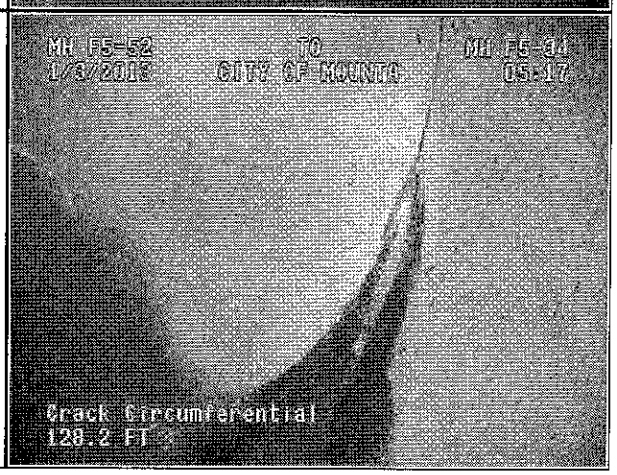
128.2	Crack Circumferential Position: 11 To 4 Severity: None Struct Weight: 1	05:14
