FAITH MINE MK012PR

RE:
Prior Reclamation Inspections

PRIOR RECLAMATION INSPECTION REPORT AND RECOMMENDATION FOR RELEASE OR PERMIT REQUIREMENT

Santa Fe Pacific Gold Corporation

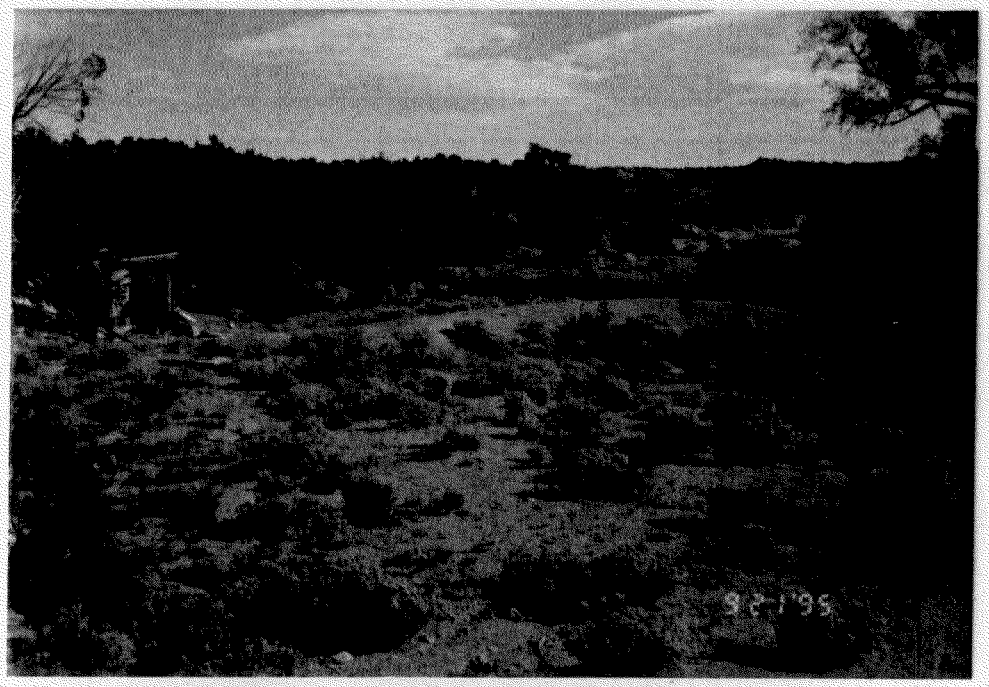
Section 13 T1N R6W, Powder Magzine, September 21, 1995

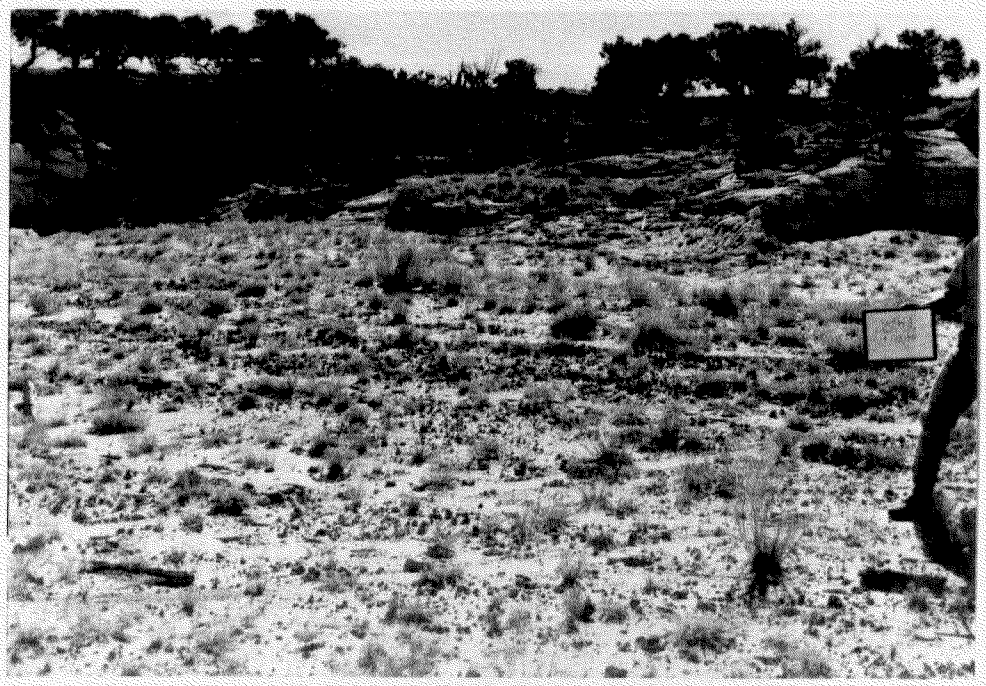
Section 1 T13N R9W, Shaft Site Looking West, 9/13/95

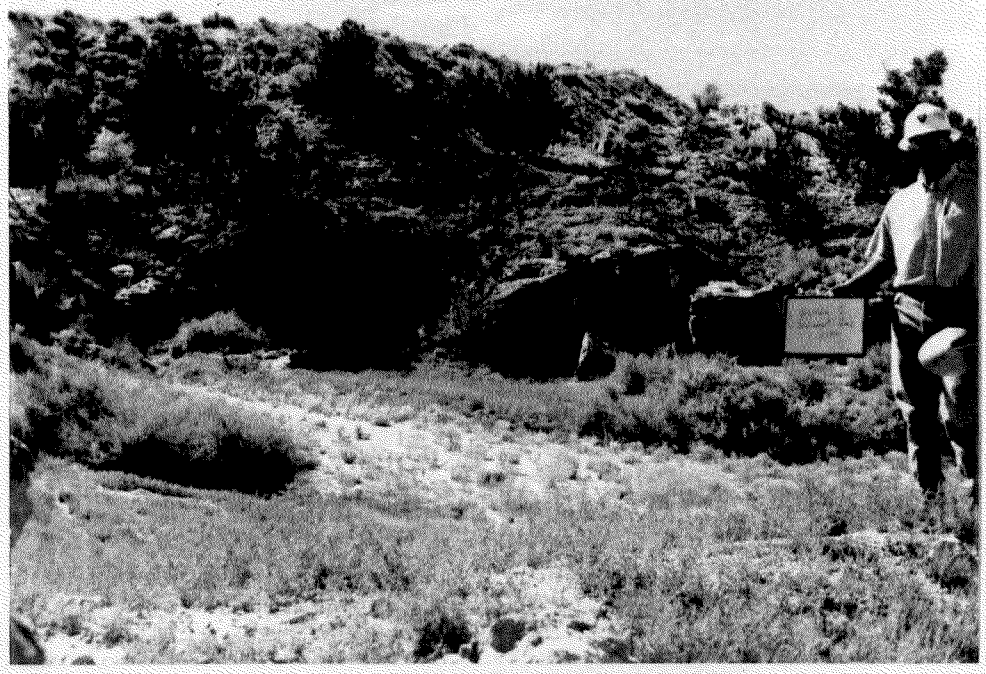
Section 1 T13N R9W,Sediment Pond, 9/13/95

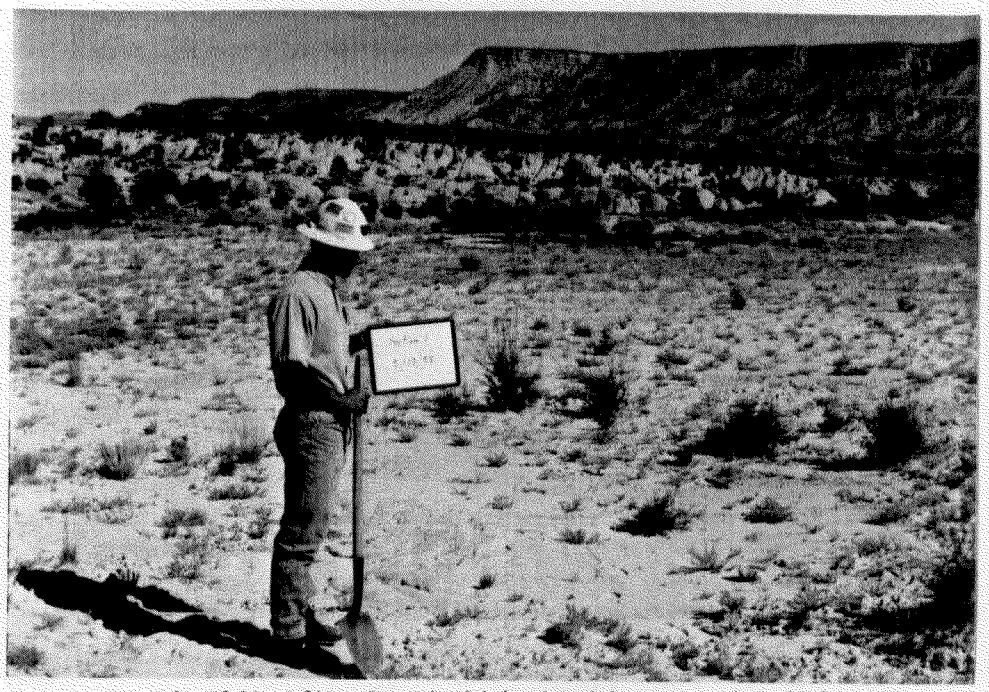
Section 1 T13N R9W, South Side Looking North, 9/13/95

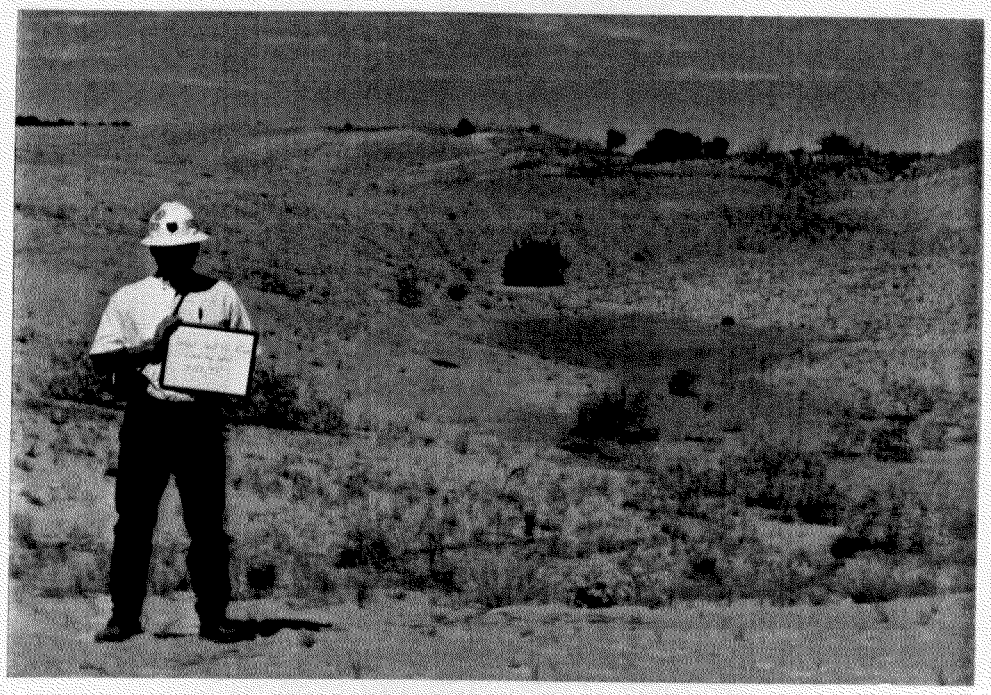
Section 25 Mine, Middle Looking East, 9/12/95

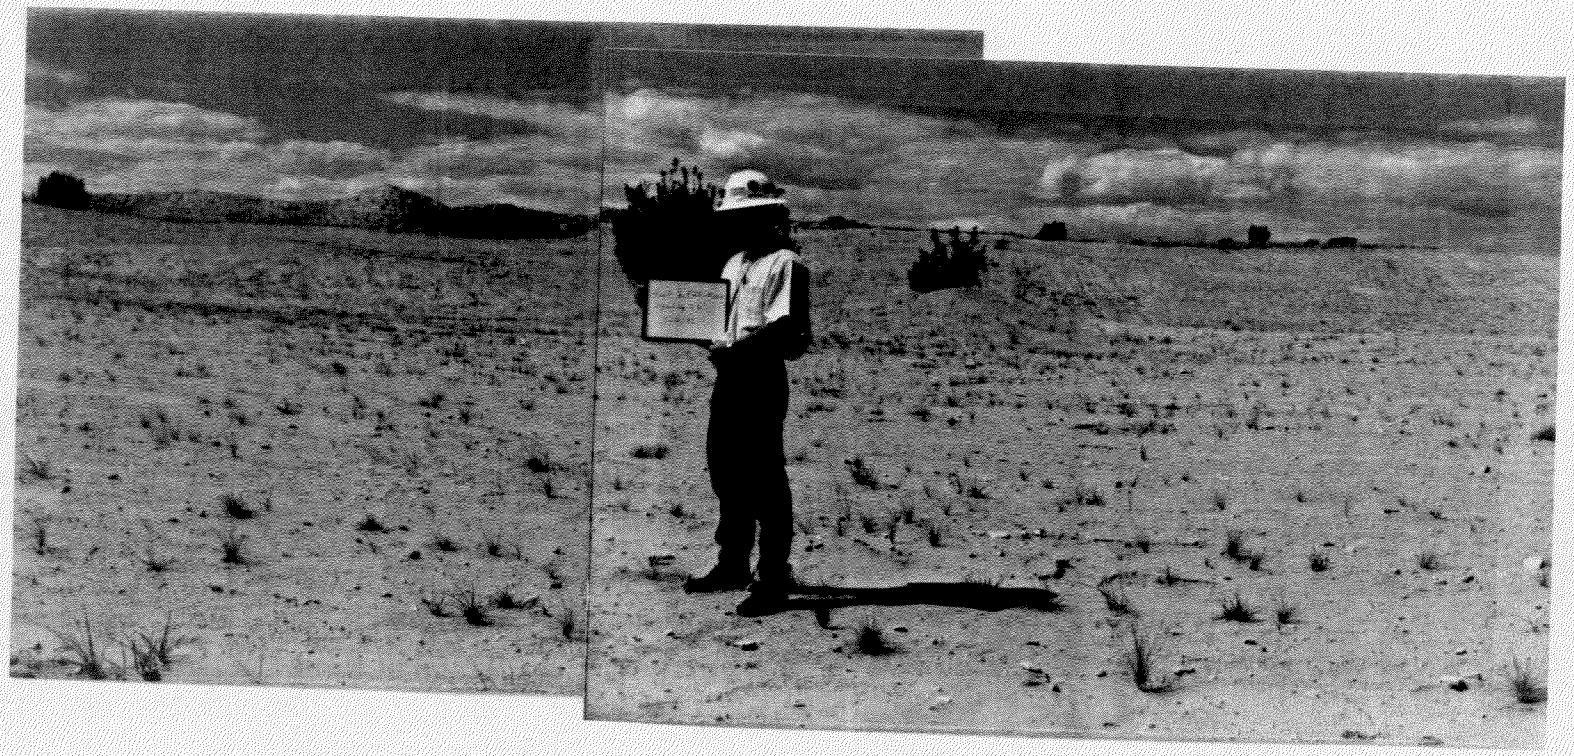
Section 25 Mine, East Side Looking Southwest, 9/12/95

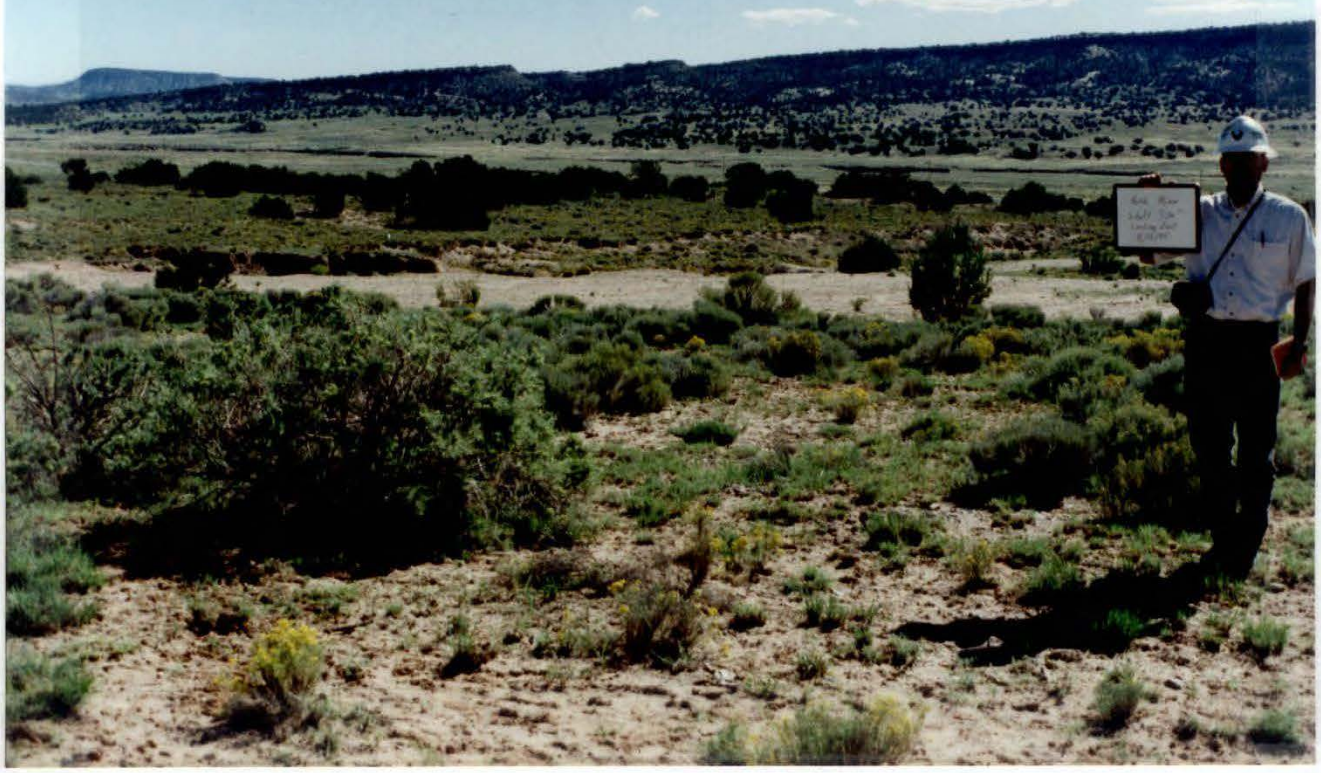
Faith Mine Shaft Site, Looking East, 9/12/95
Regraded Area in Background

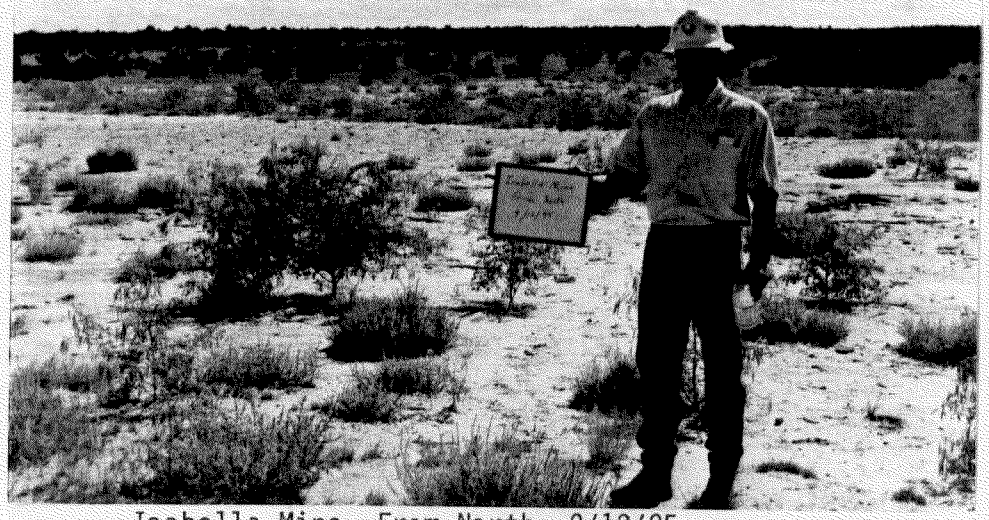
Isabella Mine, From North, 9/12/95

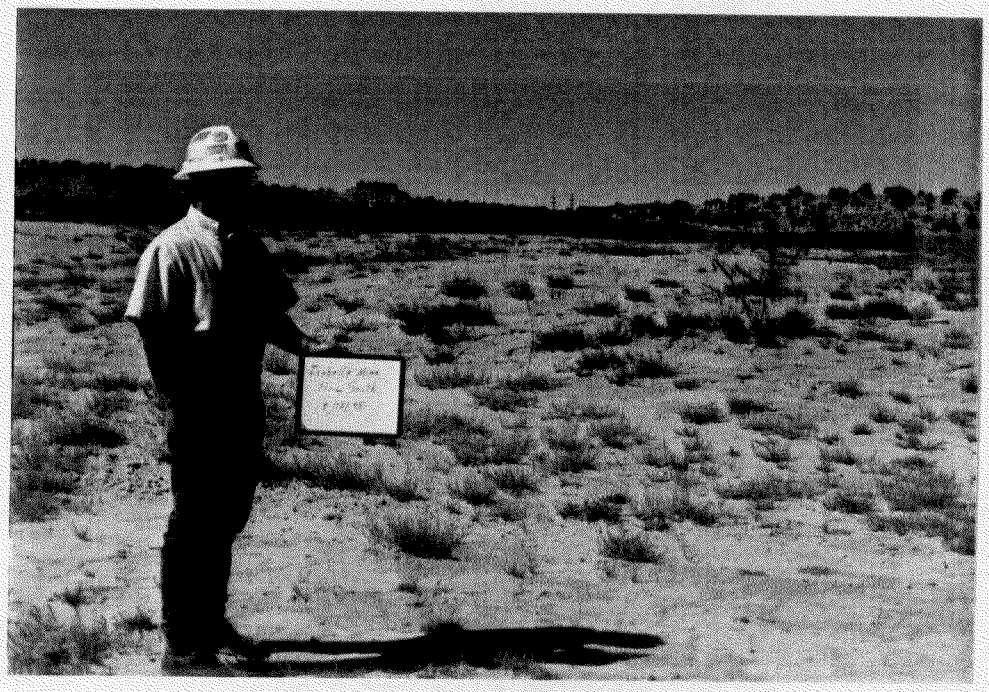
Isabella Mine, From South, 9/12/95

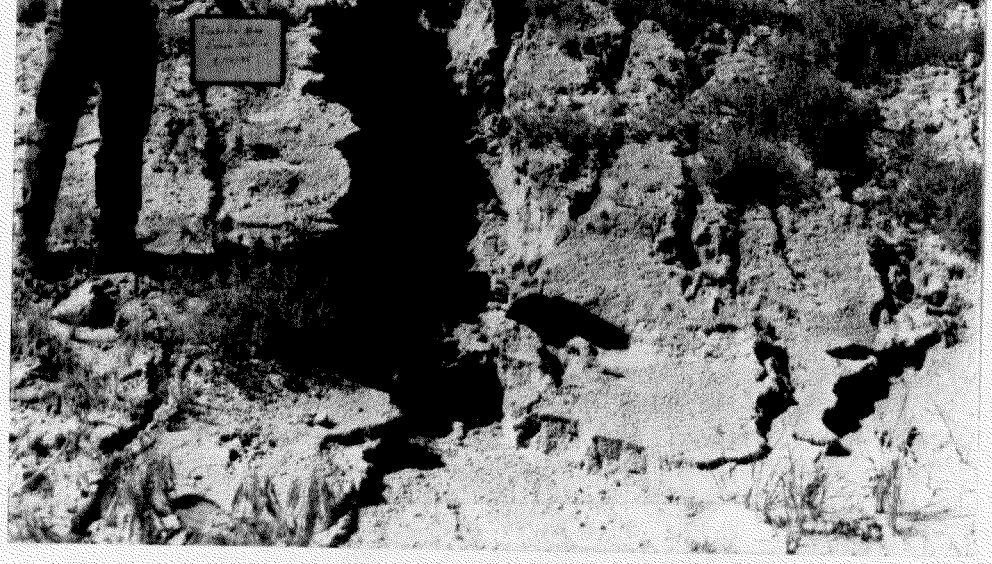
Isabella Mine, Erosion Feature, 9/12/95

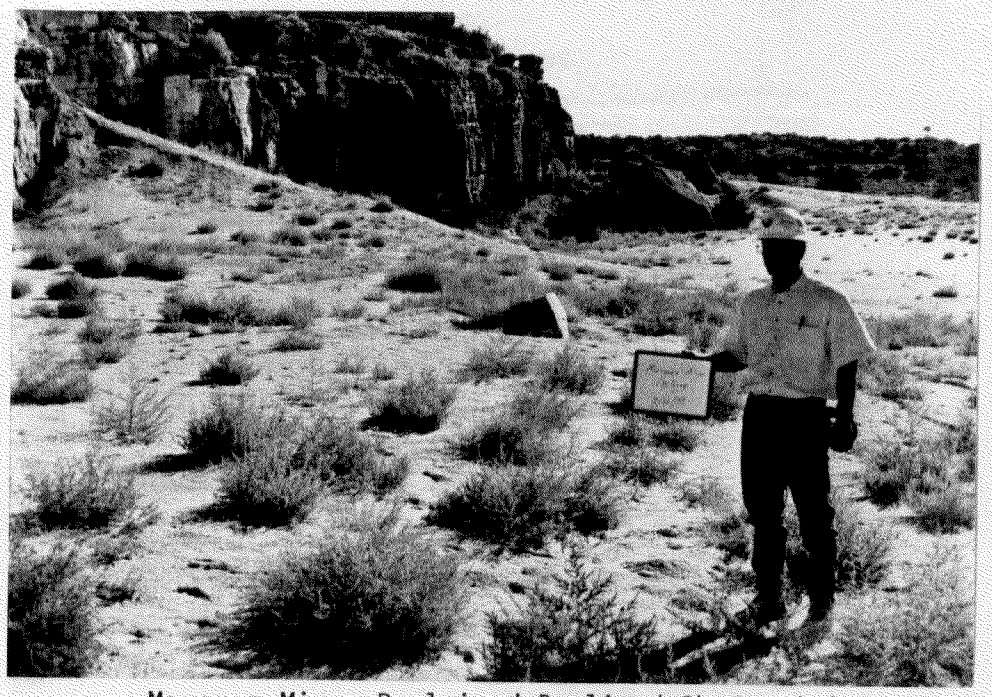
Marquez Mine, Reclaimed Declined Shaft, 9/12/95

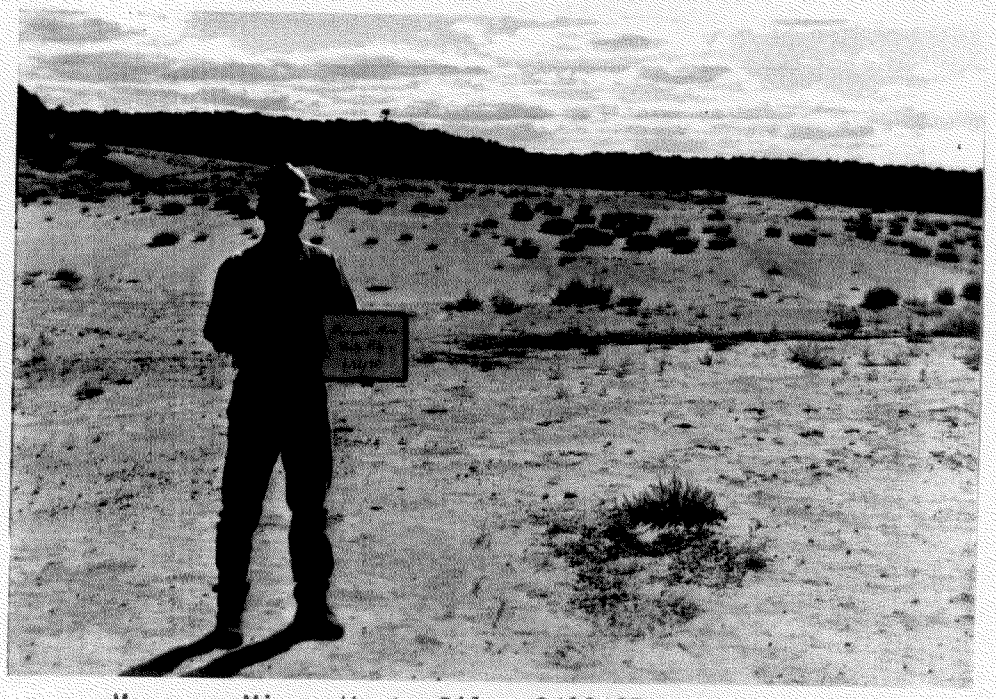
Marquez Mine, Waste Pile, 9/12/95

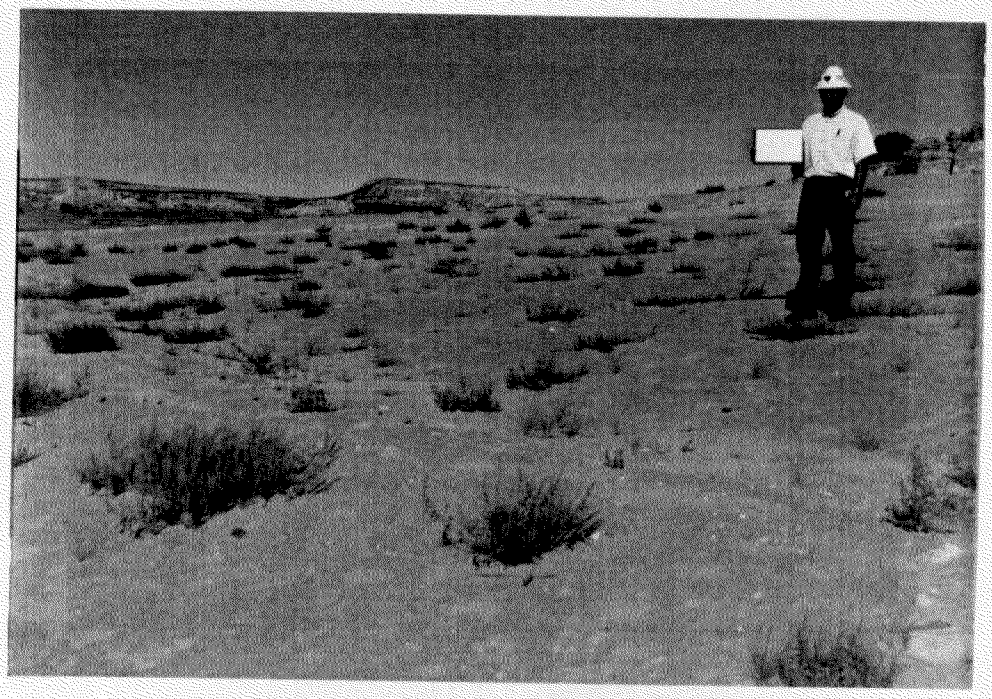
Marquez Mine, Waste Pile, 9/12/95

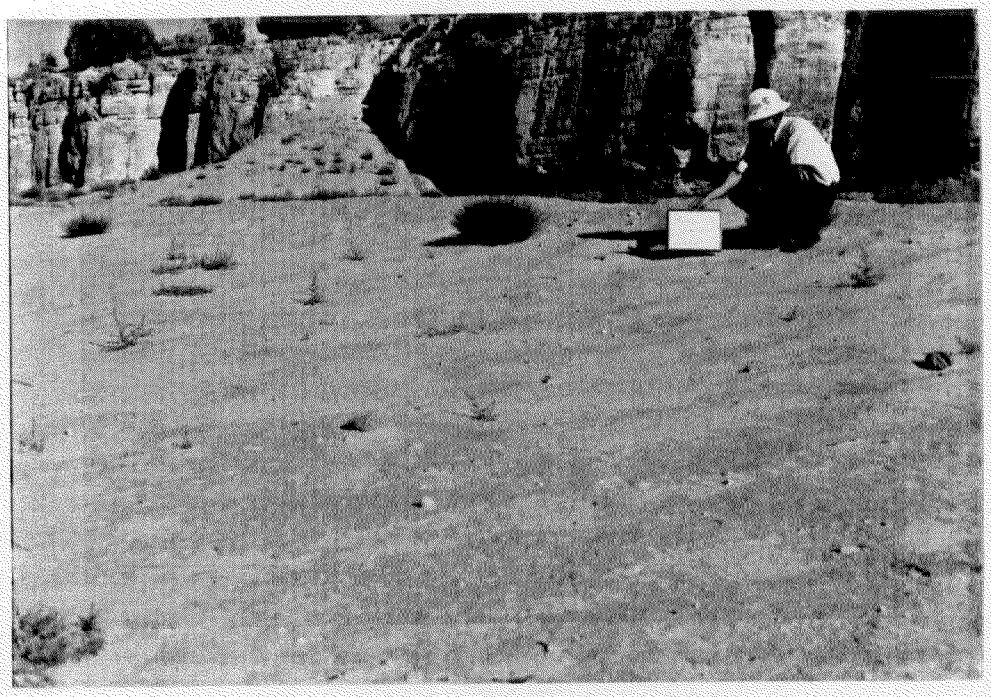
Marquez Mine, Waste Pile, 9/12/95

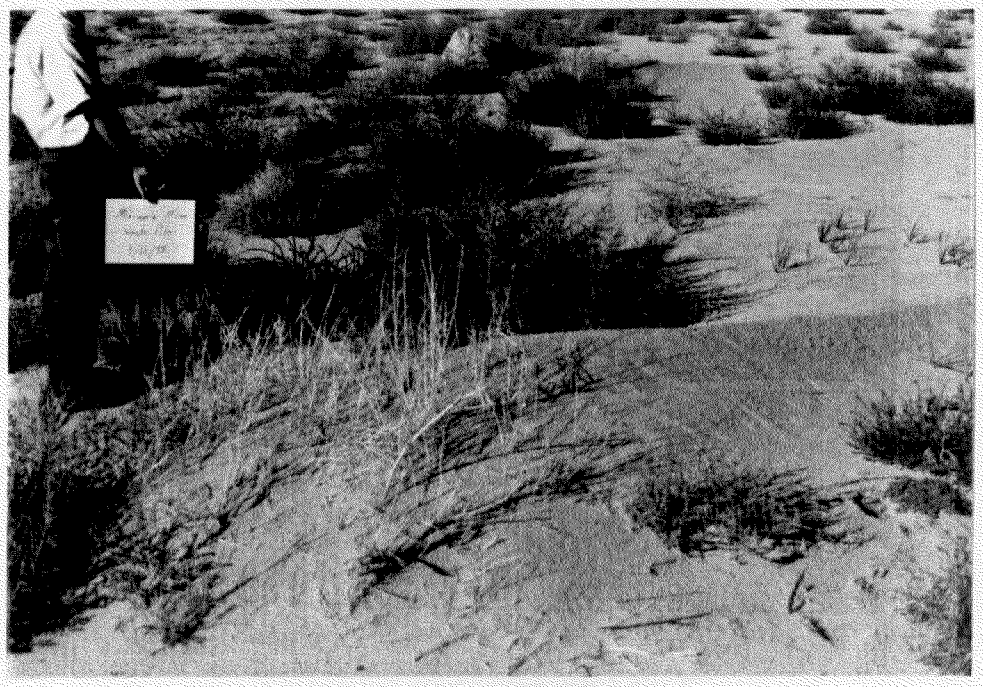
Topsoil depths across the site were greater than 12 inches, but consisted entirely of windblown sand. This area was essentially barren with most of the seed and mulch blown away before vegetation could be established. Native species such as Indian ricegrass (*Oryzopsis hymenoides*), from adjoining areas were starting to invade he disturbance area (Young, 1995). Because of the obvious lack of plant cover at the site no transects were attempted. Staff does not recommend release of this site.

Marquez Mine, Sand Dune, 9/12/95

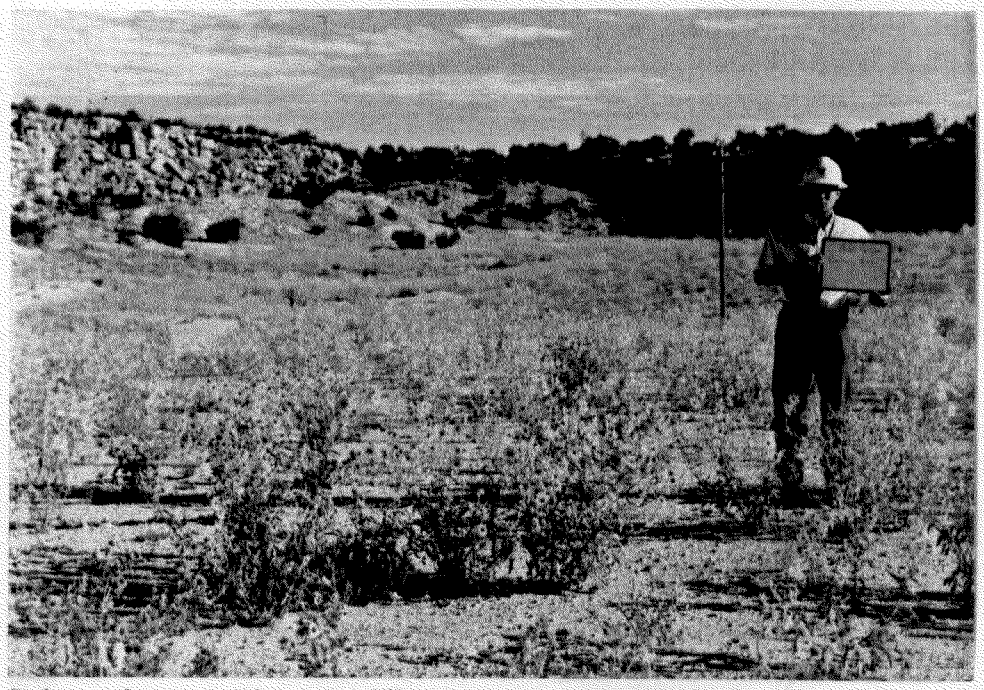
Poison Canyon Mine, Middle Looking North, 9/12/95

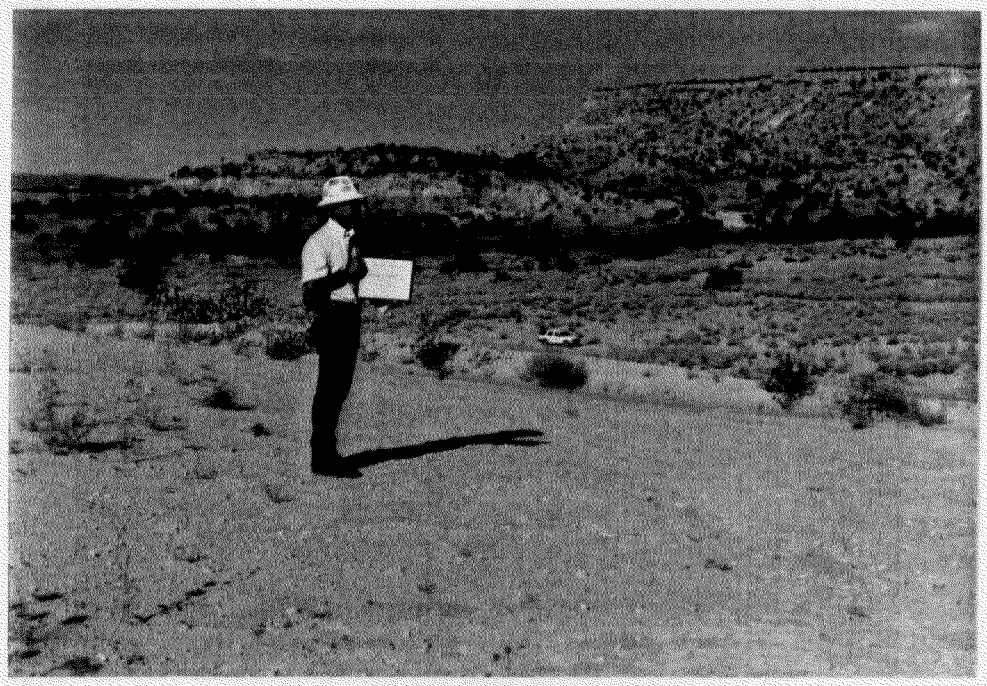
Poison Canyon Mine, Middle Looking West, 9/12/95
