CITY OF CHICAGO

DEPARTMENT OF PUBLIC HEALTH
PERMITTING AND ENFORCEMENT

NARRATIVE EVALUATION

INSPECTION DATE: 04/11/2020
SITE NAME: Crawford Smoke Stack Demo
SITE ADDRESS: 3501 S PULASKI RD, CHICAGO, IL 60623
SITE CODE: Crawford Smoke Stack Demo
PERMIT #: ENVGEN1234260

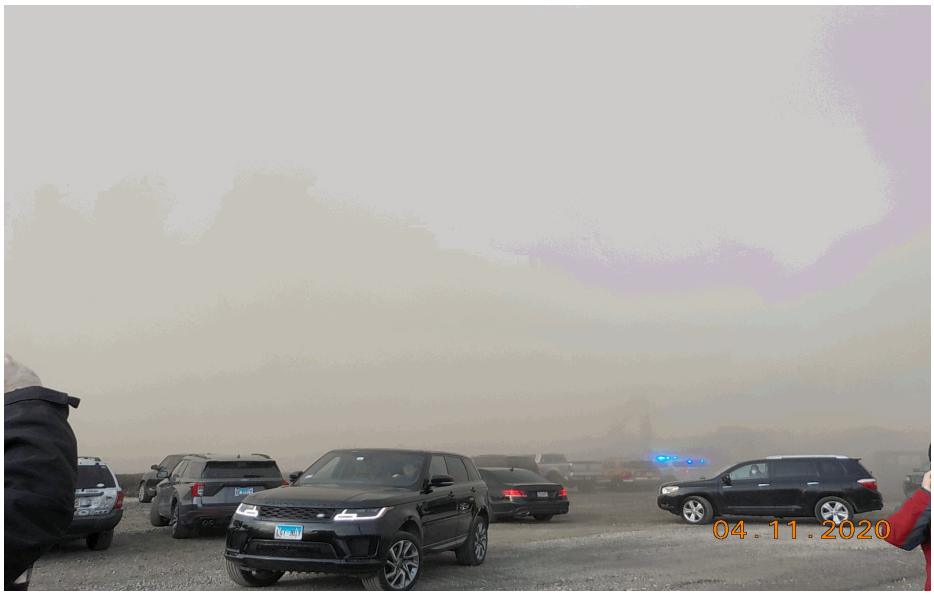
A wind current from the south to north carried the plume of dust through the site due north. The cloud of dust was thick as it traveled through the site. Visibility was limited due to the dust. Two rented water trucks stationed at the northern perimeter of the site were hosing the area to prevent the dust cloud from exiting the site.The reporting inspector's line of sight was positioned westward as the dust cloud traveled northbound. The reporting inspector did not observe what CFD was doing at the time due to the inspector's line of sight. The dust was not suppressed adequately and continued to travel off-site towards the residential area north of the site.

COMMENTS: Photo E- 3501 S. Pulaski Rd., Photo of dust cloud continuing to move north from impact drop area. Thick cloud of particulates can be seen.
