NEW MEXICO
ENVIRONMENT DEPARTMENT

Memorandum

Subject: **Pre-CERCLIS Screening Assessment of the Section 25 Decline Mine (Grants Mining District), McKinley County, New Mexico: Further Investigation under CERCLA Recommended**

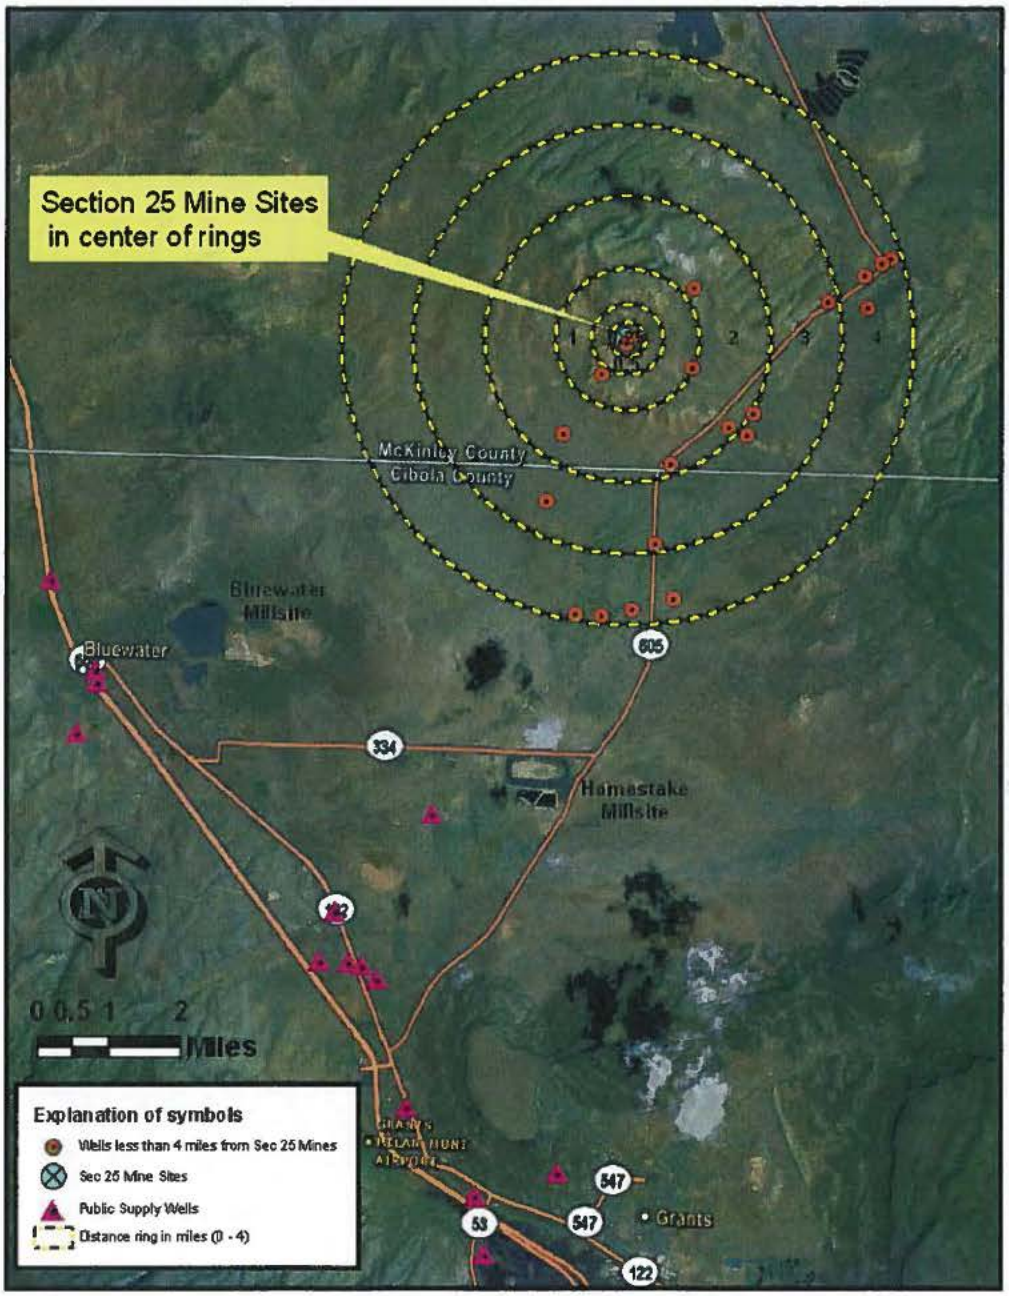
Well records from the New Mexico Office of the State Engineer (OSE) that are located within a four-mile radius of the Site are identified in Table 1 (Ref. 11). Figure 5 presents a map of the wells that are located within a four-mile radius of the Section 25 Mine Site. According to the information from the OSE, no domestic use wells are located between 0 and 1.0 miles of the Site. One well located between 1.0 to 2.0 miles from the Site is designated, "household."

Figure 5: Wells within a 4-mile radius of the Section 25 Mine Sites (Divide, Sec 25 Decline, & Sec 25 Shaft), Dos Lomas 7.5 min. quadrangle map, Grants Mining District, New Mexico (OSE 2011).

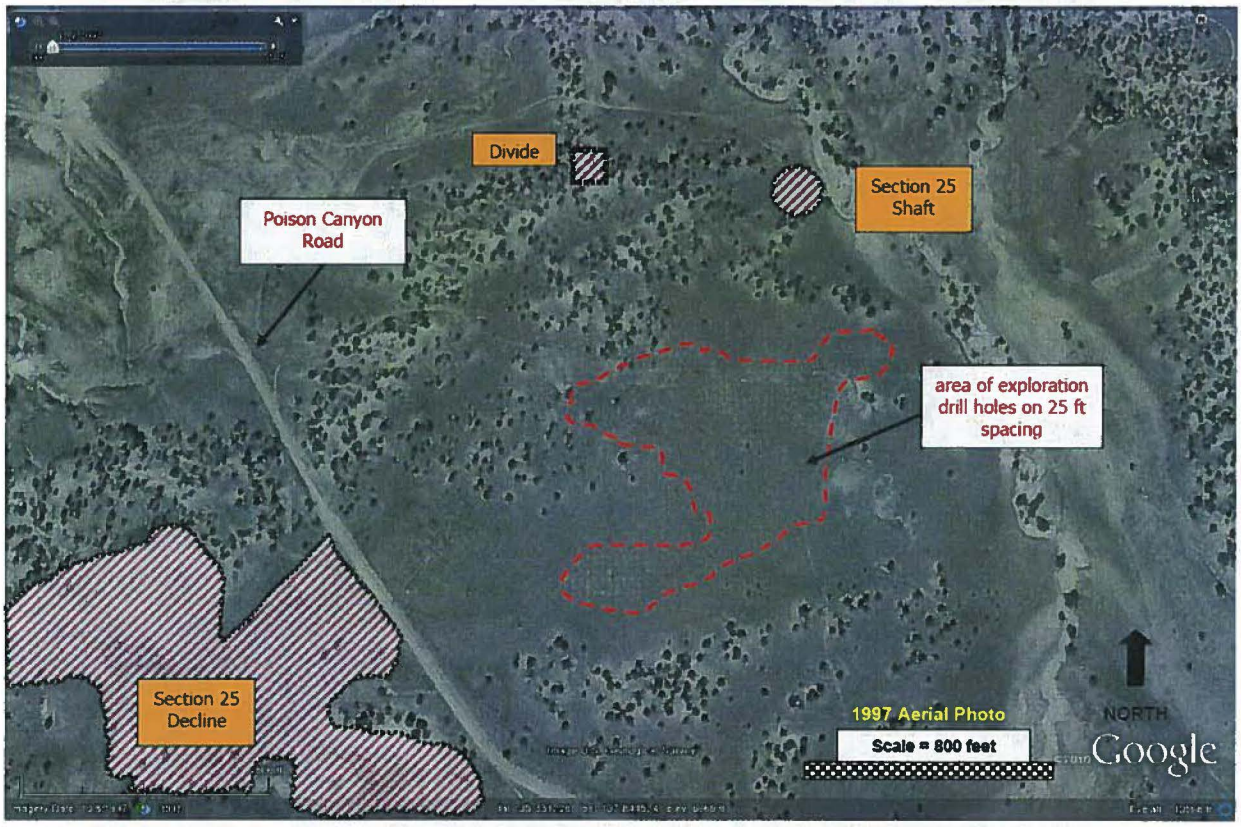
Figures 6, 7, and 8 present a Google Earth location map for the Section 25 Mines during the years 1997, 2005, and 2009 (Attachment A). Figure 6 shows in 1997, there were no residential structures and no new roads in the vicinity of the Section 25 Decline Mine. Figure 7 shows in 2005 there is one new residential structure and one new road approximately 1,400 feet northeast of the Section 25 Decline Mine. Figure 7 also shows a large rectangular feature that is assumed to be the disturbance of ground surface from the construction of a fence around the property containing the new residential structure, the Divide Mine, and the Section 25 Shaft Mine. Figure 8 shows in 2009 there are two more new residential structures and two new roads in the vicinity of the Section 25 Decline Mine. In Figure 8 one new residential structure is approximately 2,000 feet east of the Section 25 Decline Mine. Figure 8 shows another new residential structure and road that are approximately 2,400 feet northeast of the Section 25 Decline Mine.

Figure 6. 1997 Google Earth location map of the Section 25 Mines showing no residential structures in the area near the mine sites.

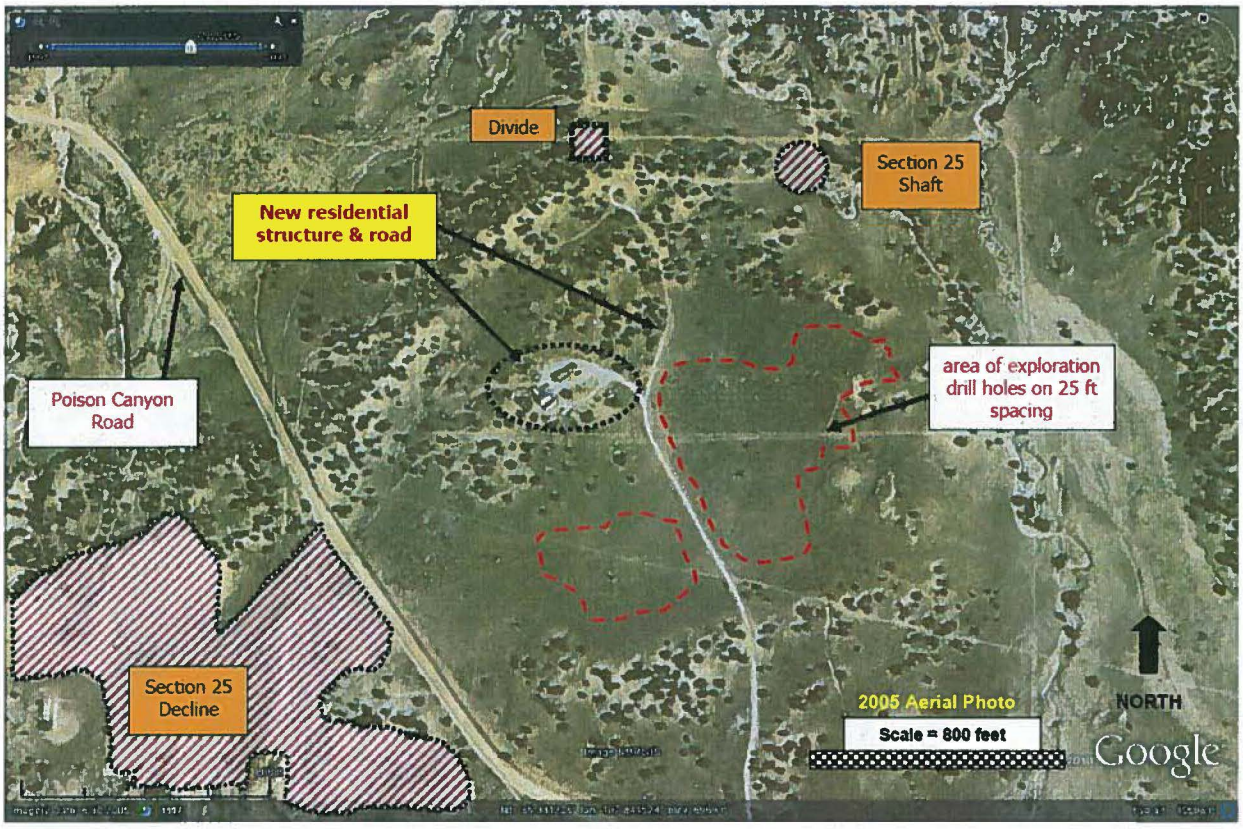
Figure 7. 2005 Google Earth location map of the Section 25 Mines showing one residential structure and a new road in the area near the mine sites.

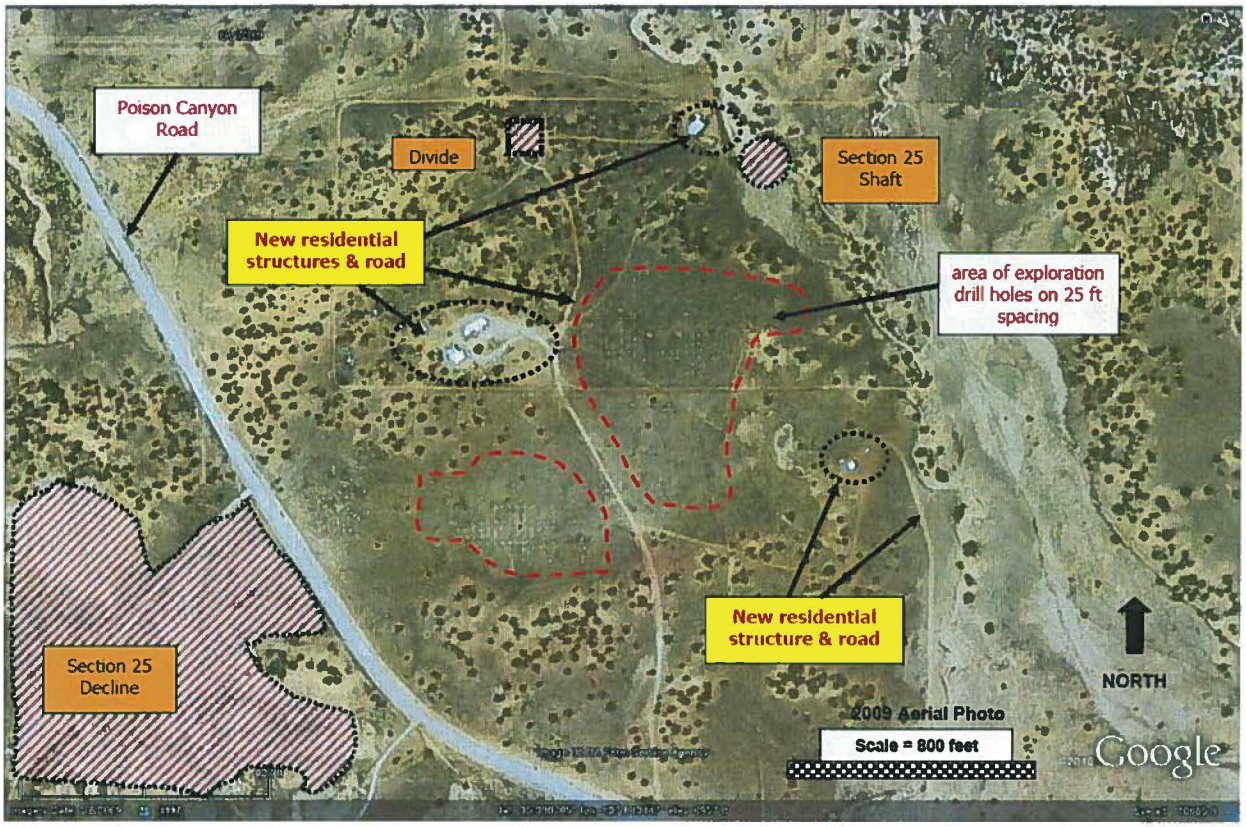
Figure 8. 2009 Google Earth location map of the Section 25 Mines showing three residential structures and two new roads in the area near the mine sites.

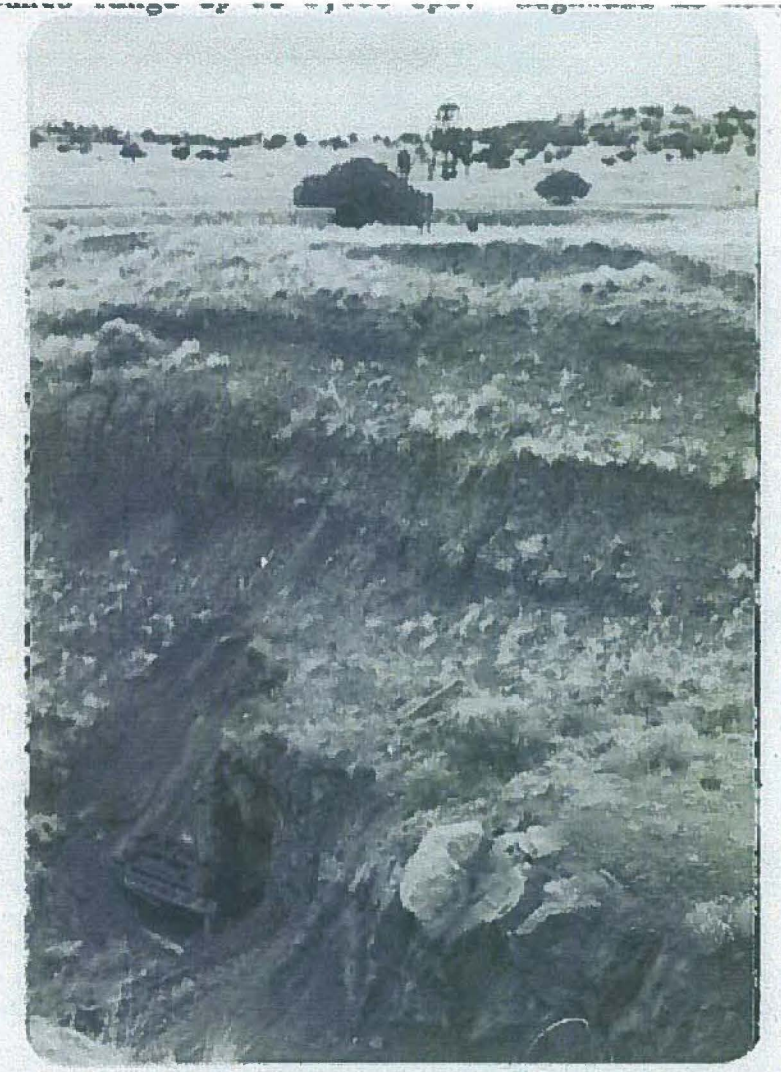
Photo (d) Looking northward into box cut with decline driven eastward at bottom. Close-up of decline is given on next page. Note section 25 head frame in background 1,000' away.

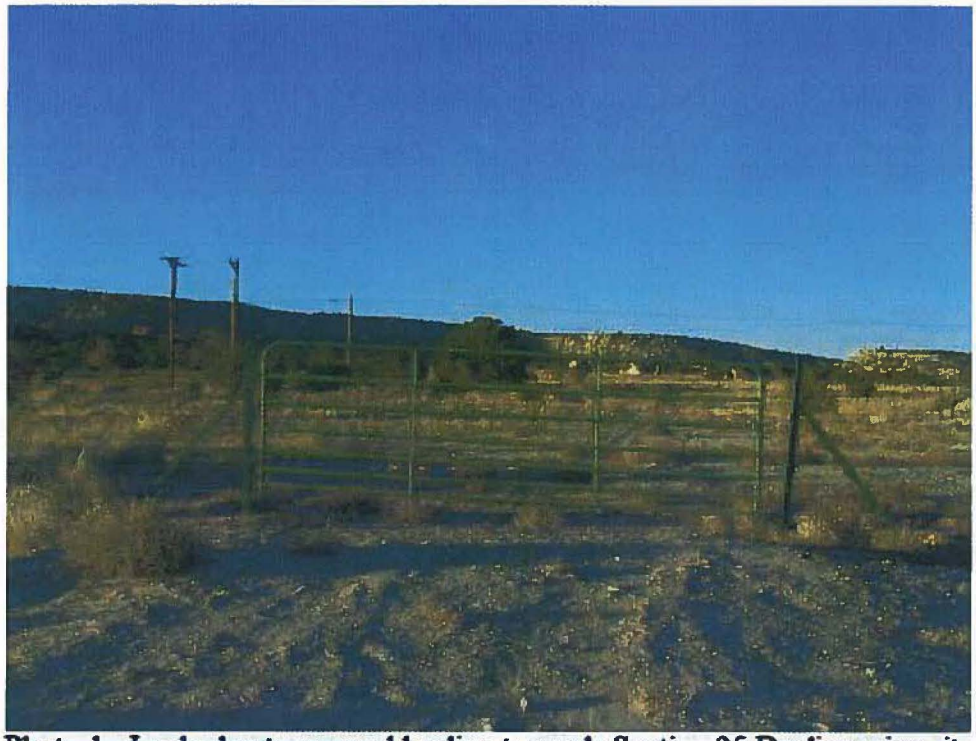
Photo 1. Locked gate on road leading towards Section 25 Decline mine site

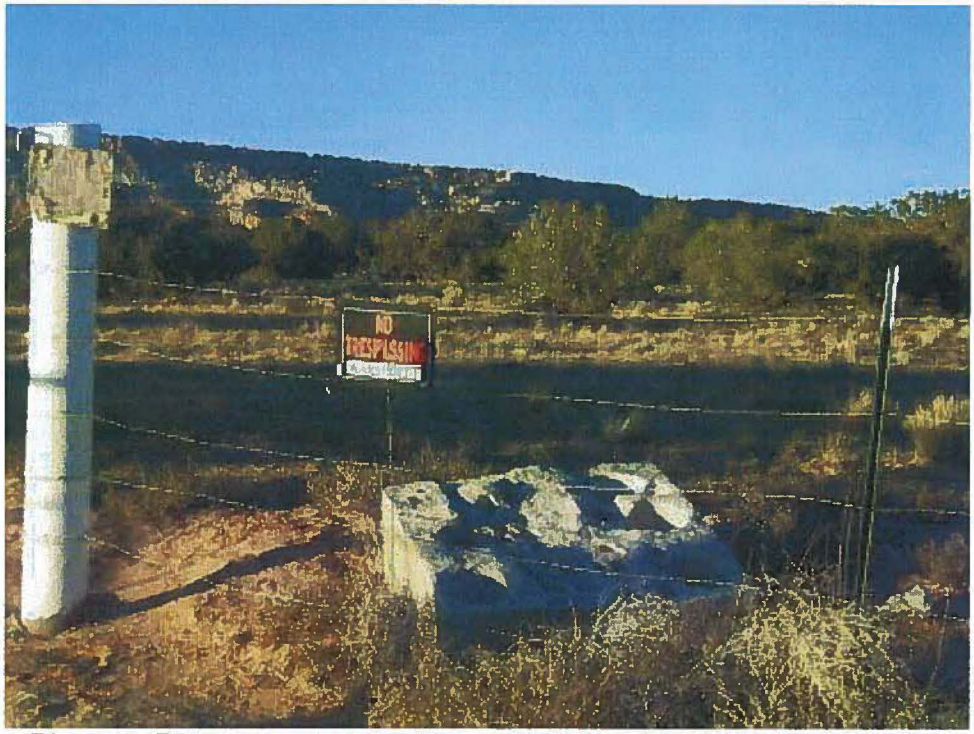
Photo 2. Private property leading towards Section 25 Decline mine site

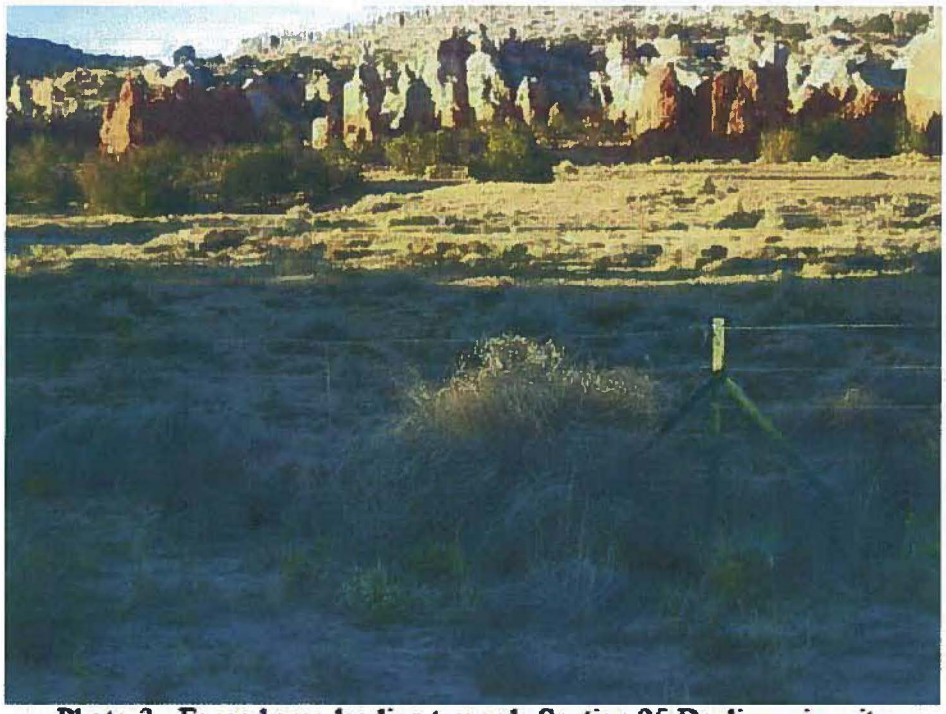
Photo 3. Fenced area leading towards Section 25 Decline mine site
