ADMINISTRATIVE RECORD

REMOVAL ACTION

SITE NAME: BUFFALO COMPRESSOR STATION

BUFFALO, HARPER COUNTY, OKLAHOMA

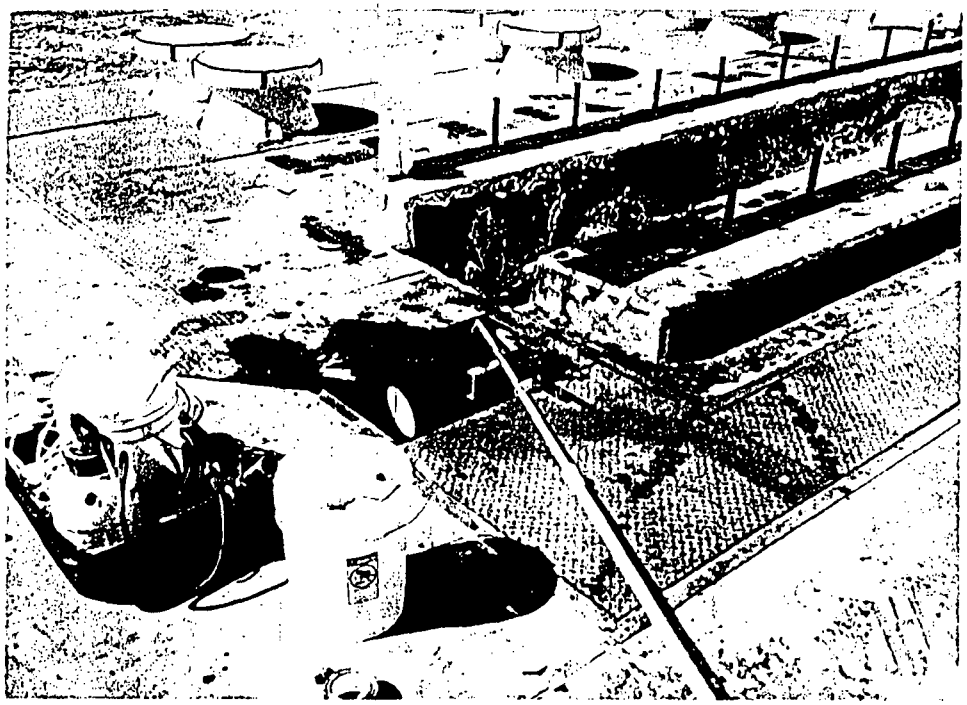
Basement (BUF-001(D)-0) (BUF-002(D)-WA).

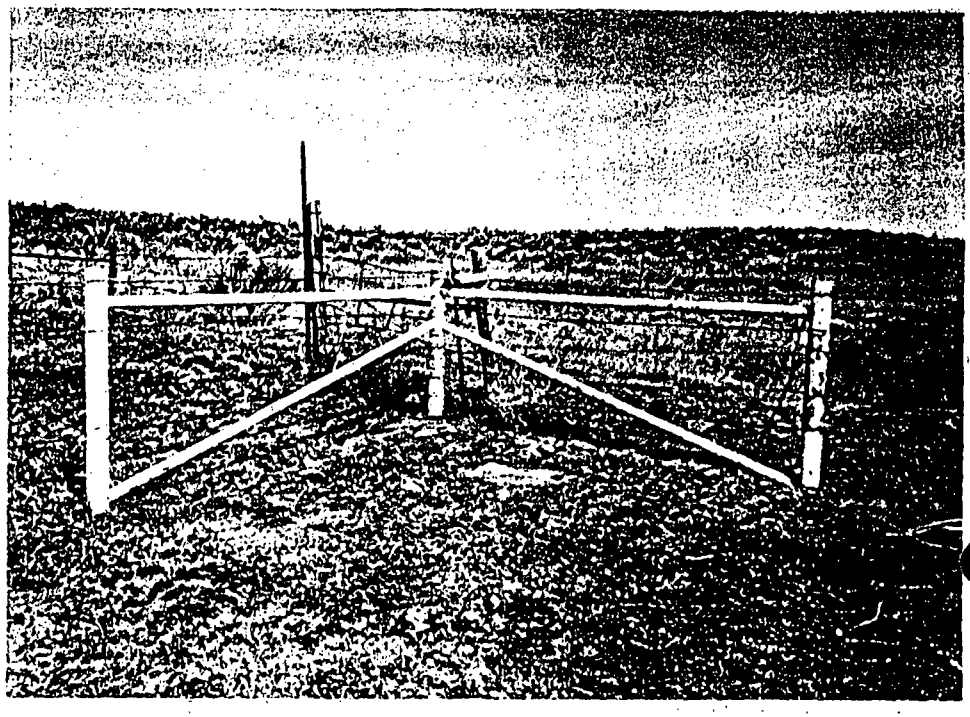
Upgradient of Site (BUF-003-S0).

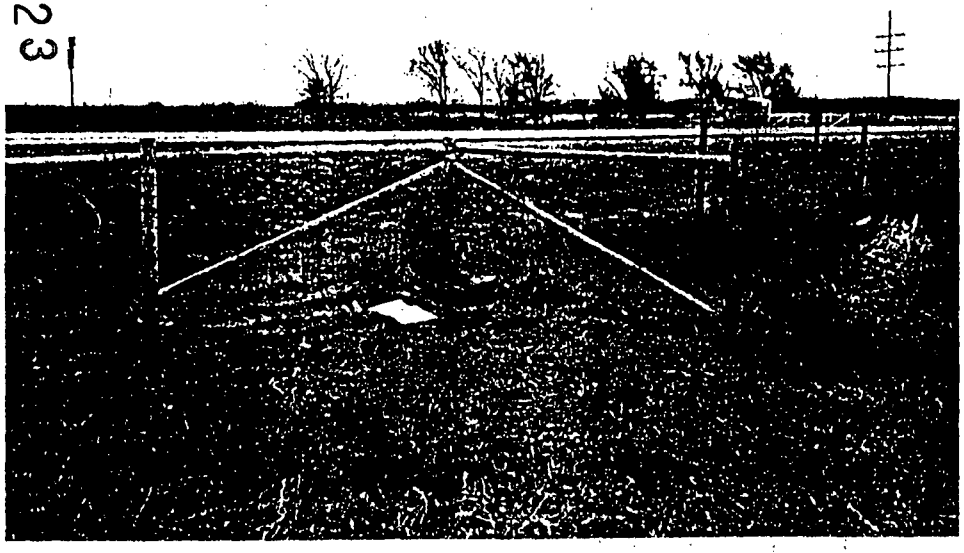
Downgradient of Site (BUF-004-S0).

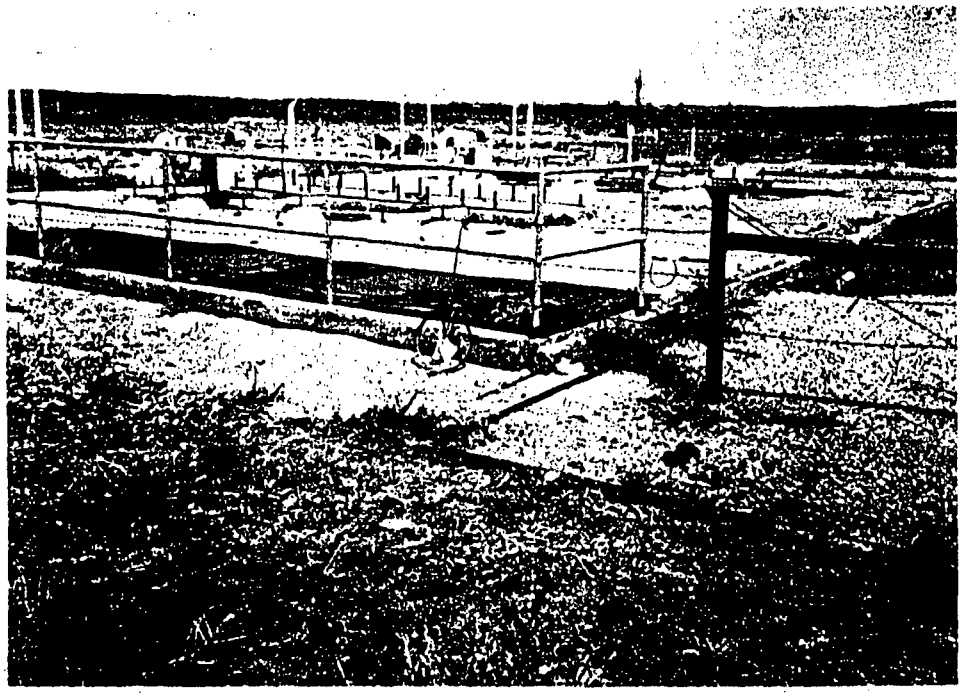
Prelube Air Pipe (BUF-007-S0 & S1).

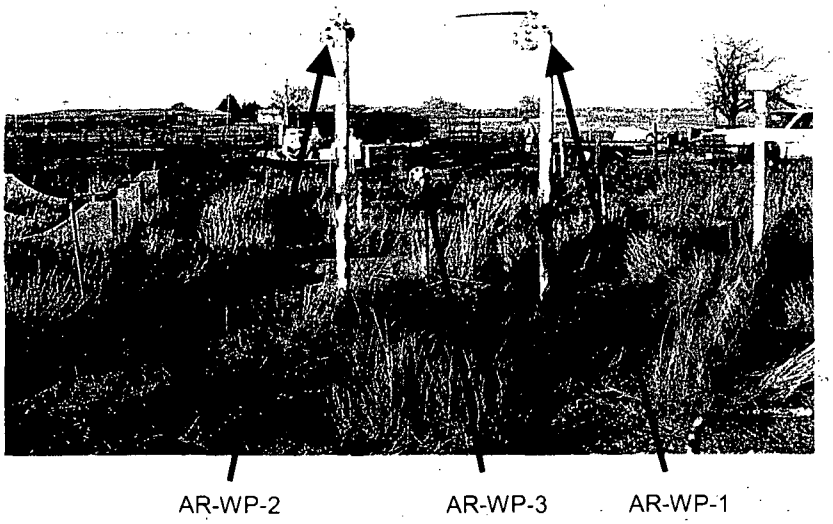
Photo #4

Description: Various lines in the air receiver area

- Williams recommends the removal of the air receiver line on the north side of the air receiver area.
