U.S. Environmental Protection Agency
Region 9 Oil Program

SPCC PHOTOGRAPHIC LOG

Facility Name & Location:	**Photographer:**	**Camera:**
ALLENCO ENERGY LOS ANGELES CA	WITUL	CANON SX230

Dates Photographs Were Taken:
11/6/2013

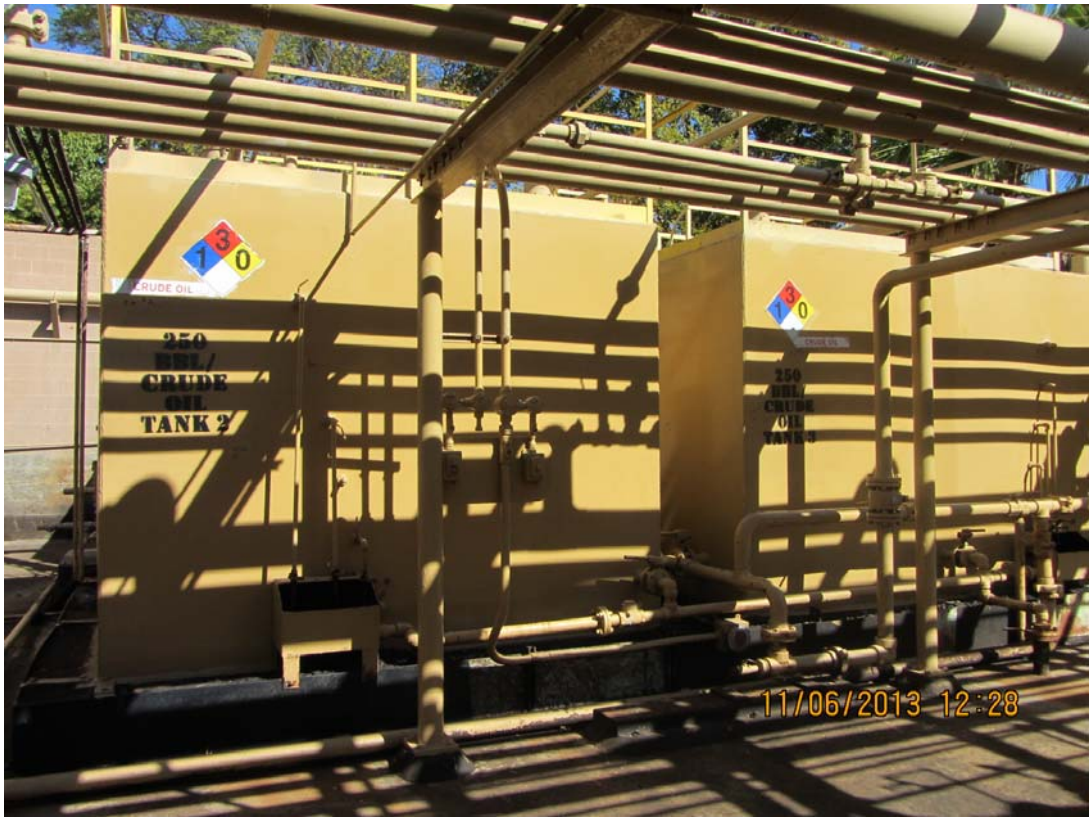
Photographer: WITUL	
Photo No. 23	**Time:** 1128
Direction Photo Taken: NE	
Photo Description: CRUDE OIL TANK 2 AND TANK 3, MARKED 250 BBLS EACH (10,500 GAL)
