Re: Request for Information
EPA ID No.: OHD987000015

REQUEST FOR INFORMATION

Photograph Log

Facility Name and ID Number:
A & B Foundry and Machining
EPA ID: OHD987000015

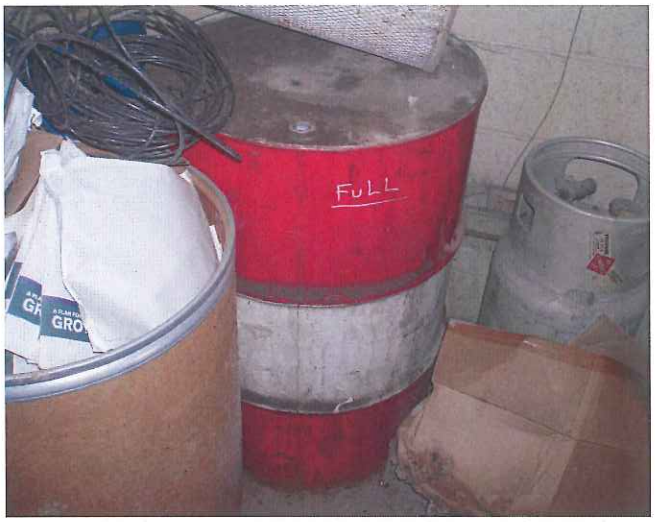
Photograph 18

2. Provide documentation supporting your non-hazardous waste determinations for the following general categories of spent materials:
    a. Tan Shake-out/knock-off sand (See Appendix A: Photograph 14);
    b. Pink Shake-out/knock-off sand (See Appendix A: Photograph 18);
    c. Sand fines collected in dust collectors;
    d. Refractory bricks generated during furnace repairs;
    e. X-ray film and developing/processing chemicals; and
    f. Fluorescing penetrant.

Piles of shake-out/knock-off sand were accumulating outside the property.
