Re: **American Steel Foundries**
OHD017497587
Mahoning County

Enclosed is the final report for the Comprehensive Ground Water Monitoring Evaluation (CME) that was conducted on October 25, 1990 at the American Steel Foundries Sebring disposal facility located in Smith Township, Mahoning County, Ohio.

AMERICAN STEEL FOUNDRIES

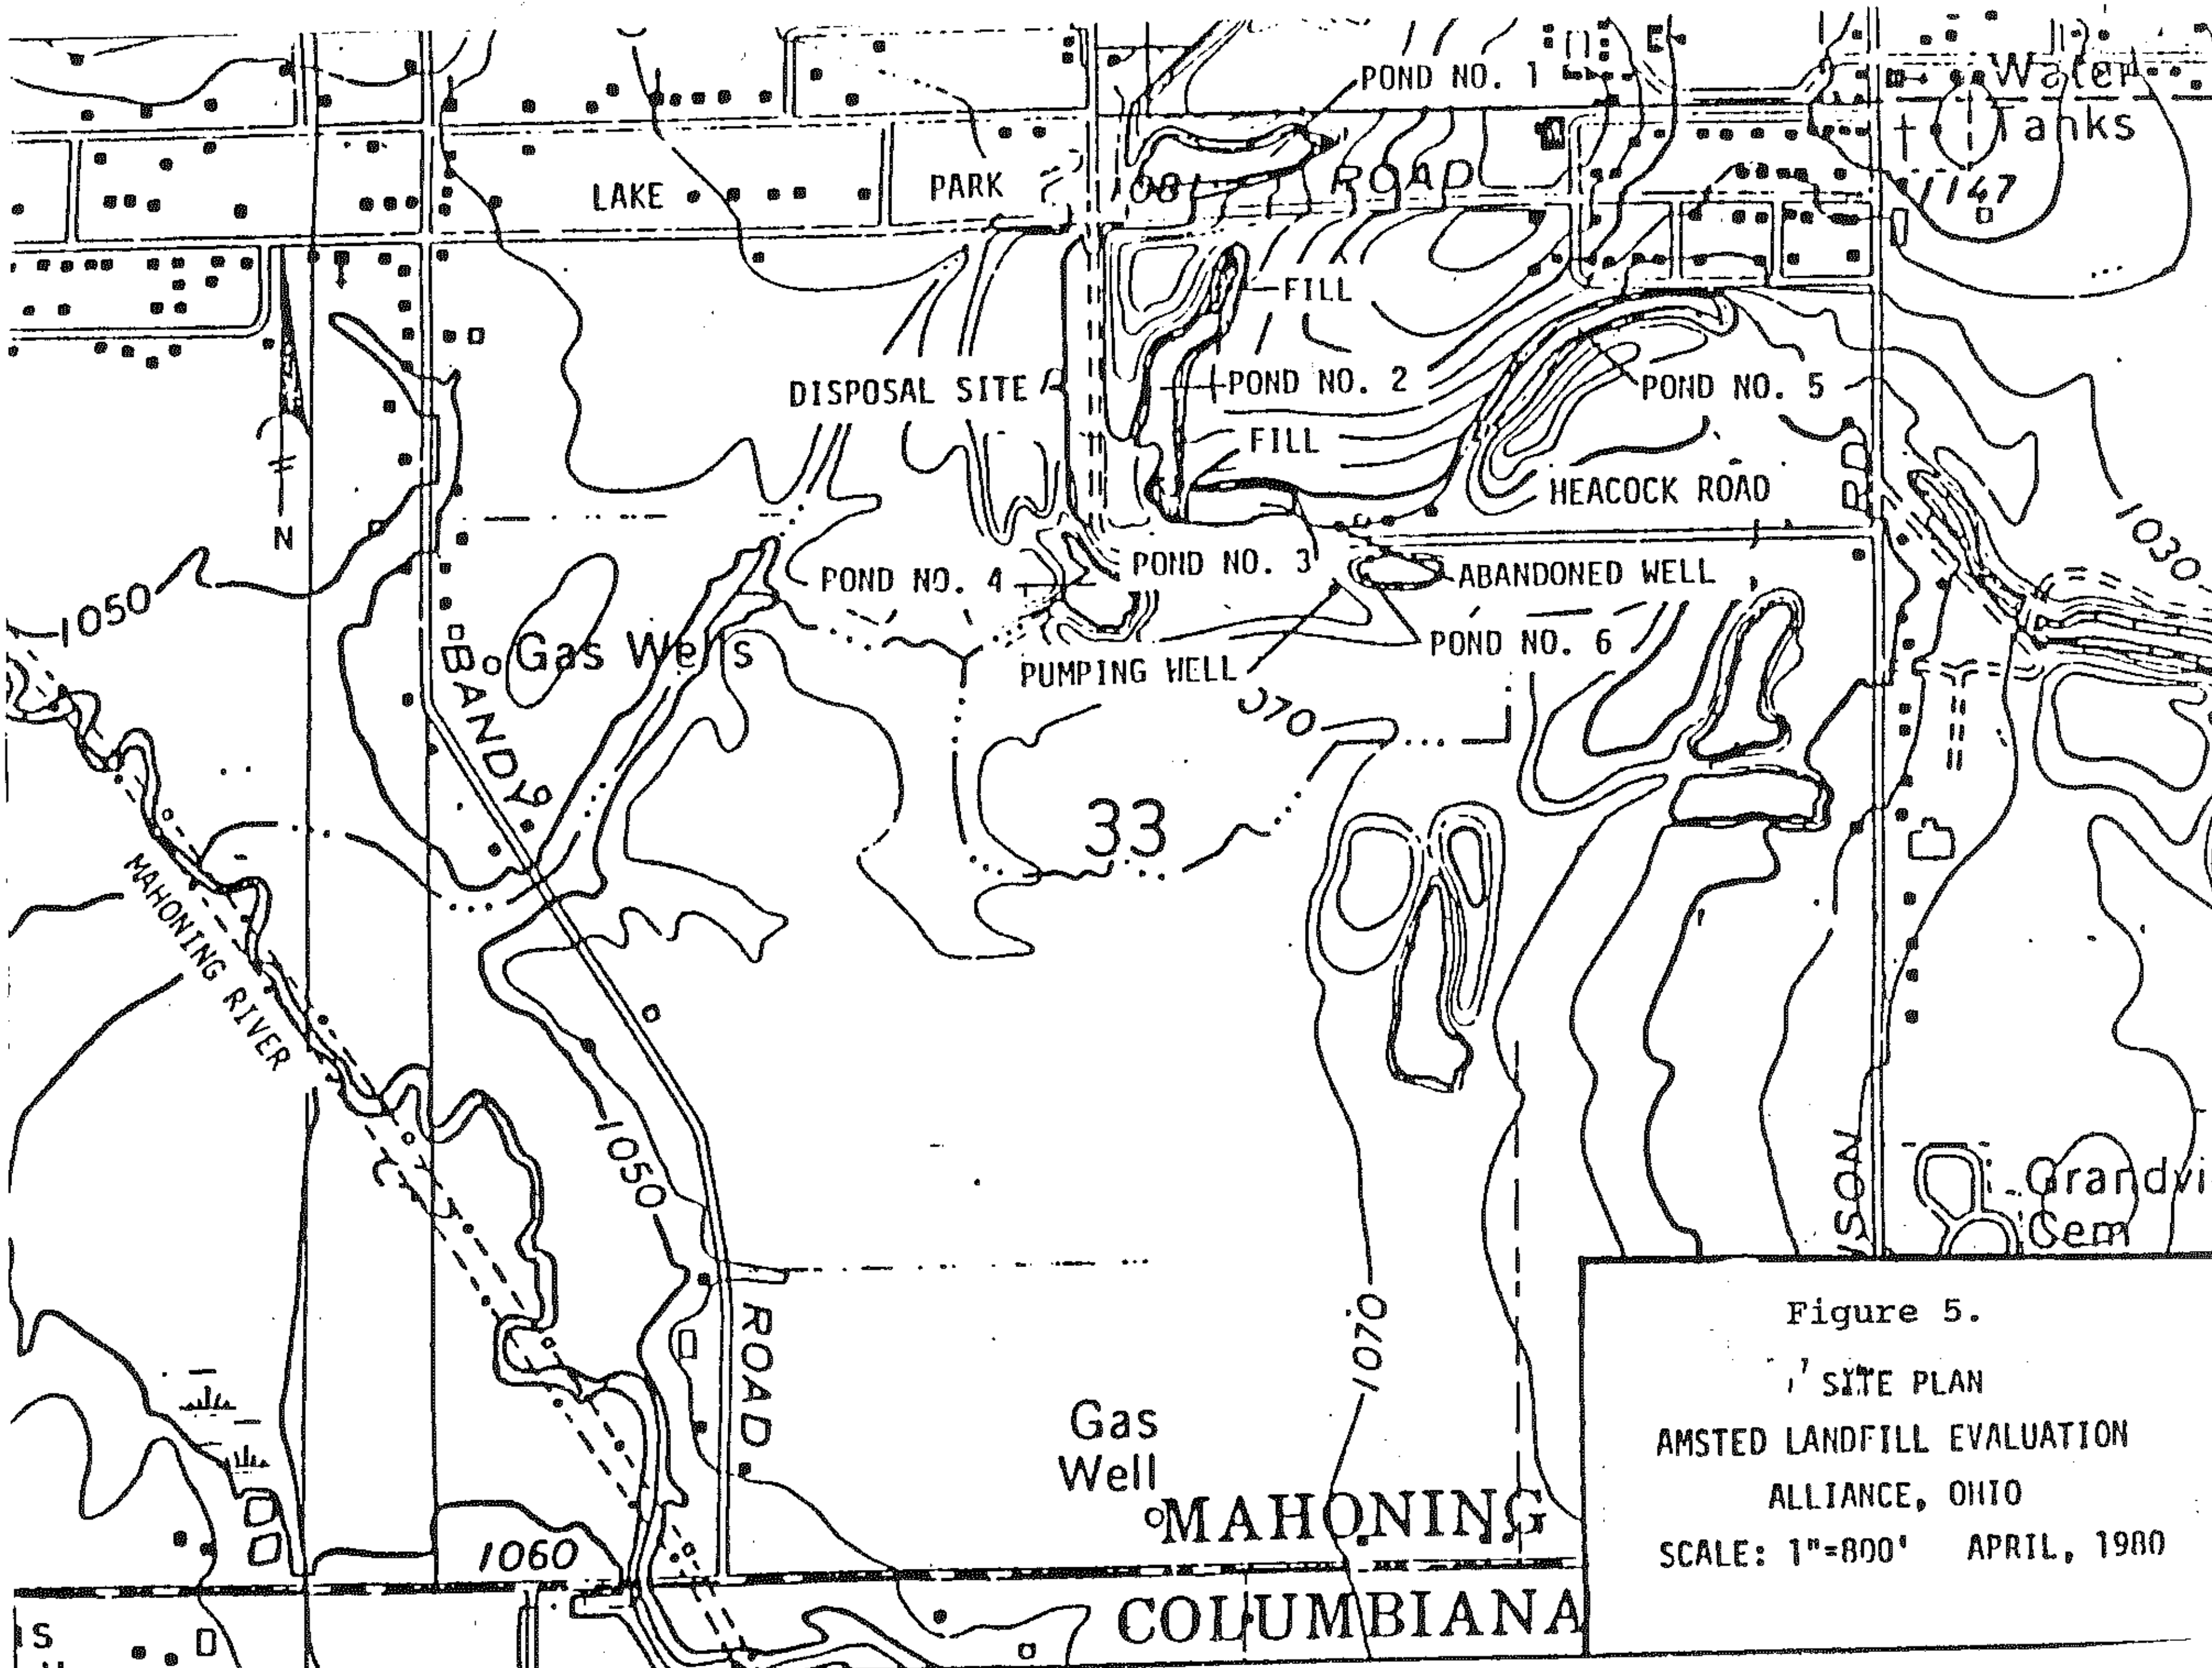
Figure 5.

These "ponds" all appear to be hydraulically interconnected with each other via local ground waters. The "ponds" all lie in close proximity to one another and all appear to have the same approximate surface water elevation. Static water levels during the initial drilling of wells #2, 3, 4, and 5 were estimated by the consultant to lie at an elevation of approximately 1,070 feet which is the same elevation as the surface waters in the American Steel Foundries site "Pond No. 2", the Tecumseh Trailer Park "Pond No. 3", and the Sebring landfill "Pond No. 4". The coincidence of static water level elevations within the wells with that of the surface ponds indicates that these "ponds" are hydraulically interconnected with ground water.

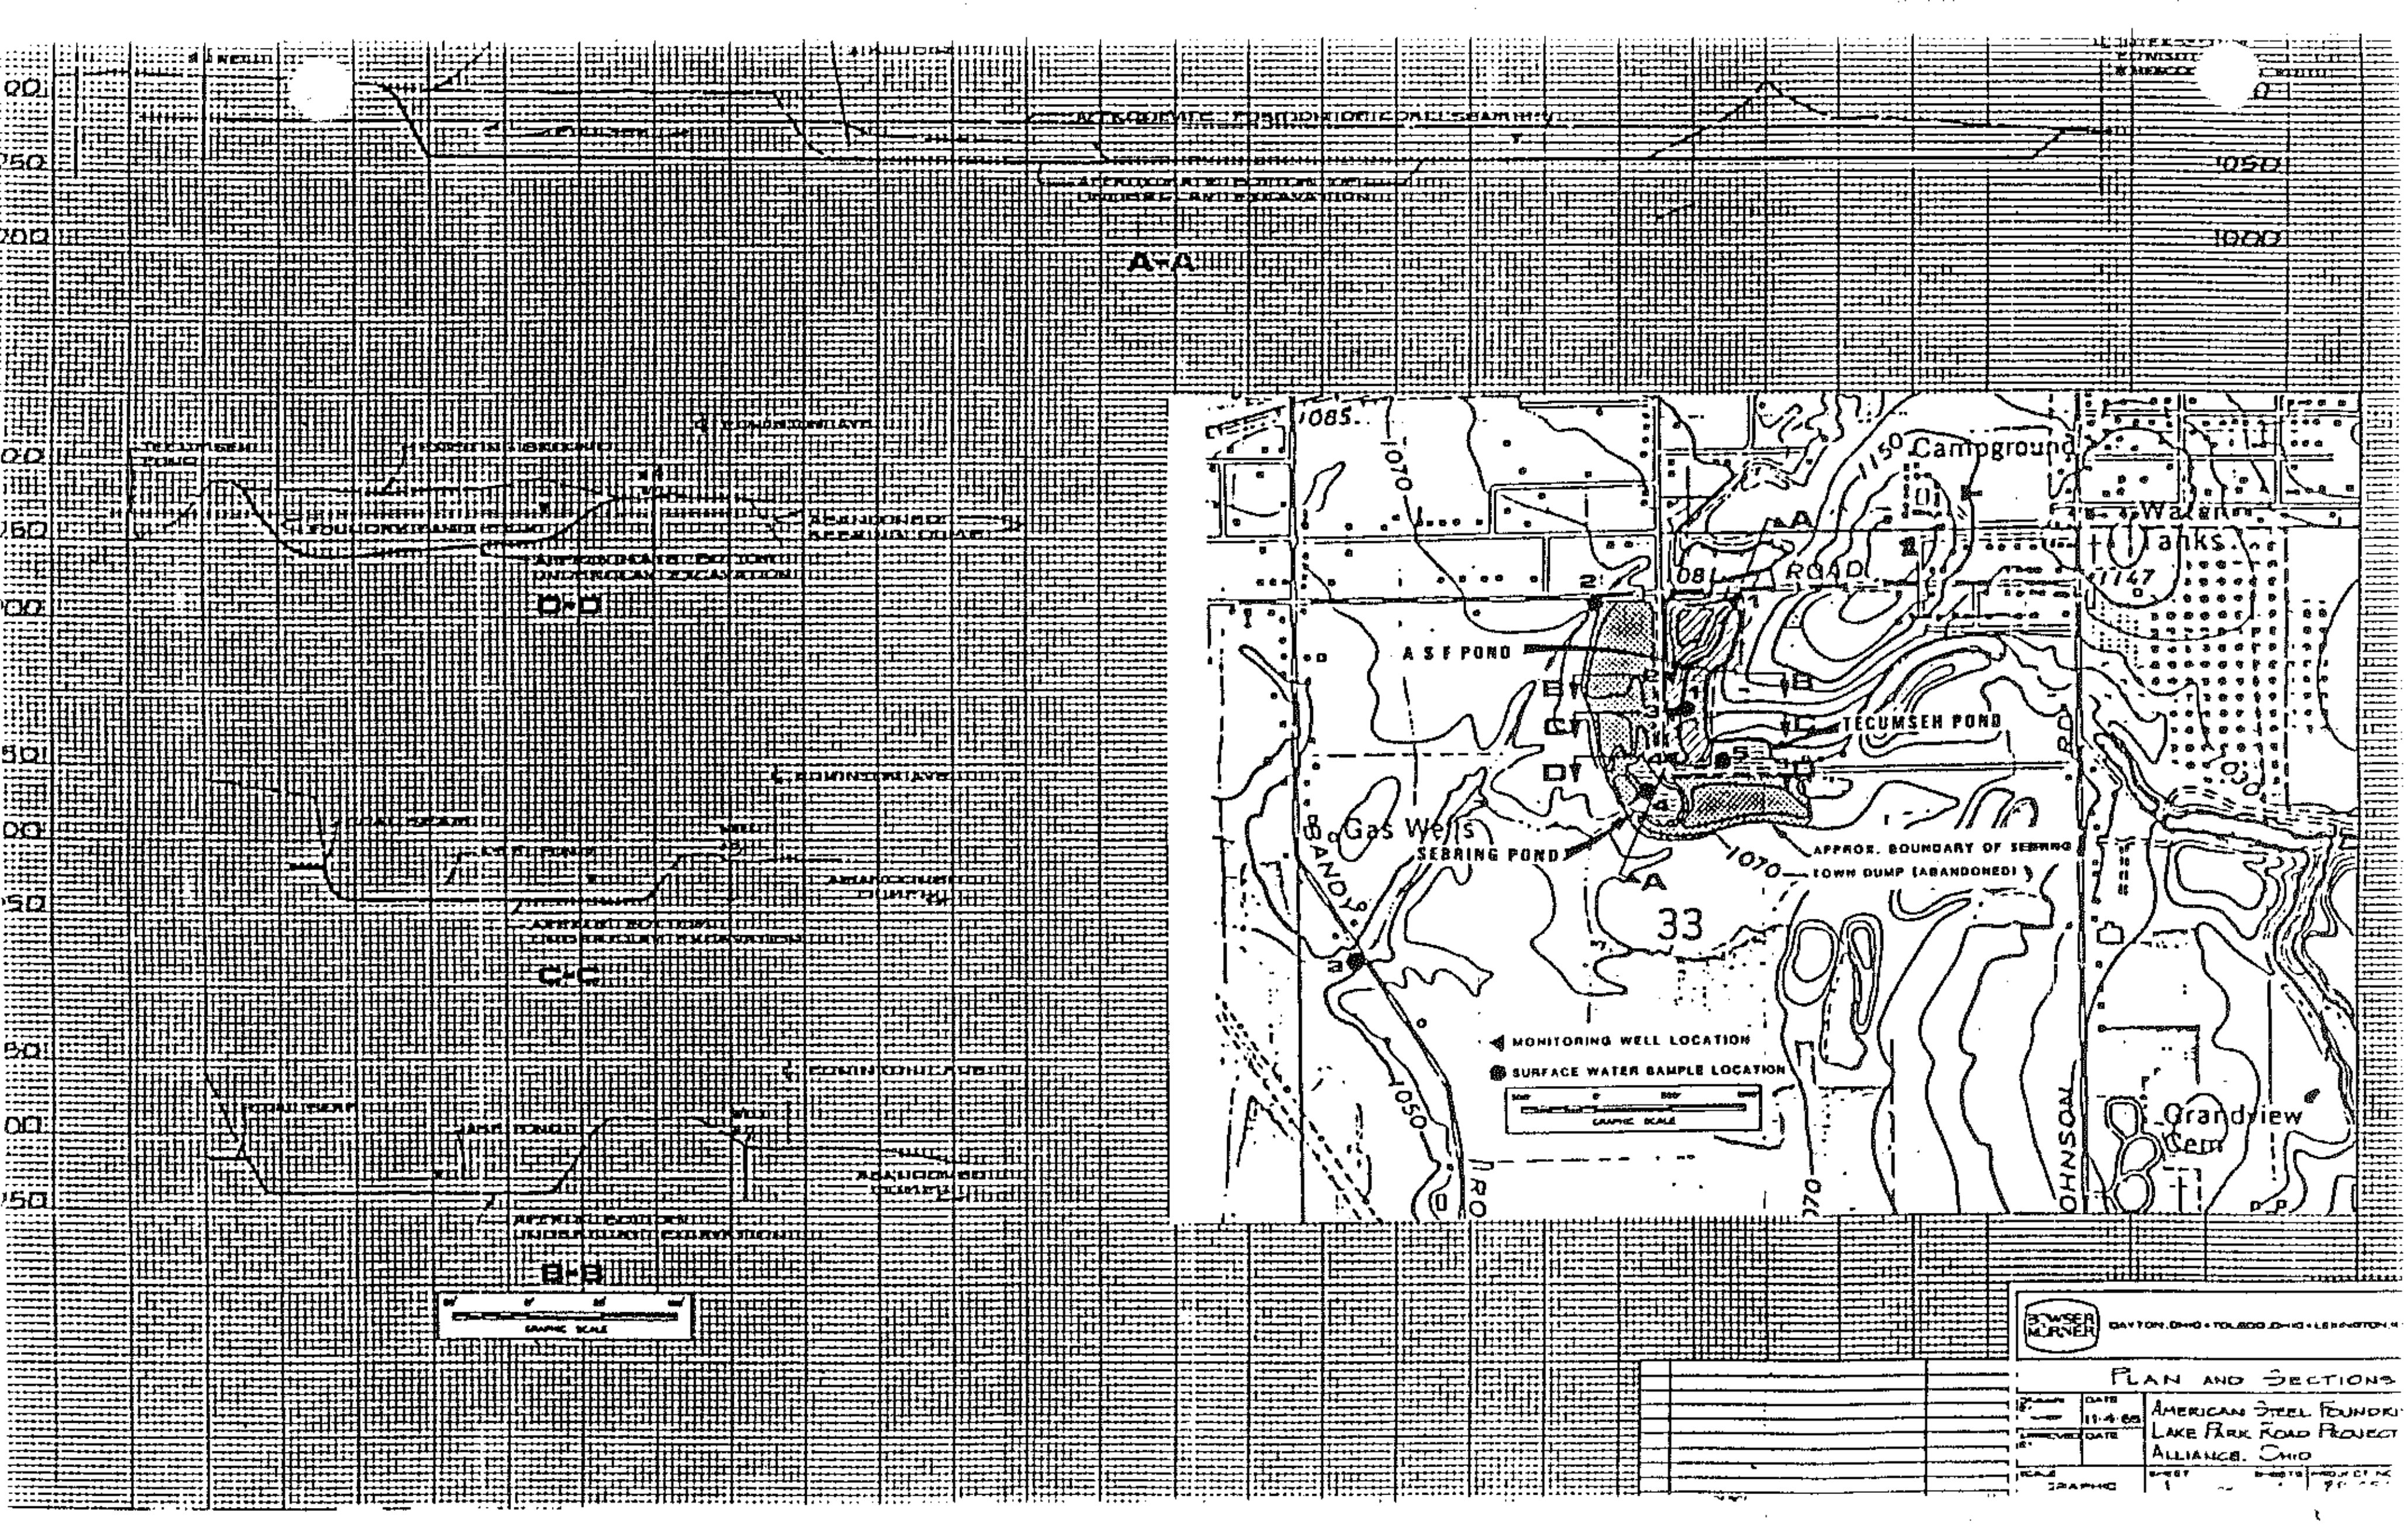
Figure 6.

Geologic cross-sections provided by the consultant are shown as figure 6. Although, these sections show the approximate geometry of the filled pit area they do not explicitly delineate the rock strata and potential aquifers exposed within the strip pit and thus provide only limited information. Screen intervals of the monitor wells should be included on these sections along with a clear indication of the aquifer system being monitored.

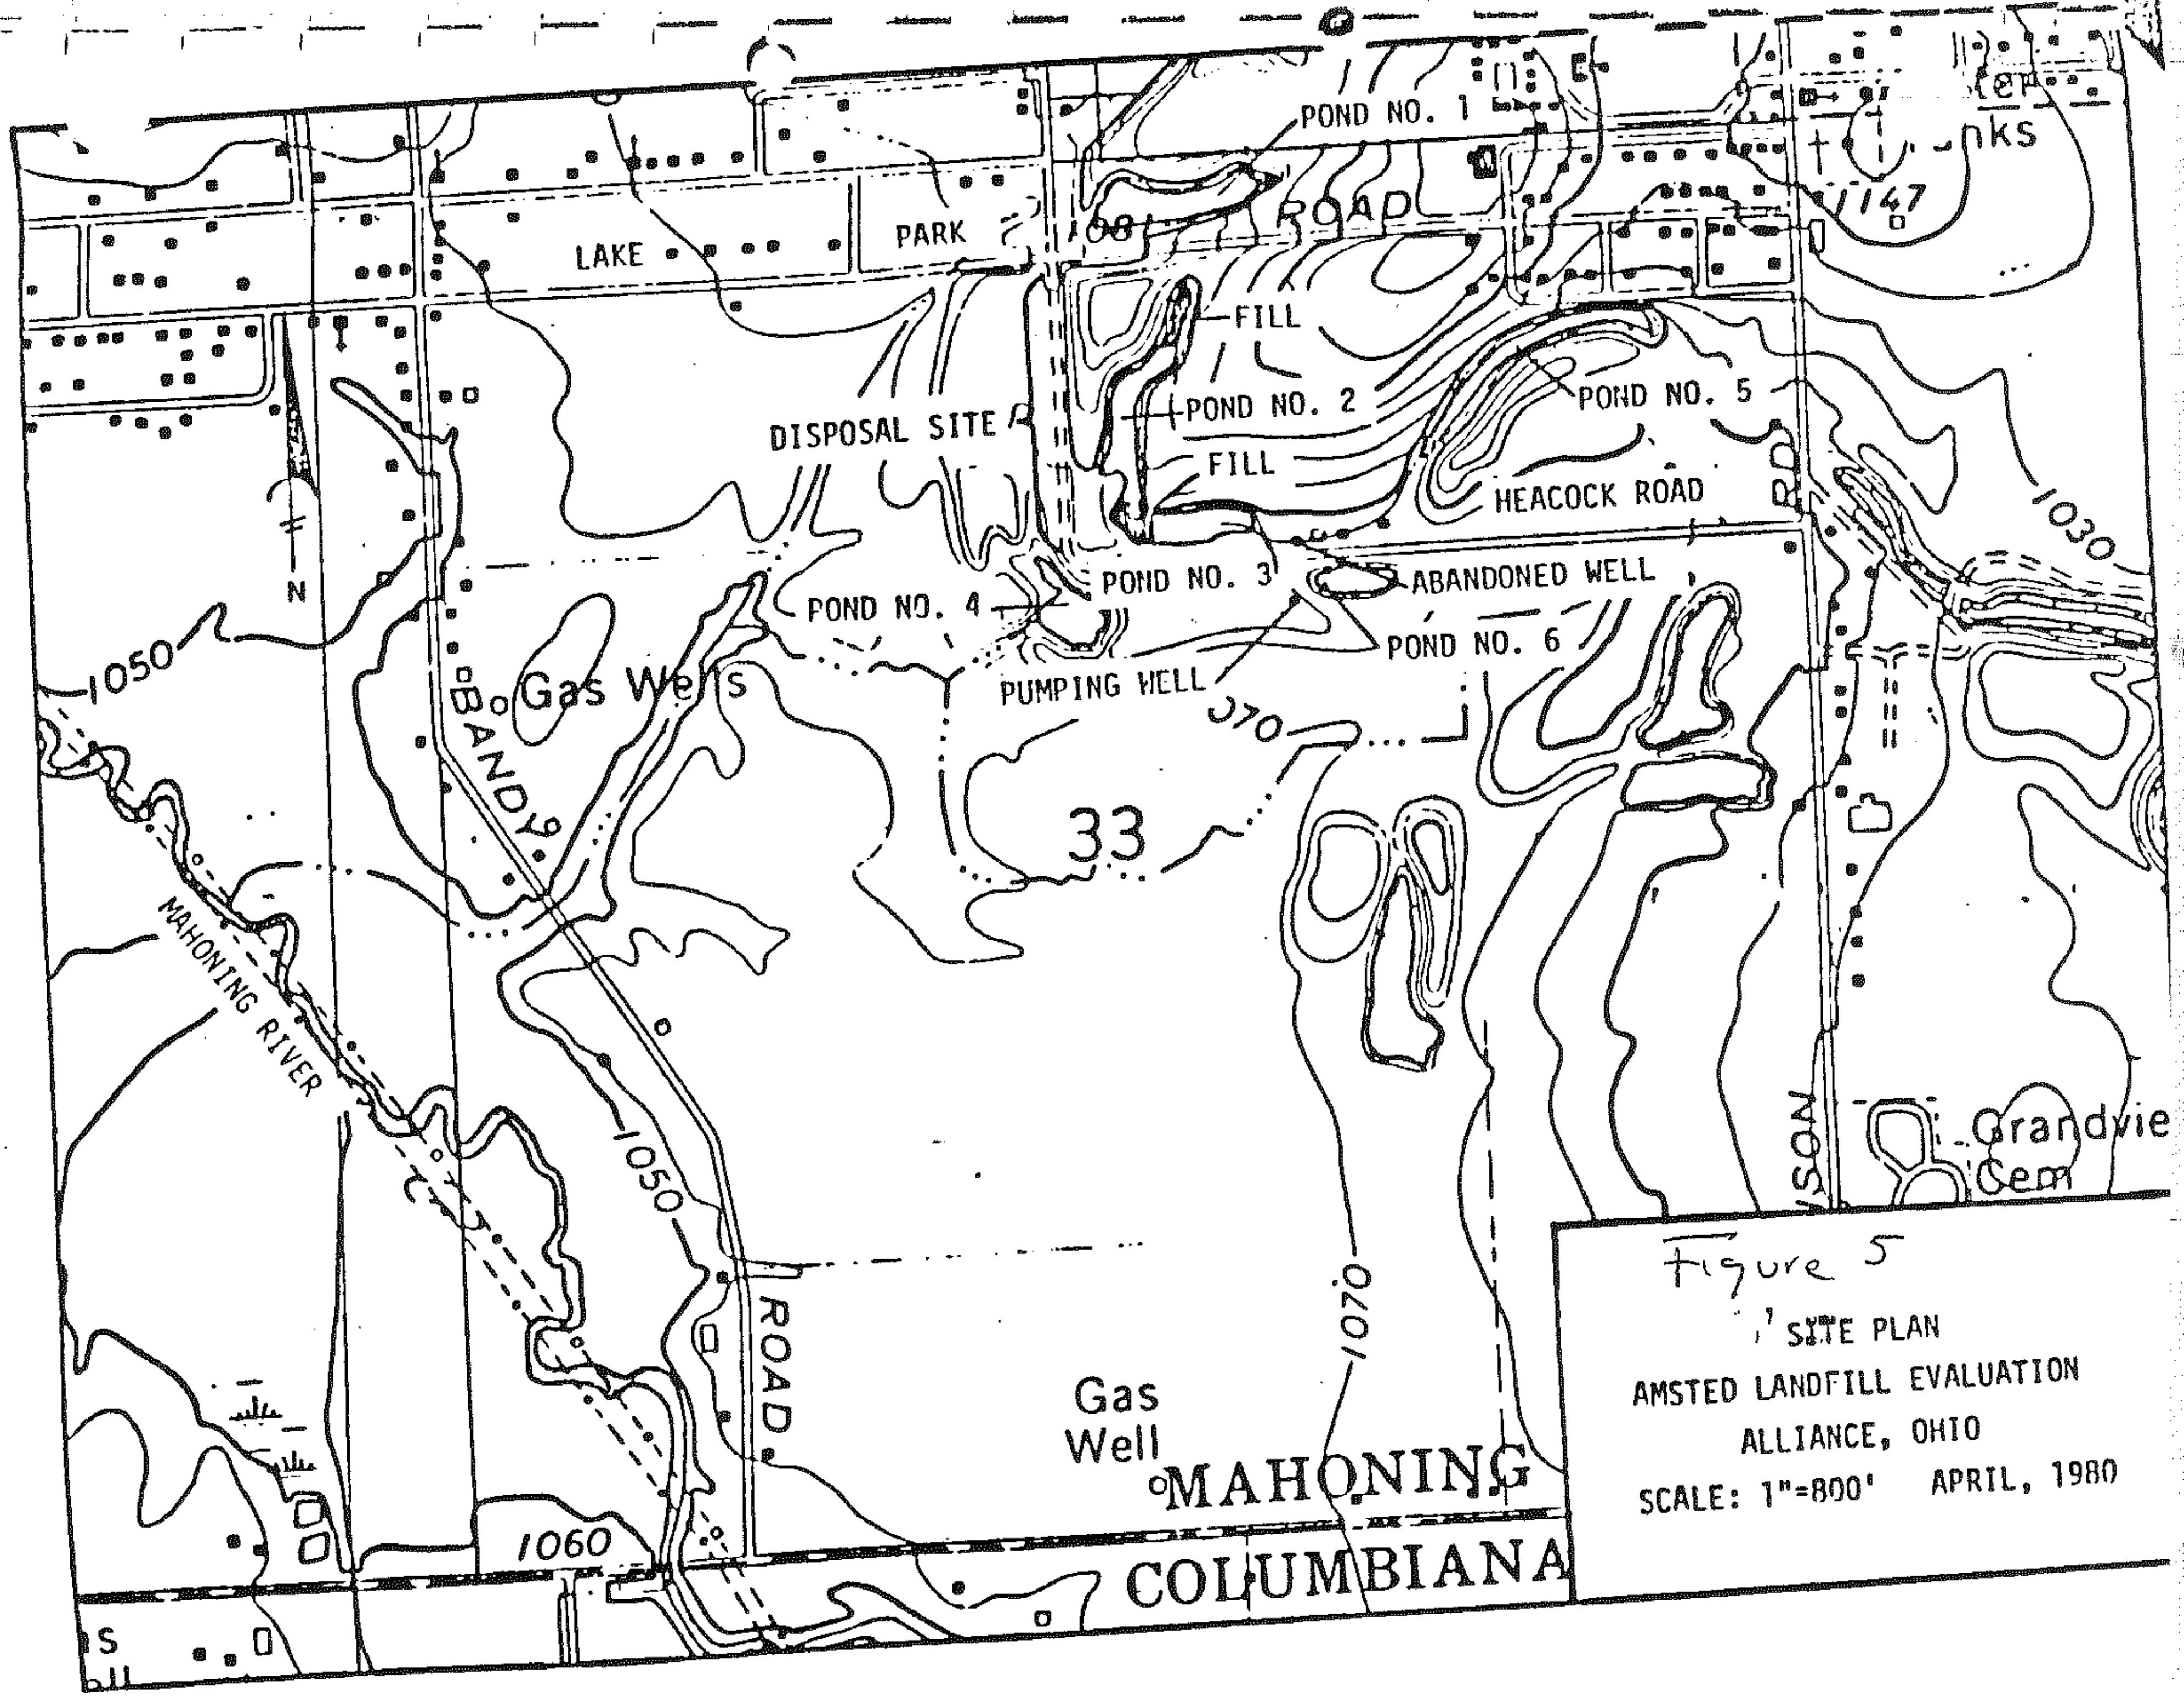
Figure 5

3) "Pond No. 3" - This water body lies immediately east of the ASF disposal pit and southwest of the Tecumseh Trailer Park which lies on the highwall of the former coal strip mine.

4) "Pond No. 4" - This water body is located immediately south of the ASF disposal "Pond No. 2 " and southwest of "Pond No. 3". This water body lies immediately south of the ASF property line along Edwinton Avenue and Heacock Roads. It is located within the old City of Sebring landfill.

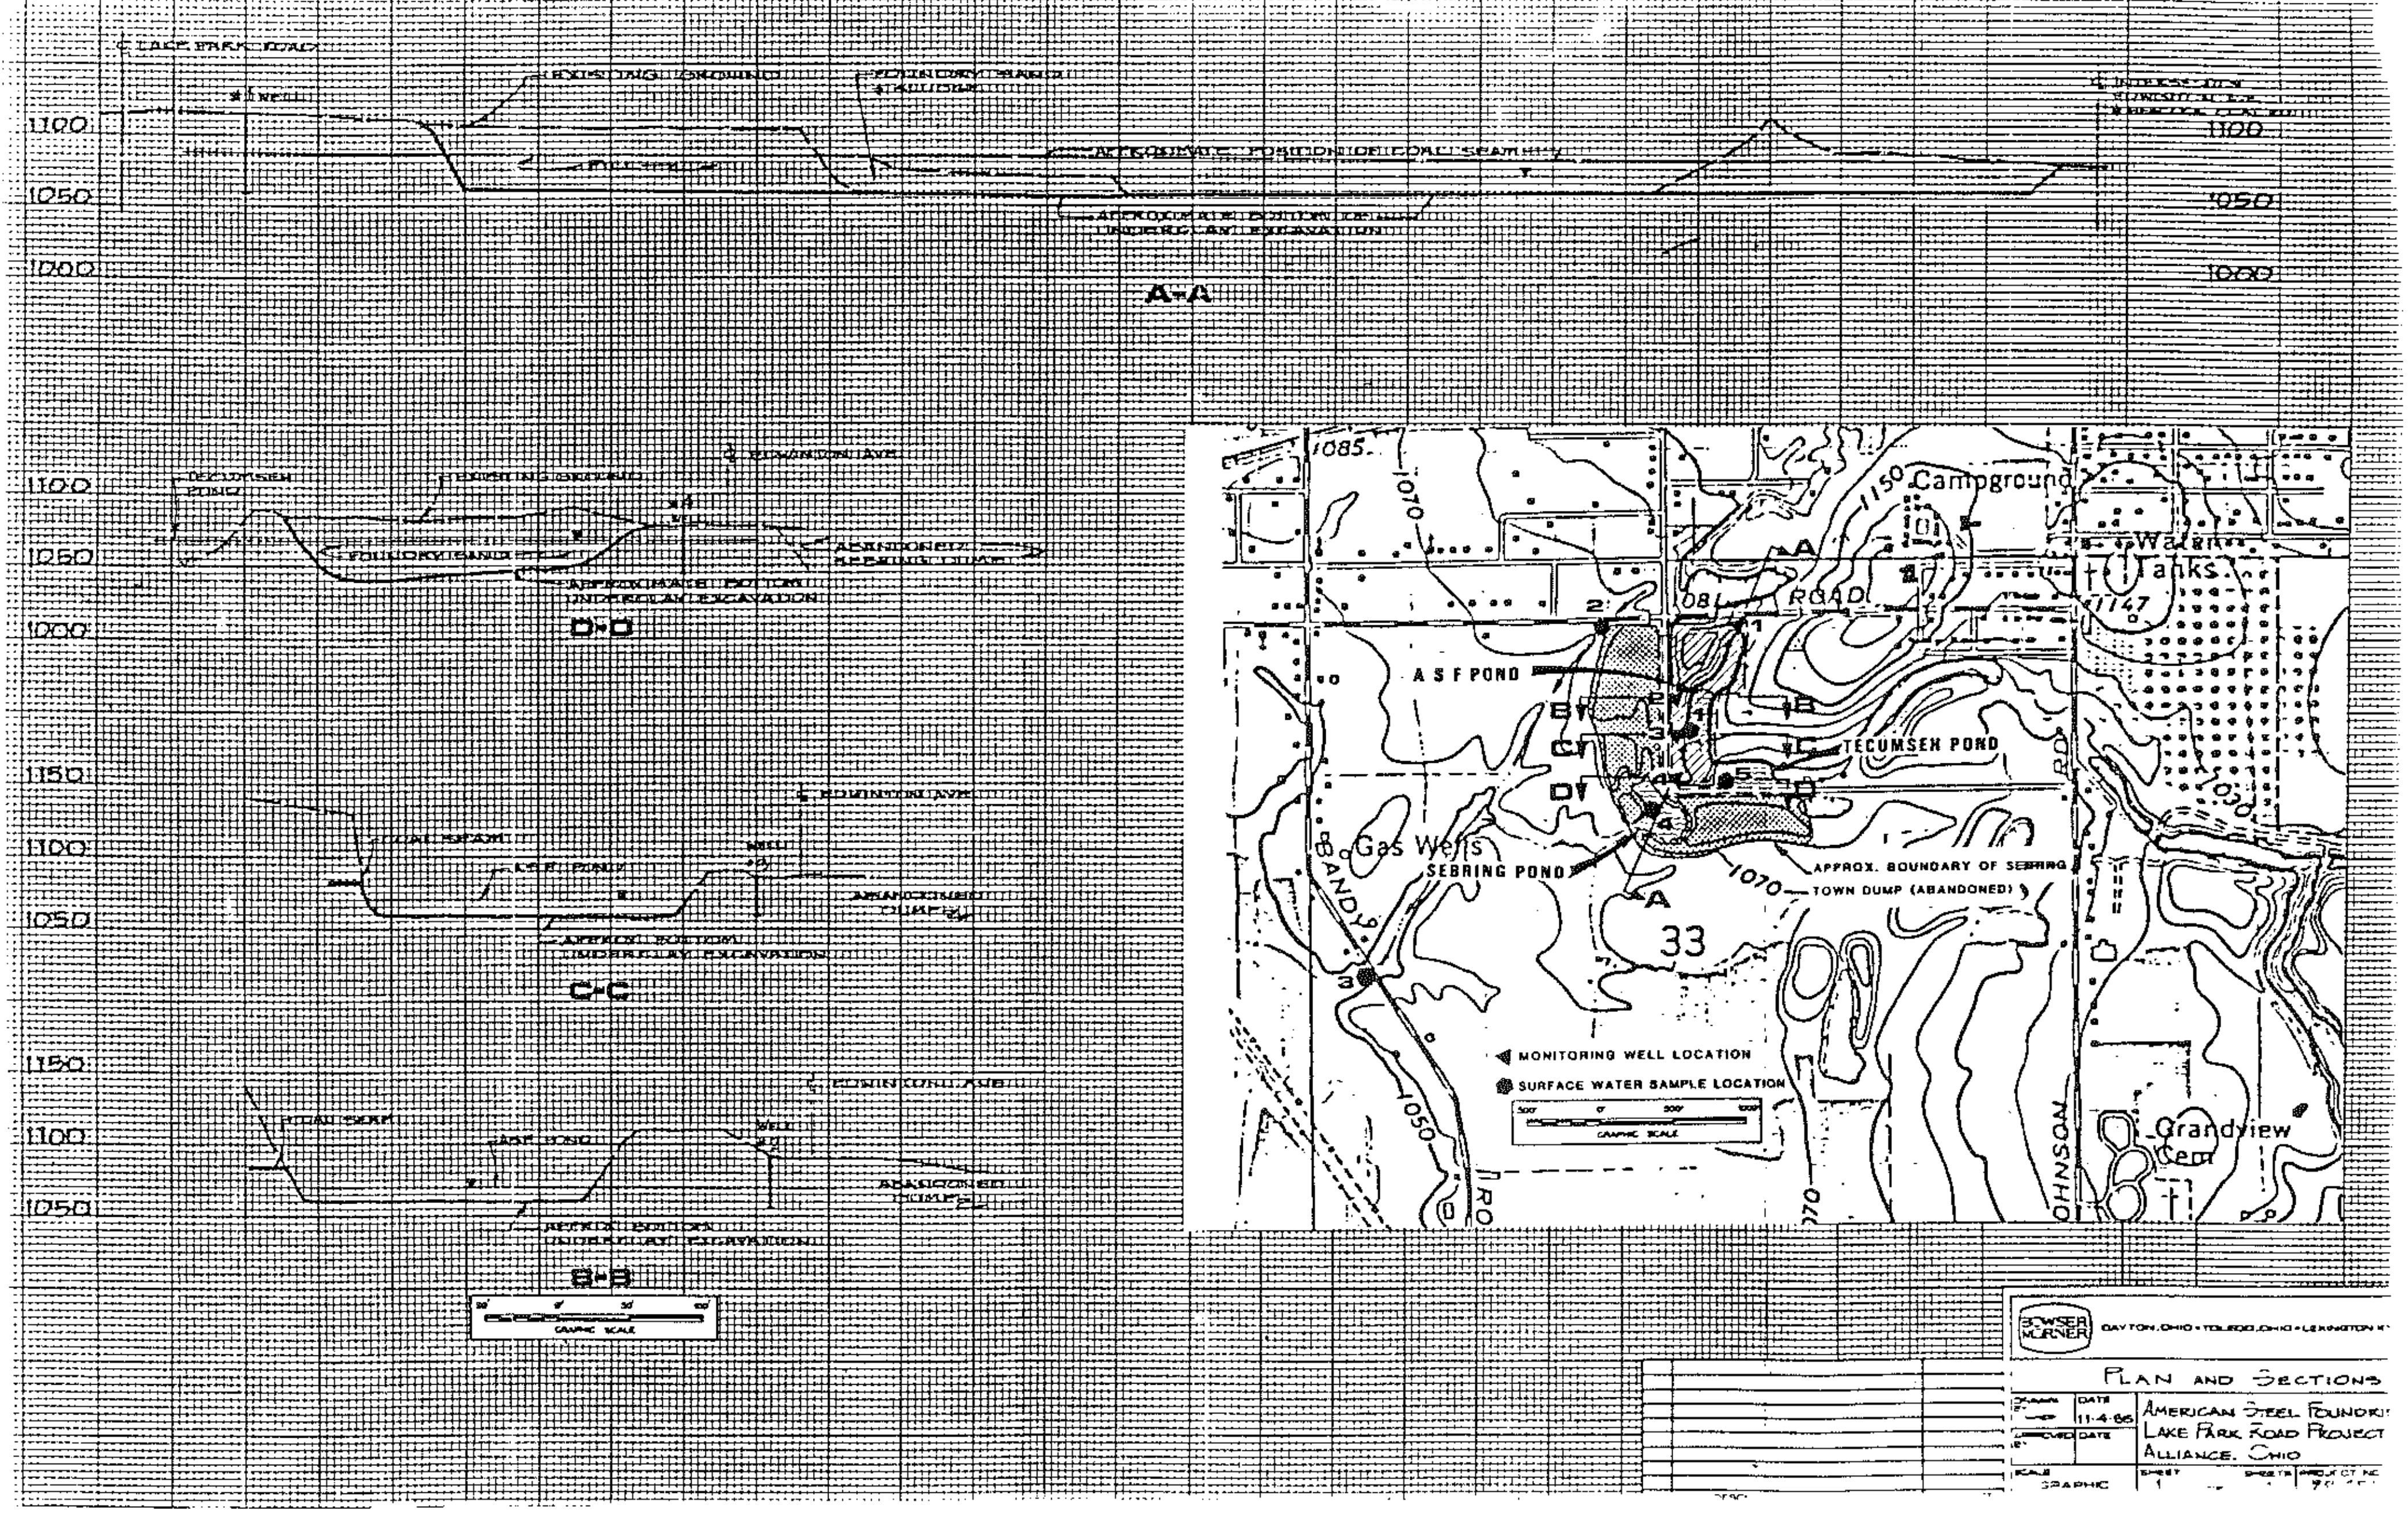
Figure 6

Geologic cross-sections provided by the consultant are shown as Figure 6. Although, these sections show the approximate geometry of the filled pit area they do not explicitly delineate the rock strata and potential aquifers exposed within the strip pit and thus provide only limited information. Screen intervals of the monitor wells should be included on these sections along with a clear indication of the the aquifer system being monitored.
