FINAL COMPLETION REPORT
PCB AND ASBESTOS ABATEMENT AND DISPOSAL

THE AGASSIZ ELEMENTARY SCHOOL
EXTERIOR WINDOWS AND DOORWAYS
JAMAICA PLAIN, MASSACHUSETTS

JULY 13, 2010

ATC Project No. 60.03187.0024

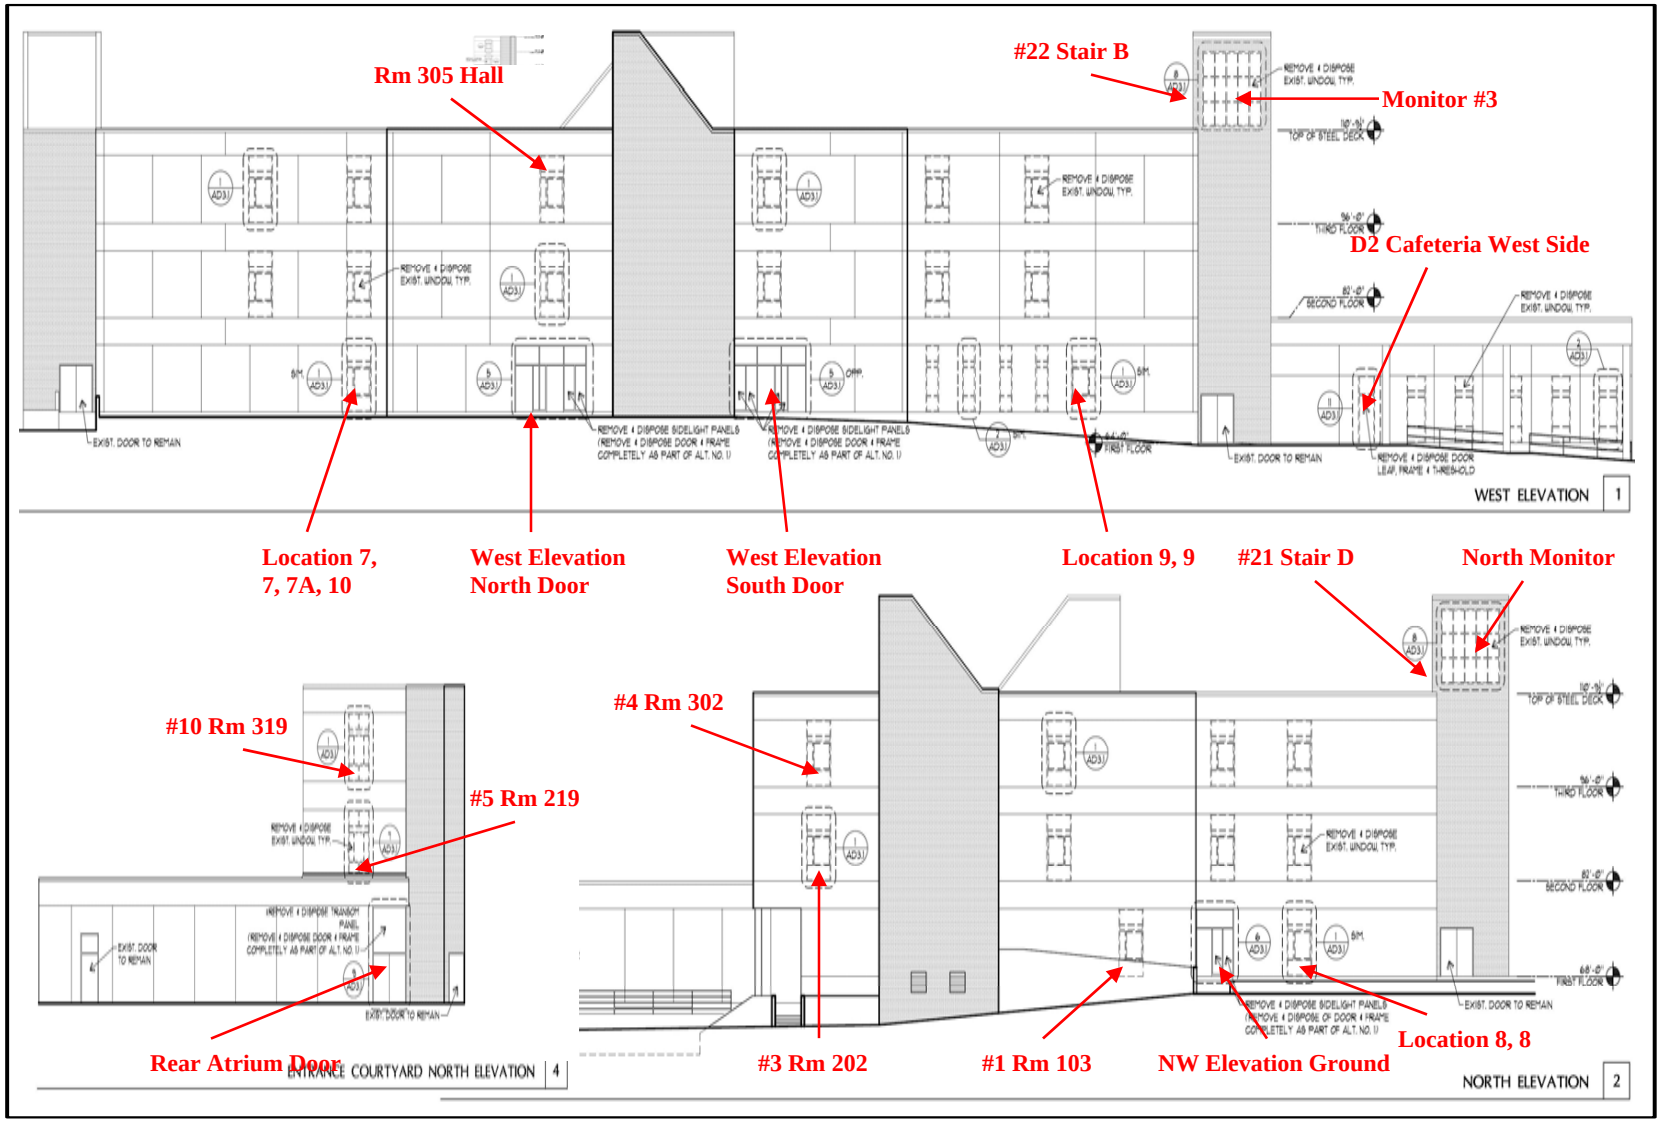
West & North Elevation Sample Locations

PCB results are summarized in the attached Table 1. The Exterior Demolition Elevation Drawings found in Appendix A show the approximate sampling location. A copy of the PCB and TCLP laboratory analytical results are included in Appendix B. A summary of these results and associated analytical chains of custody and laboratory quality control/quality assurance checks were presented to CSS in ATC's *PCB in Caulk and Glazing Evaluation* letter report dated November 16, 2009.
