UNITED STATES ENVIRONMENTAL PROTECTION AGENCY

SUBJECT: Preliminary Inspection, American Walnut Company
Kansas City, Kansas

AMERICAN WALNUT CO.
Preliminary Site Inspection Report

Prepared by
Gary B. Snodgrass
Emergency Planning and Response Branch

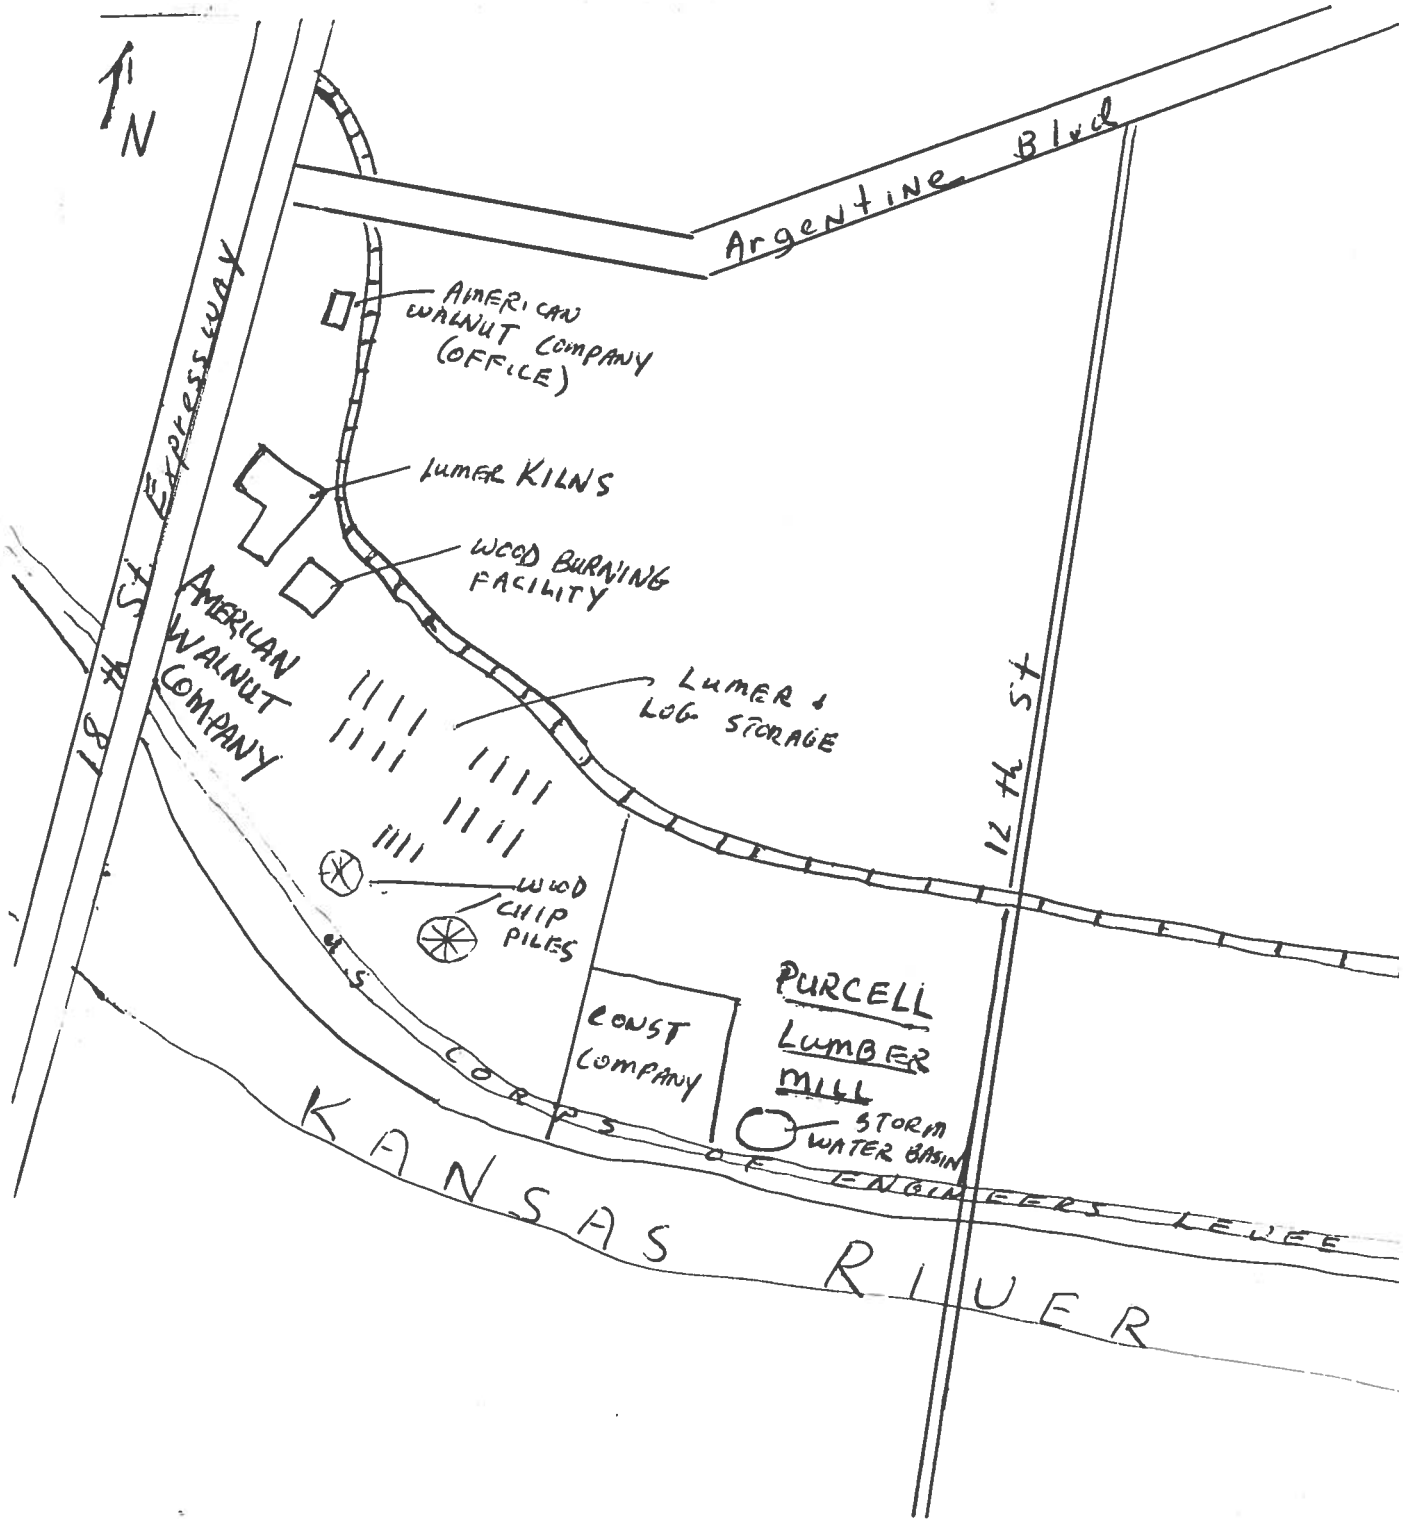
N
Argentine Blvd
18th St Expressway
12th St
AMERICAN WALNUT COMPANY (OFFICE)
LUMER KILNS
WOOD BURNING FACILITY
AMERICAN WALNUT COMPANY
LUMER & LOG STORAGE
WOOD CHIP PILES
CONST COMPANY
PURCELL LUMBER MILL
STORM WATER BASIN
U.S. CORPS OF ENGINEERS LEVEE
KANSAS RIVER

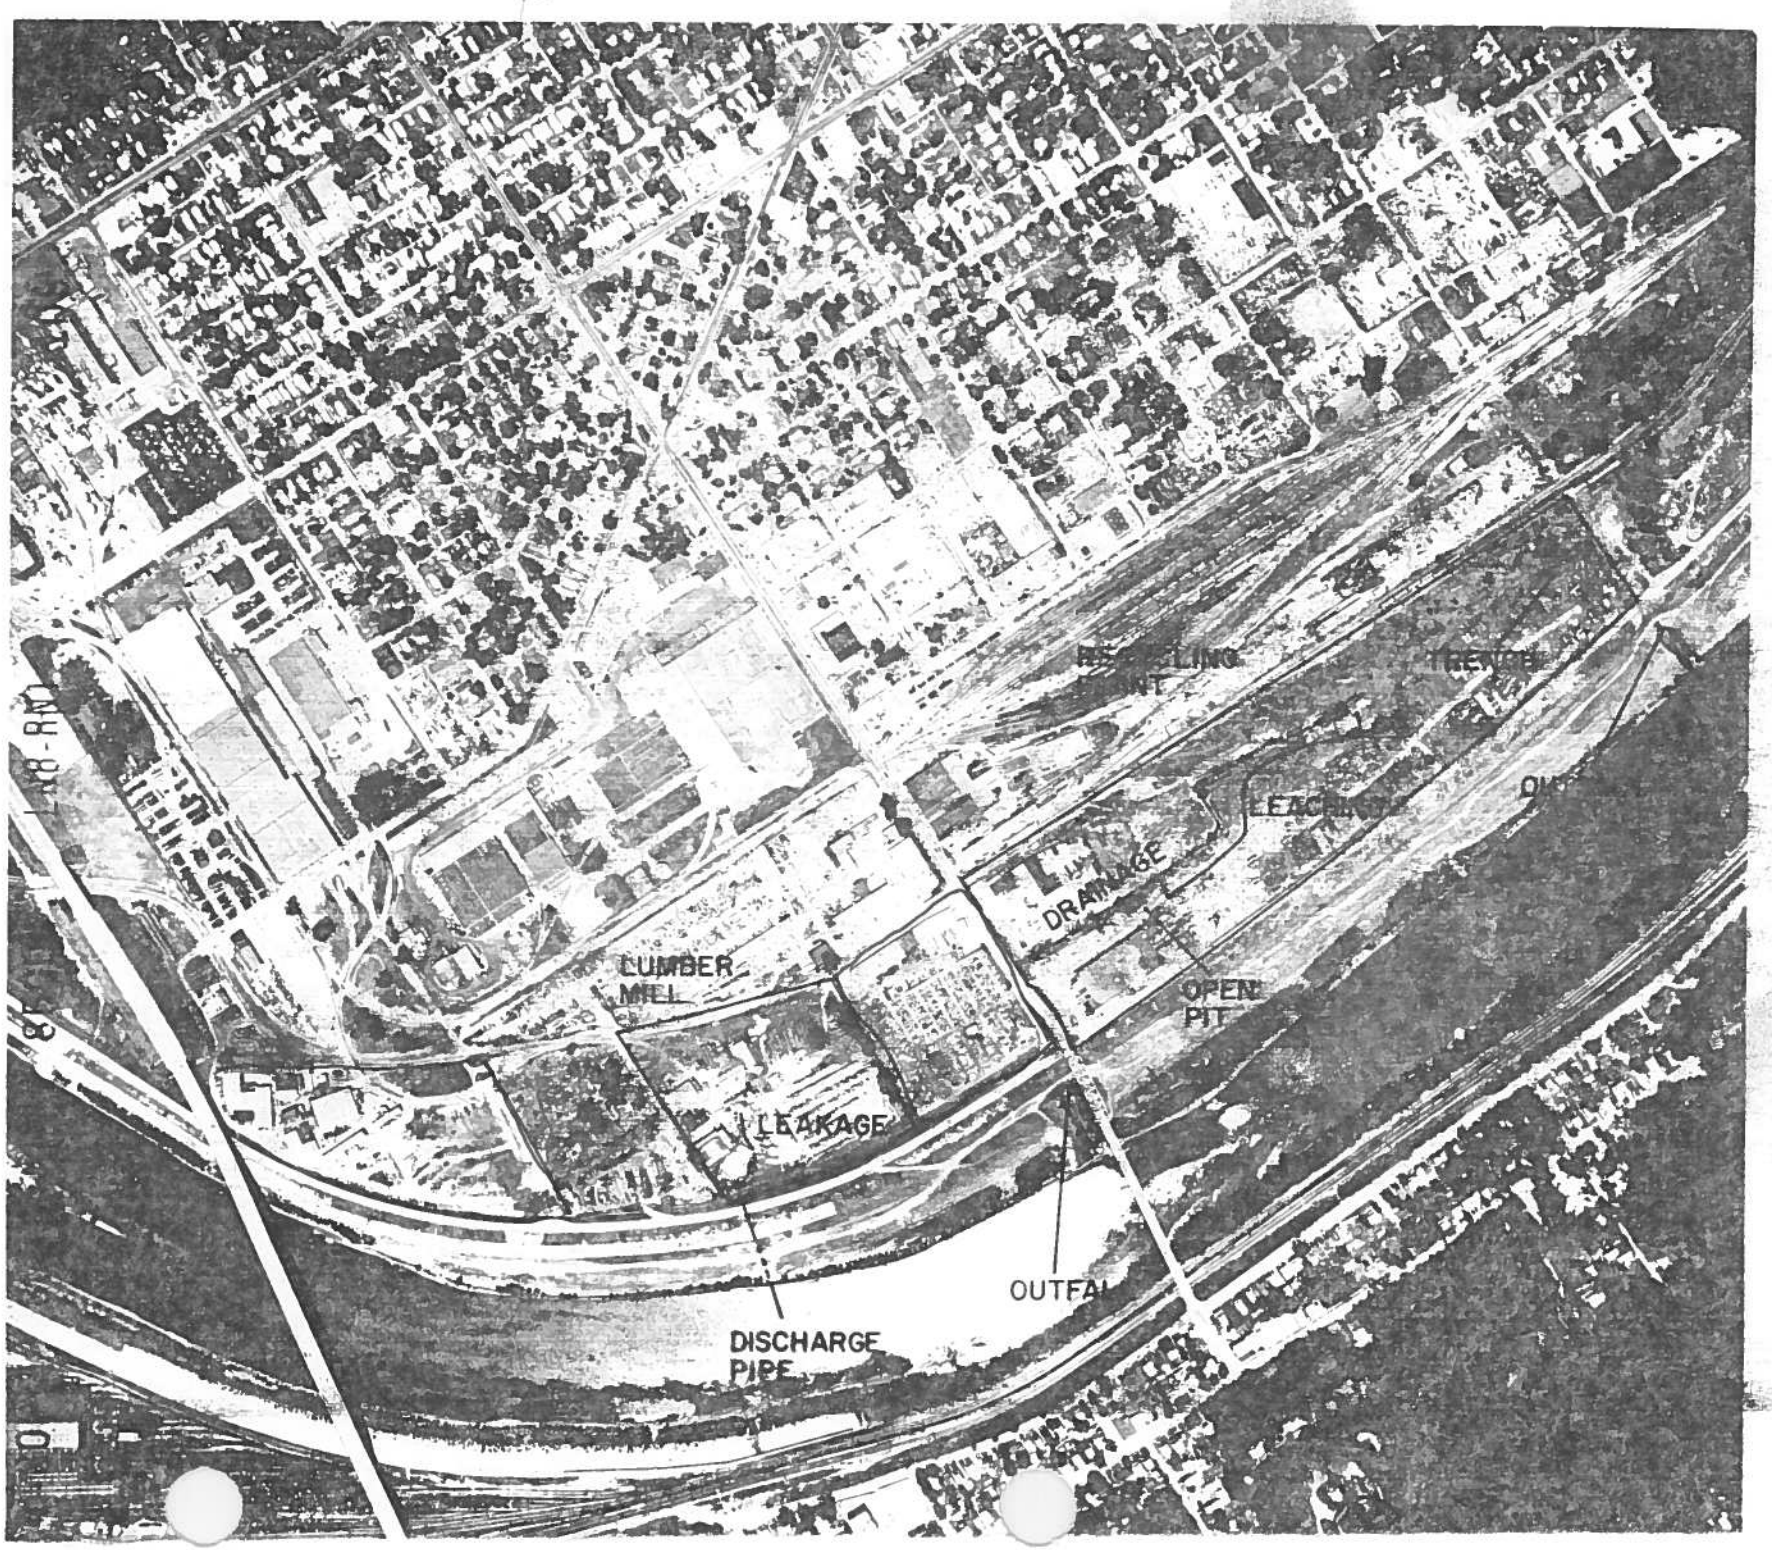
On the southwest edge of the lumber mill property there was a larger holding basin (approximately 10,000 gallon capacity) with standing liquid inside. Connected to the basin was a 3 1/2" - 4" PVC pipe which ran to the south through the Corps of Engineers levee and into the Kansas River.

LUMBER MILL
LEAKAGE
DISCHARGE PIPE
OUTFAL
DRAINAGE
OPEN PIT
