Appendix E
Photograph Log

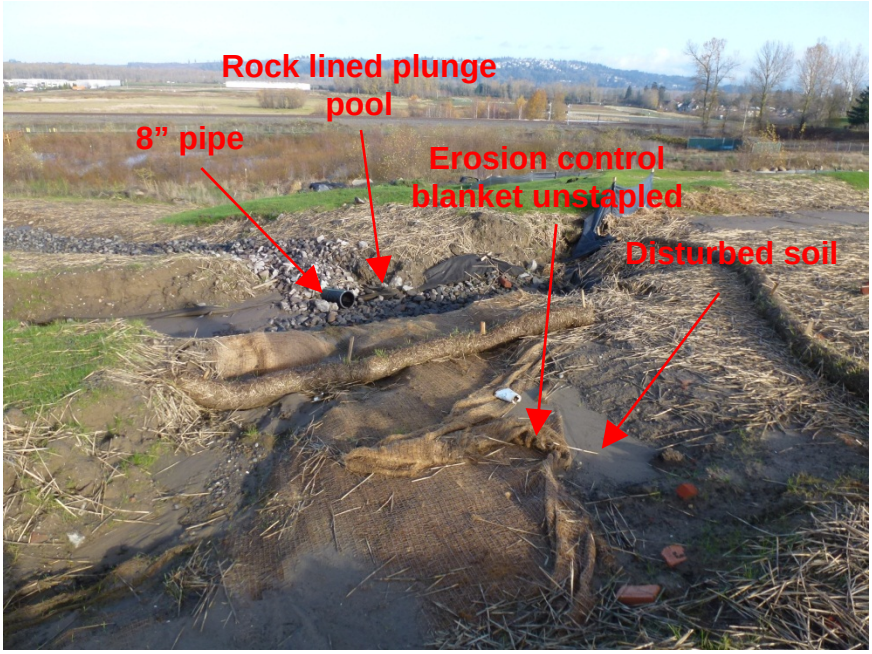
Photograph 4. Sandy Boulevard Open Fill Site – View facing west of erosion control blanket-lined trench in the central area of the site. Note erosion where the erosion control blanket is out of place.
