SAMPLE LOCATION DRAWINGS

SCHOOL: H.D. COOKE ELEM. SCHOOL	FLOOR: 3rd. Floor
OTHER: ANY OTHER NOTES	DRAWING: (A)

APPENDIX A

ASBESTOS SURVEY DATA FORMS

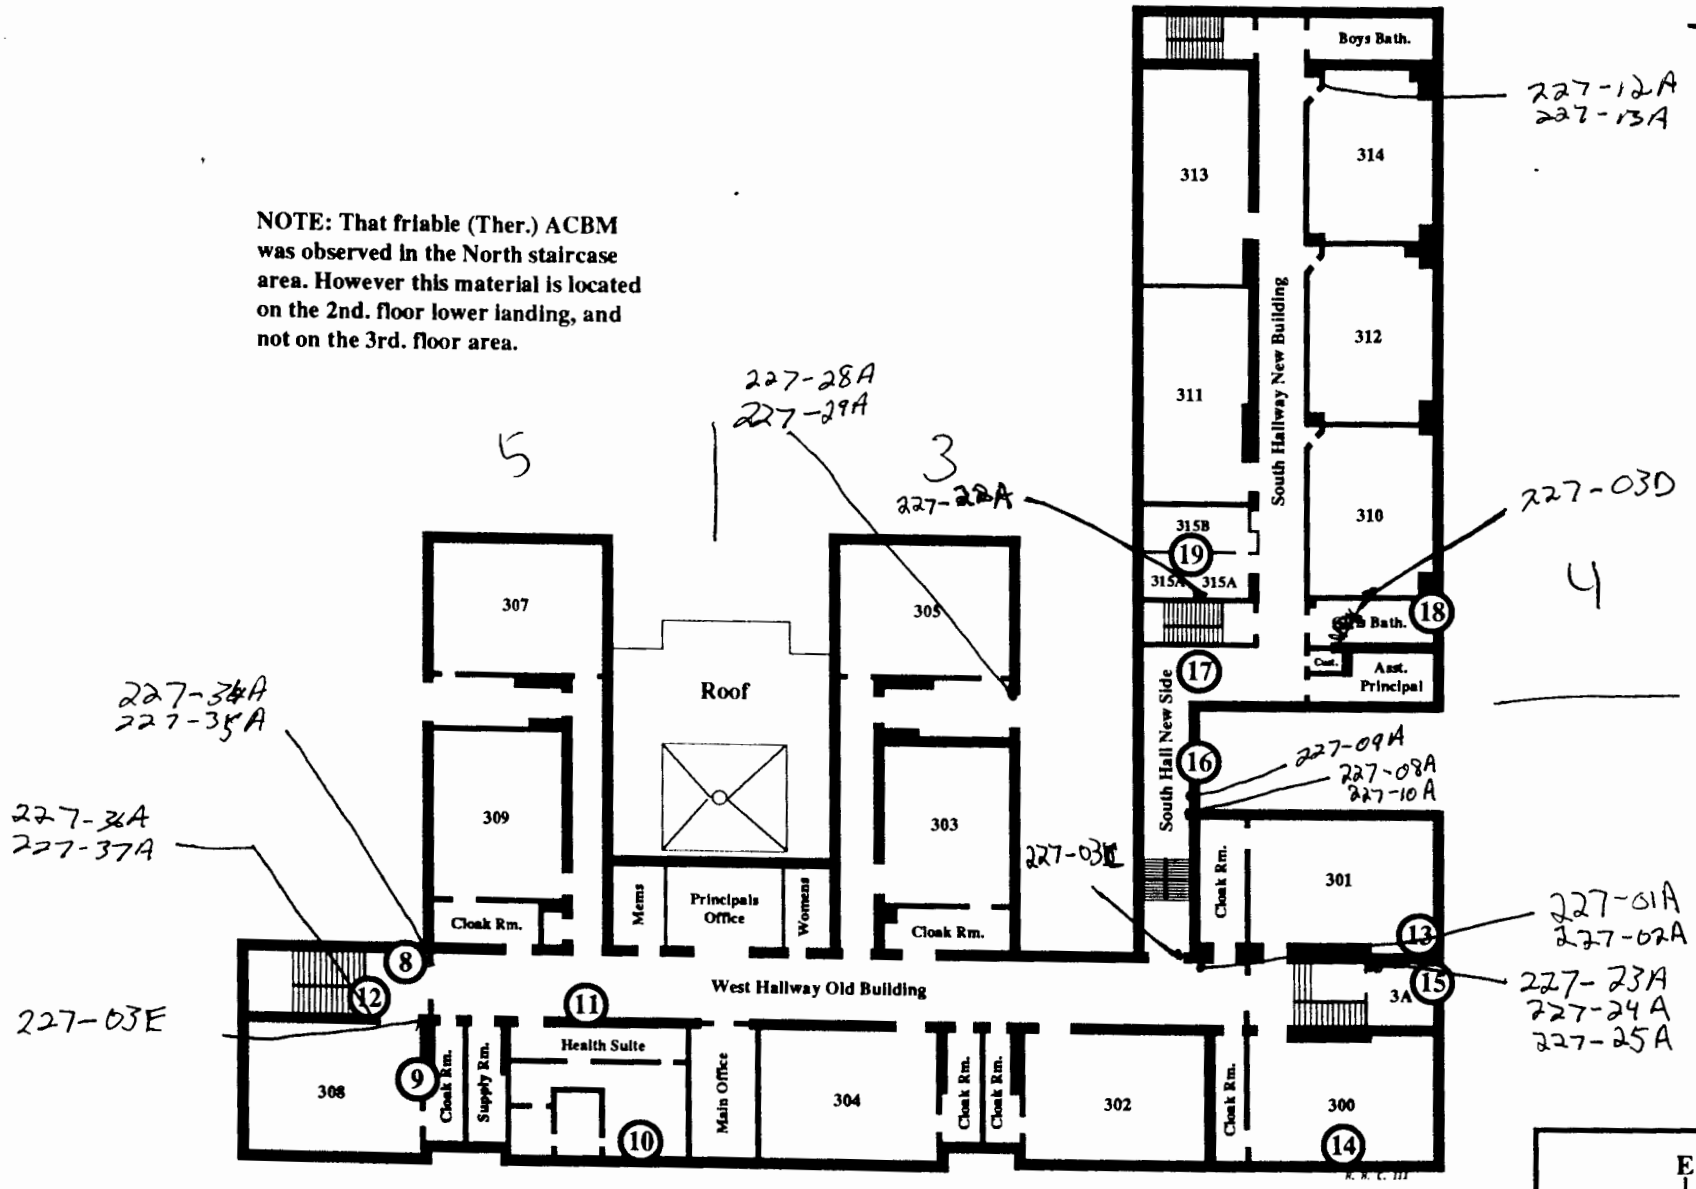
NOTE: That friable (Ther.) ACBM was observed in the North staircase area. However this material is located on the 2nd. floor lower landing, and not on the 3rd. floor area.

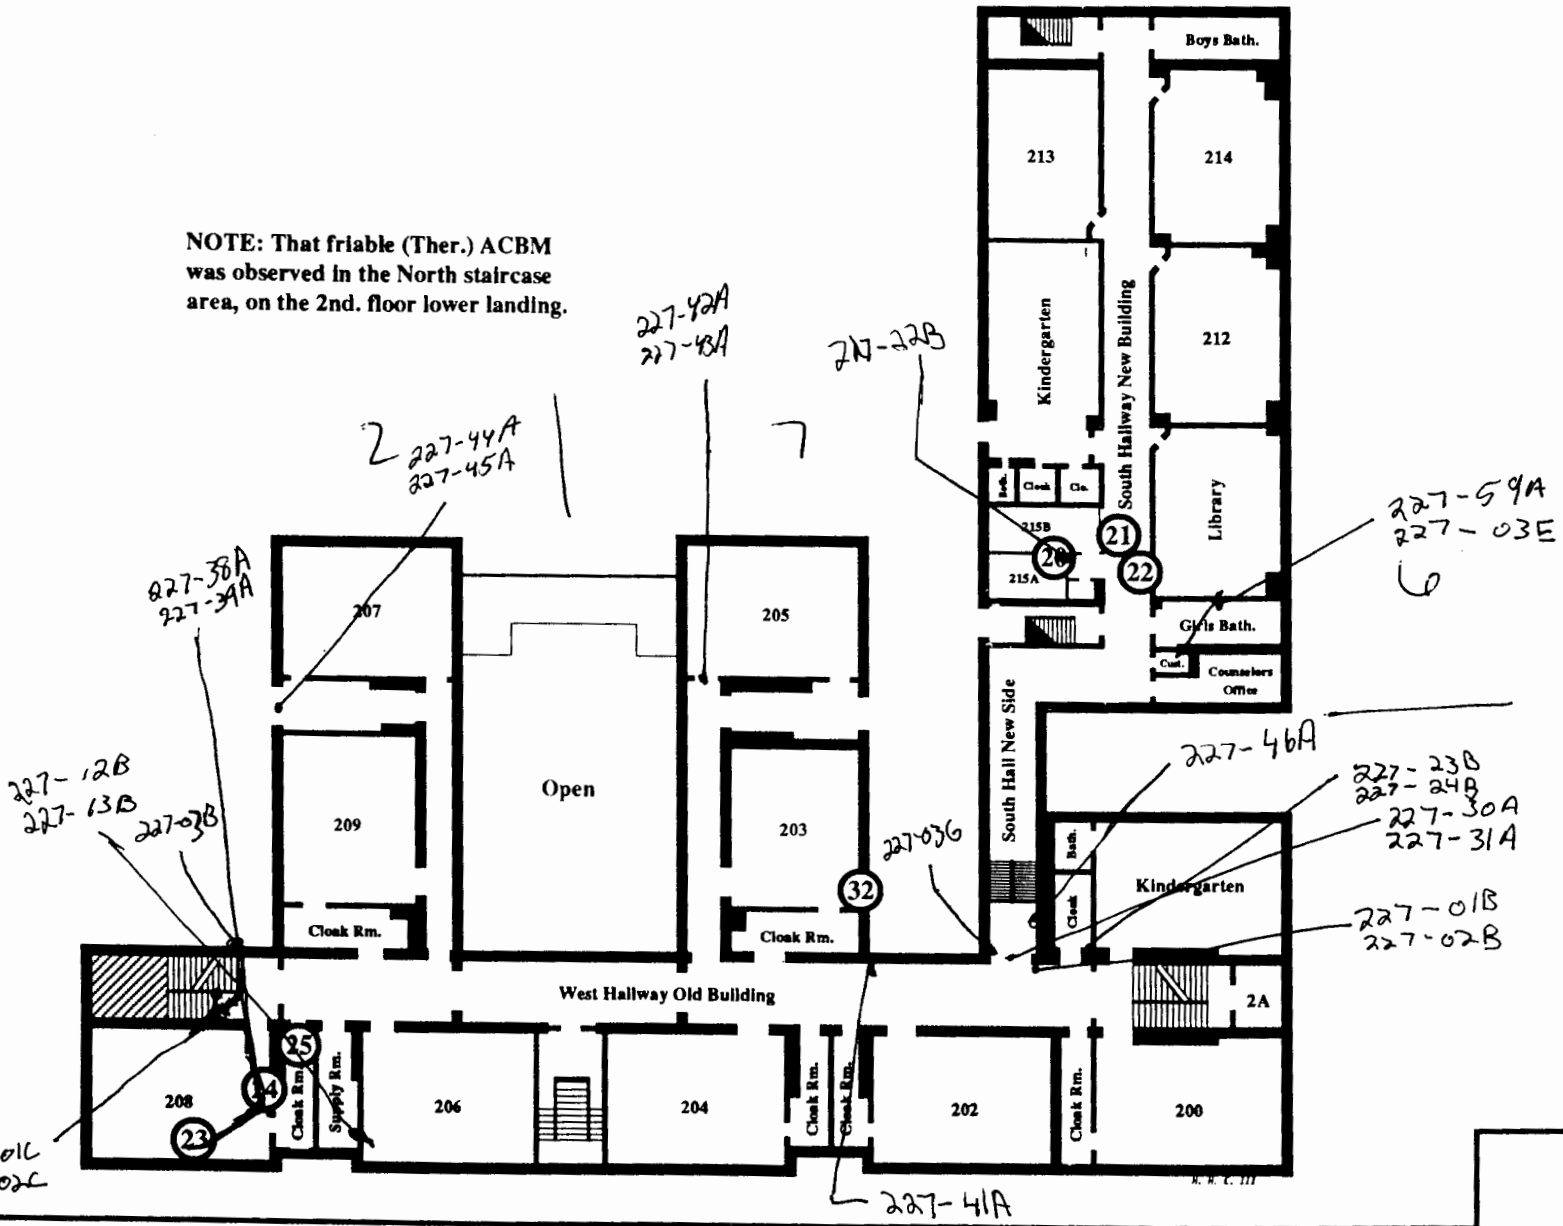
SCHOOL: H.D. COOKE ELEM. SCHOOL	FLOOR: 2nd. Floor
OTHER: ANY OTHER NOTES	DRAWING: (B)

NOTE: That friable (Ther.) ACBM was observed in the North staircase area, on the 2nd. floor lower landing.

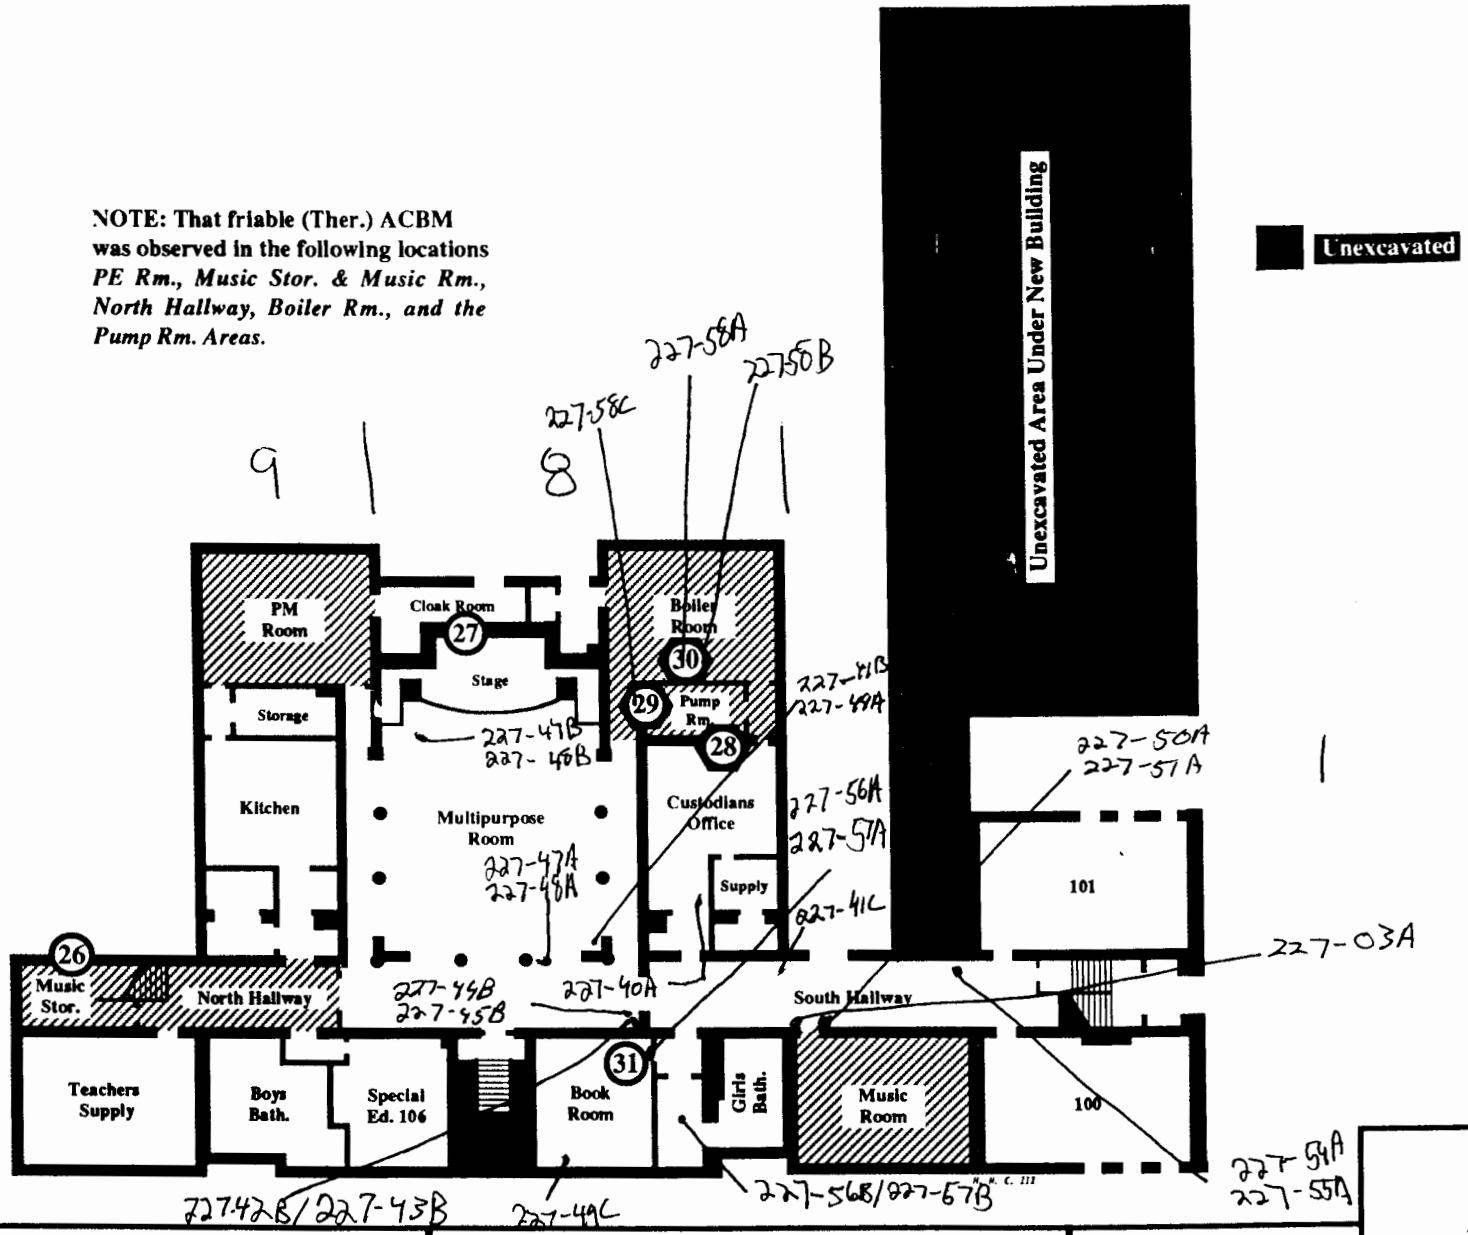
SCHOOL: H.D. COOKE ELEM. SCHOOL	FLOOR: 1st. Floor
OTHER: ANY OTHER NOTES	DRAWING: (C)

NOTE: That friable (Ther.) ACBM was observed in the following locations *PE Rm., Music Stor. & Music Rm., North Hallway, Boiler Rm., and the Pump Rm. Areas.*
