TABLE 1 - SAMPLING ANALYSIS SUMMARY

PN: 18-0317.001

HMDA - Additional PCB Sampling Soil Boring Location Map
Huntington, West Virginia Quadrangle
Cabell County, West Virginia

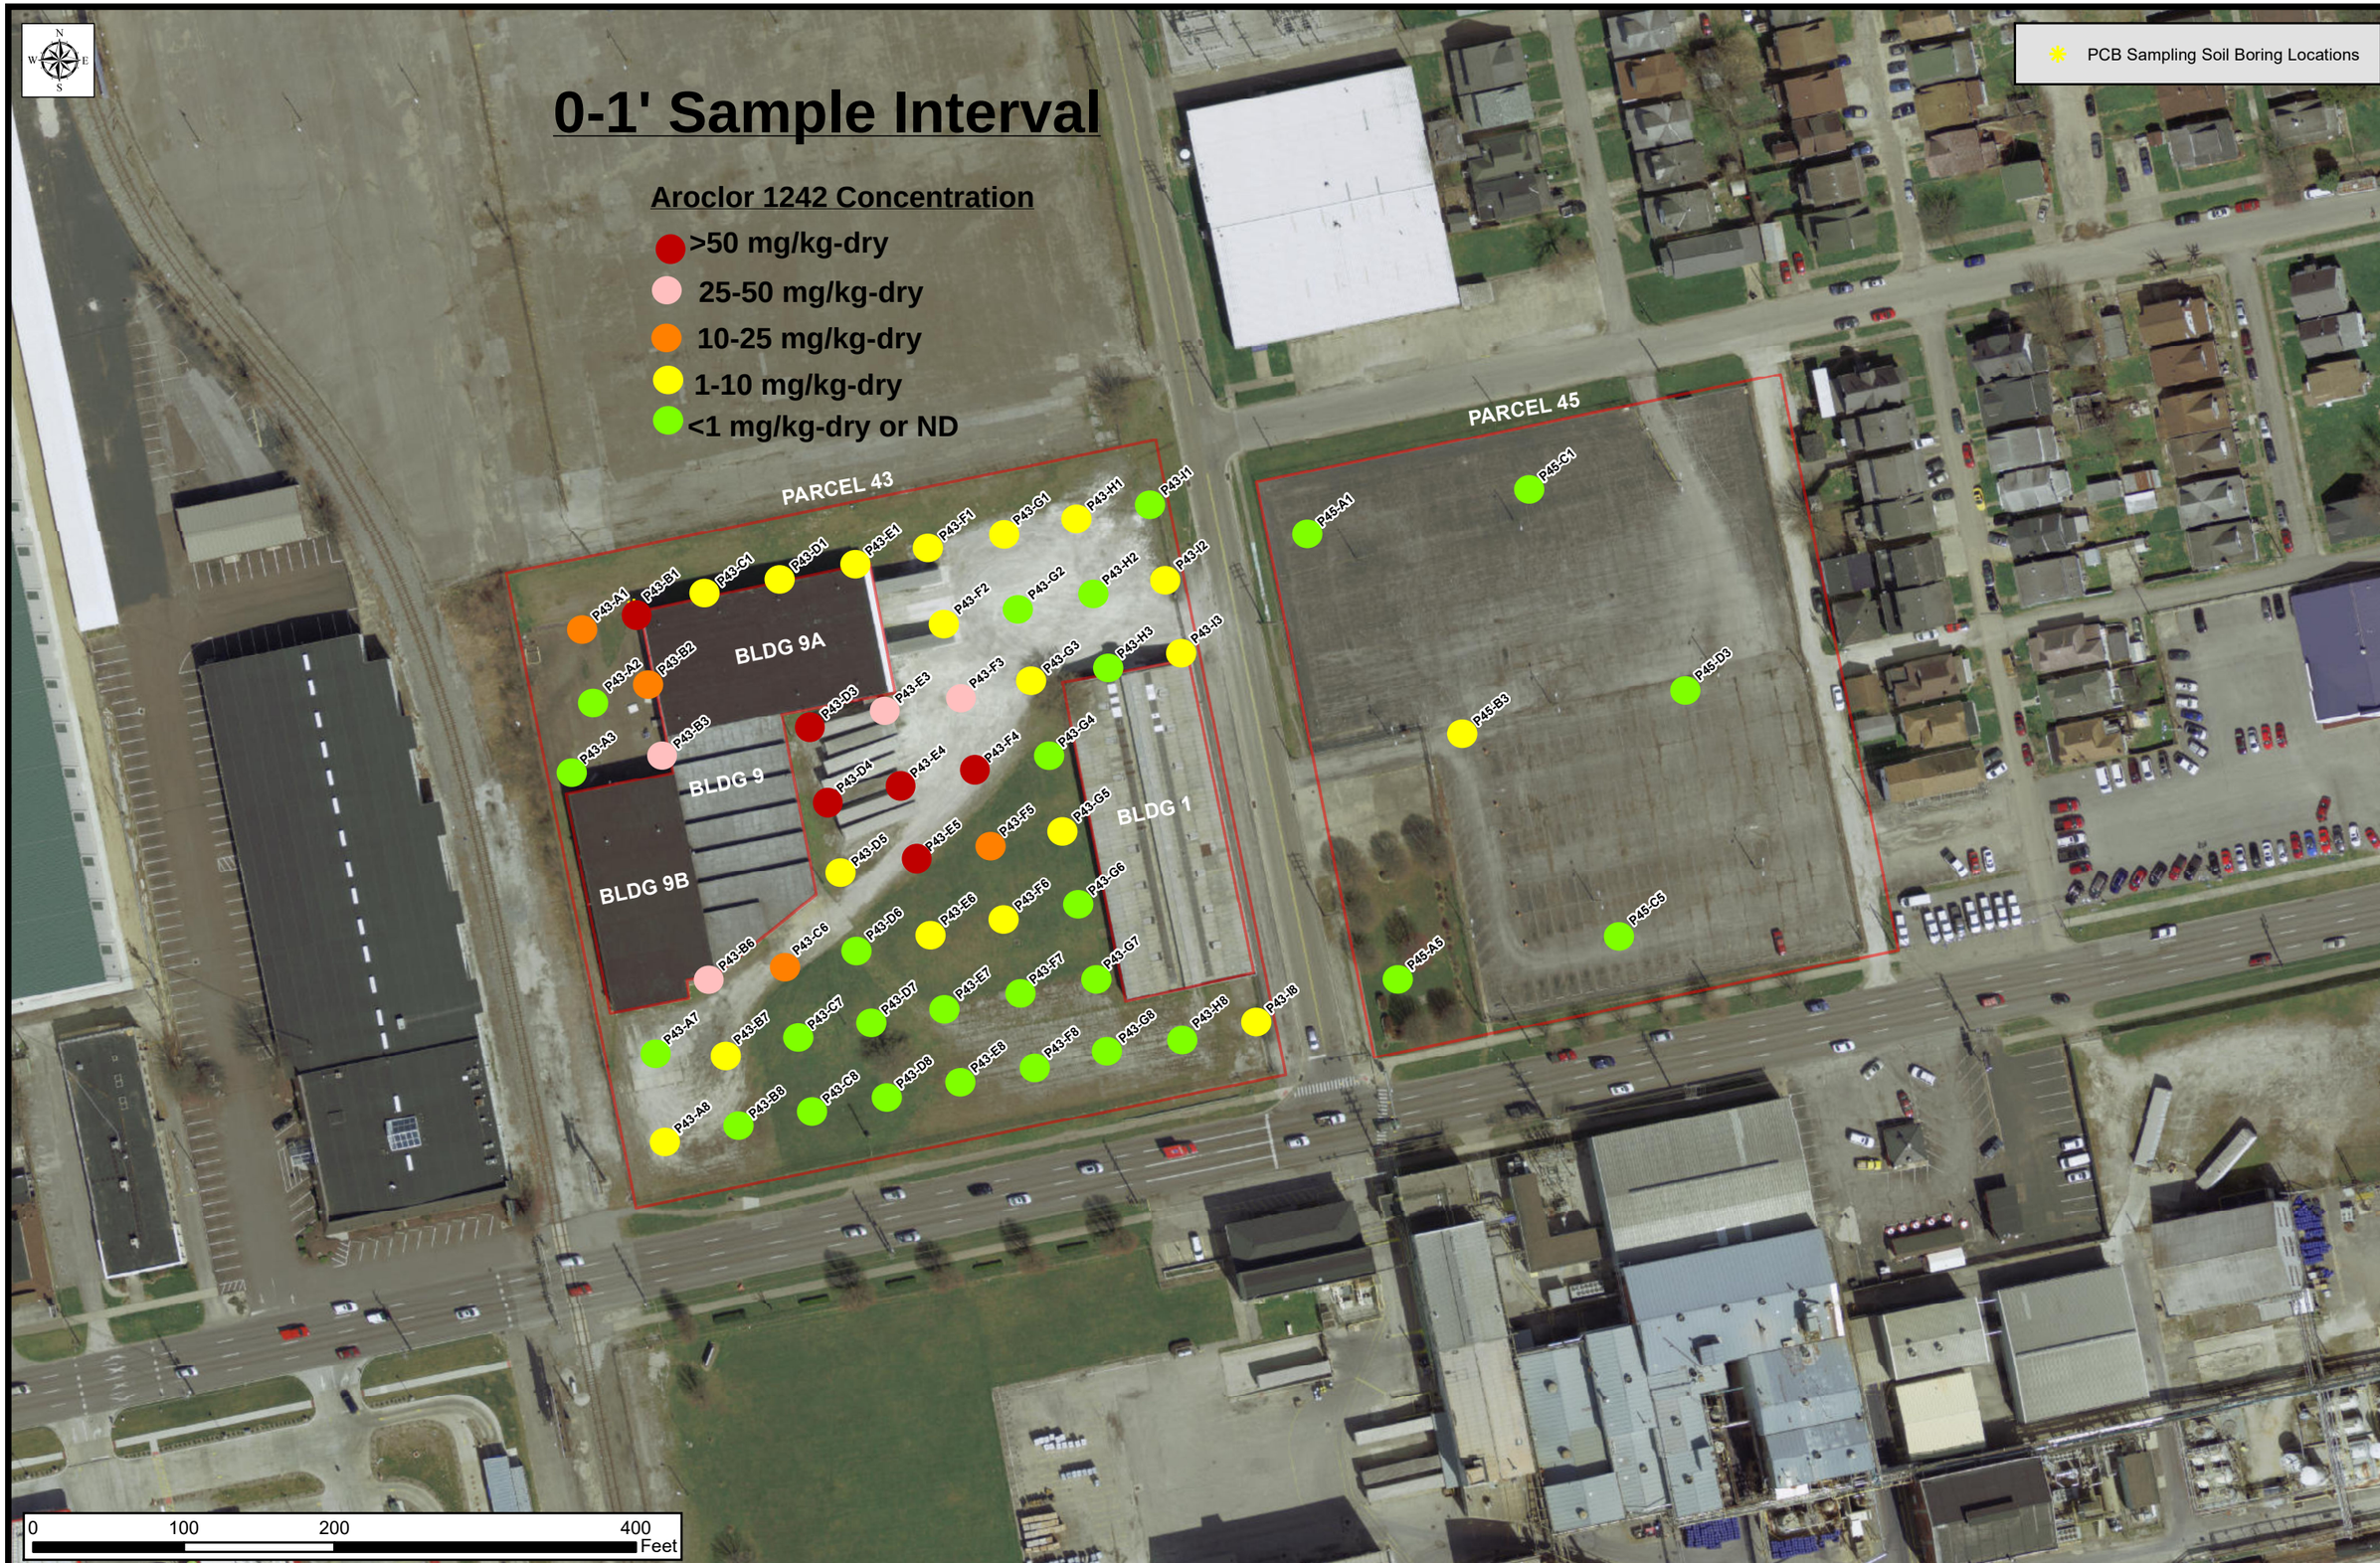
FIGURE 1

*P43-G7: When driller went to backfill with bentonite, boring took 1 1/2 bags of bentonite. Potesta inspected and determined there is an unknown size and depth cavity or tank. Air flow is noted to be coming out of boring.
