# PRELIMINARY ASSESSMENT/ VISUAL SITE INSPECTION

## BASF CORPORATION
## DETROIT, MICHIGAN
## MID 007 138 746

## FINAL REPORT

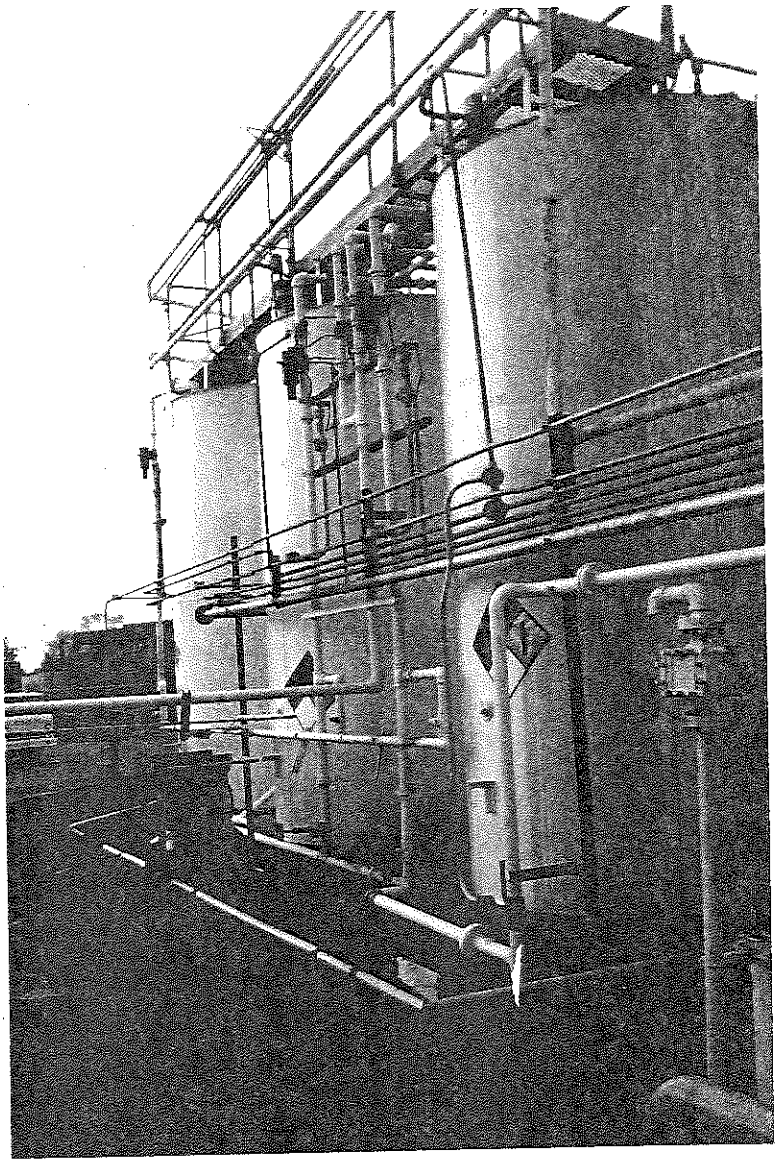
**Location:** SWMU 2
**Date:** November 6, 1991

| History of Documented Releases: | On March 14, 1989, there was a release of 350 gallons from the spent solvent tanks. The spill was contained within the tank farm. In the summer of 1991, a 15-gallon spill from a spent solvent tank was contained but stained the side of the tank. |

| Observations: | One side of one of the spent solvent tanks was stained. No cracks, other defects, or damage were observed in the tanks. |

| | SWMU | Operational Dates | Evidence of Release | Suggested Further Action |
|---|---|---|---|---|
| 2. | Tank Farm | 1967 to present | Stain on side of tank. Releases occurred in 1986, 89, and 91. The 1986 spill resulted in the release of xylene to the sewer system | No further action |

**Photograph No.** 1
**Orientation:** Northwest
**Description:** Three spent solvent tanks in tank farm

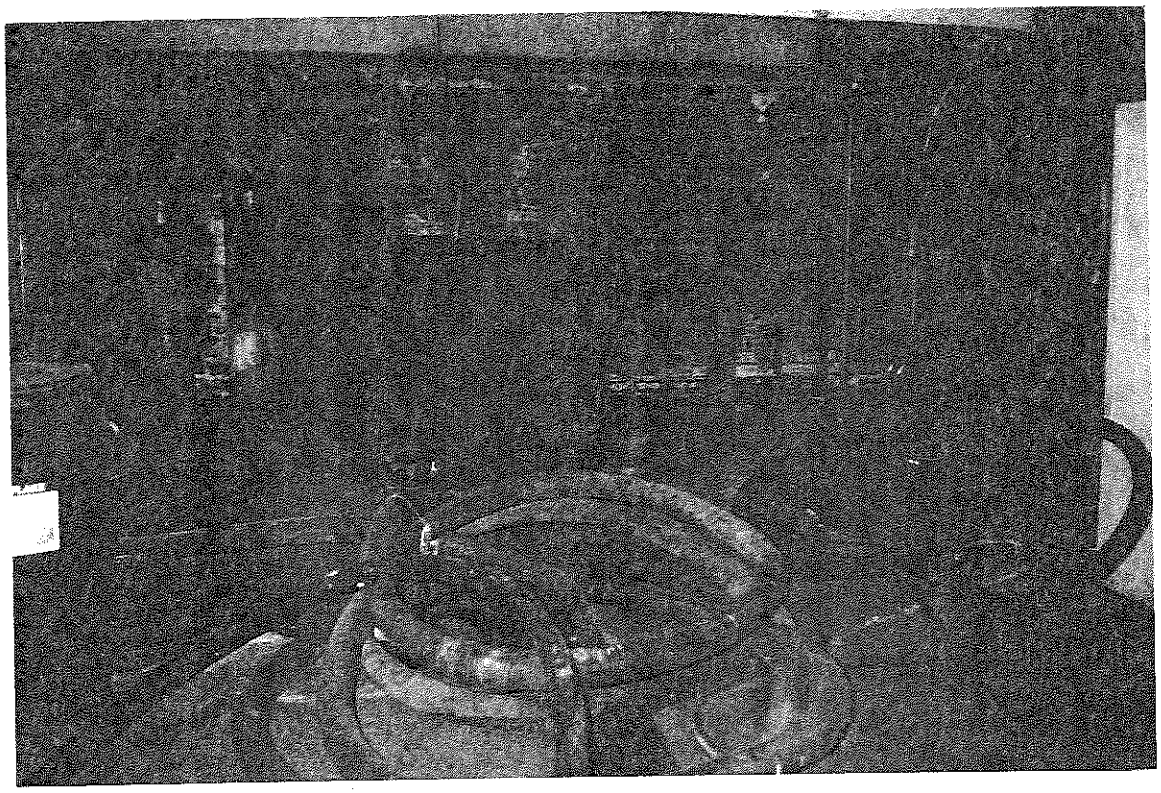
**Location:** SWMU 7
**Date:** November 6, 1991

**Photograph No.** 2
**Orientation:** Northwest
**Description:** Caustic cleaning tank and floor drains

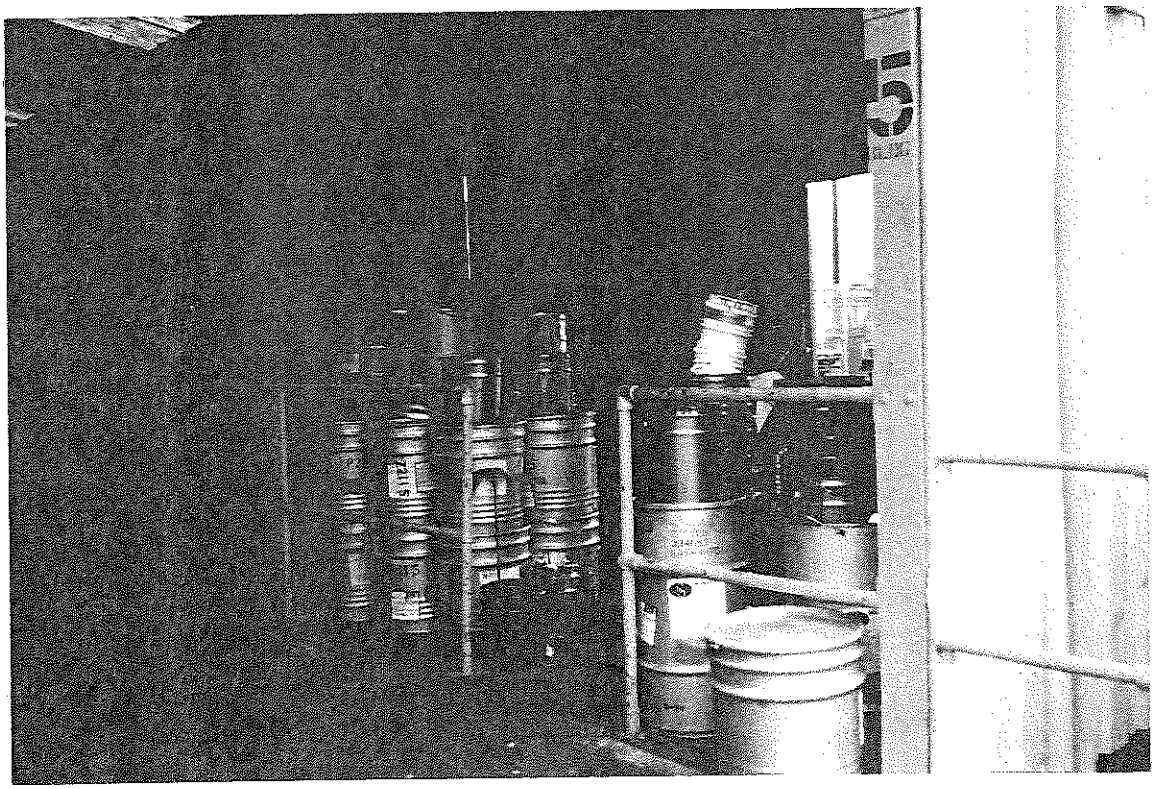
**Location:** SWMU 8
**Date:** November 6, 1991

| Observations: | There is no evidence of releases from the unit. More than 25 empty containers of various sizes were observed in the unit during the VSI. The containers were stacked and, when possible, closed. |

**Photograph No.** 3
**Orientation:** West
**Description:** Small Container Storage Area

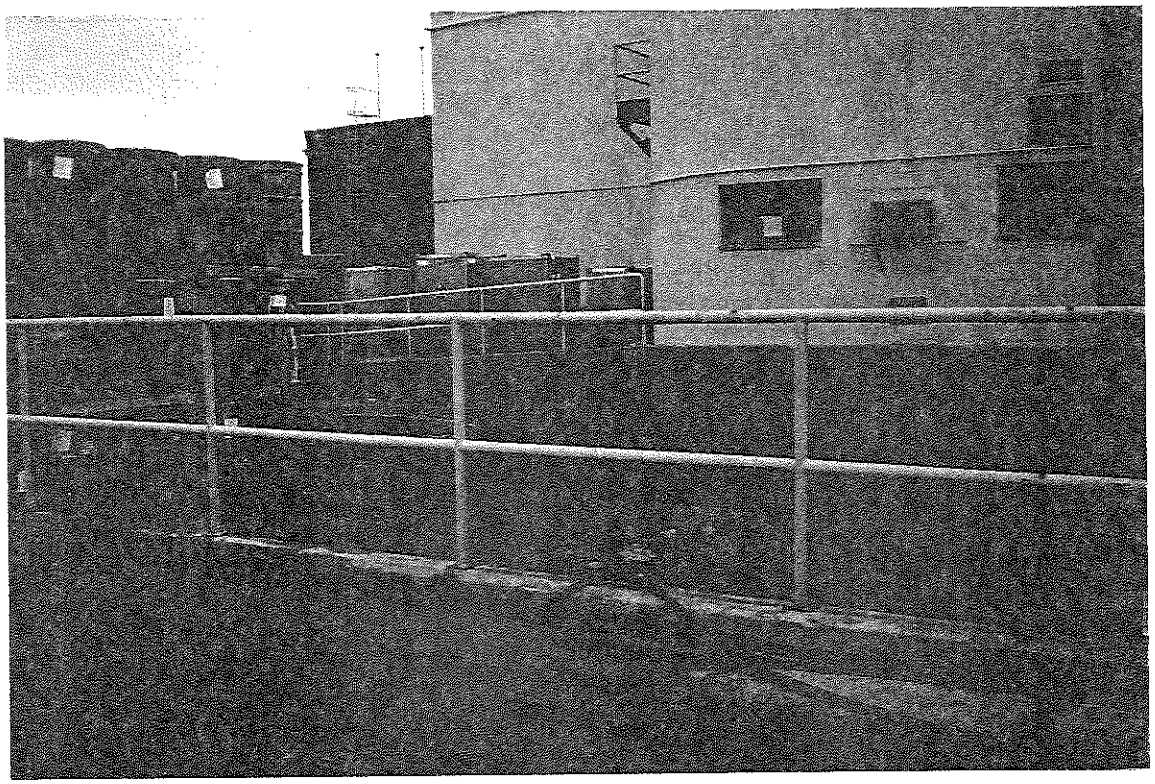
**Location:** SWMU 10
**Date:** November 6, 1991

| Observations: | The concrete walls and floors show no visible cracks or damage. The drums were in good condition. There is no evidence of a release from the unit. |

**Photograph No.** 4
**Orientation:** Southwest
**Description:** Central Drum Storage Area

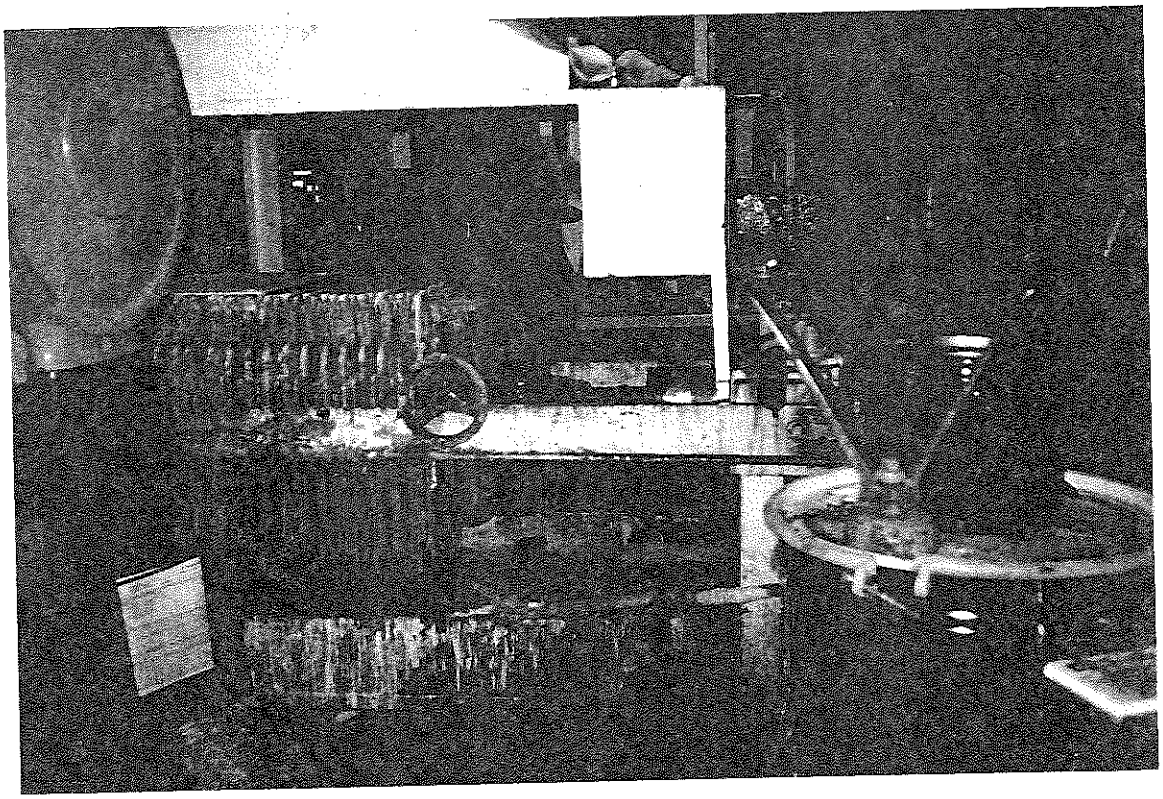
**Location:** SWMU 11
**Date:** November 6, 1991

| Observations: | There was no evidence of releases from the accumulation areas. The drums observed at the units appeared to be in good condition. |

**Photograph No.** 5
**Orientation:** North
**Description:** Satellite Accumulation Area with resin filter press

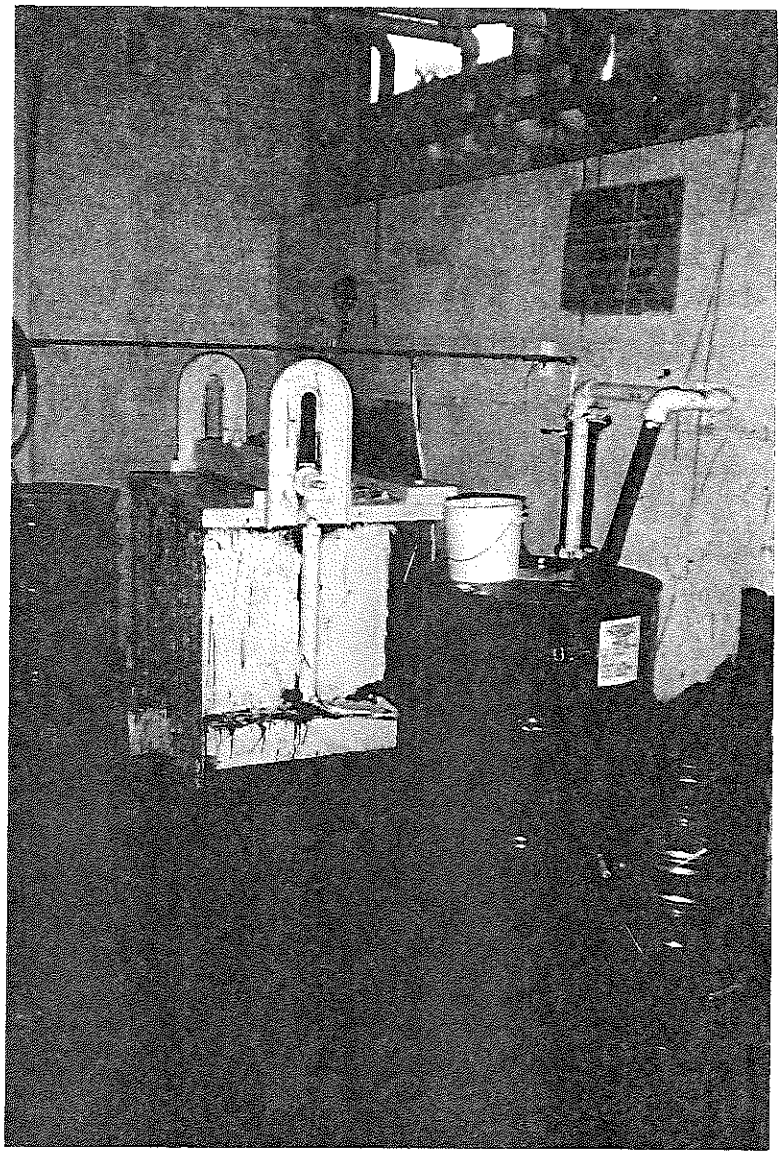
**Photograph No.** 6 **Location:** SWMU 11
**Orientation:** Northeast **Date:** November 6, 1991
**Description:** This photograph shows the Satellite Accumulation Area and filter press. The area accumulates 1 to 2 55-gallon drums of waste. The filter press has about a 16-cubic-foot capacity.

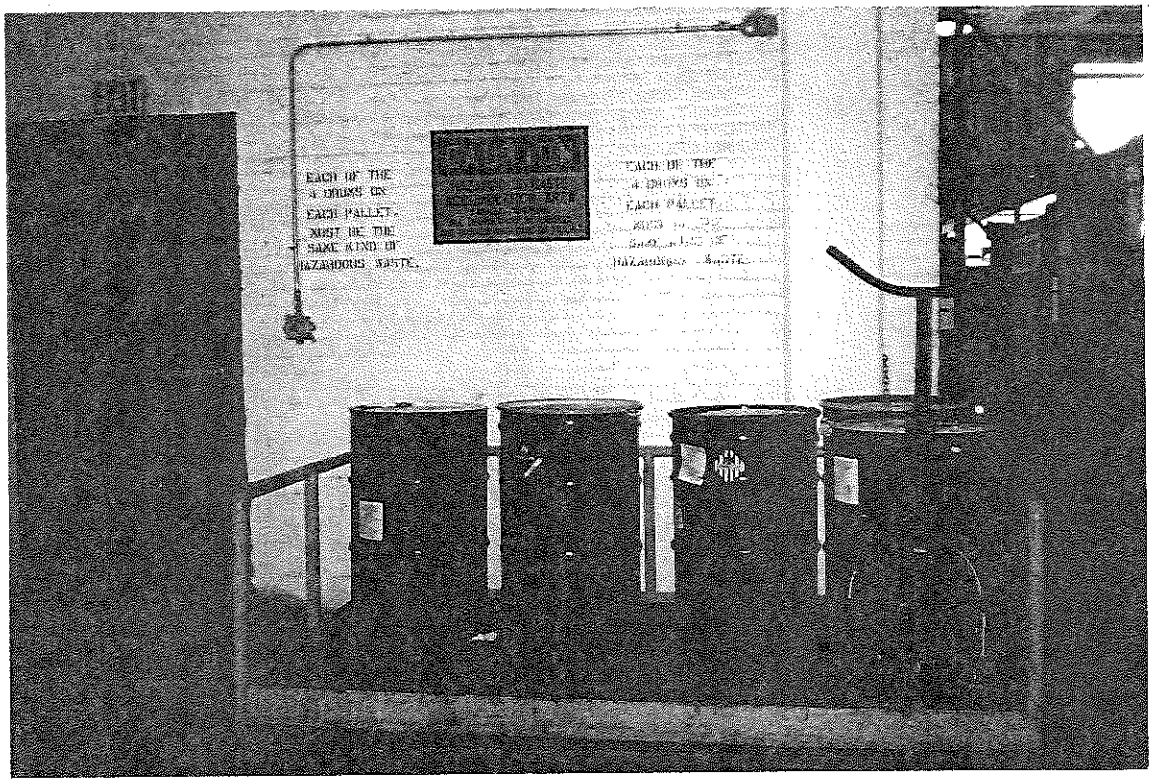
**Location:** SWMU 12
**Date:** November 6, 1991

**Photograph No.** 7
**Orientation:** North
**Description:** Paint Waste Staging Area

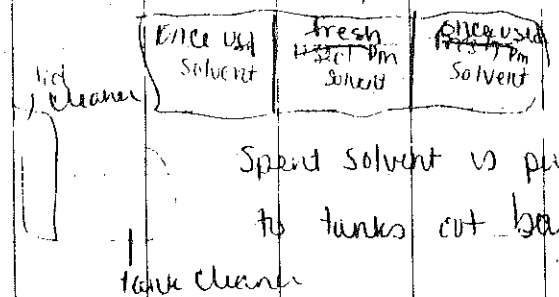
Spent solvent is pumped to tanks out back

2,900 gal - 3 spent solvent tanks
