City of Baltimore - Bureau of Water and Wastewater

Flow Monitoring Services for Sanitary Sewer System

Site Name: BDU04

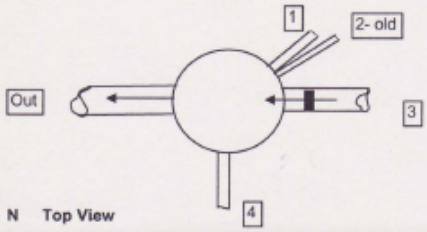
Installation Plan Sketch

MH condition poor, severe leaks at bottom.
*- No Steps in manhole.
Line # 2 may be abandoned
