3. SITE INVESTIGATION PROGRAM

TITLE:
Parcel D Soil Sample Locations
Boeing C-6 Facility
Los Angeles, CA

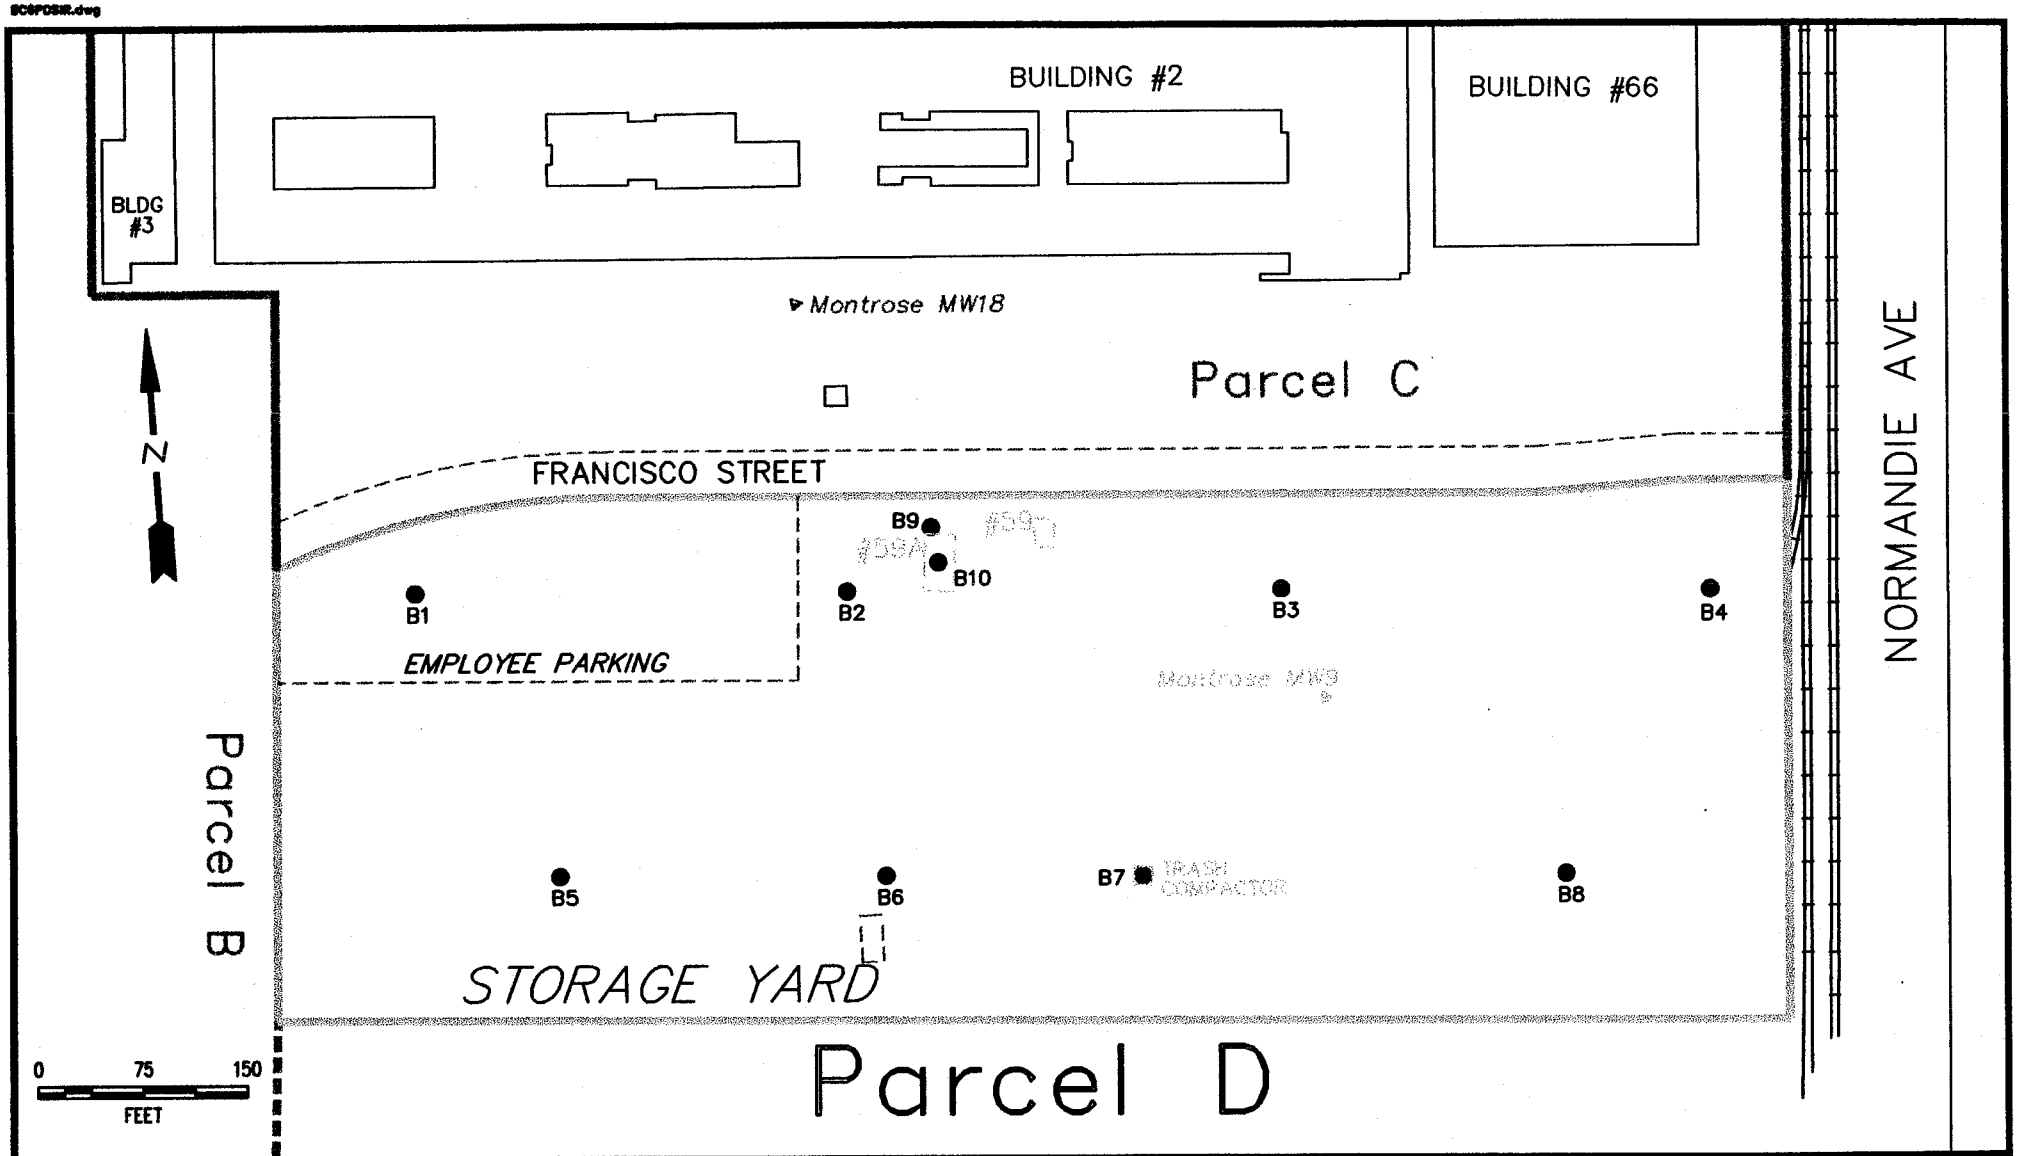
DWN: JDL	DES.: JDL	PROJECT NO.: BOC6\PDSIR
CHK: JFH	APPD: JPO	FIGURE NO.: 3-1
DATE: 09/17/99	REV.: 1

Based on the historical and current usage of the building, soil samples were collected to assess any potential impacts (Figure 3-1). In Building 59A, one boring was advanced outside the northwest corner and one inside the building; samples were analyzed for volatile organic compounds (VOCs), semi-volatile organic compounds (SVOCs), total petroleum hydrocarbons (TPH), polychlorinated biphenyls (PCBs), and metals. Details concerning soil sampling are presented in Section 3.2.

Due to the historical storage of miscellaneous equipment and materials, eight soil borings were advanced throughout the storage yard to assess any potential impacts from current or historical activities (Figure 3-1). One of the eight borings (B7) was advanced at the location of the trash compactor. Soil samples were analyzed for VOCs, SVOCs, TPH, and metals. Details concerning soil sampling are presented in Section 3.2.

Since most of the parcel had historically been used for storage and employee parking, a staggered sampling approach was used so that soil sample locations would be representative of previous site uses. As shown in Figure 3-1, the sampling approach consisted of placing two staggered rows of borings spaced approximately 200 feet apart, with the individual borings spaced approximately 300 feet apart. Sample results were compared to the Health-Based Remediation Goals (HBRGs) for surface soils (IESI 1997) to determine whether soils had been impacted by past operations.

demolished structures. Only minor adjustments were made to the proposed locations. In general, the locations of the borings correspond well with the locations proposed in the SAP. The final locations are shown in Figure 3-1.
