Navajo Abandoned Uranium Mine Site Screen Report

Bibo Trespass AUM Site

Navajo AUM Eastern Region

May 2009

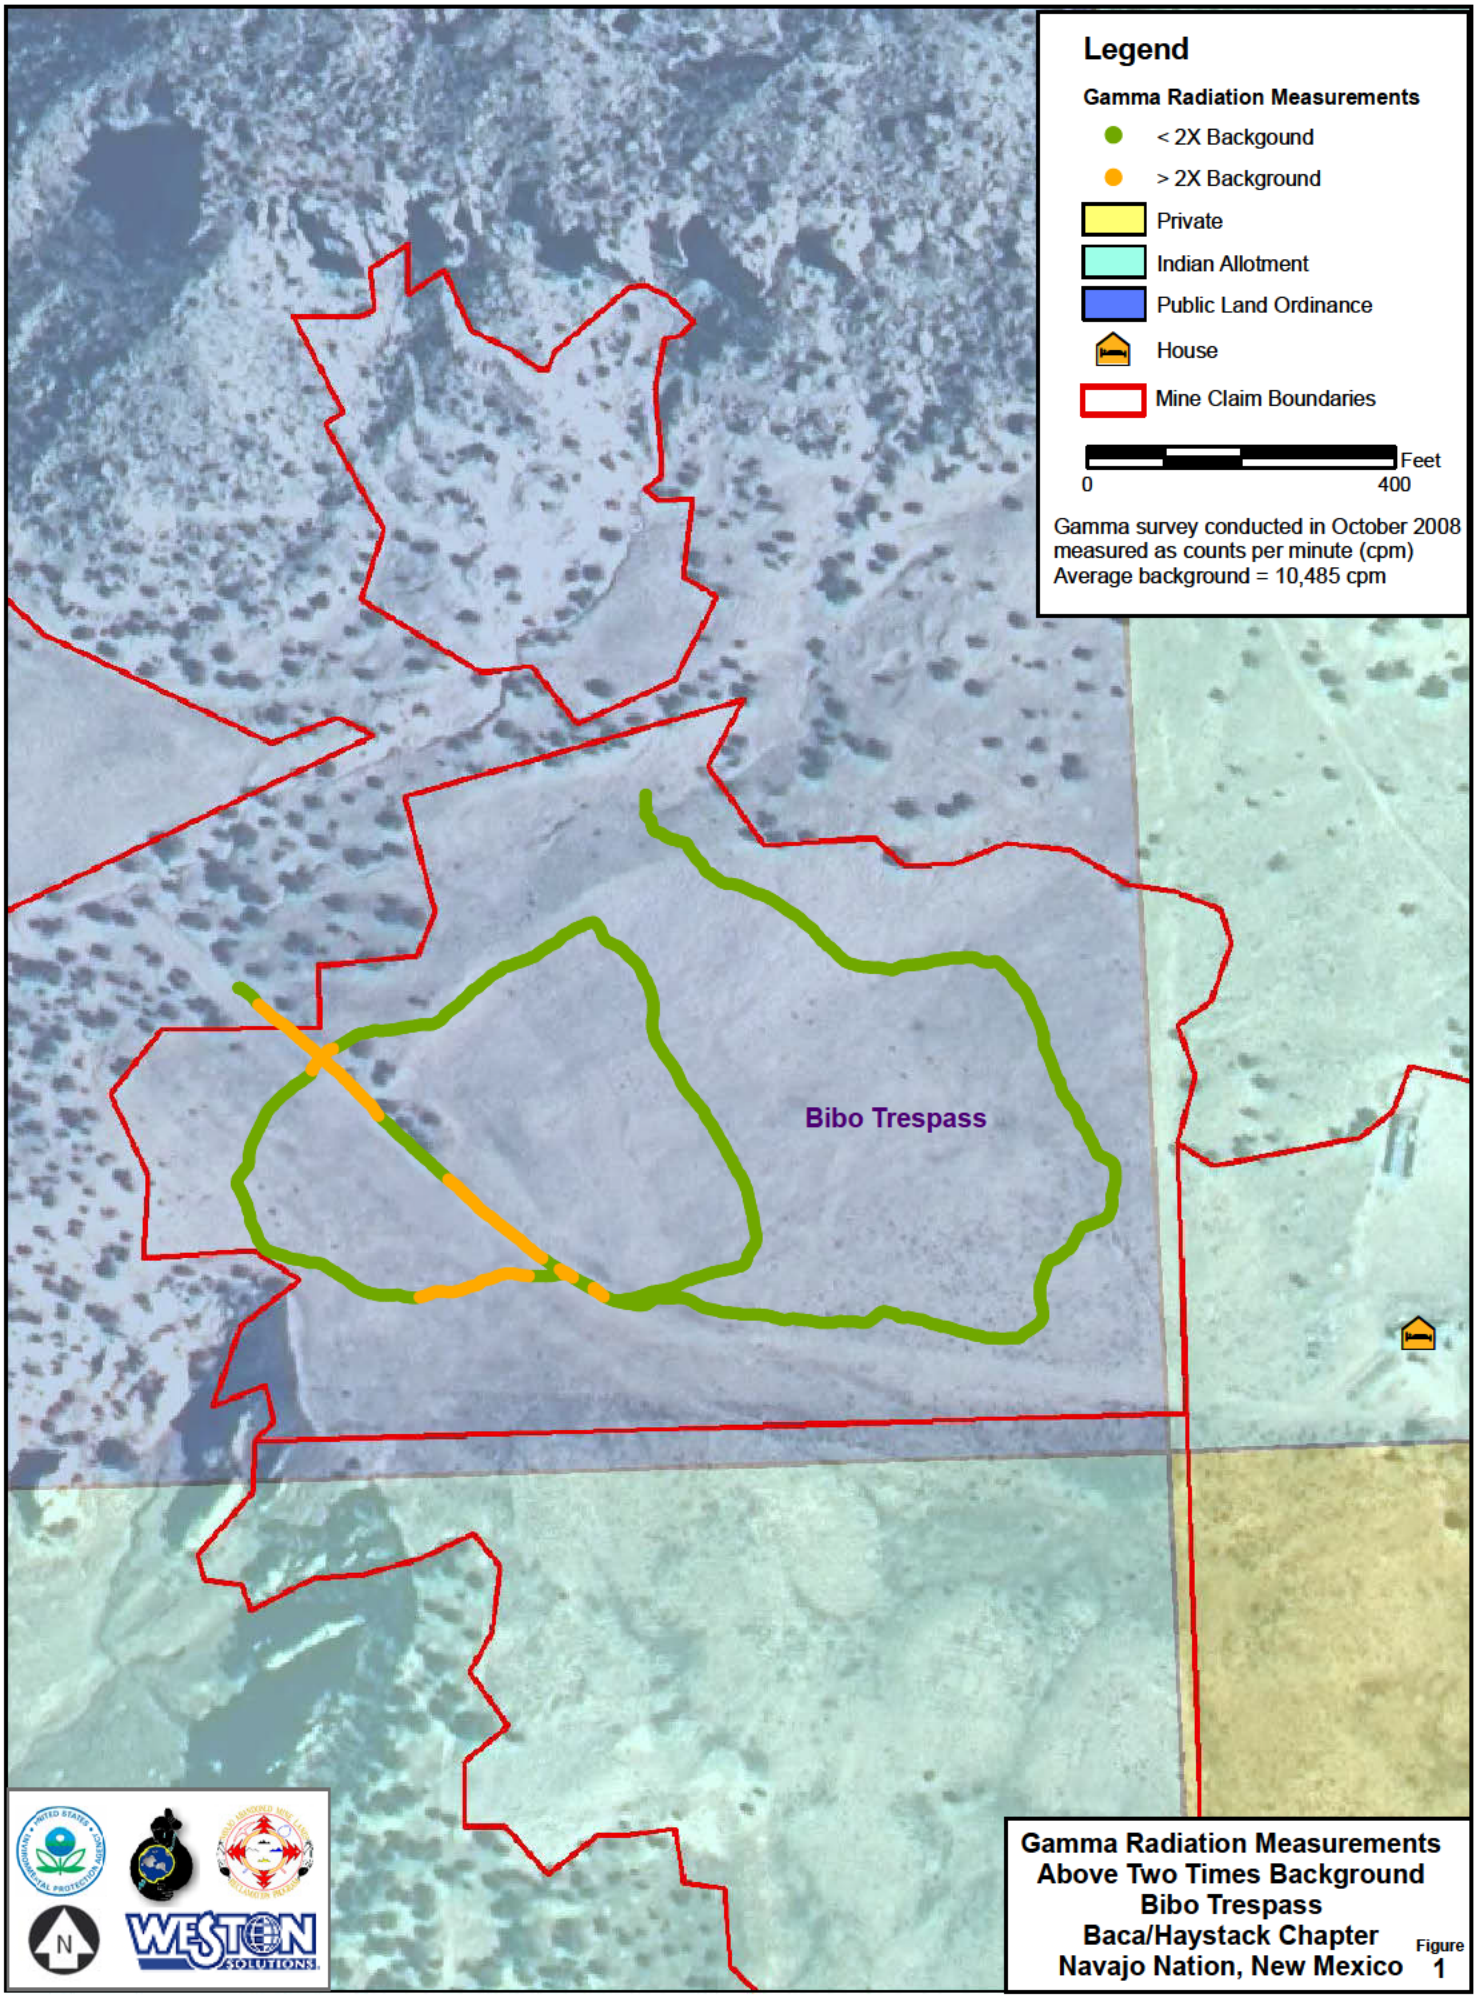
Figure 1

1,095 gamma radiation measurements were collected from mine sites, ranging from 6,552 cpm to 89,750 cpm. Measurements were found at their highest along the dirt road transecting the site. The measurements are represented in Figures 1 and 2.

Gamma Radiation Measurements Above Two Times Background
Bibo Trespass
Baca/Haystack Chapter
Navajo Nation, New Mexico

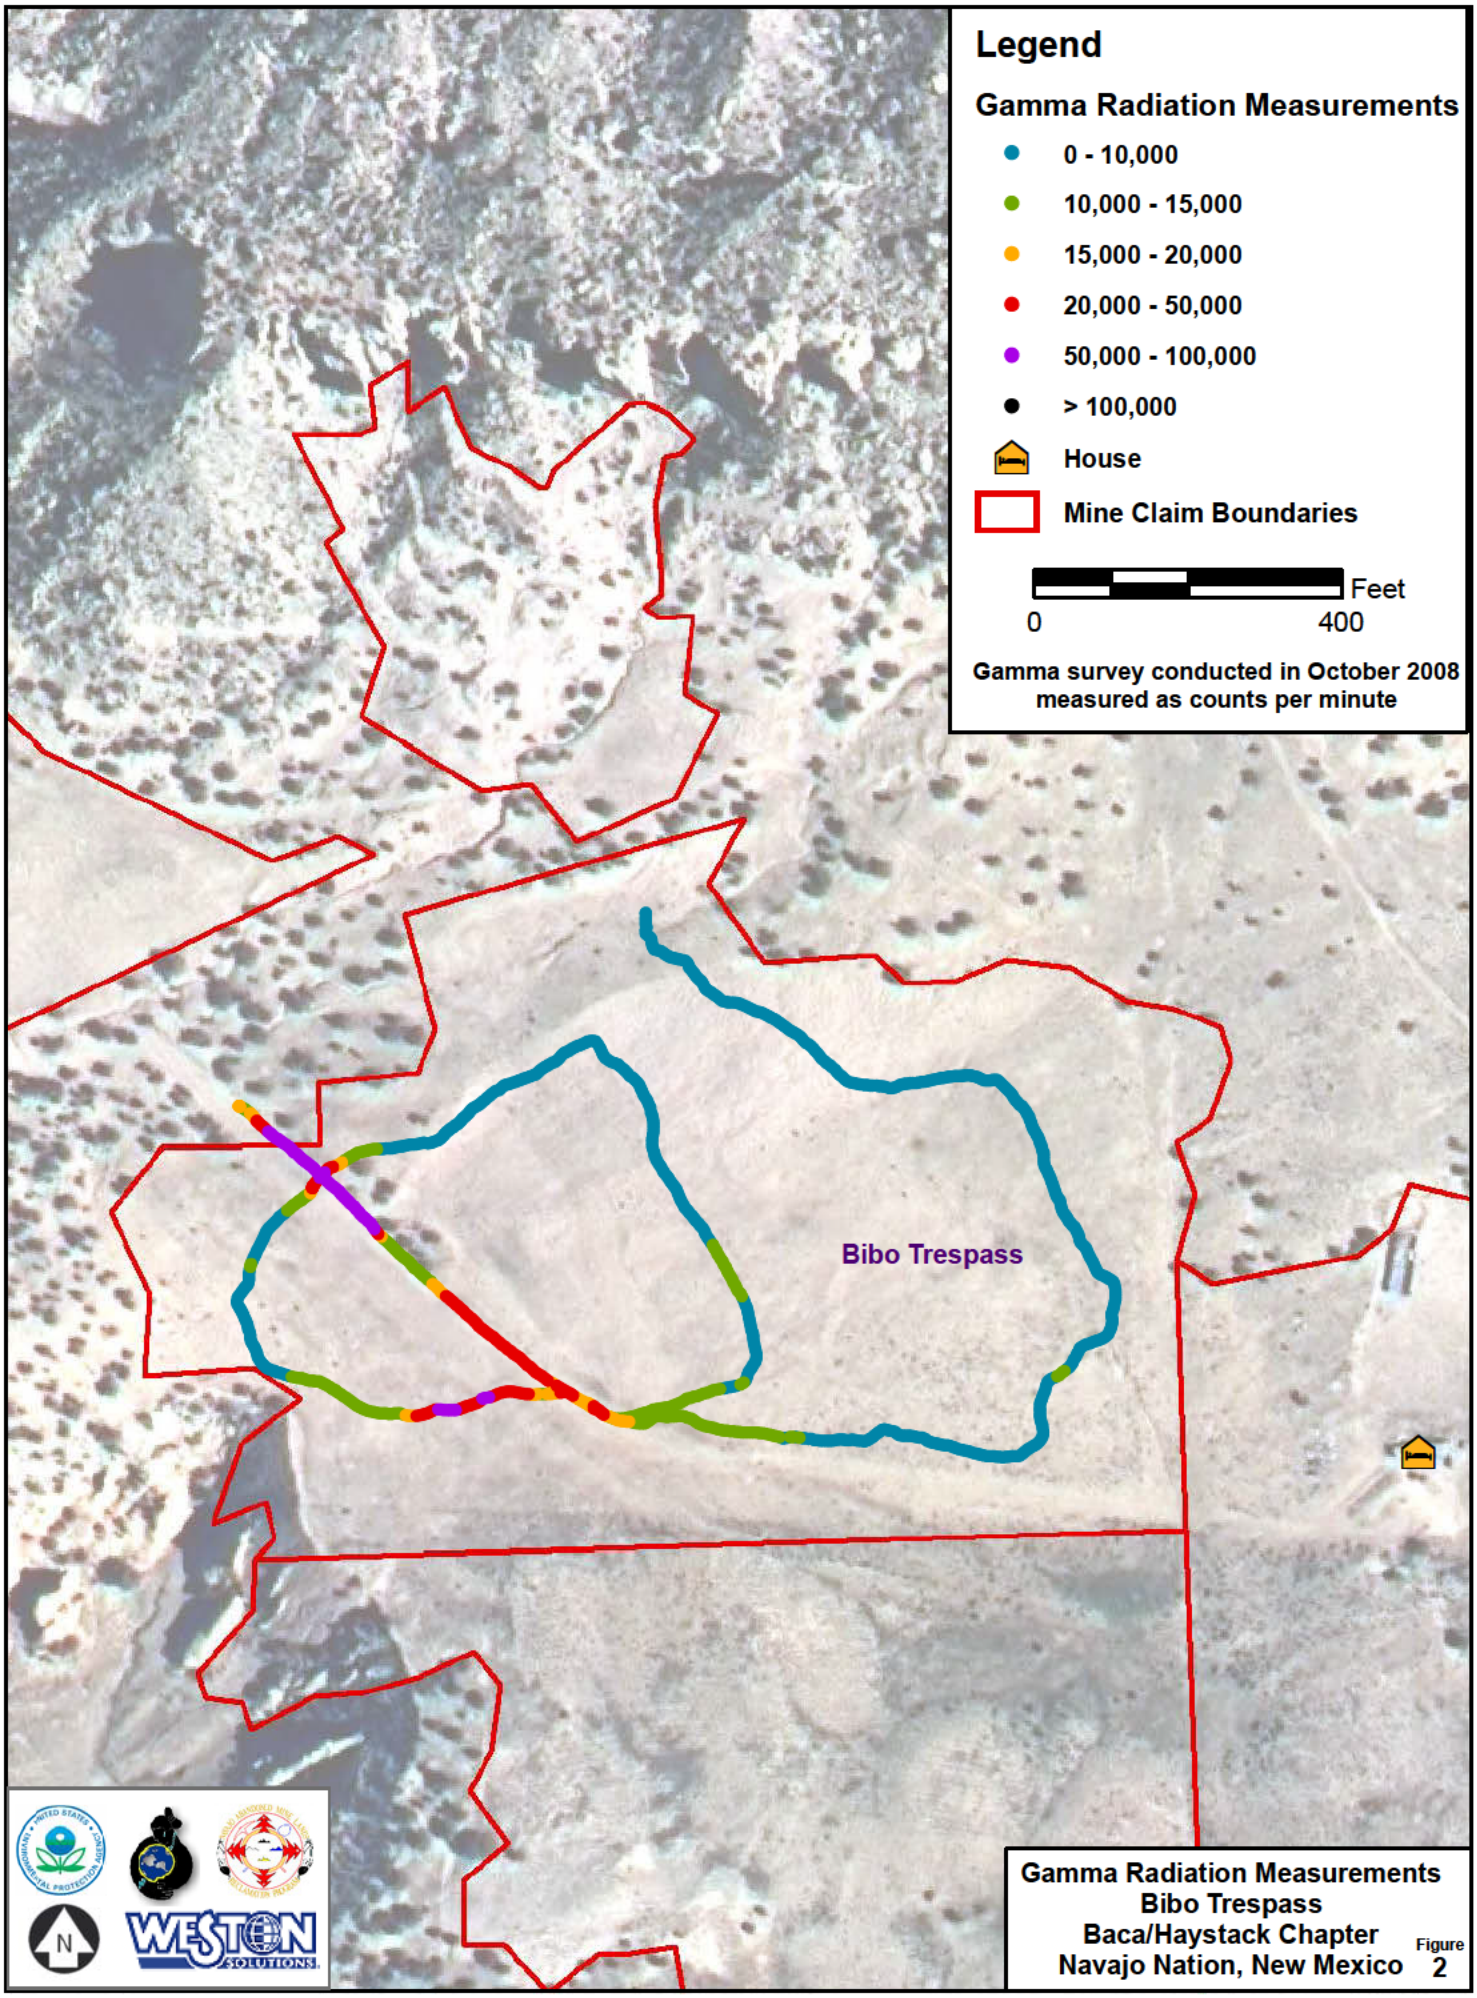
Figure 2

Gamma Radiation Measurements
Bibo Trespass
Baca/Haystack Chapter
Navajo Nation, New Mexico
