Phase I Environmental Site Assessment

1043 Peachtree Street

Cocoa, Florida
Parcel ID No. 24-36-32-03-00000.0-0006.00
Brevard County

January 2010

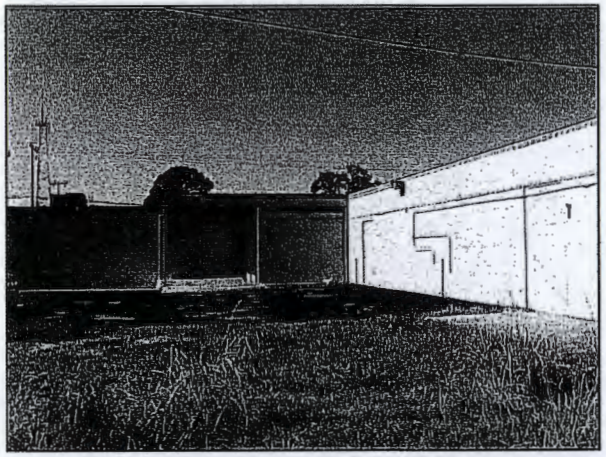
Left: View of the east side of 150 S Varr Avenue facility (former Brevard Printing and Busness Forms) – one of the adjacent sites west of the subject site.

Right: View of the other adjacent property west of the subject site located at 160 S Varr Avenue (former Albany Printing).

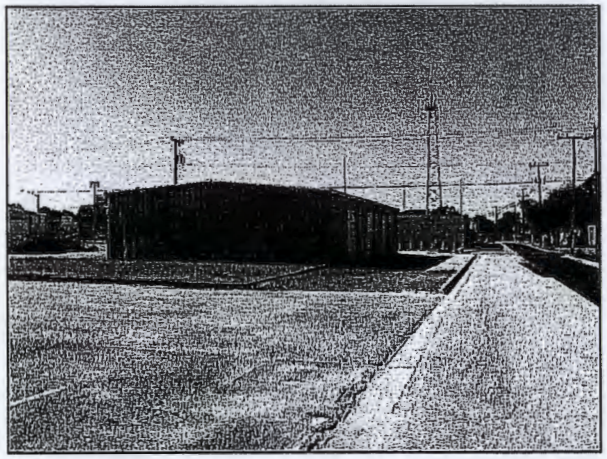
Left: View of southwest adjacent facility, which included a former pest control facility.

Right: View of adjacent site east (former residential property)
