Attachment No. 4

Photographic Log

Burke-Parsons-Bowlby Corporation
Goshen Division
9223 Maury River Road
Post Office Box 86
Goshen, VA 24439

Date of Inspection: April 8, 2004

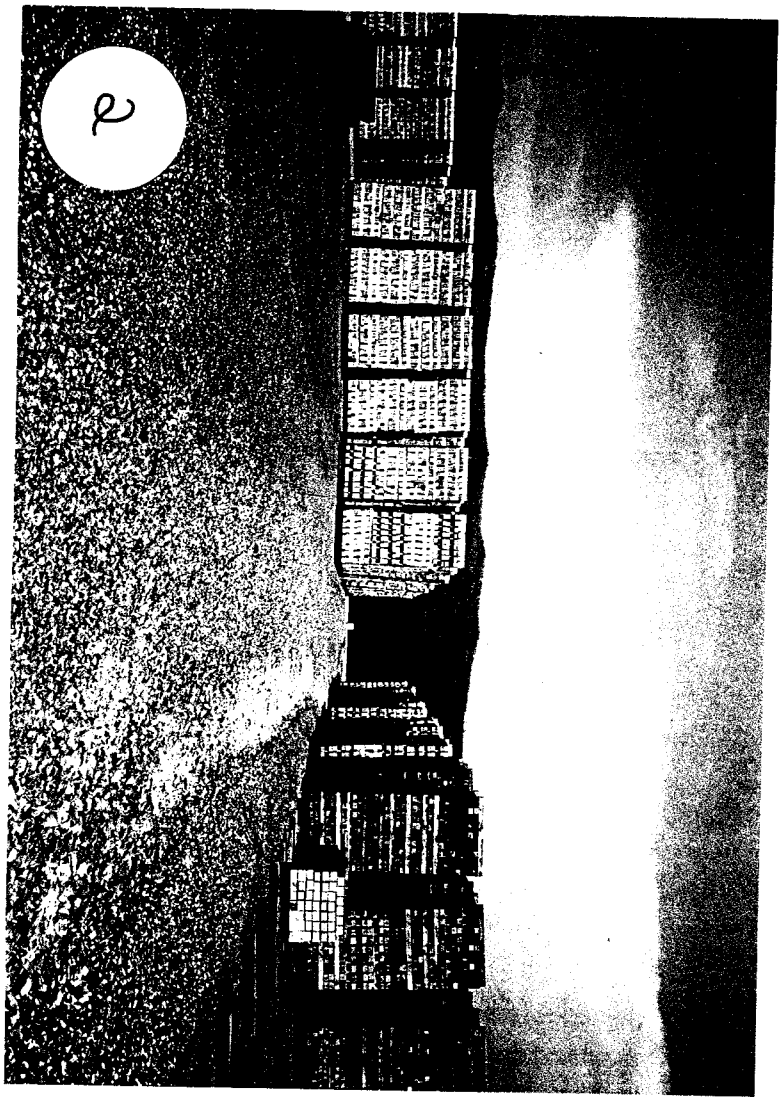
1

1. Manufacturing section of facility. Cut and plated ties being air dried before treatment.

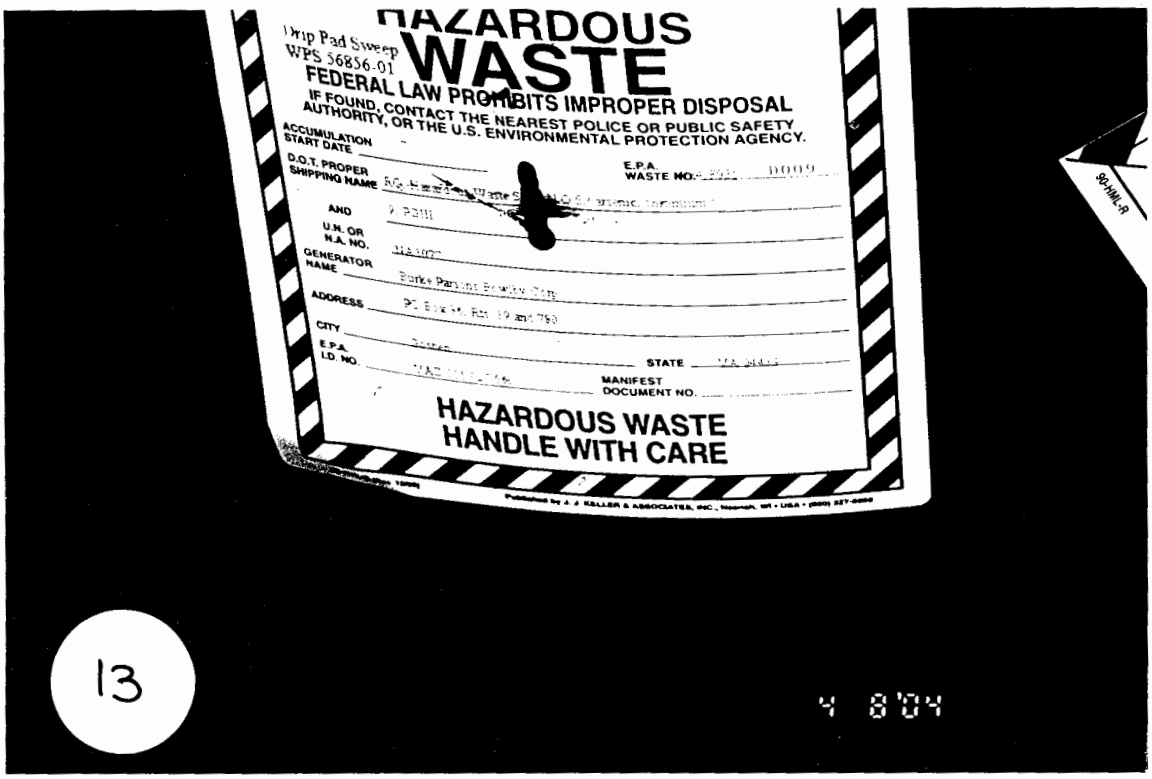
the drums were in good condition, closed and labeled with the words "Hazardous Waste." However, one of the full 55-gallon drums (not the satellite container) was not marked with an accumulation start date.

13. Close-up of "Hazardous Waste" label on the full 55-gallon drum in the hazardous waste accumulation area that was not marked with an accumulation start date.
