UNITED STATES ENVIRONMENTAL PROTECTION AGENCY
REGION 6
1445 ROSS AVENUE, SUITE 1200
DALLAS, TX 75202-2733

RCRA CORRECTIVE ACTION INSPECTION REPORT

FORMOSA PLASTICS CORPORATION

201 Formosa Drive, Point Comfort, TX 77978
(EPA ID Number: TXT490011293)

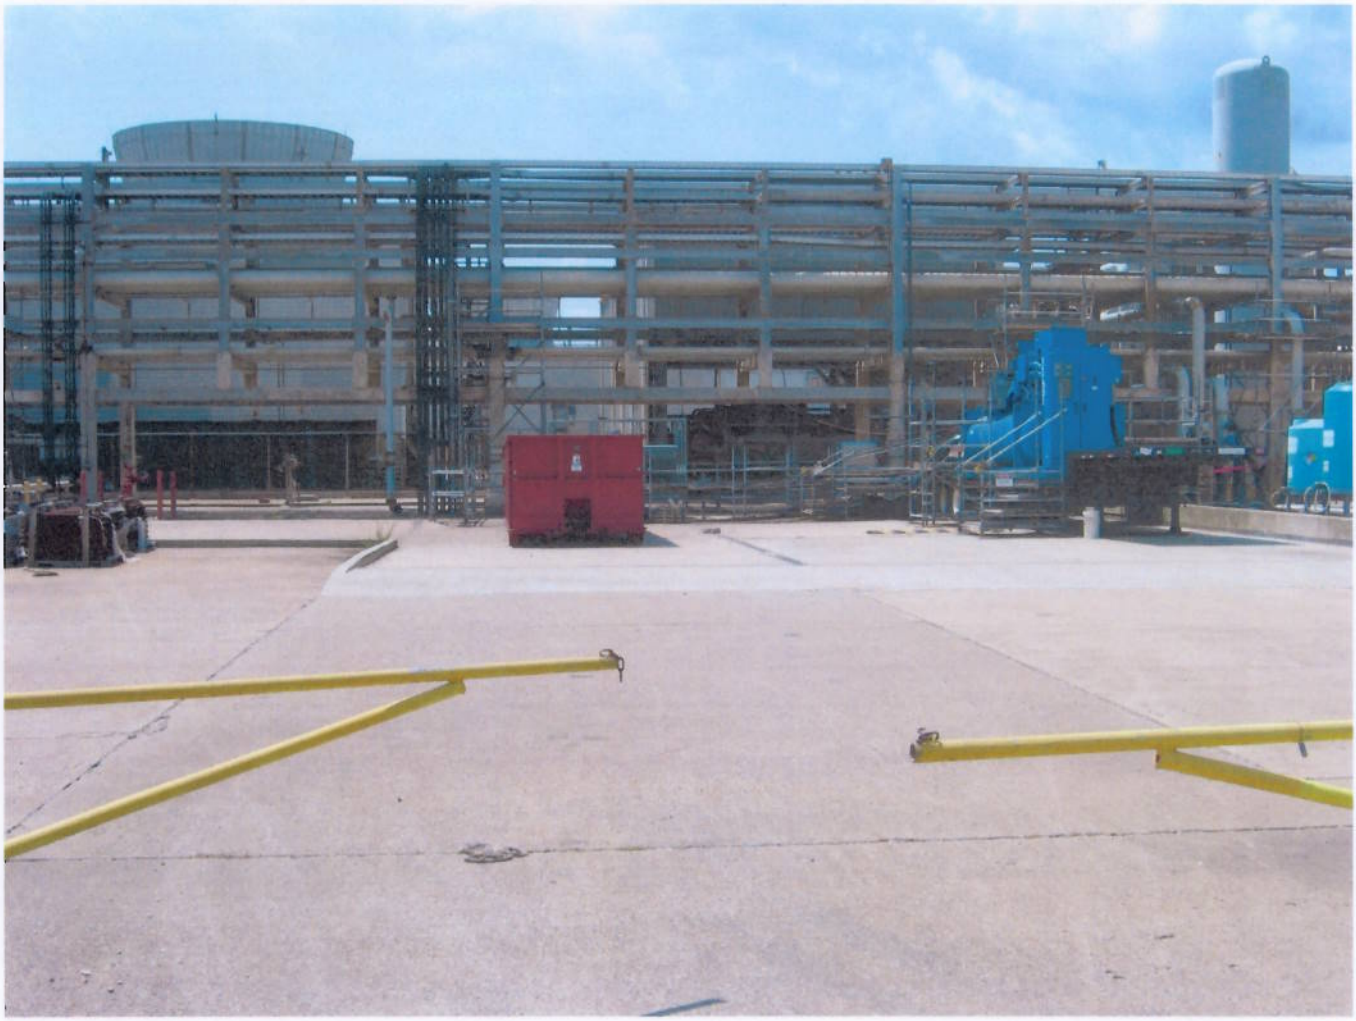
Official Photograph Log
Photo No. 7

f. SWMU 6 is a CSA within the battery limits of the Chlor Alkali plant. The CSA is used to store roll-off boxes used for plant maintenance and repair activities. Once the roll-off boxes are full, the boxes are moved to the less than 90-day container storage yard in the pre-1991 area of the facility. At the time of inspection, there was one roll-off box containing scrap metal in the CSA (see Attachment B, Photograph 7).

Photographer: Matt Brogger	Date: 8/21/12	Time: 1435 hours
City/County: Point Comfort, Calhoun	Direction (facing): West	State: TX
Location: Formosa Plastics Corp.		
Subject: CSA in Chlor Alkali Plant (SWMU 6)		
Photo ID: IMG-1007 (Canon SureShot A510, #S28099)
