Puntos de Descargas a Cuerpos de Agua

Región No. 2

Sector: Puerto Nuevo Sur

Cuerpo de Agua: Canal Puerto Nuevo

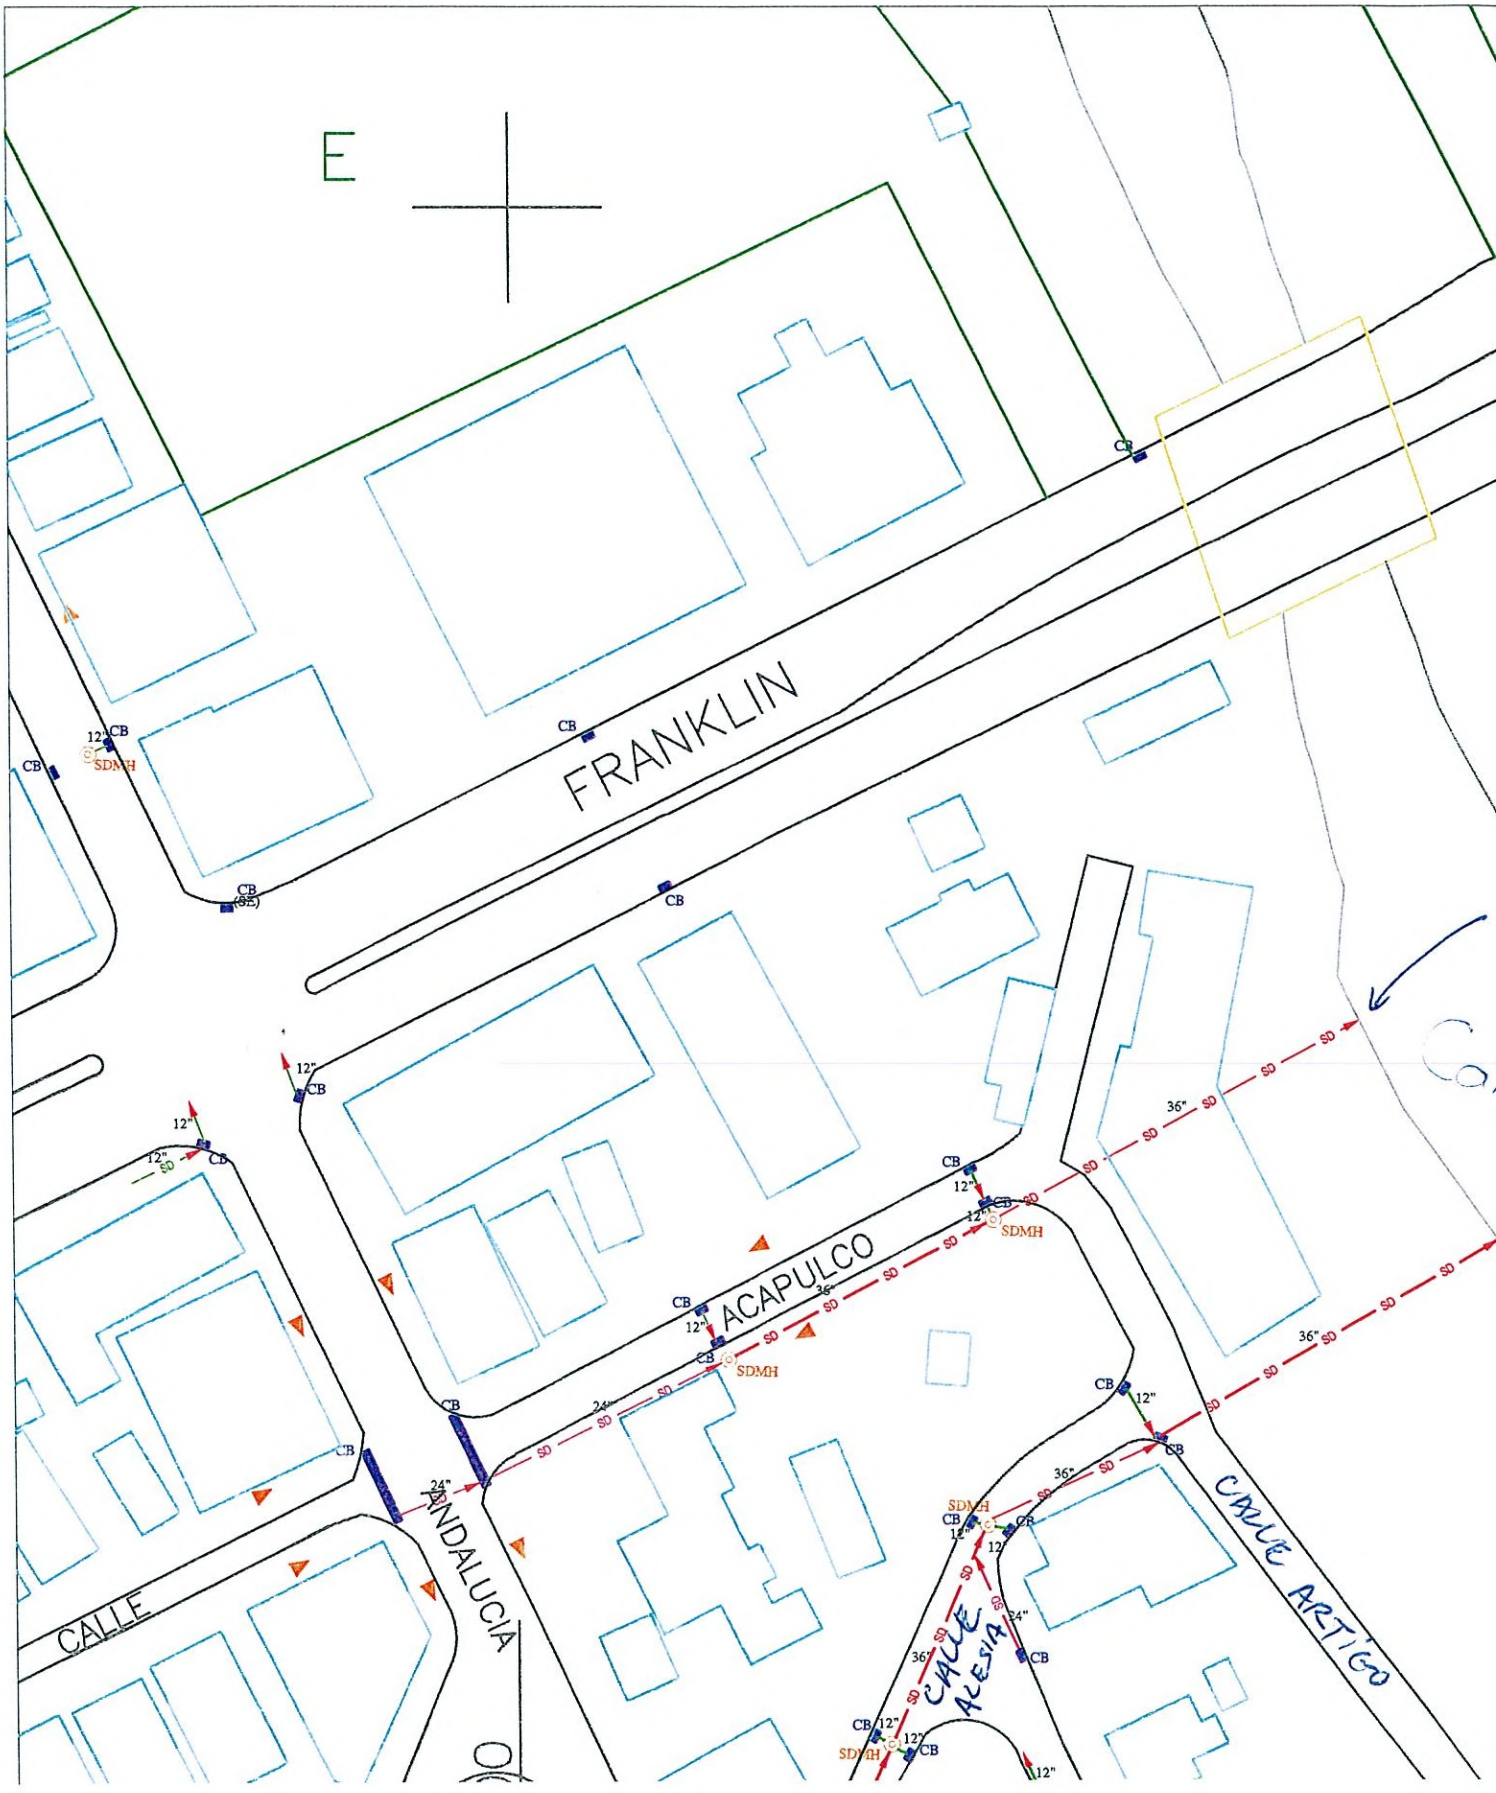
En este estudio se analizaron las cuadriculas G14a y G14c. De las estructuras analizadas tenemos que un 100% están sucias o tapadas. Hay varias estructuras de drenaje que se encontraron en el lugar que no estaban identificadas en los dibujos del Municipio de San Juan.

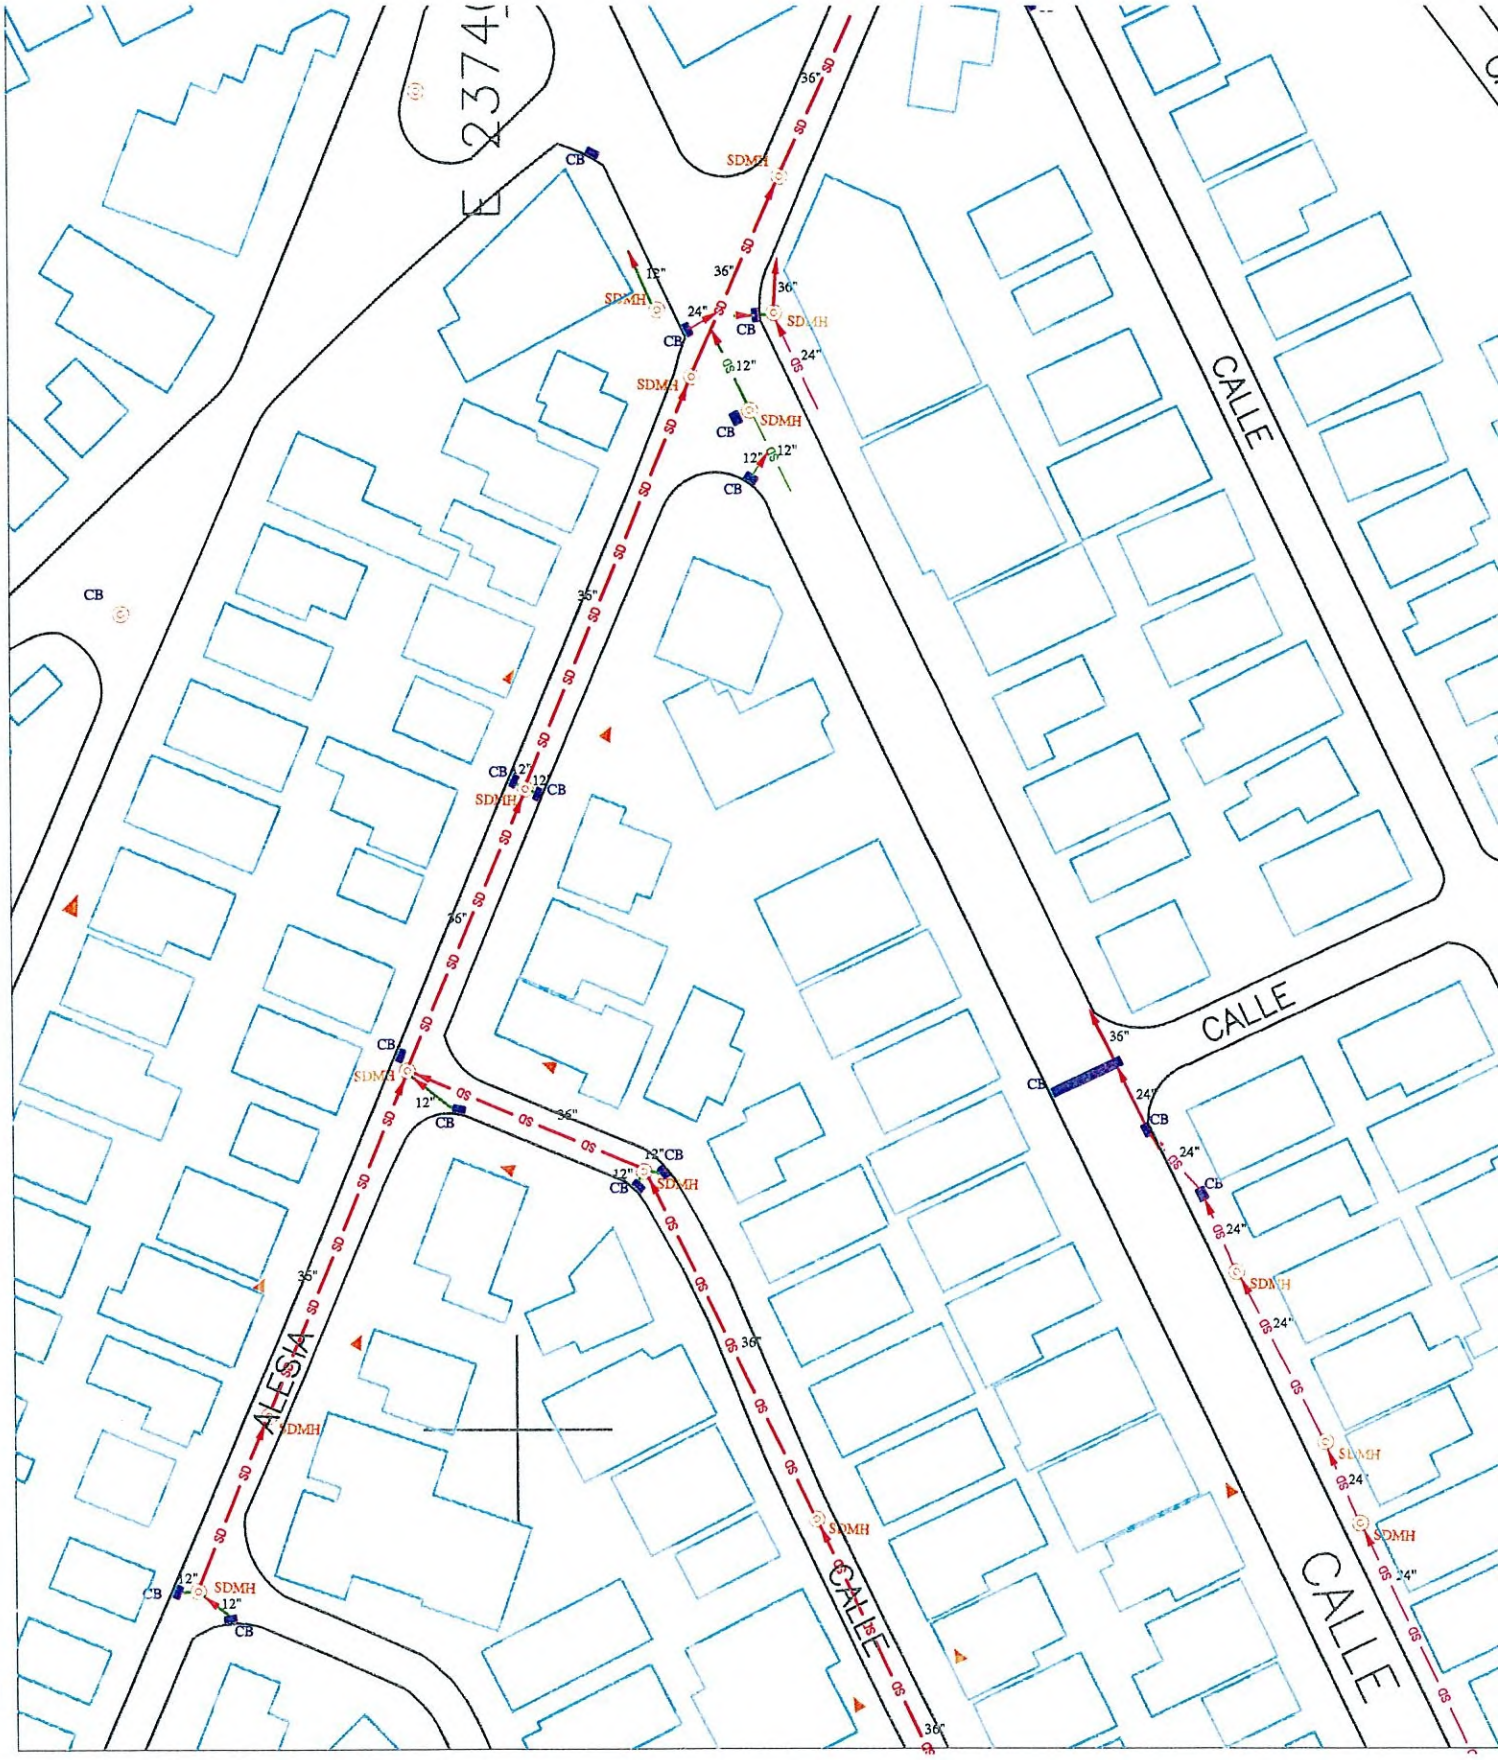
Notes:
NO PUDIMOS ACCEDER A LA SALIDA DEL TUBO POR QUE ESTA DETRAS DE PROPIEDAD PRIVADA, PERO CONFIRMAMOS LA DIRECCION DEL TUBO HACIA EL CANAL
