Re: EPA Reconnaissance Inspection December 19, 2018
Faztec Industries, Chelsea Road, Staten Island, NY
EPA NPDES No. NYU009854

Program: Industrial Stormwater	**Inspection Type:** Compliance Evaluation Inspection
Permittee Name: Faztec Inndustries	**NPDES/ICIS No.:** NYU009854
Inspection Entry Date: December 19, 2018 **Inspection Entry Time:** 2:50 PM	**Inspection Exit Date:** December 19, 2018 **Inspection Exit Time:** 3:10PM
Facility Information: Faztec Industires, 200 Bloomfiled Ave. Staten Island, NY 10314 Or 331 Edward Curry Avenue, SI NY 10314	**Lat, Long:** 40.611546°, -74.186653° **NAICS / SIC Code:** Primary SIC Code 5032, Brick, Stone, and Related Construction Materials
EPA Representative(s): Murray Lantner, P.E. Environmental Engineer, EPA Region 2, DECA-WCB. (212) 637-3976	
State Representative(s): None	
On-Site Facility Representative(s): Steve Falcone, General Manager, Faztec Industries, 718 494 1600	
Responsible Official: Steve Falcone, General Manager, Faztec Industries, 200 Bloomfield Ave. SI, NY 10314

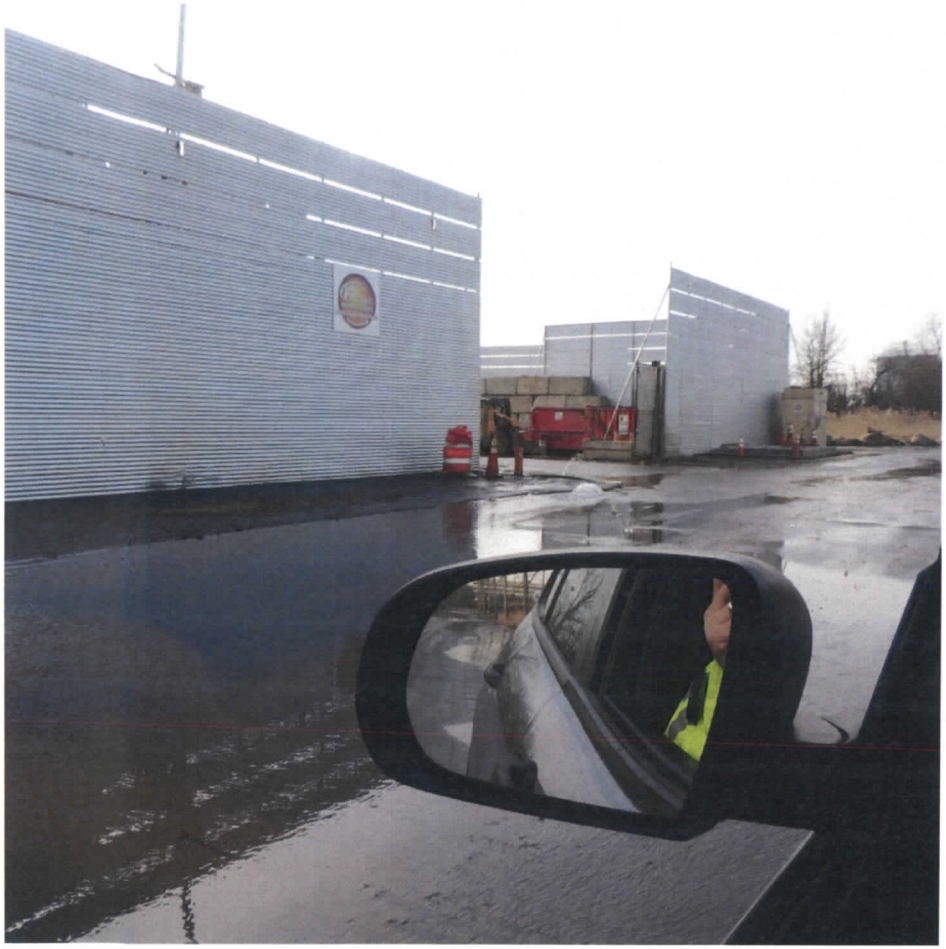
3. As shown in the photos 305 to 307, there was wheel wash water/dust suppression water flowing onto Bloomfield Avenue from the Facility. Facility should consider reducing its water discharges when not needed for dust suppression and road wash.

DSCN6305 – Entrance to Faztec Industries on Bloomfield Ave.
Hose running (for truck wheel wash/road washdown)
creating ponding on bloomfield Ave.

DSCN6306 - Entrance to Faztec Industries on Bloomfield Ave.
Hose running (for truck wheel wash/road washdown)
creating ponding on bloomfield Ave.

DSCN6307 - Entrance to Faztec Industries on Bloomfield Ave.
Hose running (for truck wheel wash/road washdown)
creating ponding on bloomfield Ave.
