Re: **Request for Information**
Docket No. CWA-IR-13-013
United Talmudic Academy of Kiryas Joel (UTA of KJ) - Bakertown Road, Kiryas Joel NY
NPDES Tracking Number: NYU400900
Tax Map Section 310- Block 1- Lots 4.14, 4.16, 4.171 Orange County, Town of Monroe, Village of Kiryas Joel

Water Compliance Inspection Report

A. INTRODUCTION

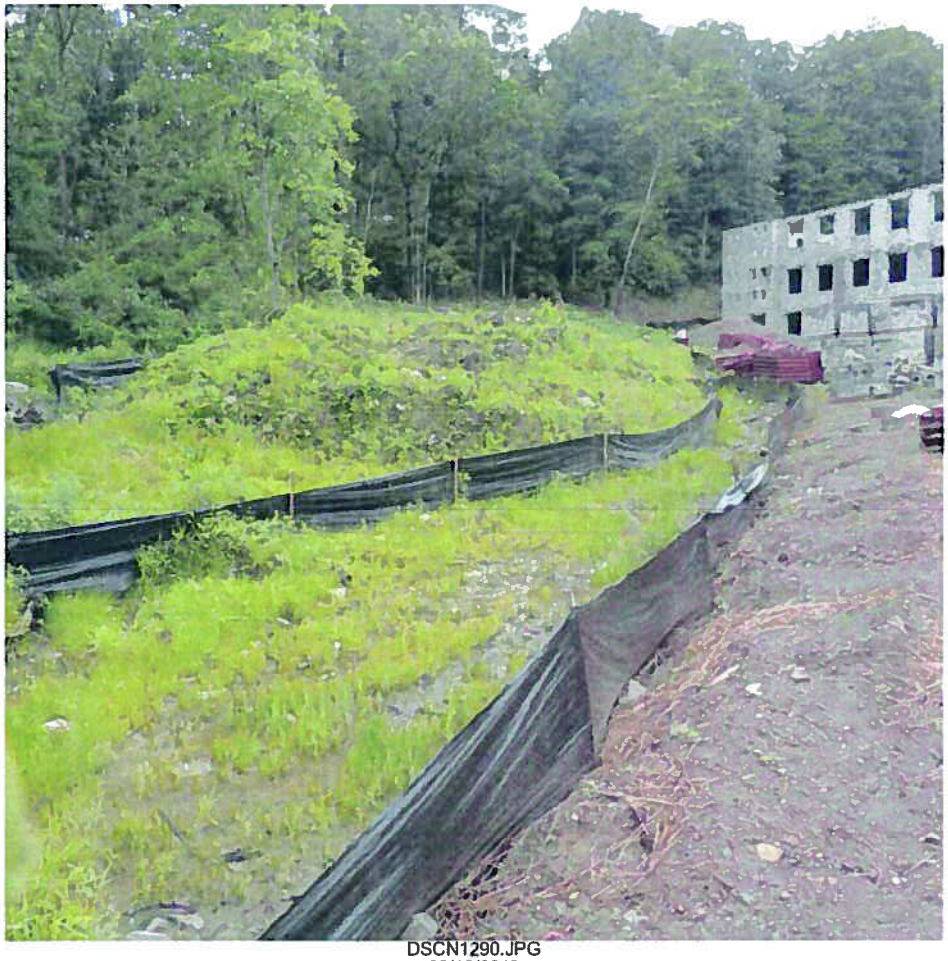
DSCN1289.JPG
06/13/2013

1. At multiple portions around the perimeter of the site, the silt fence was not properly buried into the ground and material from the site was able to flow beneath the gap in the silt fence via point sources (rivulets, eroded paths) directly into the unnamed tributaries of Highland Brook and directly into Highland Brook (See photographs DSCN1283 ("1283"), video 1284, photos 1285, 1289 1298, video 1299, 1300, 1314-1316, 1320, 1324 to 1333 among others). Photograph 1340 and 1341 shows a discharge point where channelized flow goes around the silt fence and enters Highland Brook at the site entrance into Highland Brook.

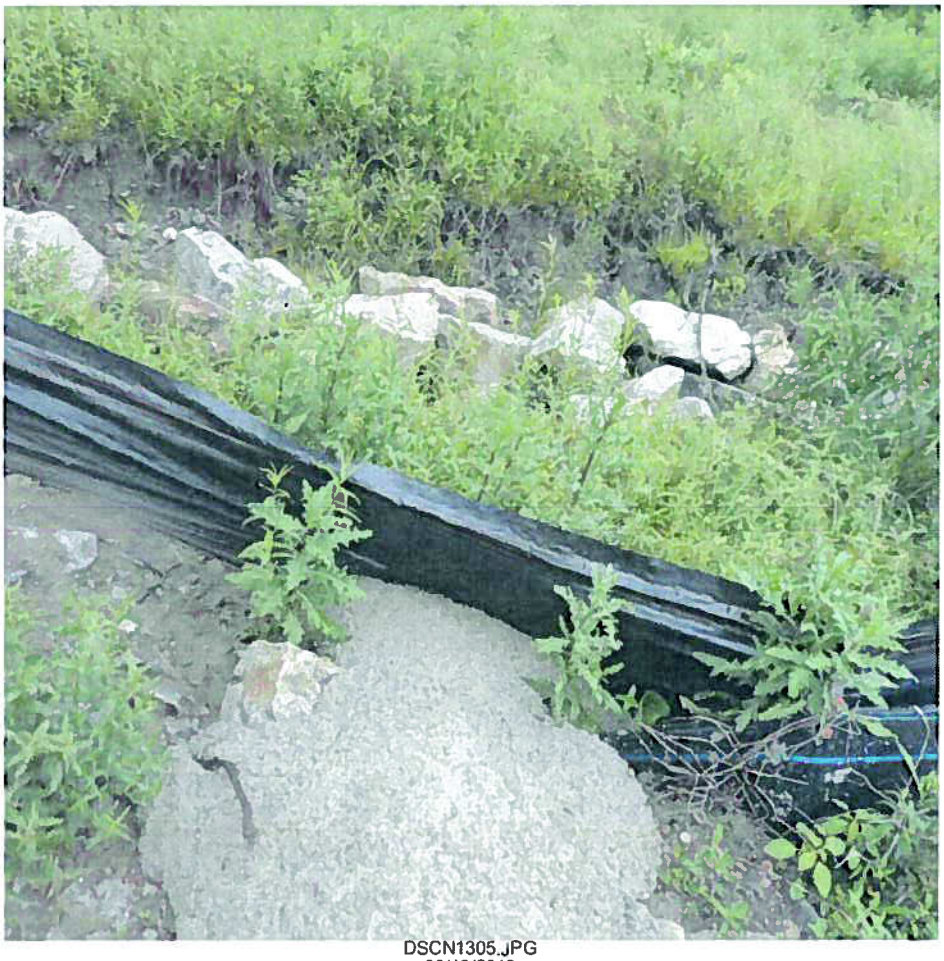
DSCN1304.JPG
06/13/2013

5. As shown in photos 1303 to 1305, there was apparent concrete washout from the site adjacent to a tributary of Highland Brook on the eastern side of the site. Part

DSCN1303	6/13/2013	Dried up flow of concrete visible on the left. Silt fencing and unnamed tributary of the Highland Brook on the eastern side of the site.
DSCN1304	6/13/2013	Dried up flow of concrete located on eastern side of the site near another unnamed tributary of Highland Brook.
DSCN1305	6/13/2013	Dried up flow of concrete. Another tributary is found beyond the silt fence on the east side of the site. The rocks are seen in the channel, water is seen in the channel.
DSCN1306	6/13/2013	Sediment/Soils overtopping the silt fencing into the unnamed tributary of Highland Brook with water/standing water on the eastern side of the site. Rocks from the construction site are clearly shown impeding any sort of flow.
DSCN1307	6/13/2013	Silt fence is improperly secured and is failing.
DSCN1308	6/13/2013	Flow path on the East side of the site that goes under the silt fence into the unnamed tributary of Highland Brook on the east side of the site.

B.1.j requires proper pollution prevention measures for the disposal of construction waste to prevent stormwater pollution.

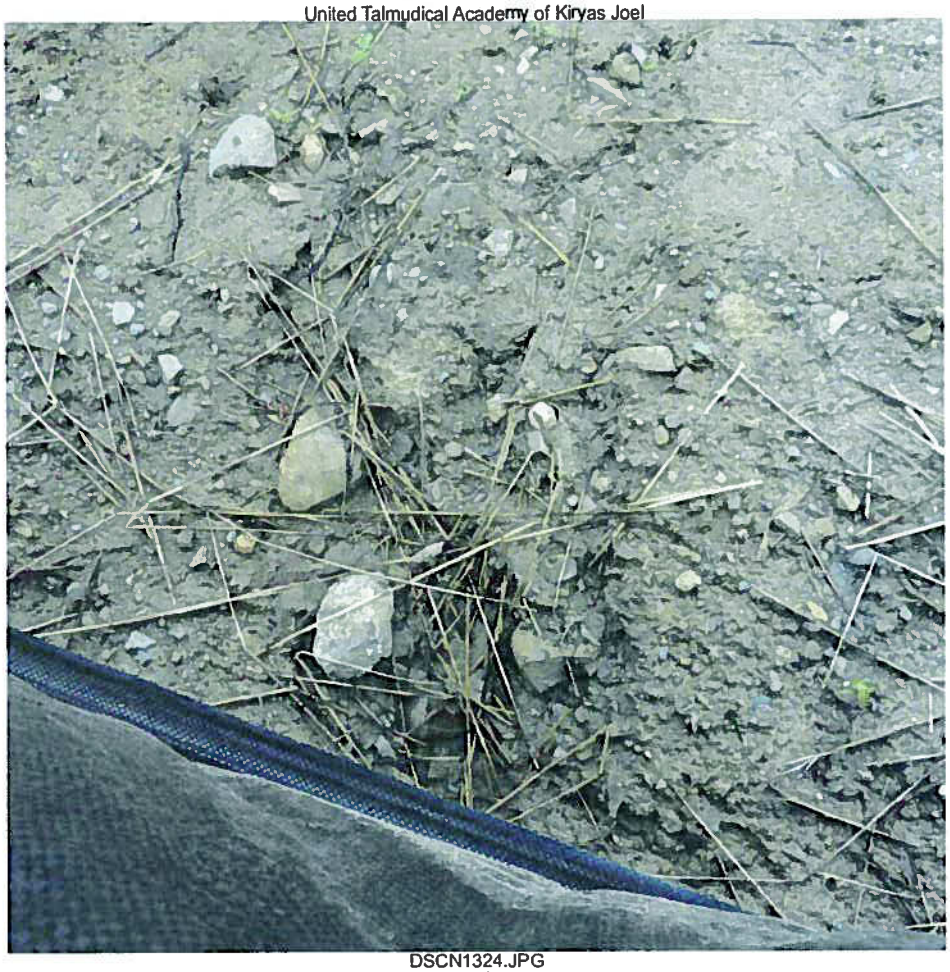
DSCN1323.JPG
06/13/2013

DSCN1323	6/13/2013	Silt fence crossing over the northern portion of the unnamed tributary on the western side of the site. This is not an appropriate installation of the silt fence. Vegetated material storage pile seen beyond the silt fence on western side of site.
DSCN1324	6/13/2013	Flow pathway under the silt fence into the unnamed tributary on the western side of the site.
DSCN1325	6/13/2013	Flow channel cut under the silt fence by flowing water.
DSCN1326	6/13/2013	Flow channel cut under the silt fence by flowing water.
DSCN1327	6/13/2013	Flow channel cut under the silt fence by flowing water.
DSCN1328	6/13/2013	Flow pathway under the silt fence into the unnamed tributary on the western side of the site.
DSCN1329	6/13/2013	Unnamed tributary on western side of site and silt fencing. Gaps are visible under the silt fence.
DSCN1330	6/13/2013	Flow path that extends from under the construction material to beyond the silt fencing on the western side of the site.

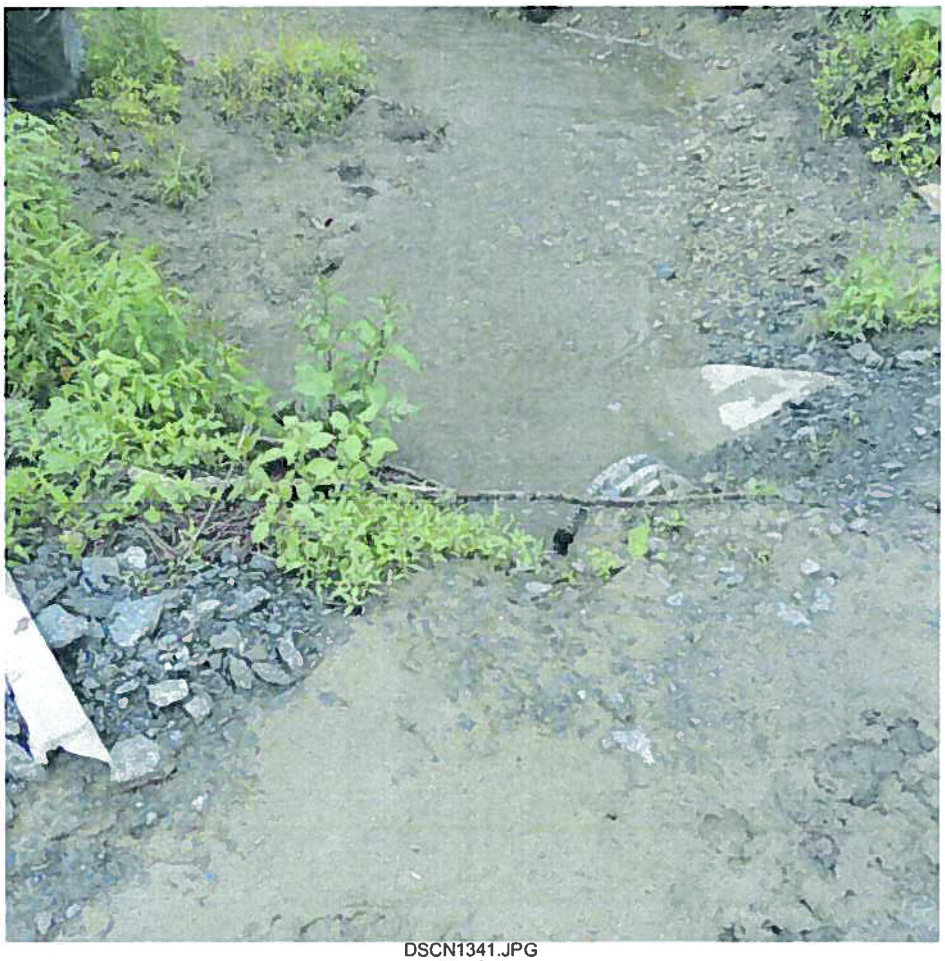
DSCN1340.JPG
06/13/2013

DSCN1340	6/13/2013	Multiple water runoff pathways are able to carry sediments under and around the silt fence into the flowing Highland Brook at the site entrance.
DSCN1341	6/13/2013	Signs of sediment being washed around the silt fence into Highland Brook are visible at the site entrance.
