EPA 550-R-98-001
March 1998
www.epa.gov

EPA CHEMICAL ACCIDENT INVESTIGATION REPORT

Pennzoil Product Company Refinery Rouseville, Pennsylvania

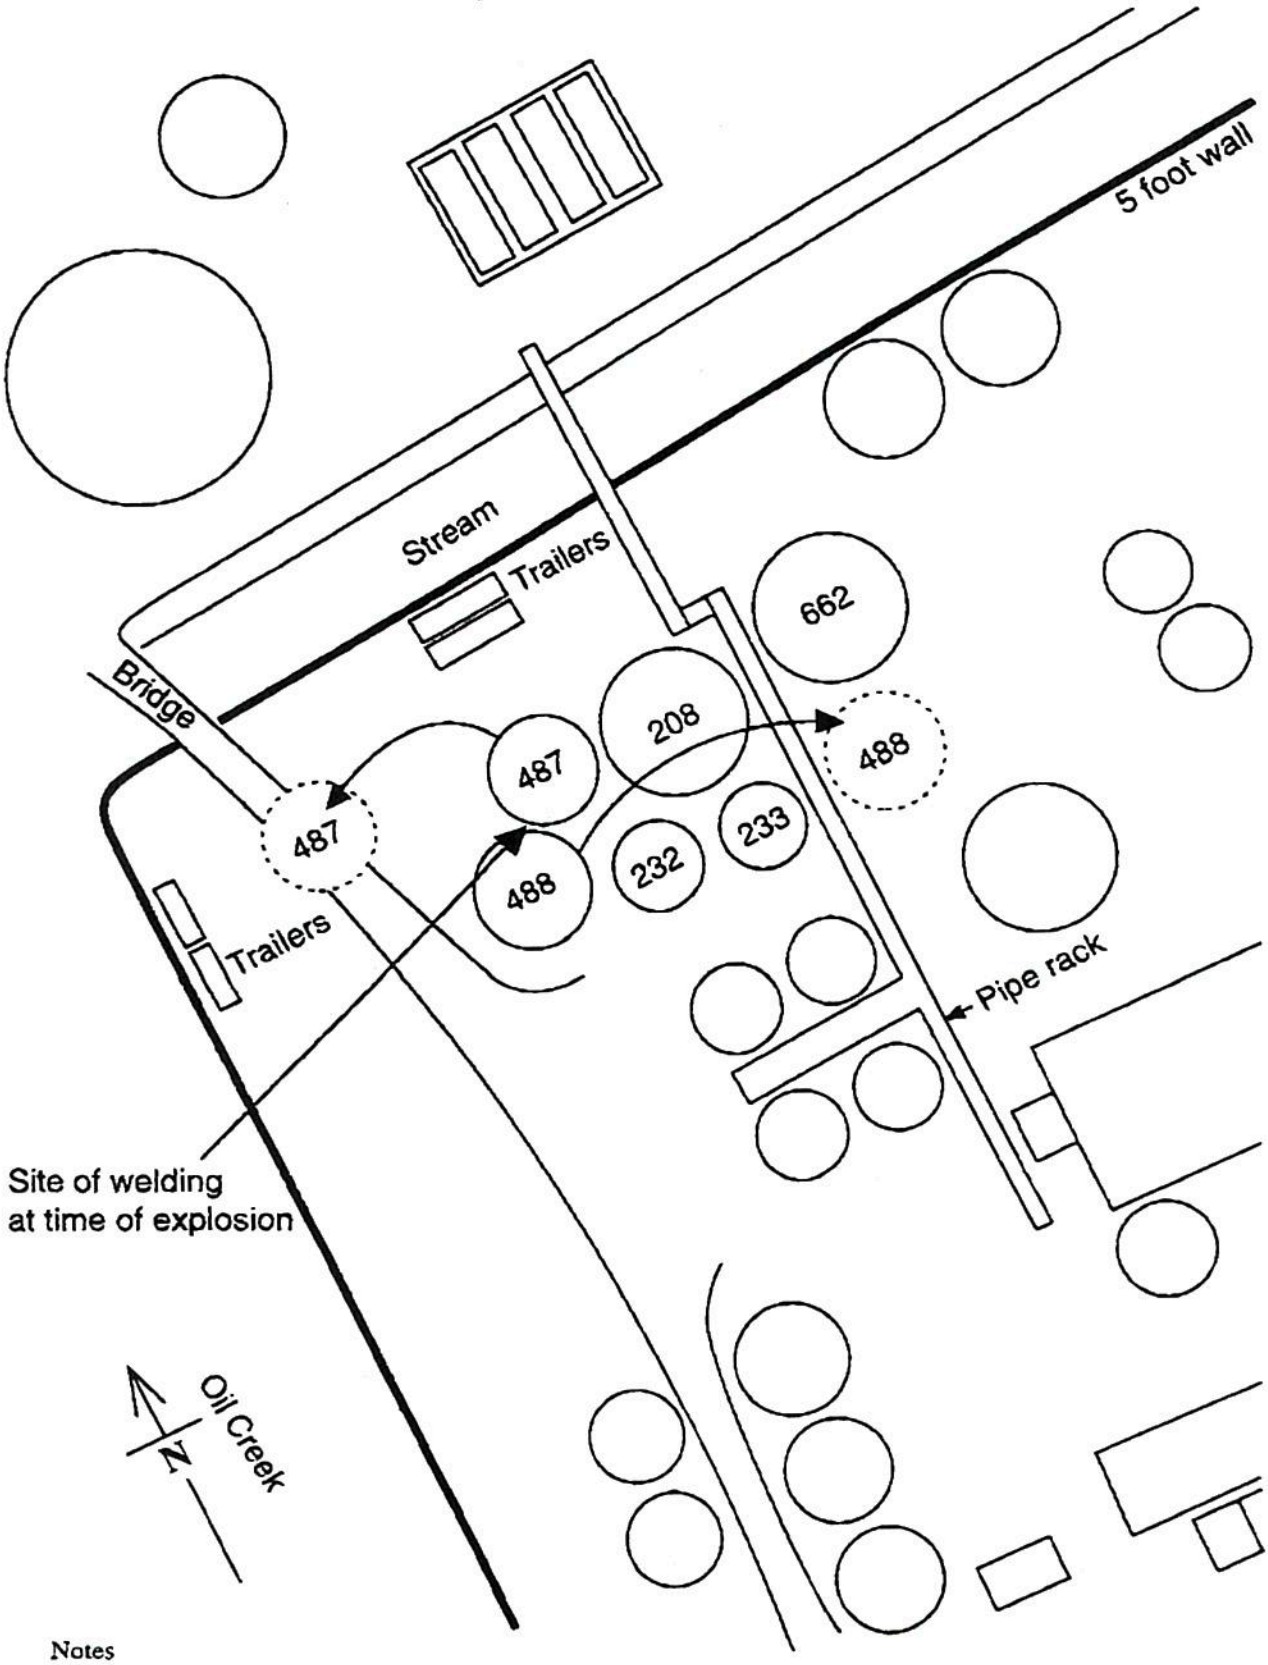
Exhibit 3
Area of Explosion and Fire at Pennzoil Refinery

Notes
Curved lines indicate trajectory of tanks 487 and 488
Tanks 487 and 488: Oil and water mixture
Tank 208: Naptha; burned in place
Tank 662: Empty, being cleaned
Tanks 232, 233: No. 6 fuel oil (thick, heavy oil)

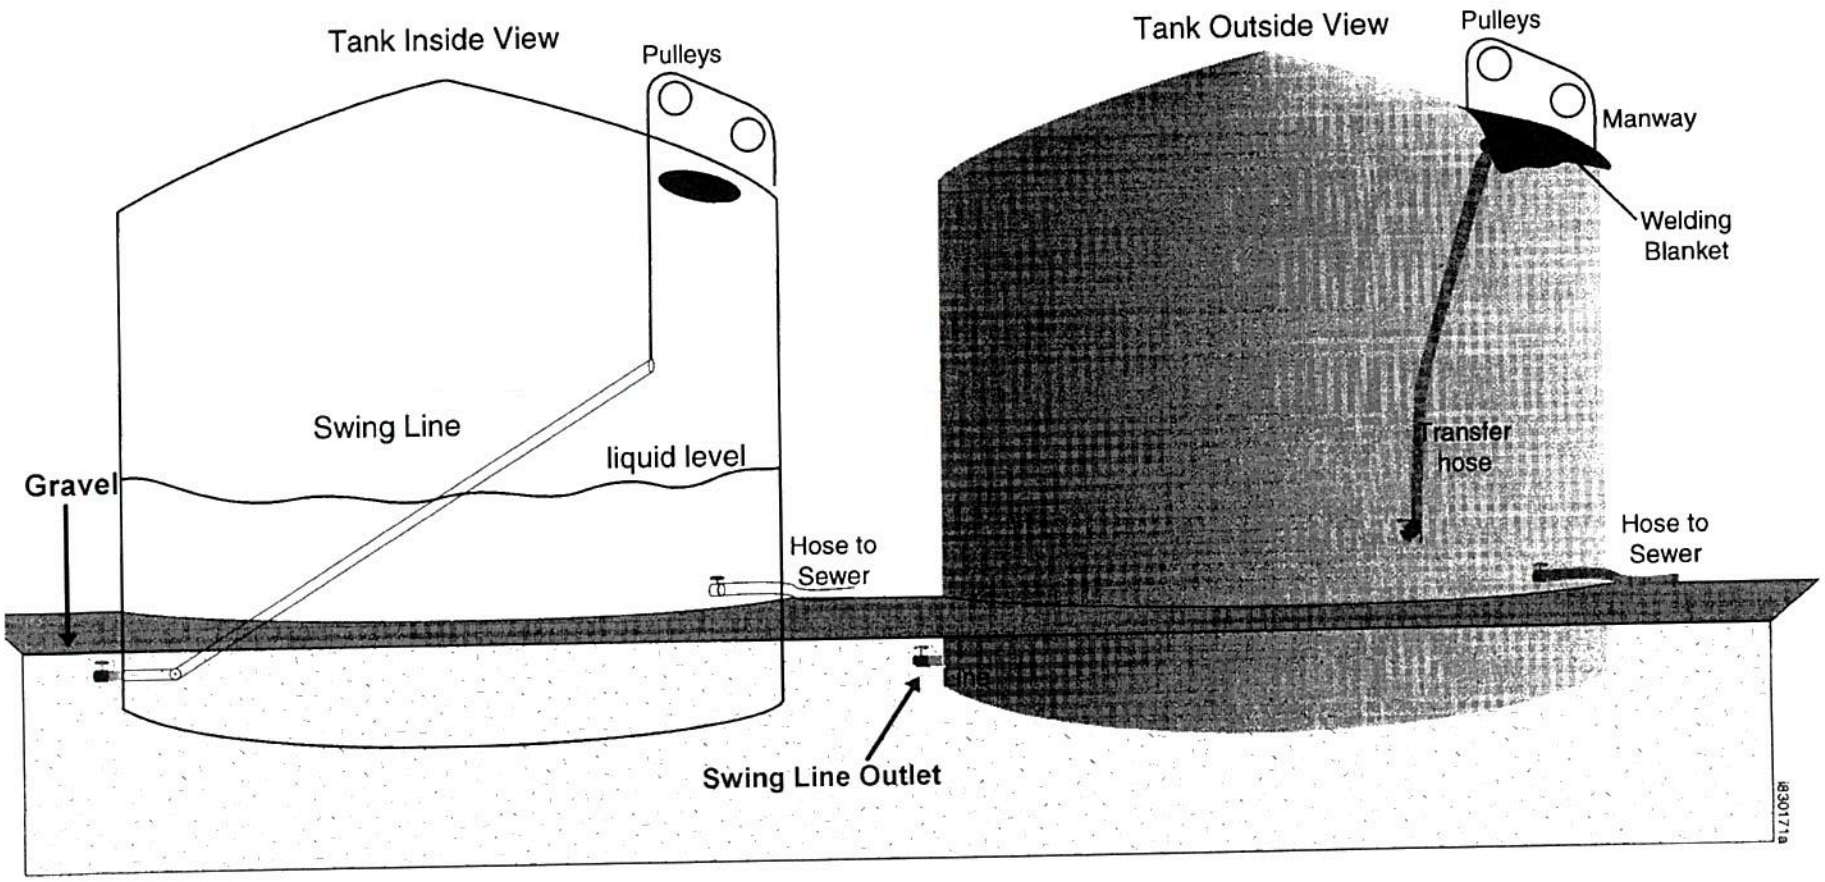
Exhibit 4
Inside and Outside Views of Tank 487

Vapor Escaping from Holes in Tank. After the explosion and fire, investigators discovered some holes up to a quarter inch in diameter, presumed to be from corrosion, near the top of the tank. If these holes were present before the explosion, they could have provided a route for vapor release and flame front flashback (see Exhibit 7). However, ignition sources would need to be very close to ignite the small amount of diluted vapor expected from this

2. Tanks 487 and 488 failed along their bottom seams, releasing their entire contents. There was evidence of corrosion along the bottom seam. The roofs of these tanks had been replaced since initial construction but the CAIT has no other information about whether these tanks were properly inspected or maintained on a routine basis.

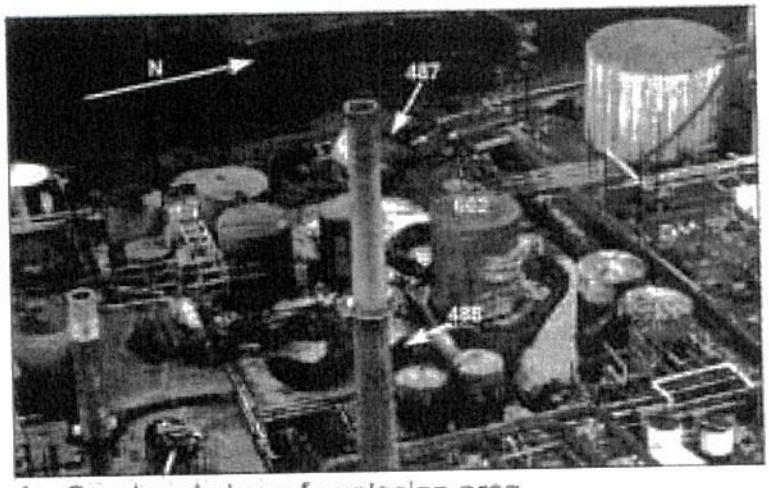
Exhibit 5
Photographs of Explosion Area

A. Overhead view of explosion area.

B. Dips in ground showing the original site of tanks 487 & 488. Tank 487 in background.

- The bottoms of the tanks at the shell wall seam may have been weakened through corrosion. The tanks generally contained water at the bottom. Gravel was also built up around the bottoms and sides of the tanks, which may have allowed moisture to collect on the outside, on the bottom and tank wall edge, leading to corrosion and weakening of the bottom seam at the shell wall. (Evidence of this gravel can be seen in Exhibit 5-B, which shows the indentations left in the ground by tanks 487 and 488.)

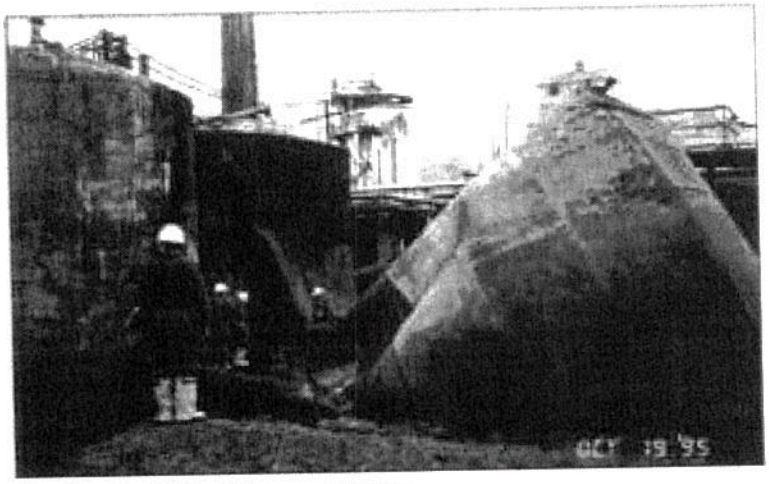
C. Tank 488, after explosion.

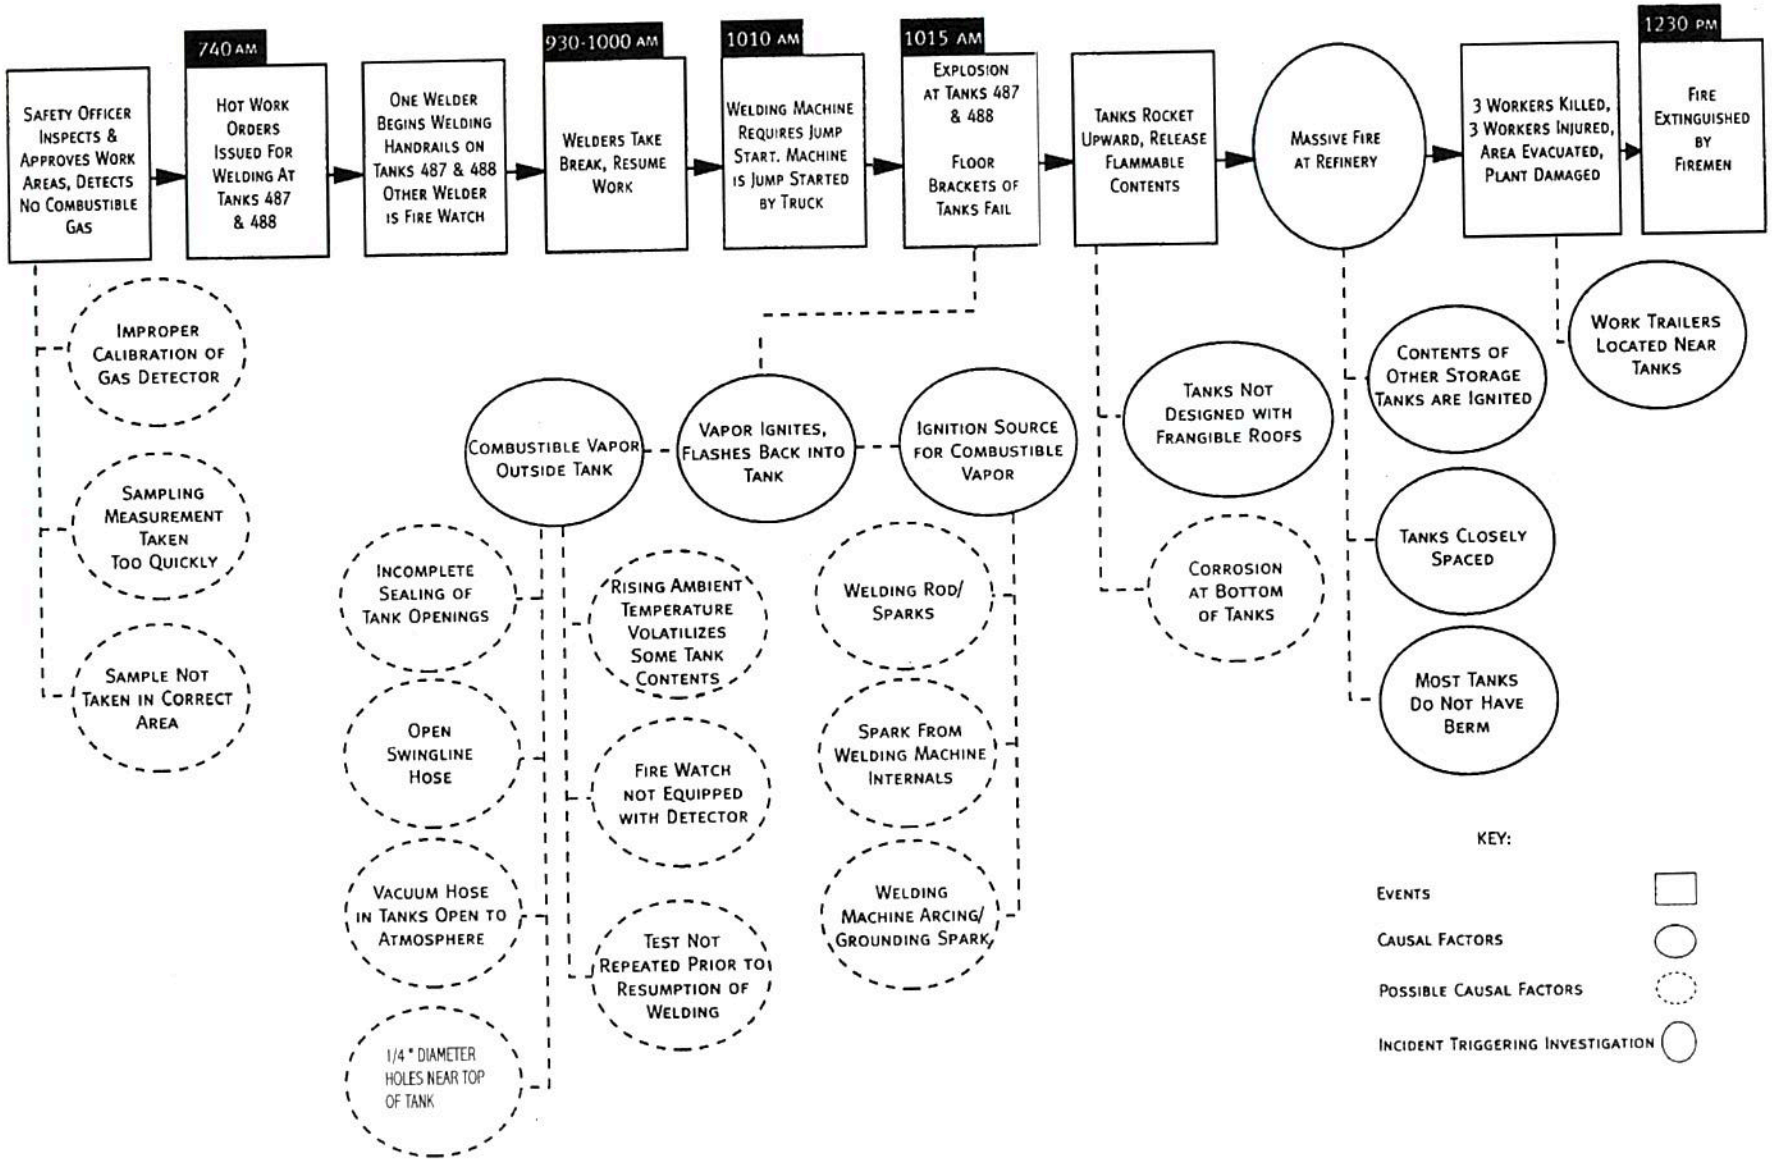
Exhibit 6
Event and Causal Factors Diagram
October 16, 1995 Explosion of Tanks 487 & 488 at Pennzoil Refinery - Rouseville, PA

- Following ignition of vapors, the storage tanks failed along their bottom seam and lifted off their base, releasing their contents.

- Once released, the burning liquid flowed without restriction to other areas nearby involving trailers, storage tanks and other equipment in the fire; and

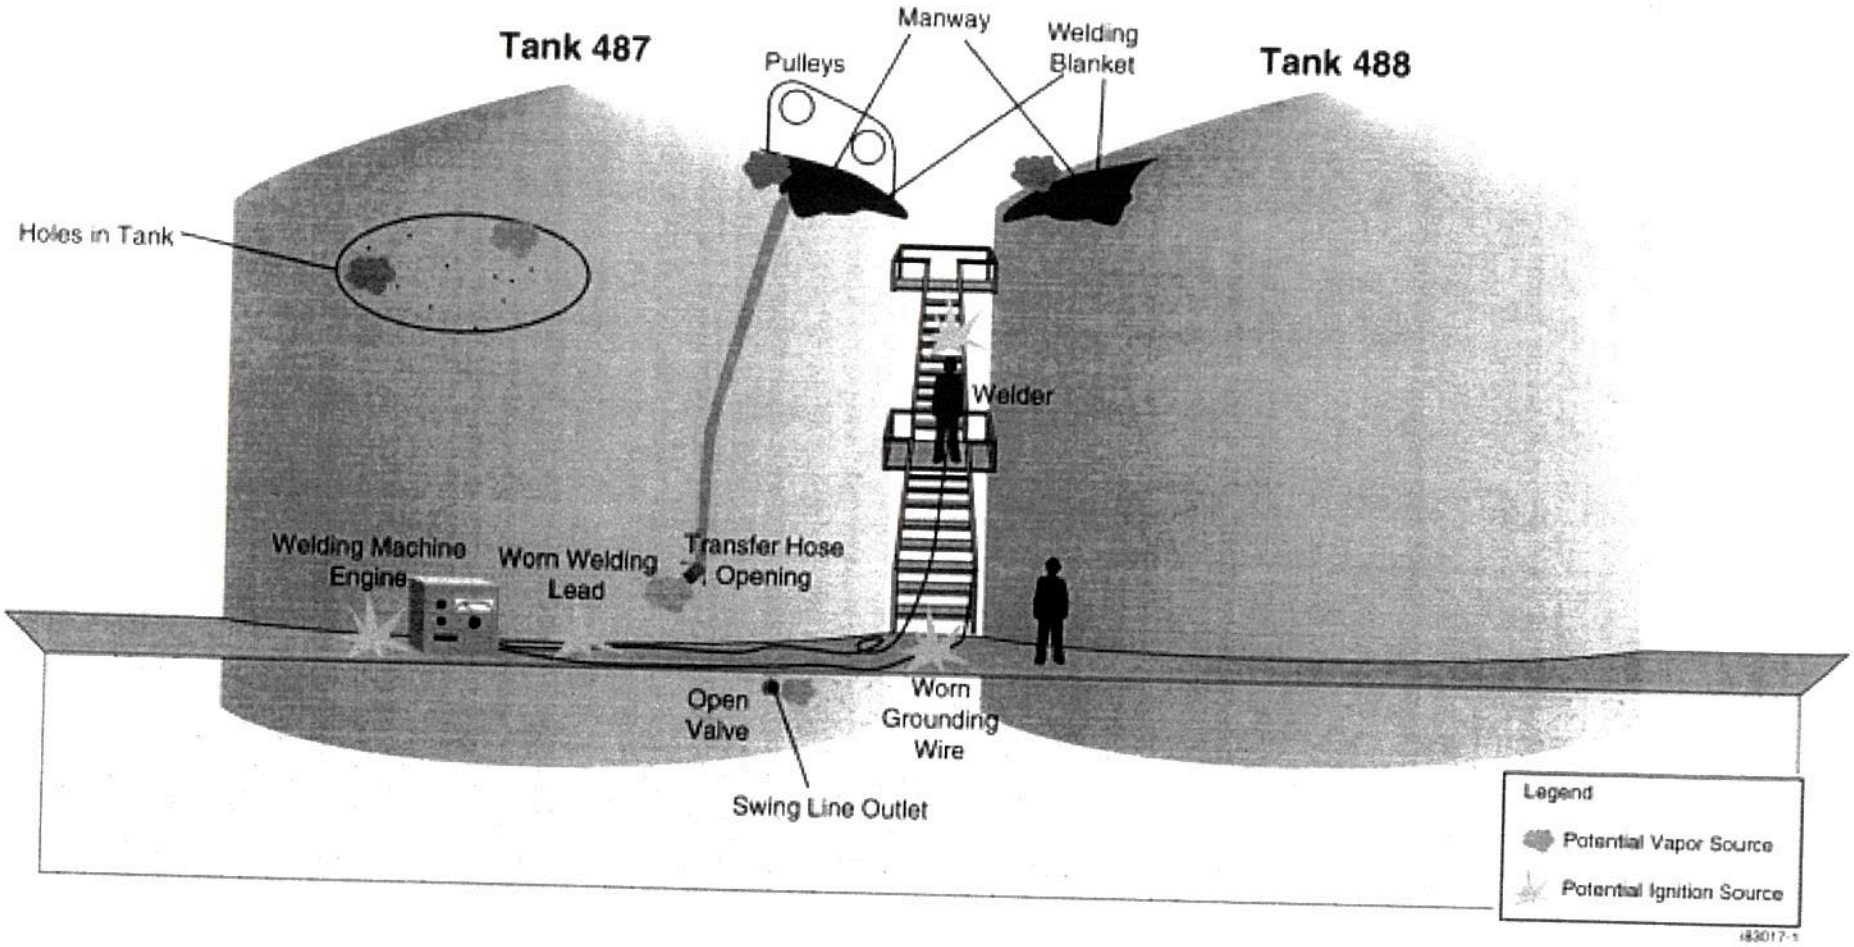
Exhibit 7
Pennzoil Tank Explosion:
Potential Vapor and Ignition Sources at Tanks 487 & 488

Vapor Escaping from Swingline. The swingline could have provided a route for vapor release (see Exhibit 7). The swingline portion inside the tank was raised above the liquid level in the tank vapor space. Investigators found after the accident that the outside valve near the base of the tank connected to the swingline inside the tank was open. As above, as the tank warmed, if sufficient driving force was present, undiluted heavier-than-air flammable vapors could have been pushed out through the swingline and open valve. If there was little or no wind, these dense vapors could have collected at grade level near ignition sources (see below). After ignition, the flame front could have flashed back through the swingline, igniting vapors in the tank. However, the end fitting on the swingline valve outside the tank was buried under the soil. Further, inspection of the inside of the swingline, after the accident, revealed no evidence of burn or scorch marks.

- The welding rod or sparks from hot slag or spatter possibly could have caused ignition of vapors present, if welding had been started (see Exhibit 7 for employee accounts of the position of the welder). During welding, flux coating the welding rod burns off. The welding rod being used by the welder was found after the accident and inspection revealed that flux on the tip was not burned off; however, there could have been an instantaneous arc, which could have caused ignition, but could have been of such short duration that the flux was not burned off. Or, the welding gun may have been dropped or kicked against the stairway causing an arc. However no evidence was discovered (e.g. arc marks) to support this scenario. Flammable and combustible materials are often ignited during hot work; generally, the material ignited is in the equipment being worked on. It is relatively rare for hot work to ignite a vapor cloud (Lees, 1996).
