Subject: Phase II Soil Investigation Report for the Jervis B. Webb Company Property at 5030 Firestone Boulevard in South Gate, California (EKI 961025.02)

Phase II Soil Investigation Report

5030 Firestone Boulevard
South Gate, California

Phase II Soil Investigation Report
Jervis B. Webb Company Property
5030 Firestone Boulevard, South Gate, California

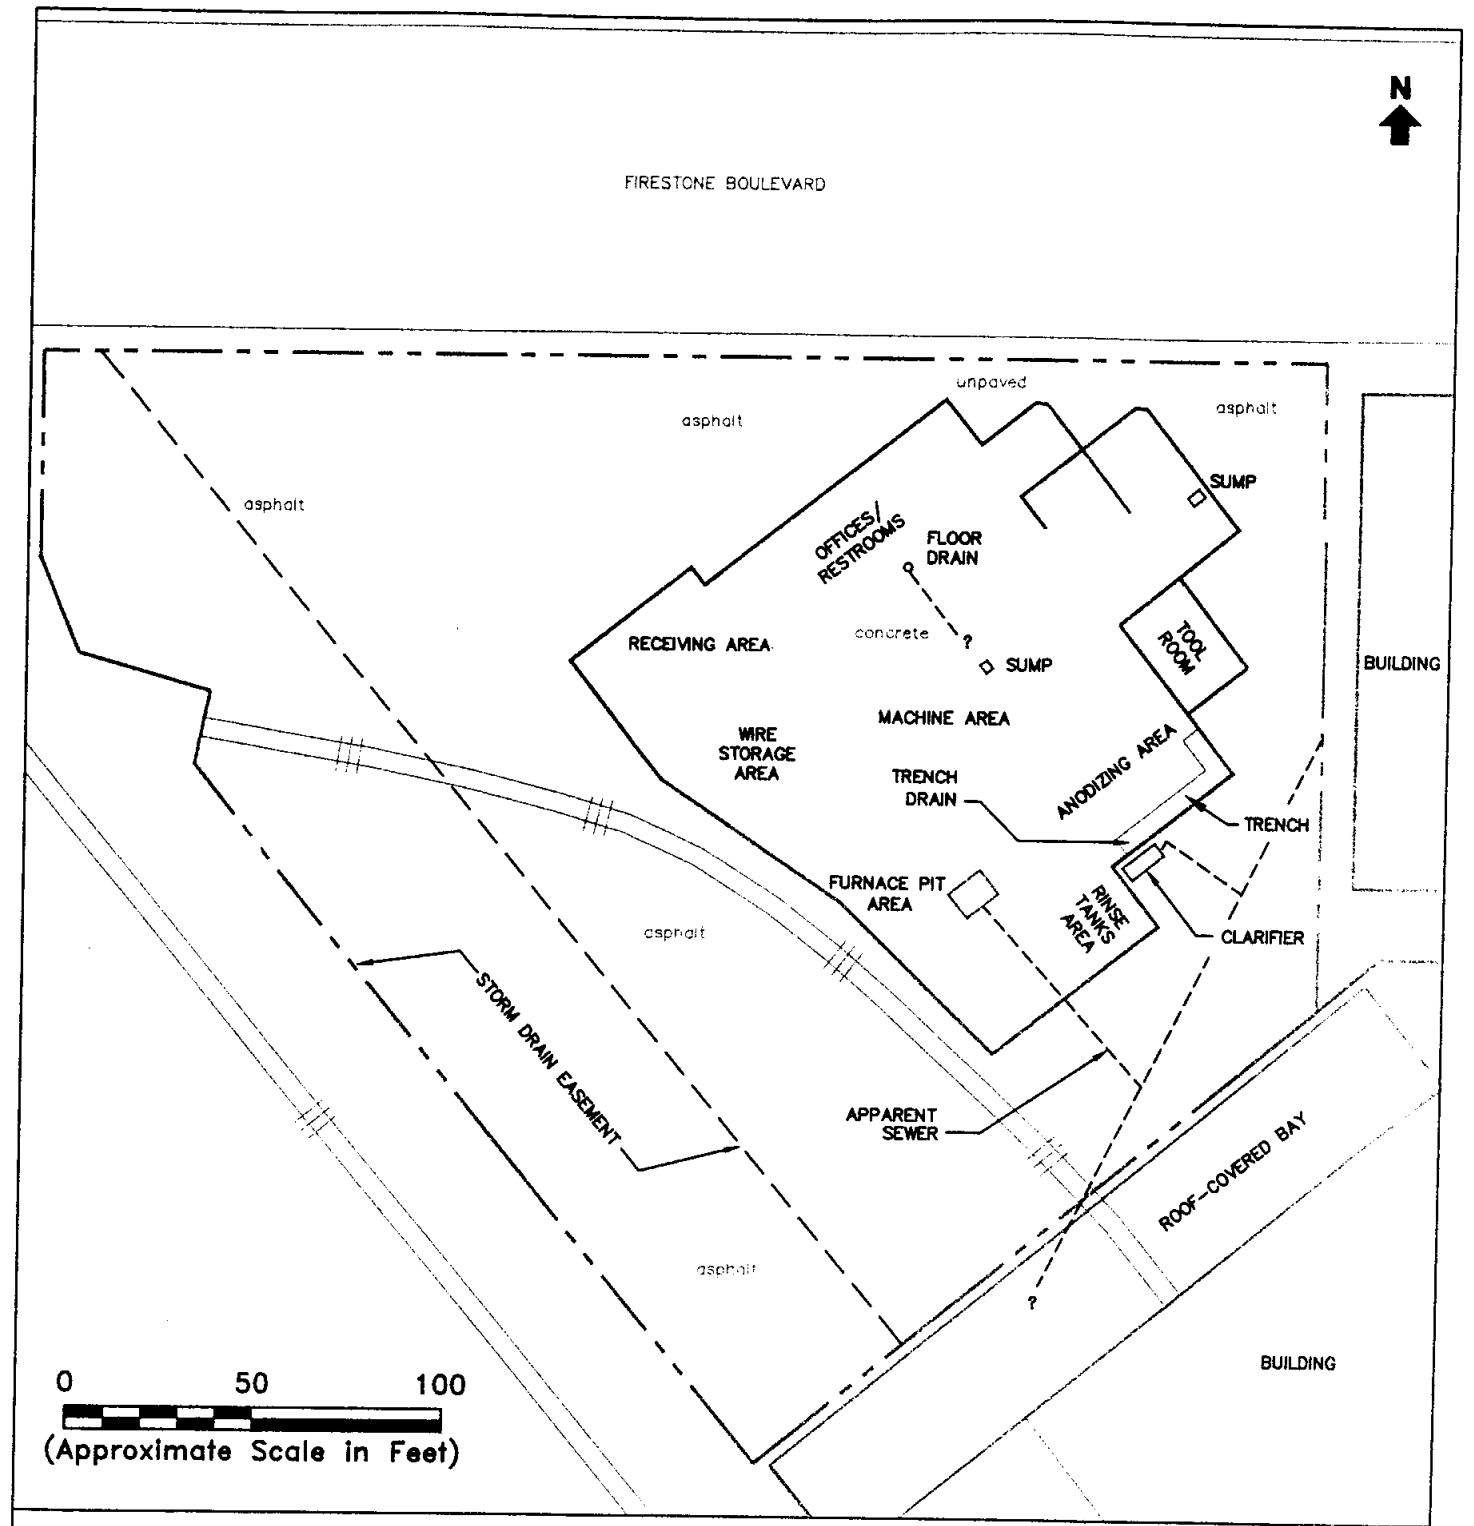
Jervis B. Webb Company
South Gate, CA
February 1998
EKI 961025.02
Figure 2

Just outside an inset corner on the southeast side of the building, under an overhanging roof, is a three stage clarifier approximately 4-feet wide by 8-feet long in area (see Figure 2). Based on a detail shown on the Plumbing Plan, the clarifier is approximately 4-feet deep. The structure is set in a concrete pad that rises approximately six inches above the surrounding asphalt area. A sample collection box at the northeasterly end of the clarifier was observed to be filled with concrete. The main chambers of the structure were observed to be filled with sand and covered with steel plates. No plumbing for the clarifier was visible at the surface on the outside of the building. Following Blake, this area was later used by Webb for temporary storage of drums of hazardous materials before the drums were transported off-site for disposal. No drums or other materials were present at this location during the walk-through.

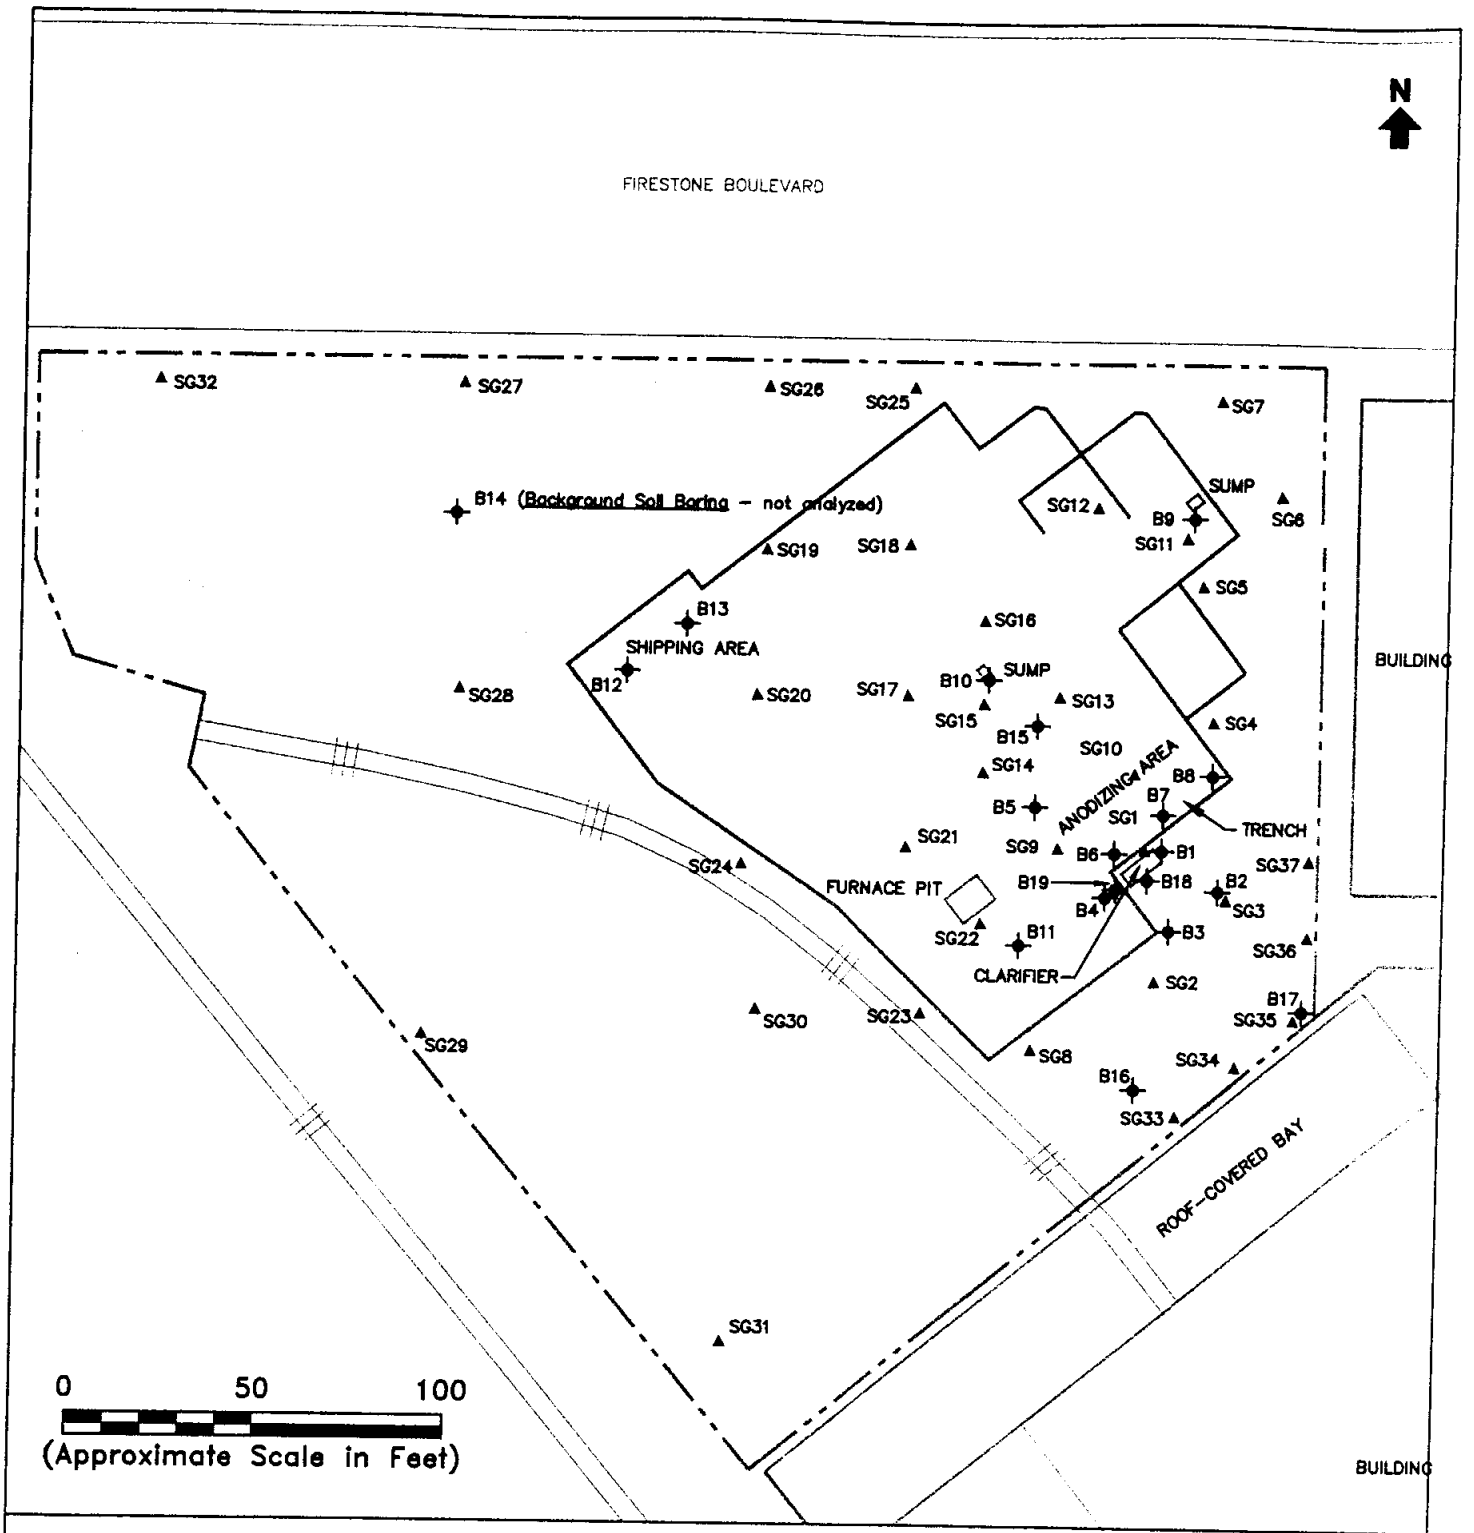
Jervis B. Webb Company
South Gate, CA
February 1998
EKI 961025.02
Figure 3

Fourteen soil borings (B1 through B14) were completed as part of the October 1997 soil investigation (see Figure 3). Eleven soil borings were located in the central and southerly portions of the Property near the location of the clarifier, the former anodizing area, the former furnace pit, and near several suspected underground structures (described in Section 3.6.2.). Two additional soil borings (B12 and B13) were located in the northwest corner of the building in the former wire storage/receiving area, where additional concrete patches were observed by EKI. A final soil boring (B14) was installed in the parking lot north of the building for the purpose of collecting background soil samples for potential analysis of CCR-Metals pending results for soil samples collected in the former anodizing and clarifier areas. Samples from boring B14 were not analyzed.

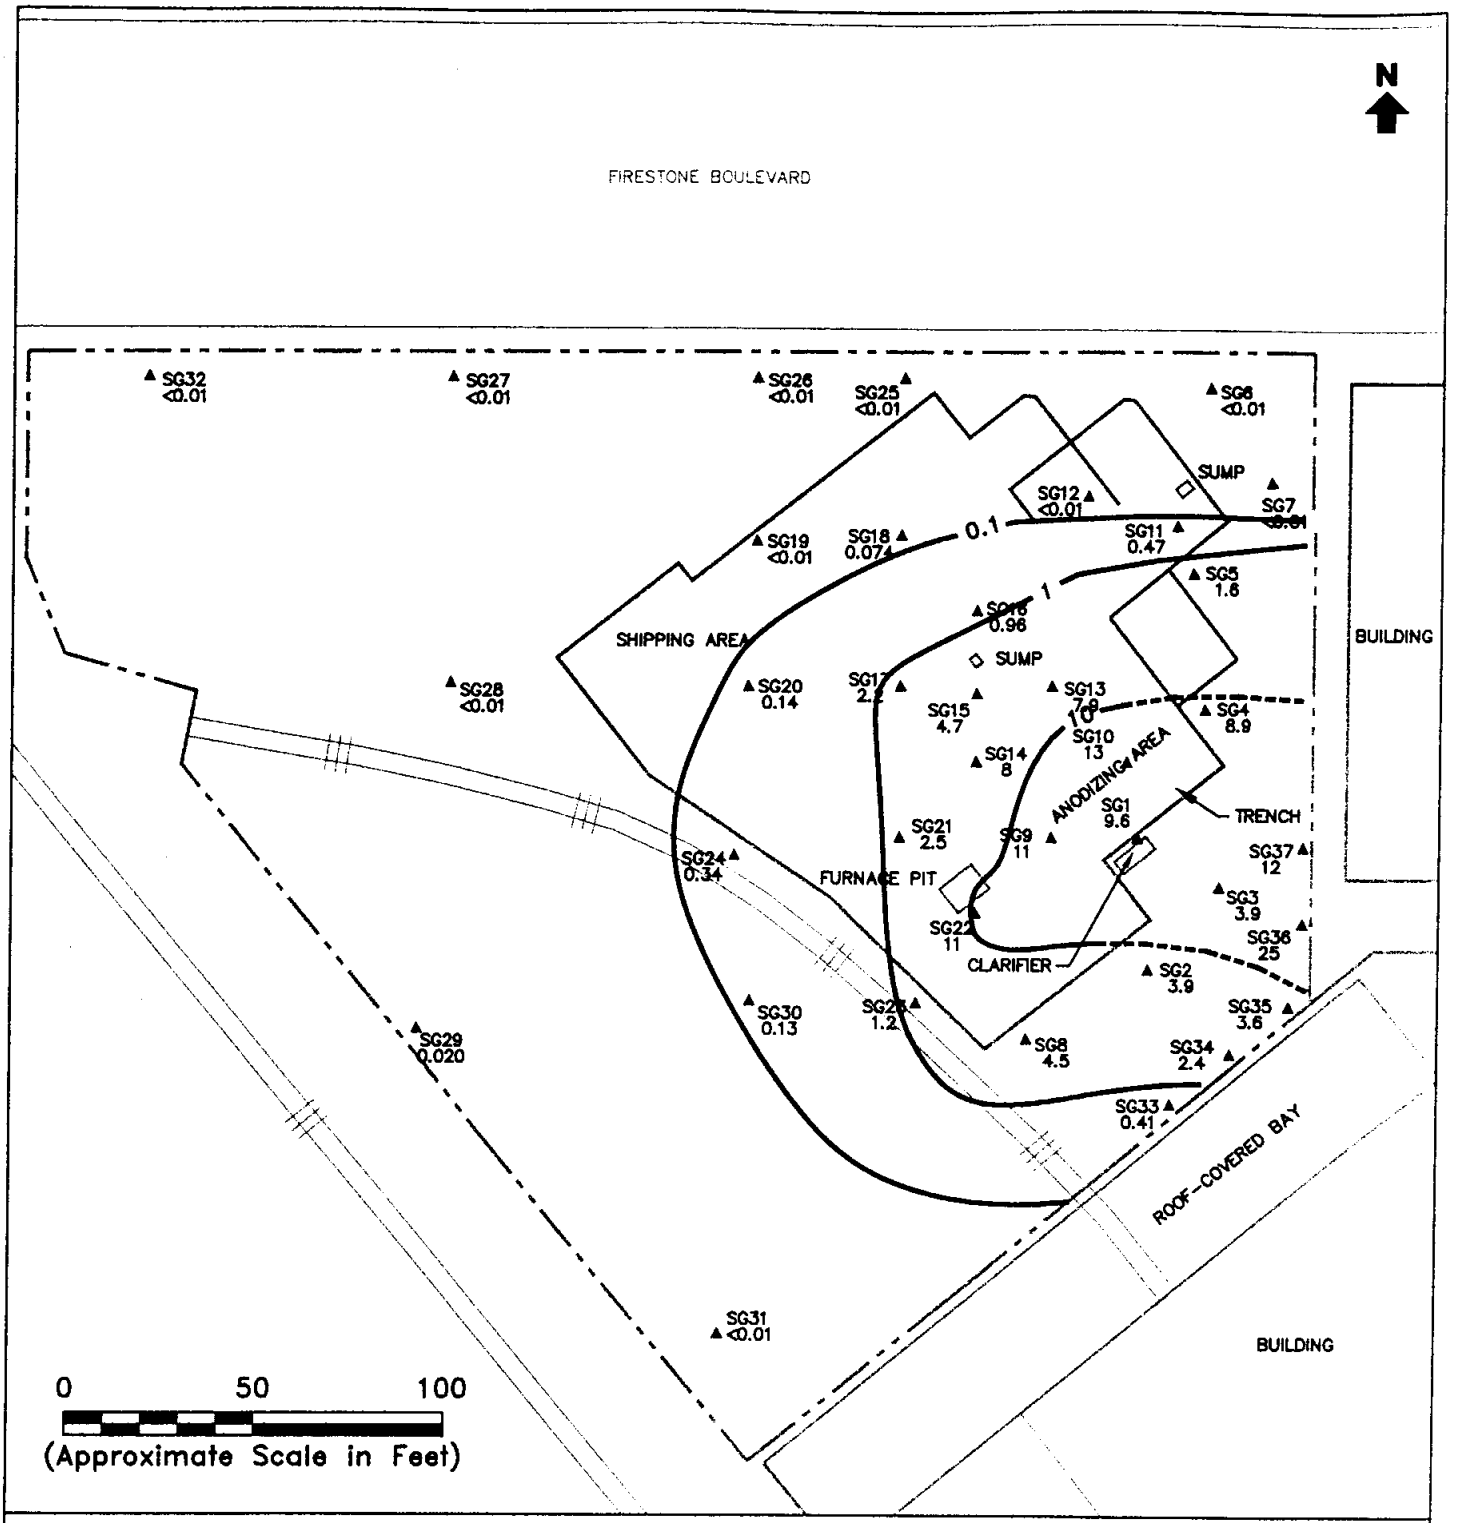
Jervis B. Webb Company
South Gate, CA
February 1998
EKI 961025.02
Figure 4

Concentrations of TCE detected in samples of shallow soil gas ranged from 0.13 ug/L to 25 ug/L. As shown on Figure 4, the highest concentrations of TCE were detected in samples of soil gas collected in the southeast corner of the Subject Property. The highest soil gas detection of TCE was from the sample collected from location SG36, located at the boundary of the Subject Property (Figure 3). Soil gas samples collected from points immediately surrounding the clarifier were found to contain TCE at concentrations ranging from 3.9 ug/L at location SG3 to 13 ug/L at location SG10.

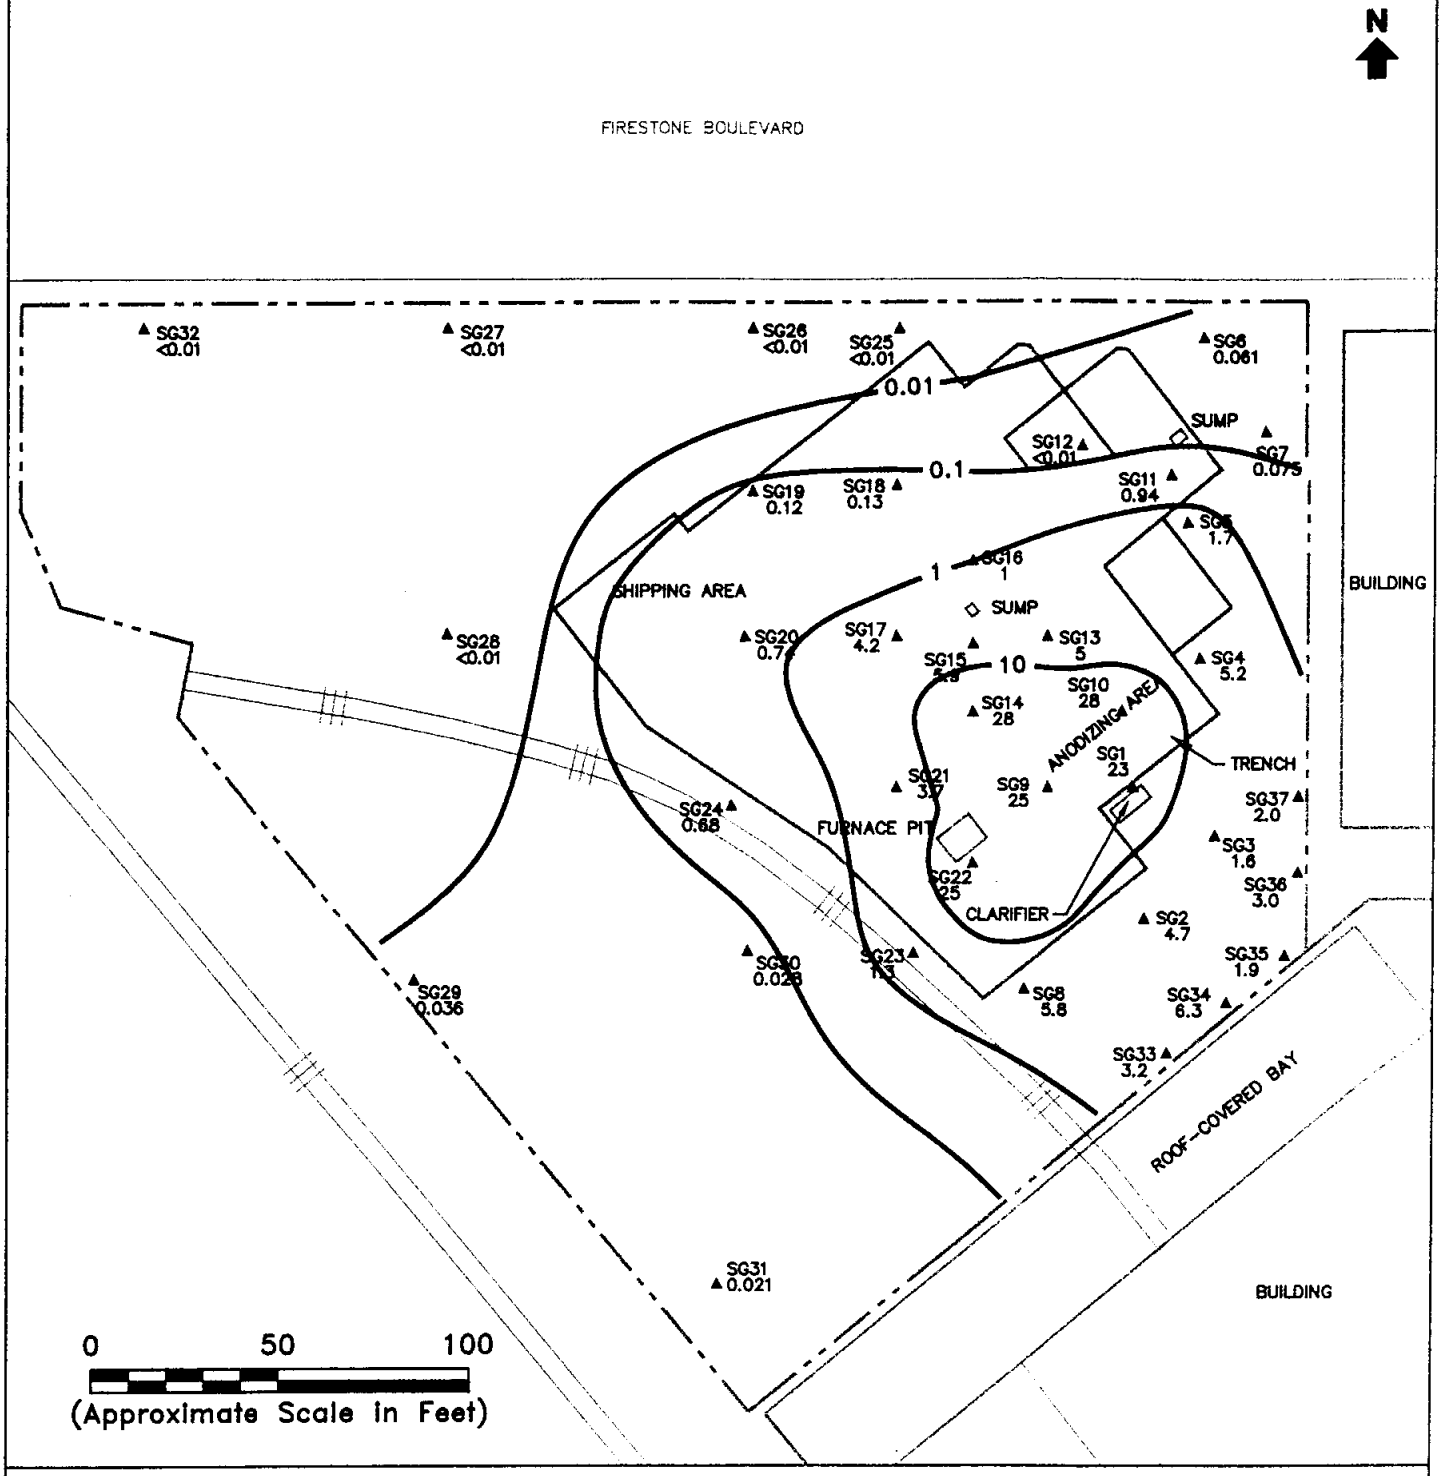
Jervis B. Webb Company
South Gate, CA
February 1998
EKI 961025.02
Figure 5

Concentrations of PCE detected in samples of shallow soil gas ranged from 0.021 ug/L to 28 ug/L. As shown on Figure 5, the highest concentrations of PCE were detected samples of soil gas collected in the southeast corner of the Subject Property. The highest soil gas detection of PCE was from the sample collected from location SG10, located approximately 10 feet northeast of the anodizing area trench (Figure 3). Soil gas samples collected from points in the clarifier area were found to contain PCE at concentrations ranging from 1.6 ug/L at location SG3 to 28 ug/L at location SG10 (Figure 3).

Concentrations of PCE Detected in Shallow Soil Gas

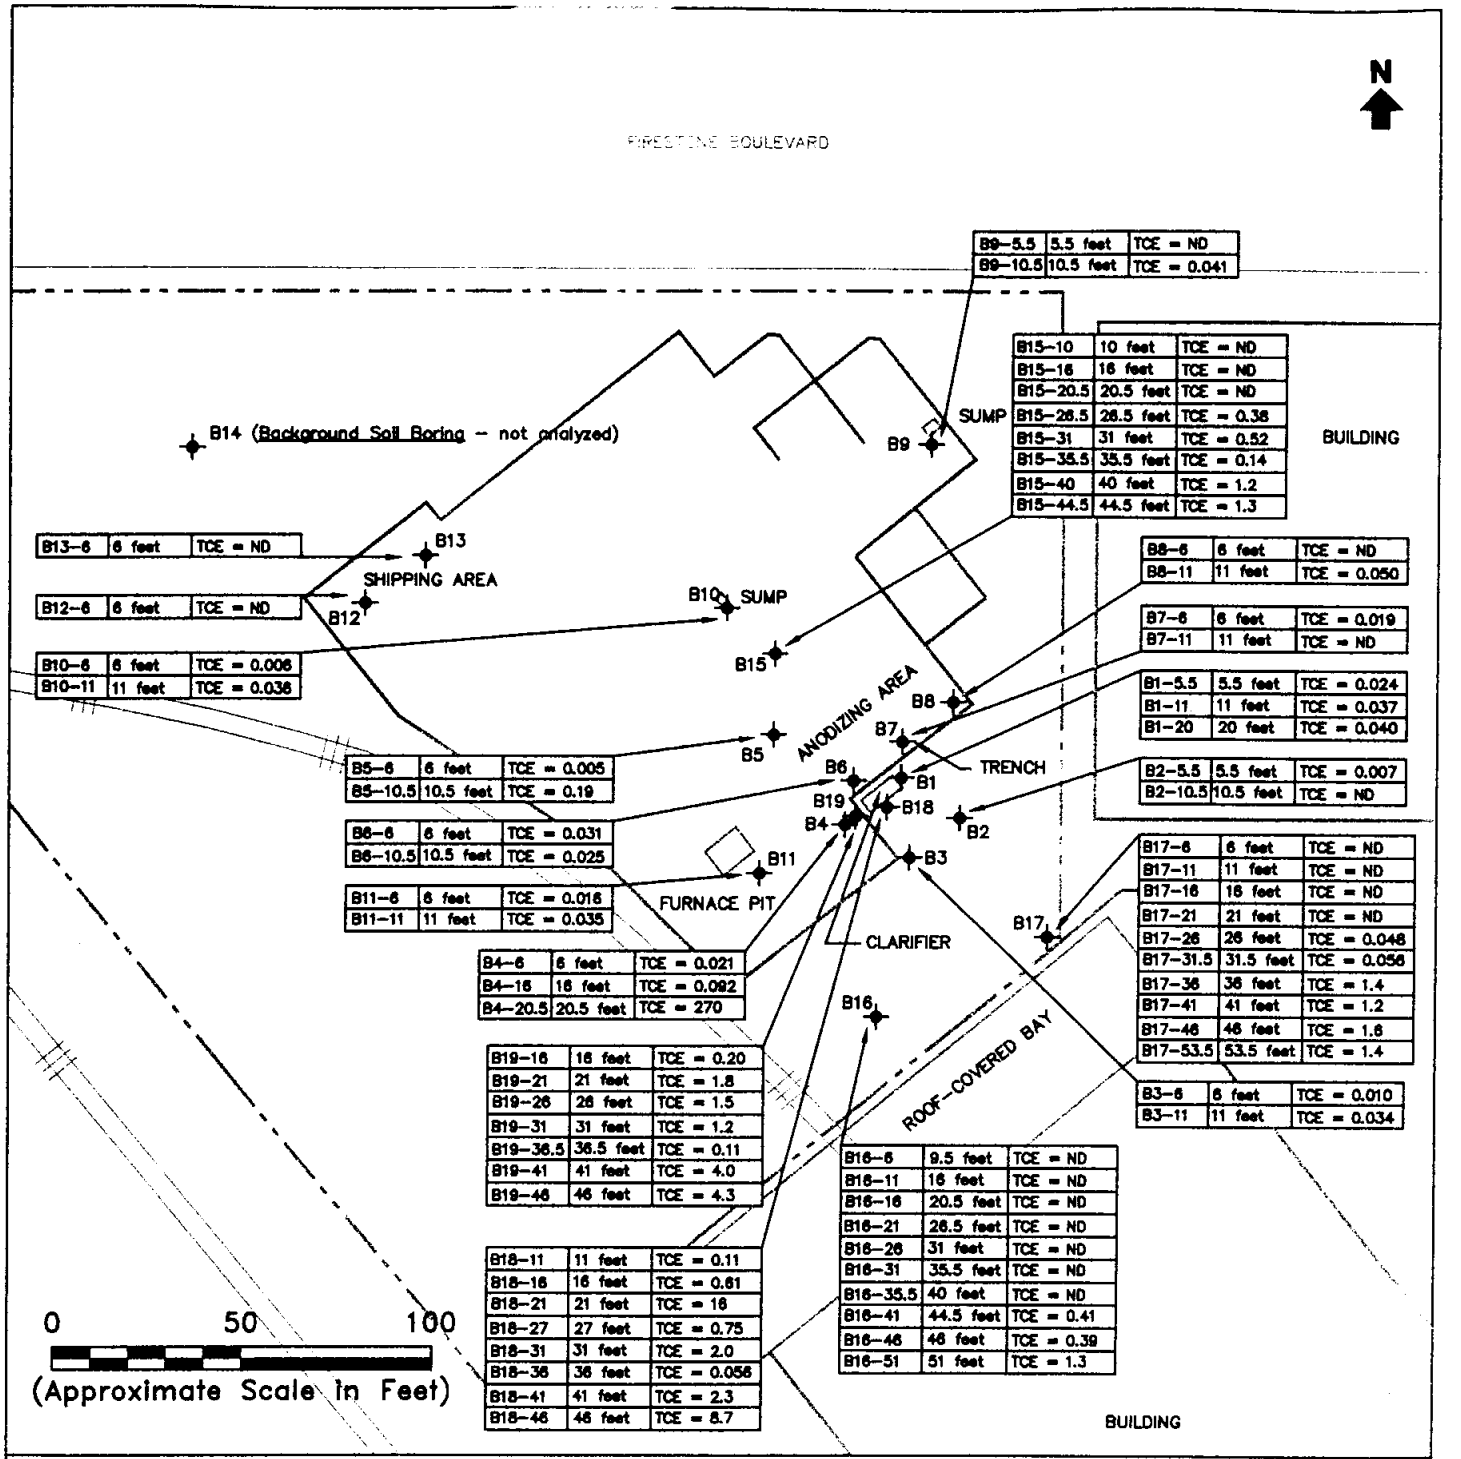
Jervis B. Webb Company
South Gate, CA
February 1998
EKI 961025.02
Figure 6

Concentrations of 1,1,1-TCA were detected in approximately half of the soil gas samples collected. Concentrations of 1,1,1-TCA detected in samples of soil gas ranged from 0.013 ug/L at location SG6 to 0.89 ug/L at location SG22, located adjacent to the furnace pit area. As shown on Figure 6, the highest concentrations of 1,1,1-TCA in soil gas appear to be centered in the southeast corner of the Subject Property.

Concentrations of 1,1,1-TCA Detected in Shallow Soil Gas

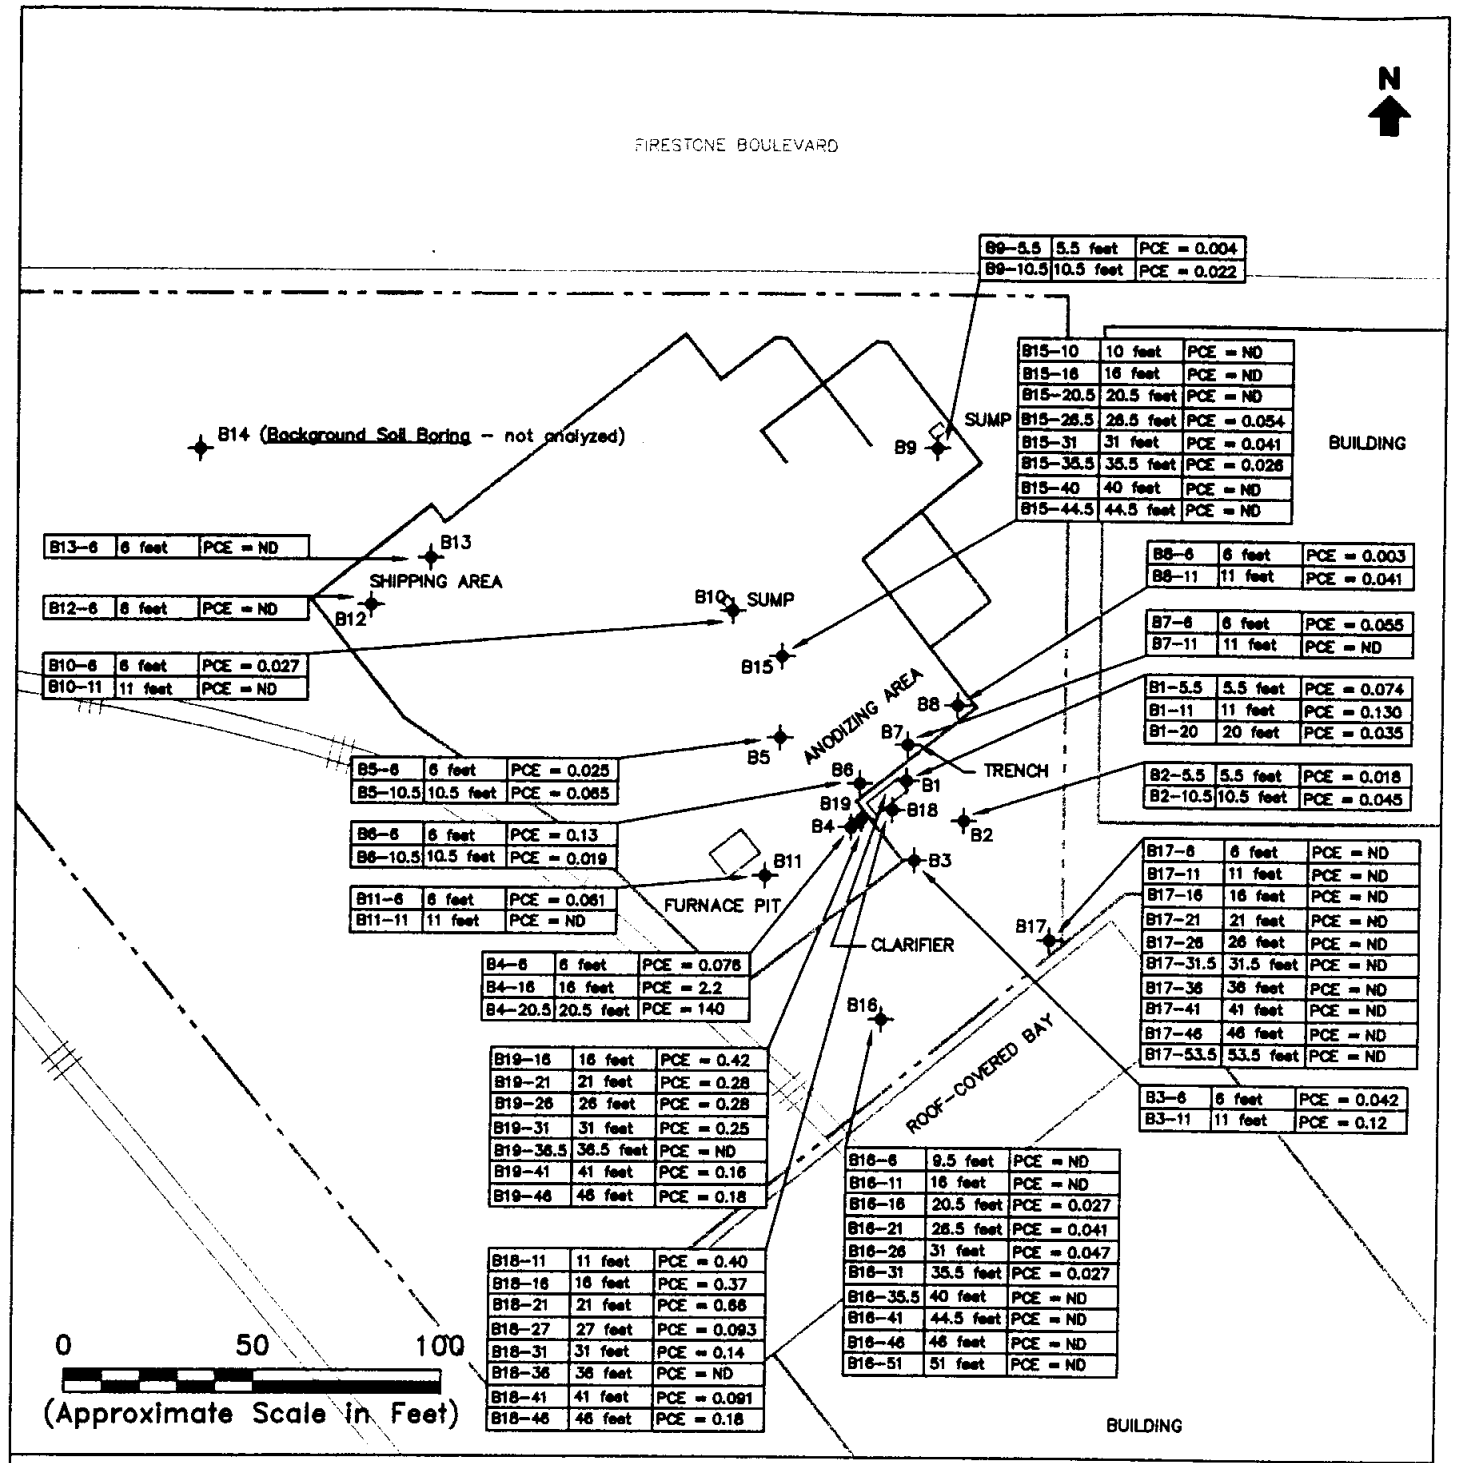
Figure 7

TCE and PCE were the only VOCs were detected in samples of soil collected during the October and December 1997 soil boring investigations. TCE and PCE were detected at maximum concentrations of 270 mg/kg and 140 mg/kg in one soil sample (B4-20.5) collected from approximately 20 feet below ground surface ("ft bgs") beneath the clarifier. At surrounding sampling locations, VOCs concentrations in soil samples typically ranged from 0.003 mg/kg to 0.13 mg/kg. Results of VOC analyses are summarized in Table 5 and in Figures 7 and 8.

The highest concentrations of TCE and PCE detected at the site were in deep soil samples (between 20 ft bgs to 46 ft bgs) from borings B4, B18, and B19 next to the clarifier. The highest concentration of each was detected in soil sample B4-20.5 beneath the clarifier with TCE at 270 mg/kg and PCE at 140 mg/kg. Concentrations of TCE were greater than 1 mg/kg in most of the soil samples analyzed between 20 ft bgs and 46 ft bgs at the clarifier (Figure 10). Concentrations of PCE were much lower in the same soil samples. None of the soil collected from below sample B4-20.5 had concentrations of PCE greater than 0.66 mg/kg.

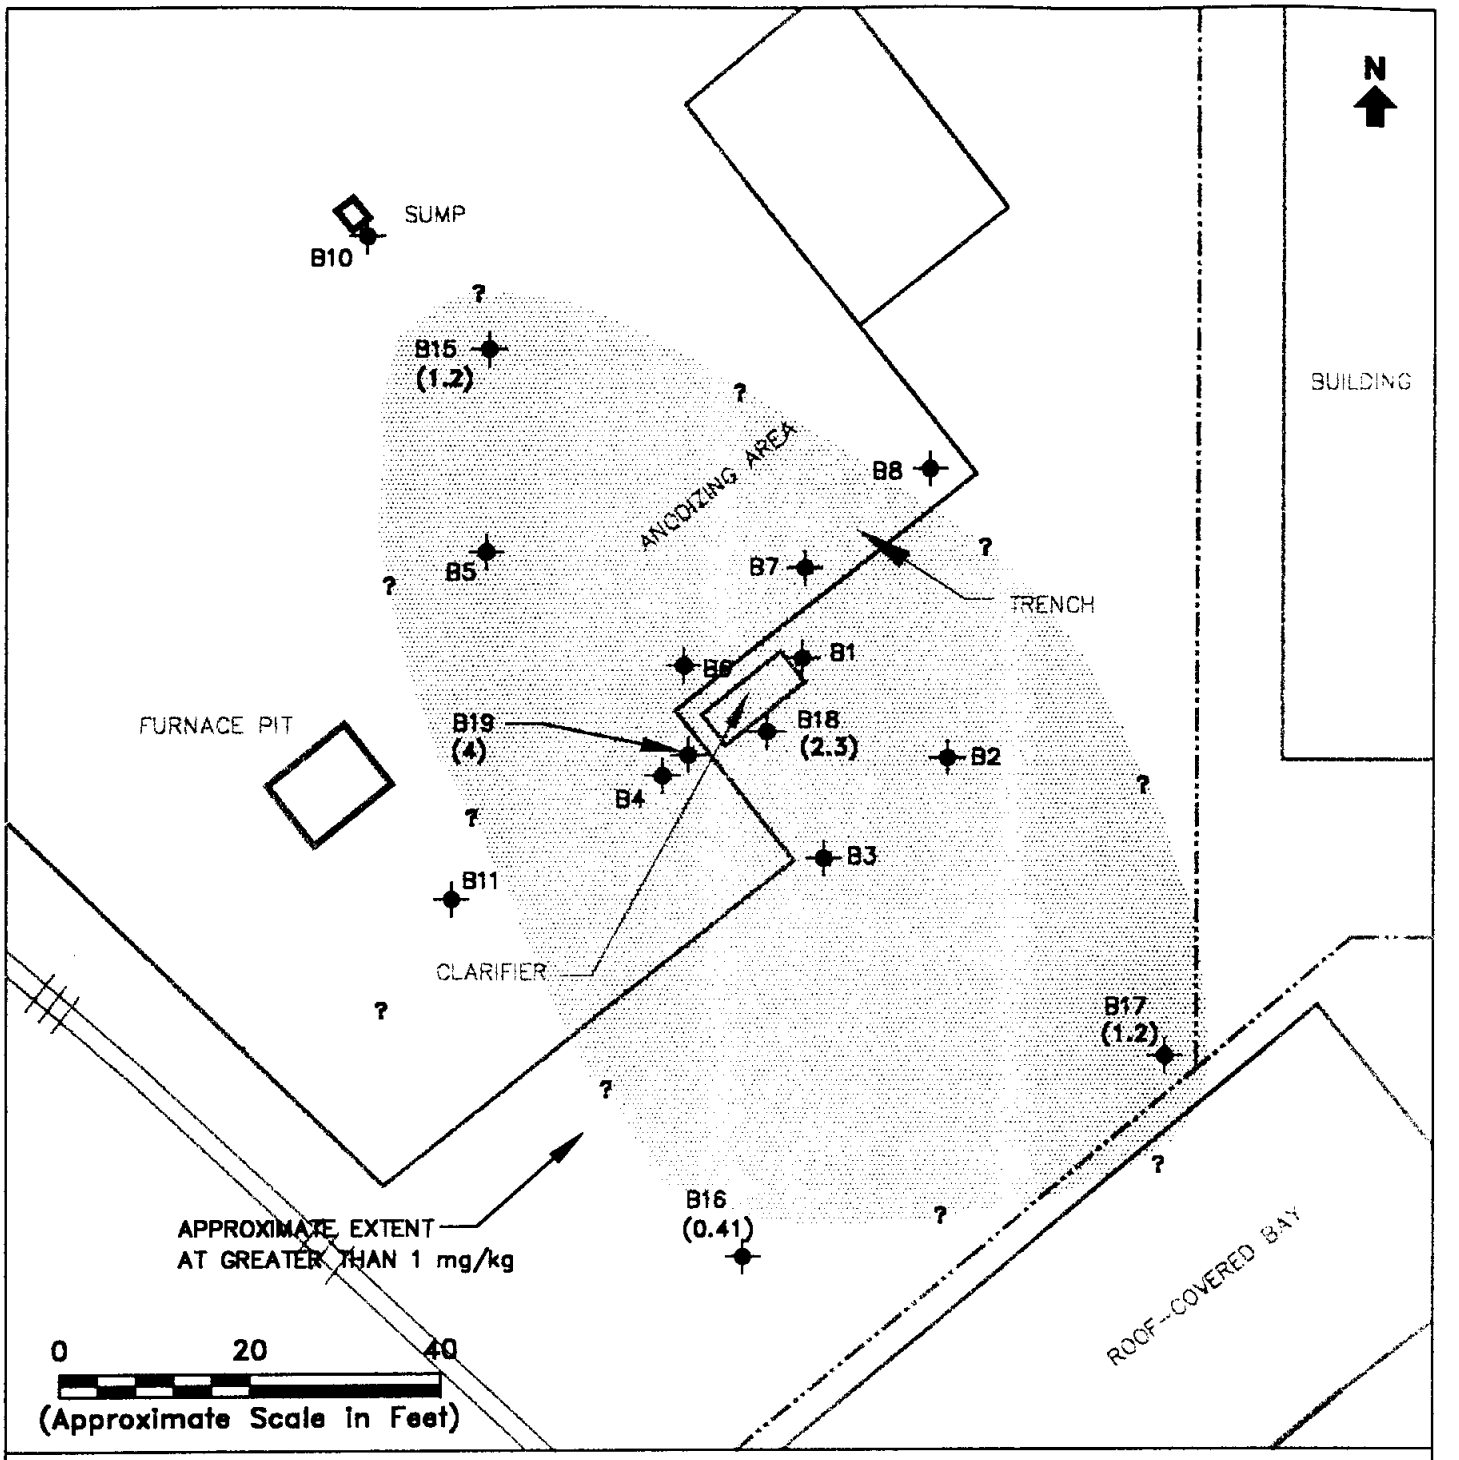
Figure 11

borings. An approximation of the lateral distribution of TCE in soil at 20 and 40 ft bgs are shown on Figures 11 and 12, respectively.
