TABLE 4

DAMAGED AND SIGNIFICANTLY DAMAGED ACBM

SAMPLE LOCATION DRAWINGS

APPENDIX A

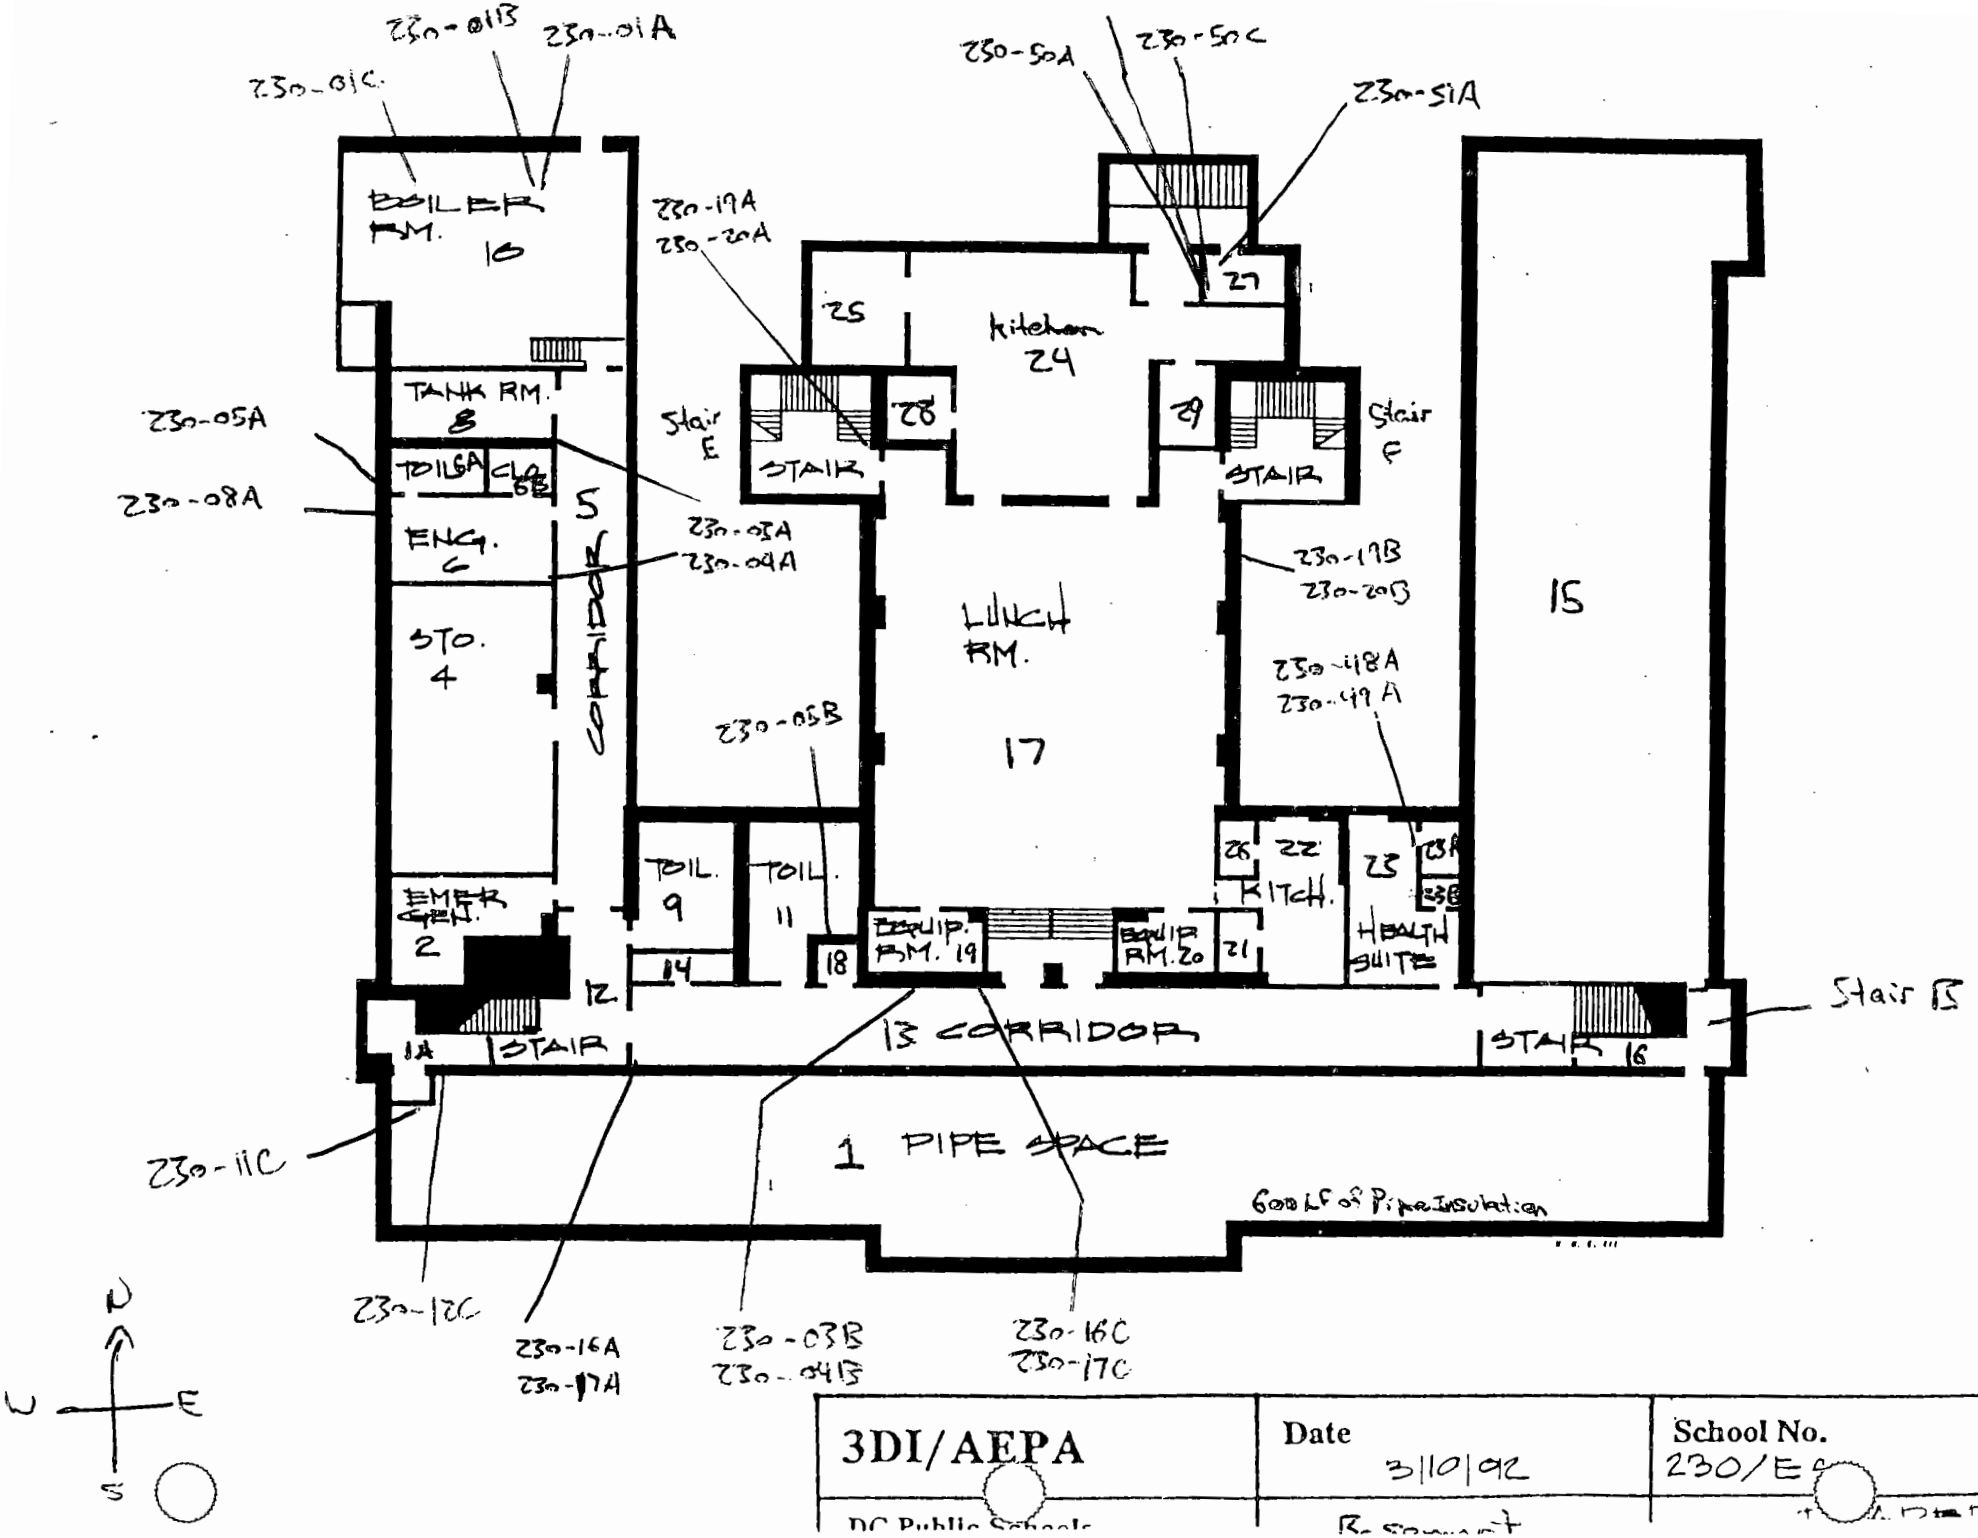
3DI/AEPA	Date 3/10/92	School No. 230/E
DC Public Schools	Basement
