PHOTOGRAPH LOG

Project Name:	Site Location:	Project No.
Gold King Mine	Silverton, San Juan County, Colorado	0001/1408-01

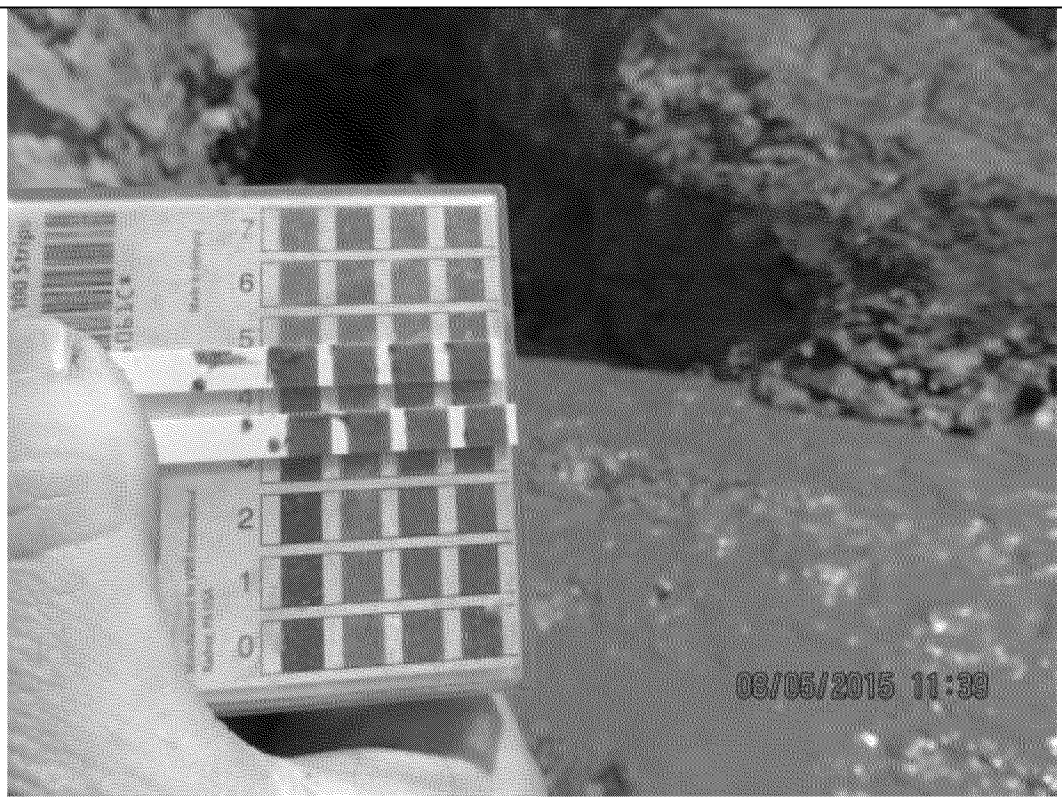
Photo No.	Date:
28	08/05/2015

pH of discharge water is approximately 4 to 4.5.
