PHOTOGRAPH LOG

Project Name:	Site Location:	Project No.
Gold King Mine	Silverton, San Juan County, Colorado	0001/1408-01

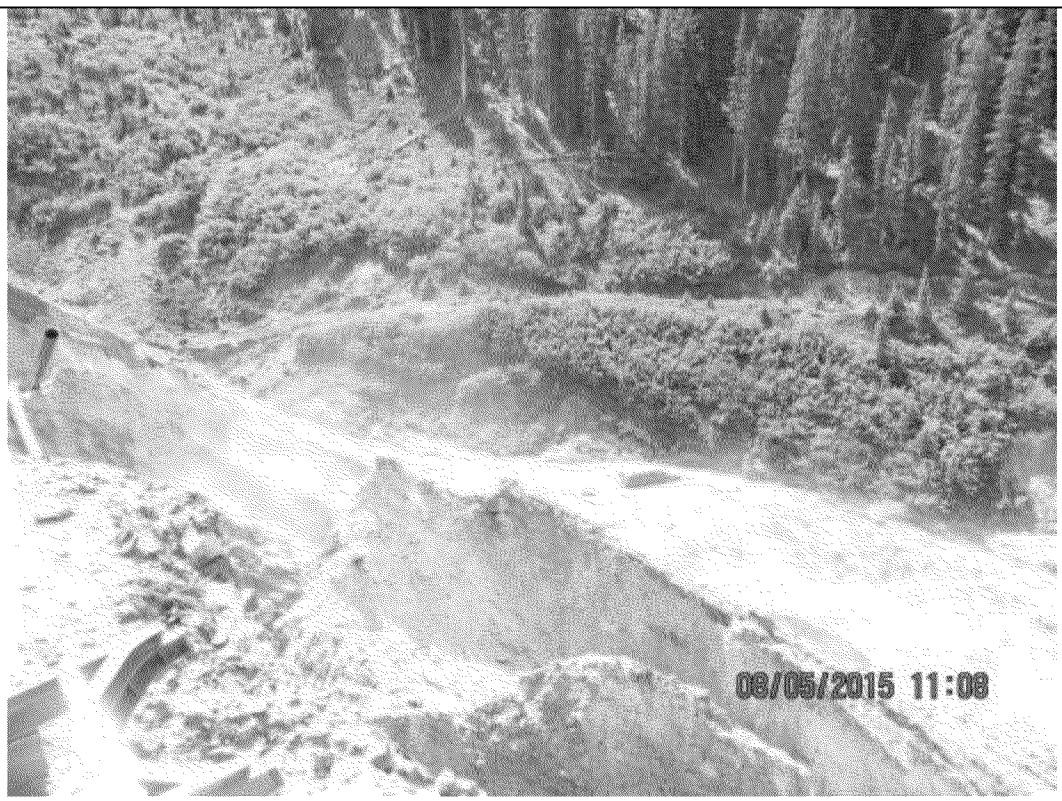
Photo No.	Date:	
24	08/05/2015

Description:
Edge of the tailings dump collapsed, suburban trapped and half submerged in center of photo.
