PHOTOGRAPH LOG

Project Name:	Site Location:	Project No.
Gold King Mine	Silverton, San Juan County, Colorado	0001/1408-01

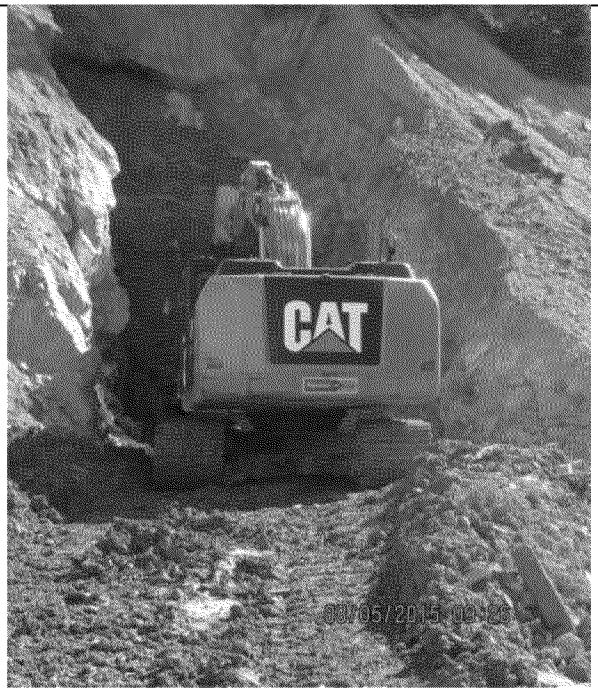
Photo No.	Date:
14	08/05/2015

Description:
Excavating material above the collapsed adit.
