U.S. ENVIRONMENTAL PROTECTION AGENCY
POLLUTION/SITUATION REPORT
2015 Gold King Mine Release SITREP

Subject:	Situation Report #8 Gold King Mine Release San Juan County, CO Latitude: 37.8945 Longitude: -107.6384
From:	Durango Unified Command (Situation Unit)
Date:	08/16/2015
Reporting Period:	08/15/2015 through 08/15/2015
Website:	http://www2.epa.gov/goldkingmine

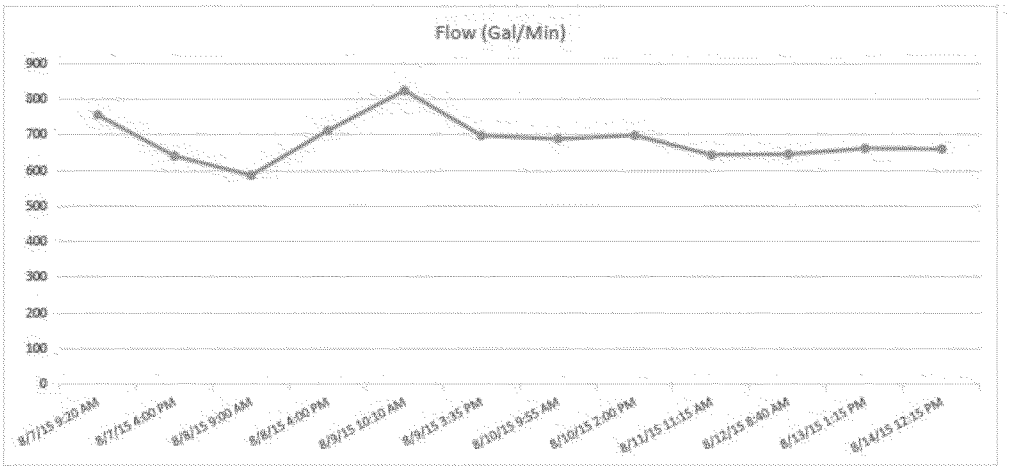
Flow from the mine through the morning of 8/14/2015 is shown in the following chart. The flow chart will be updated for the next SITREP. **The treatment pond effluent pH on the afternoon of 8/13/2015 was 4.95.**

Treated water from the last treatment pond is discharging into Cement Creek. Flow data out of the mine is being collected manually two times per day. Water quality data is being collected at the influent and effluent of the treatment system as well.
