PHOTOGRAPH LOG

Project Name:	Site Location:	Project No.
Gold King Mine	Silverton, San Juan County, Colorado	0001/1408-01

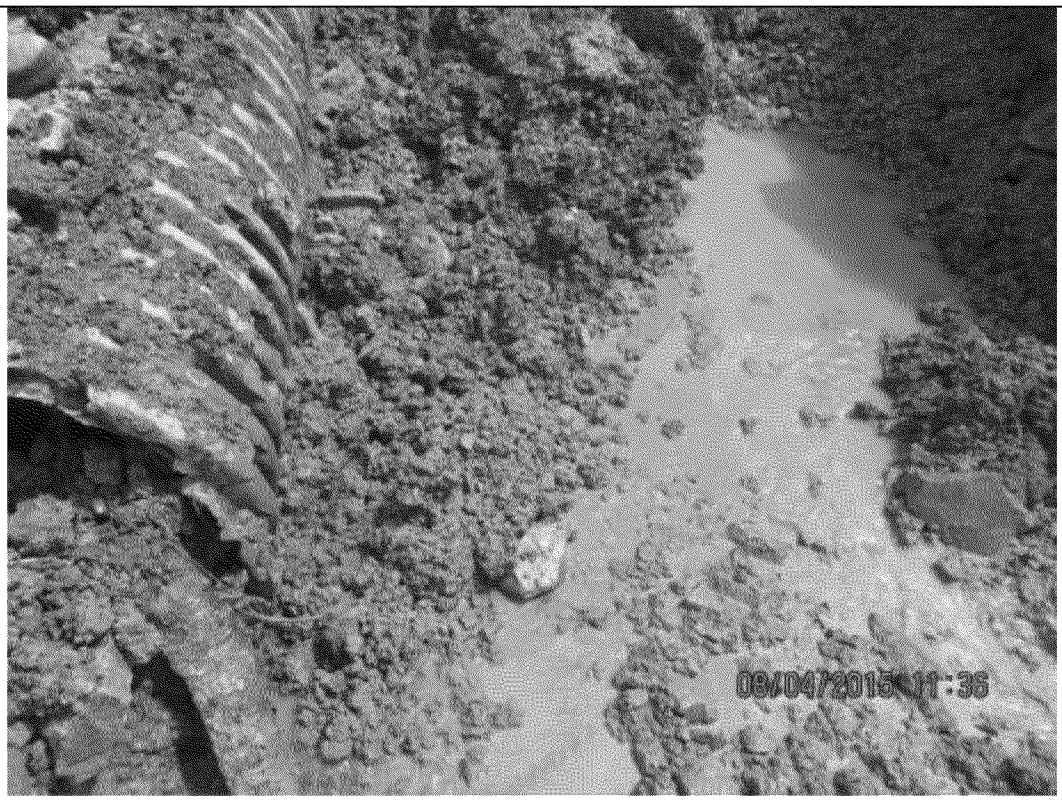
Photo No.	Date:
3	08/04/2015

Description:
Seepage from soil next to piping.

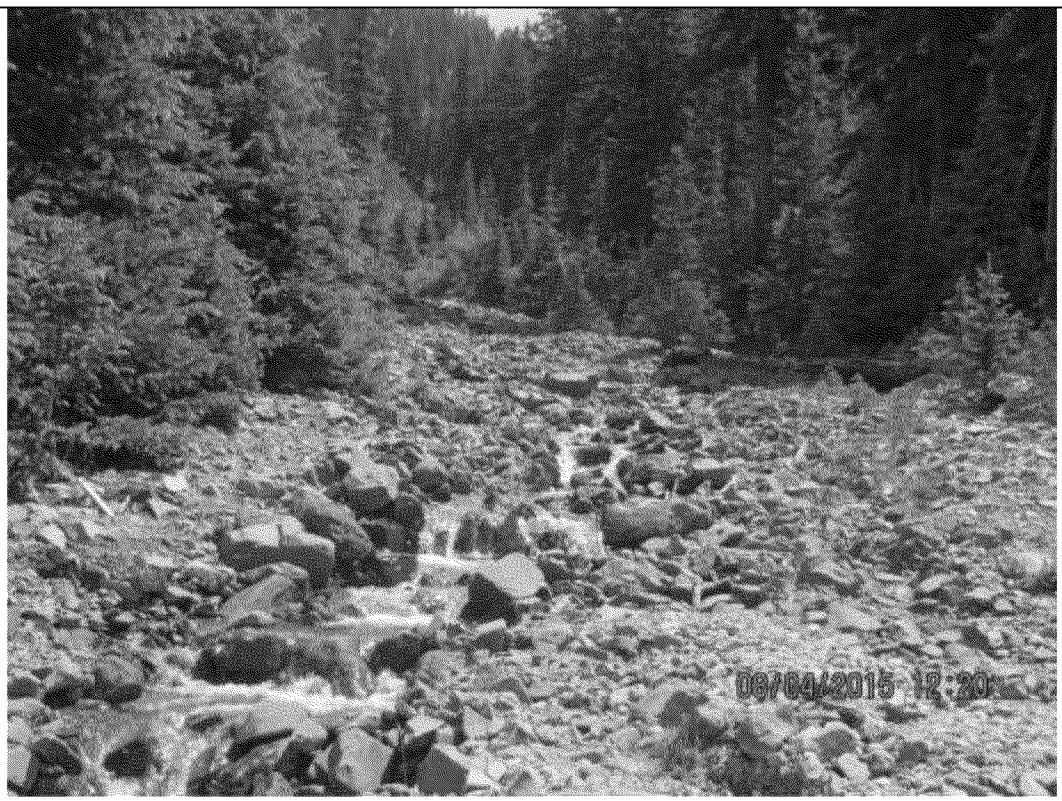
Photo No.	Date:
10	08/04/2015

Description:
Water of the North Fork just upstream of Cement Creek.

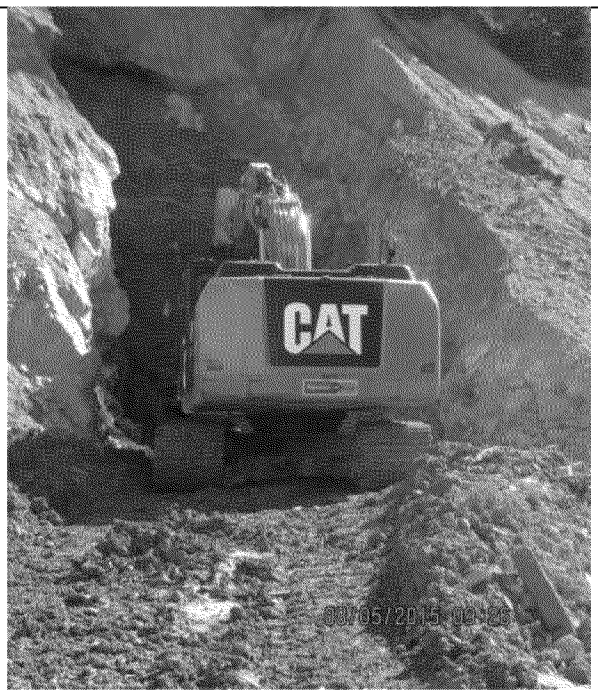
Photo No.	Date:
14	08/05/2015

Description:
Excavating material above the collapsed adit.

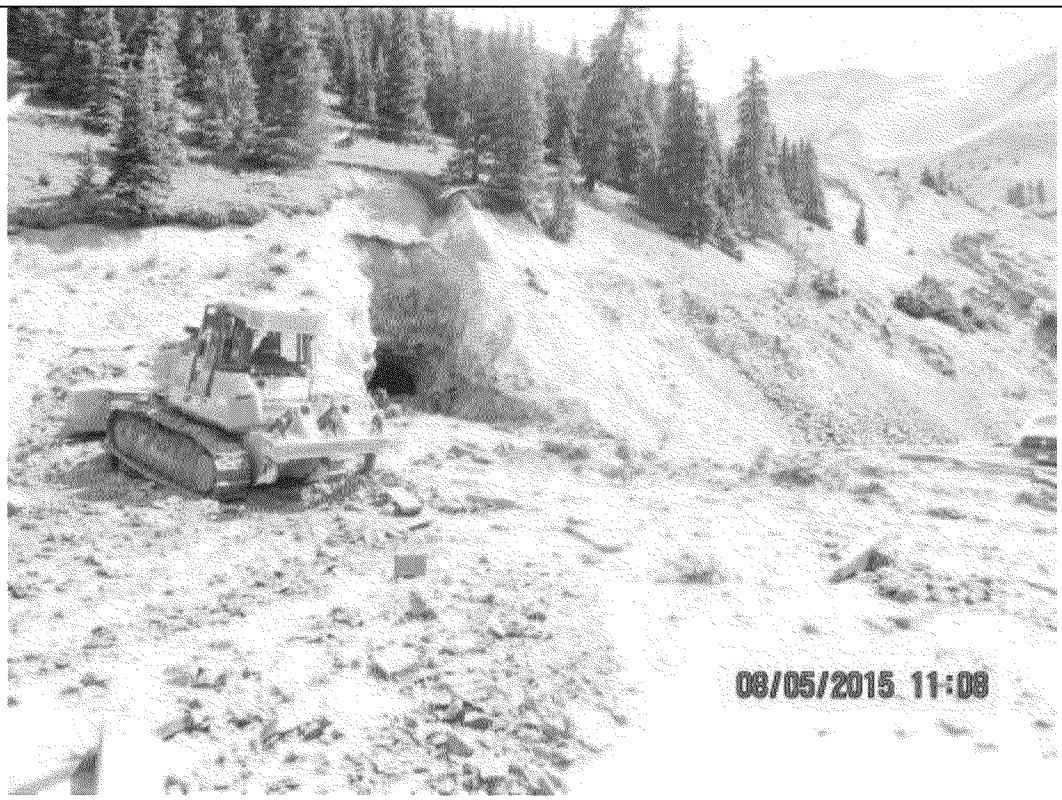
Photo No.	Date:
25	08/05/2015

Description:
Gold King adit exposed.

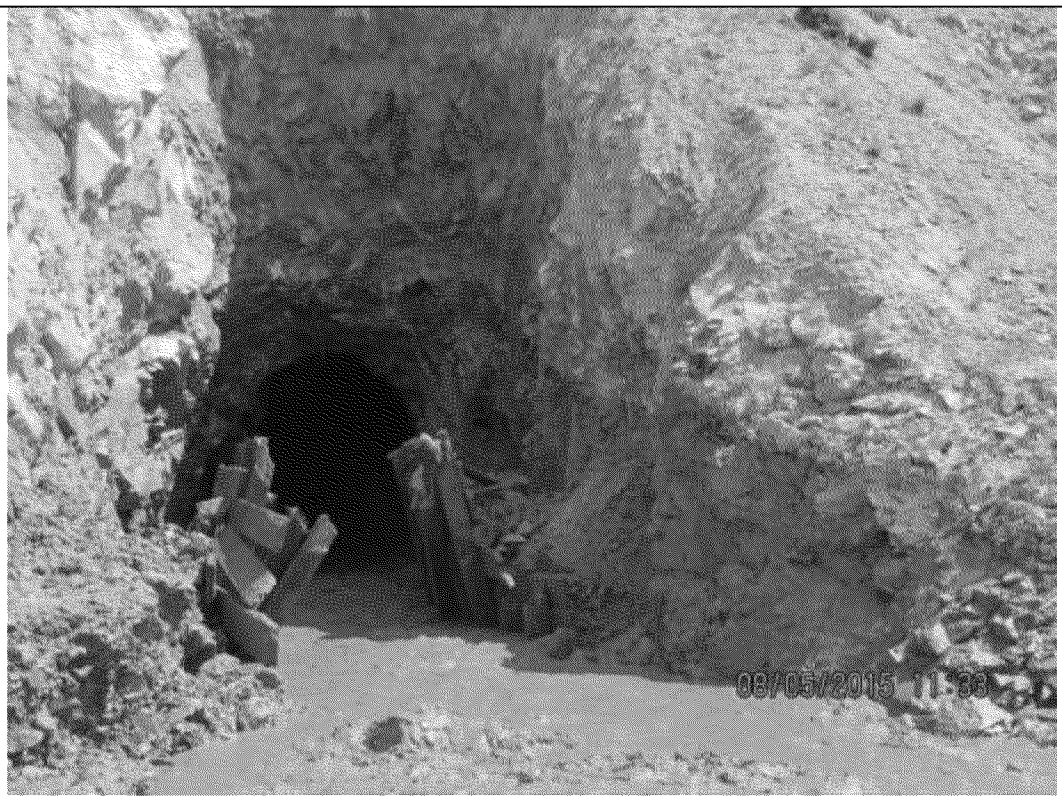
Photo No.	Date:
27	08/05/2015

Description:
Exposed adit, roughly 10 feet wide by 15 feet high.

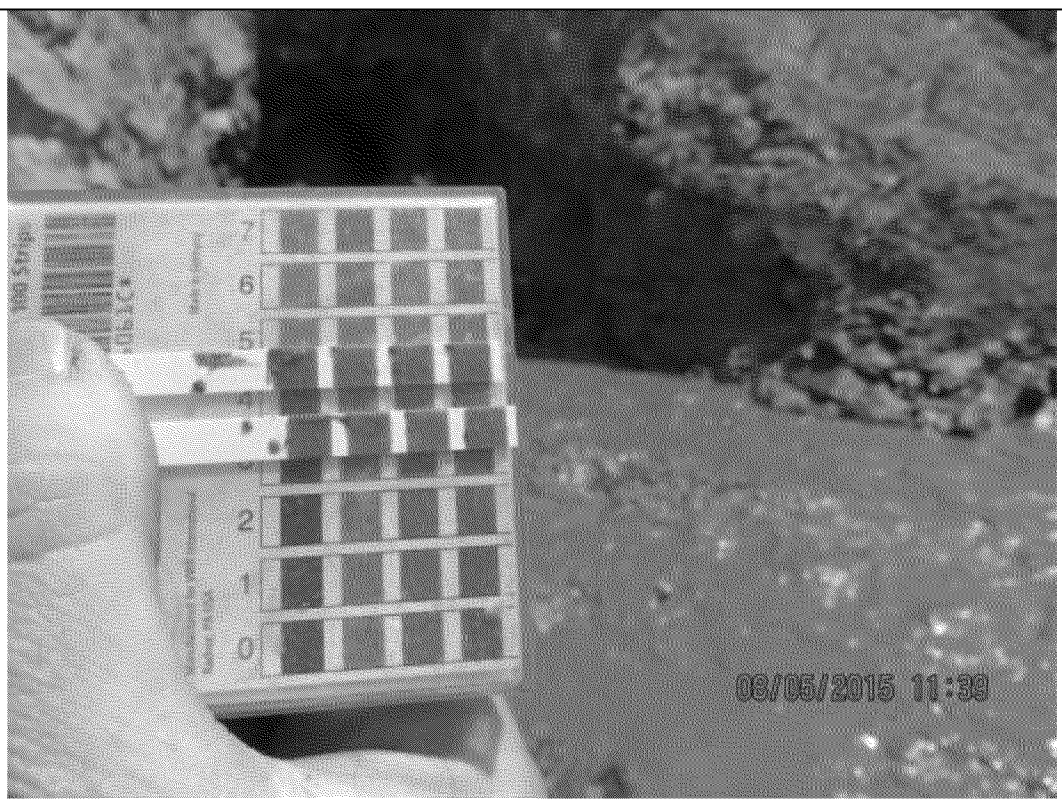
Photo No.	Date:
28	08/05/2015

pH of discharge water is approximately 4 to 4.5.

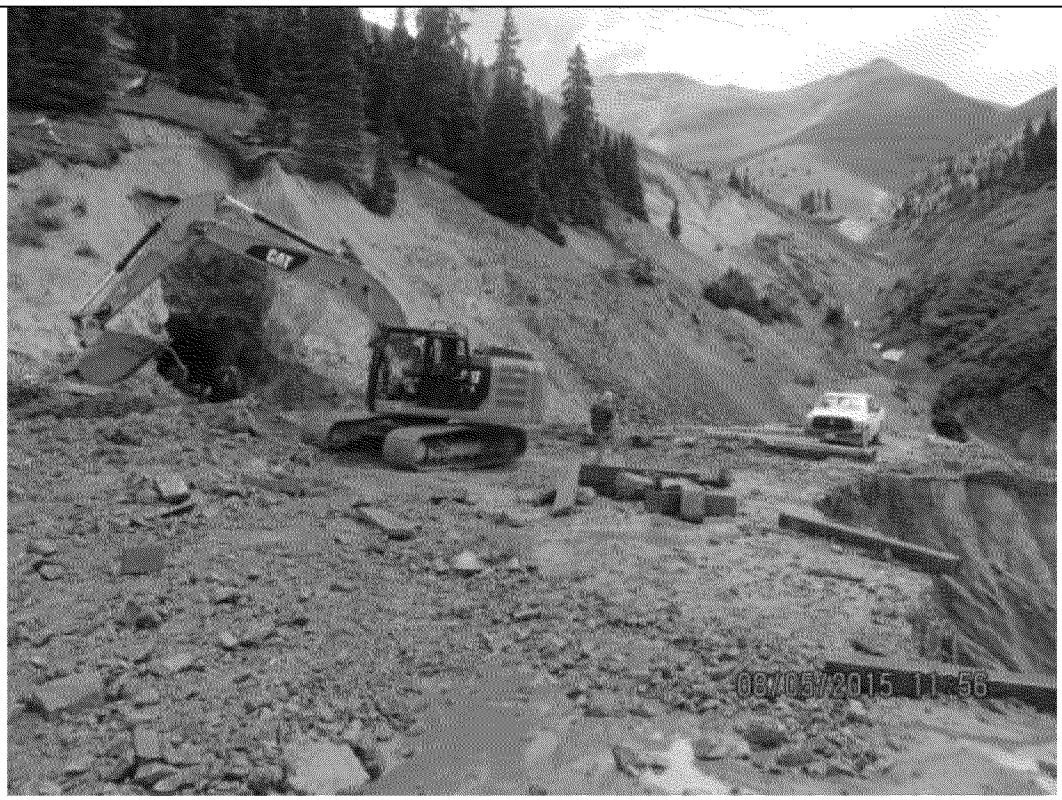
Photo No.	Date:	
29	08/05/2015

Description:
Excavator redirecting water into existing half-pipe channel.

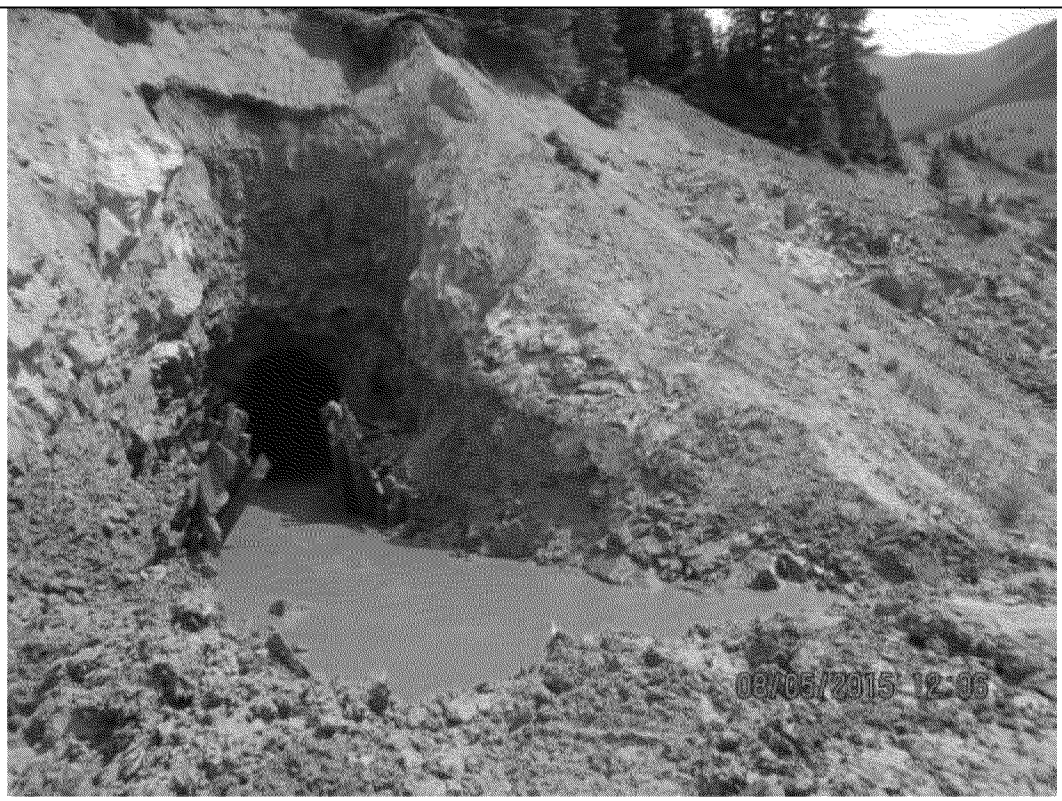
Photo No.	Date:
32	08/05/2015

Description:
Exposed adit and redirected flow, flow is beginning to subside.
