FIELD ACTIVITIES REPORT
Mine Entry

RED AND BONITA MINE SITE
Silverton, San Juan County, Colorado

TDD No. 1008-01

December 14, 2012

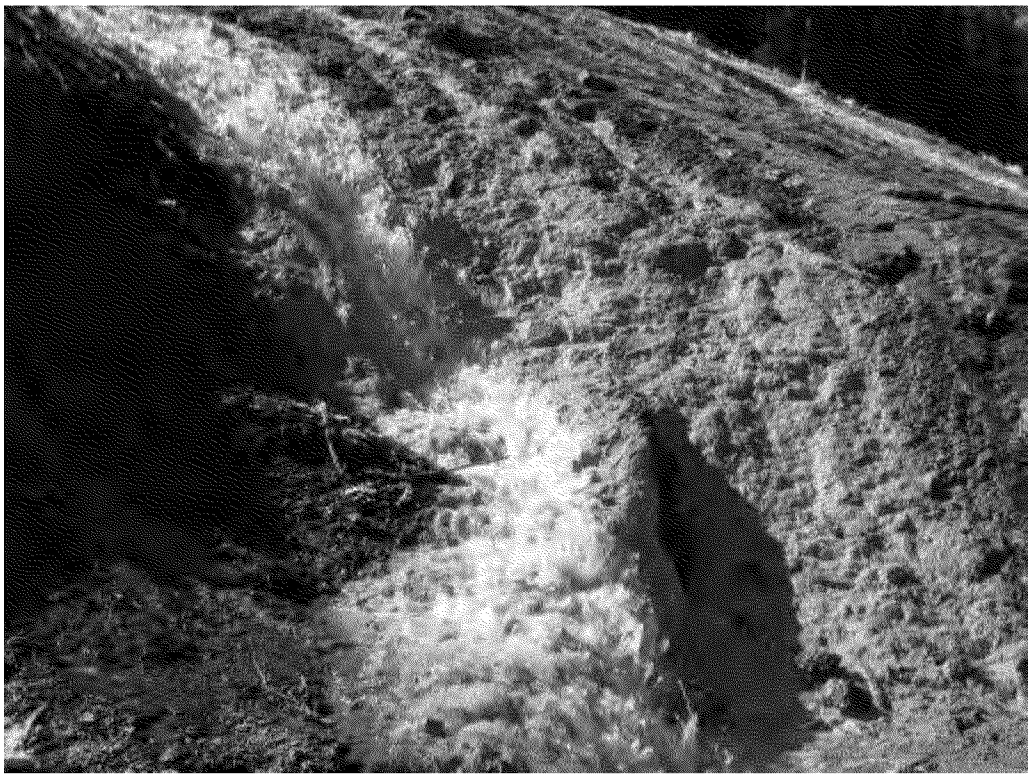
PHOTO 1
5-31-12. Yellow-orange and red colored iron precipitate on dump face, flowing mine drainage.

PHOTO 2
6-6-12. Mine adit entry preparation by Colorado Division of Reclamation Mining and Safety.

PHOTO 10
6-14-12. Instrumentation used to obtain water parameter observations.

PHOTO 11
6-7-12. Temporary walkway inside mine adit as viewed from mine portal, placed above yellowboy accumulation. Note that adit is passing through ferricrete deposit, photo top.

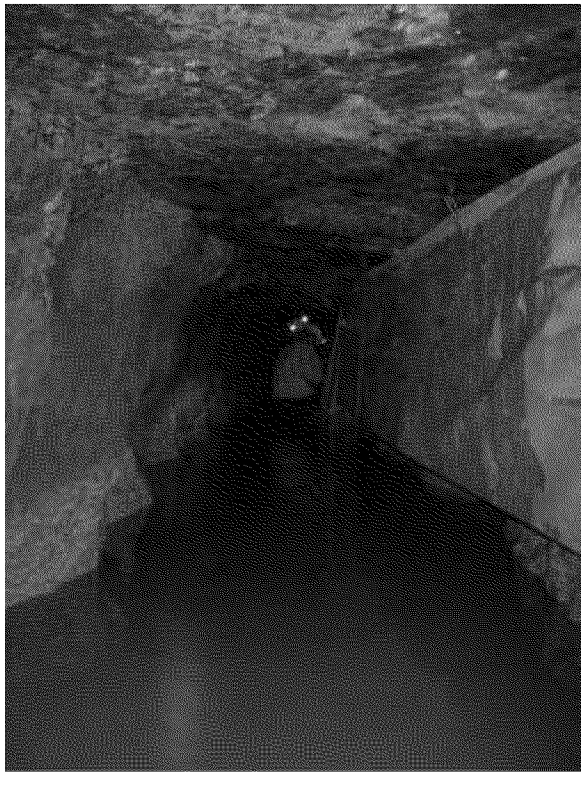
PHOTO 12
6-12-12. Securing collapsible air duct in adit approximately 100 feet inby. Note that adit appears competent, no required supports through andesitic rock.

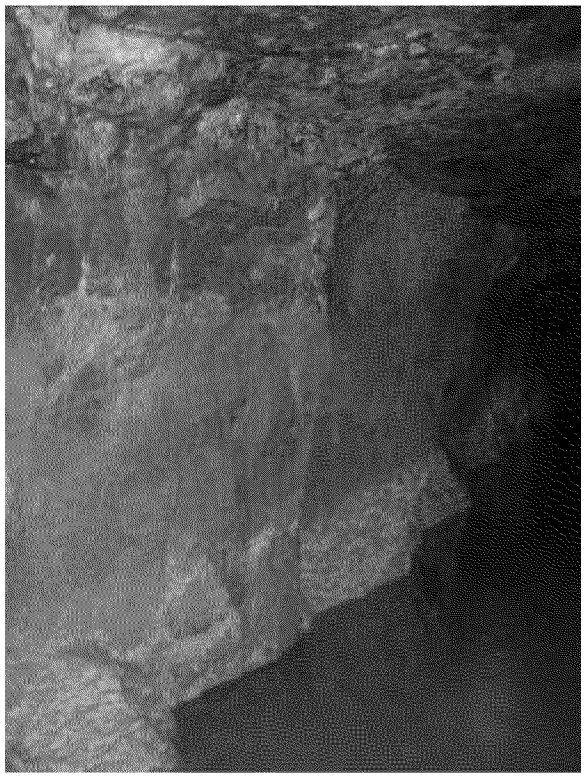
PHOTO 13
6-12-12. Adit left rib at approximately 60 feet inby. Note yellowboy stain and accumulation near (current) water line.

PHOTO 14
6-12-12. Adit back at approximately 60 feet inby. Note competent andesitic rock and fracture planes.

PHOTO 15
6-12-12. Yellowboy accumulation in adit at (current) water line, approximately 50 feet inby. Note red, orange, yellow colors.

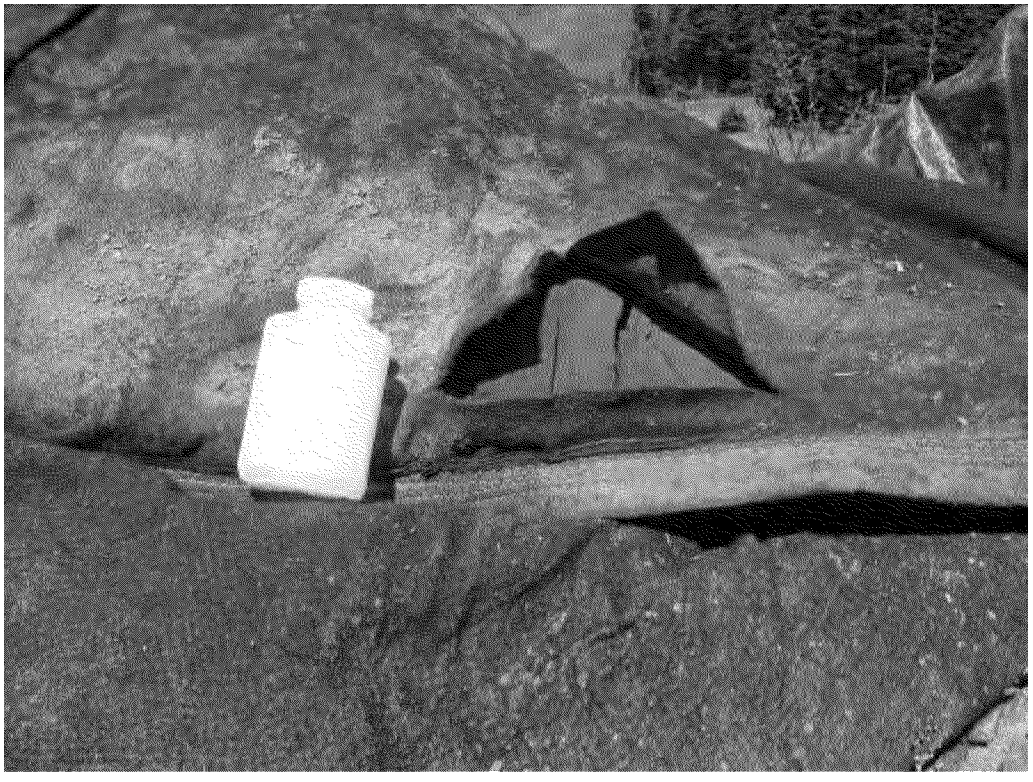
PHOTO 16
6-14-12. Sampling clay-like filtrate from filter bag.

PHOTO 17
7-13-12. Loading spent filter bags for landfill disposal.
