Navajo Abandoned Uranium Mine Site Screen Report

Haystack No. 1 AUM Site

Navajo AUM Eastern Region

Weston Solutions, Inc.

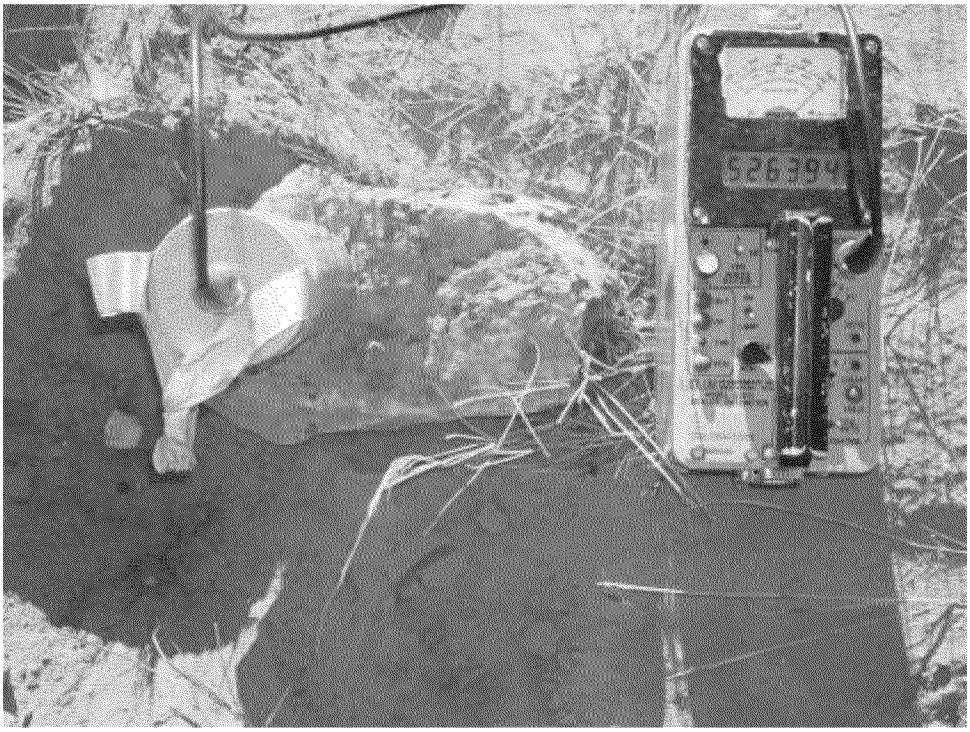
Photo 5. Haystack No 1 Mine site, section corner survey marker
