Navajo Abandoned Uranium Mine Site Screen Report

Nanabah Vandever AUM Site

Navajo AUM Eastern Region

May 2009

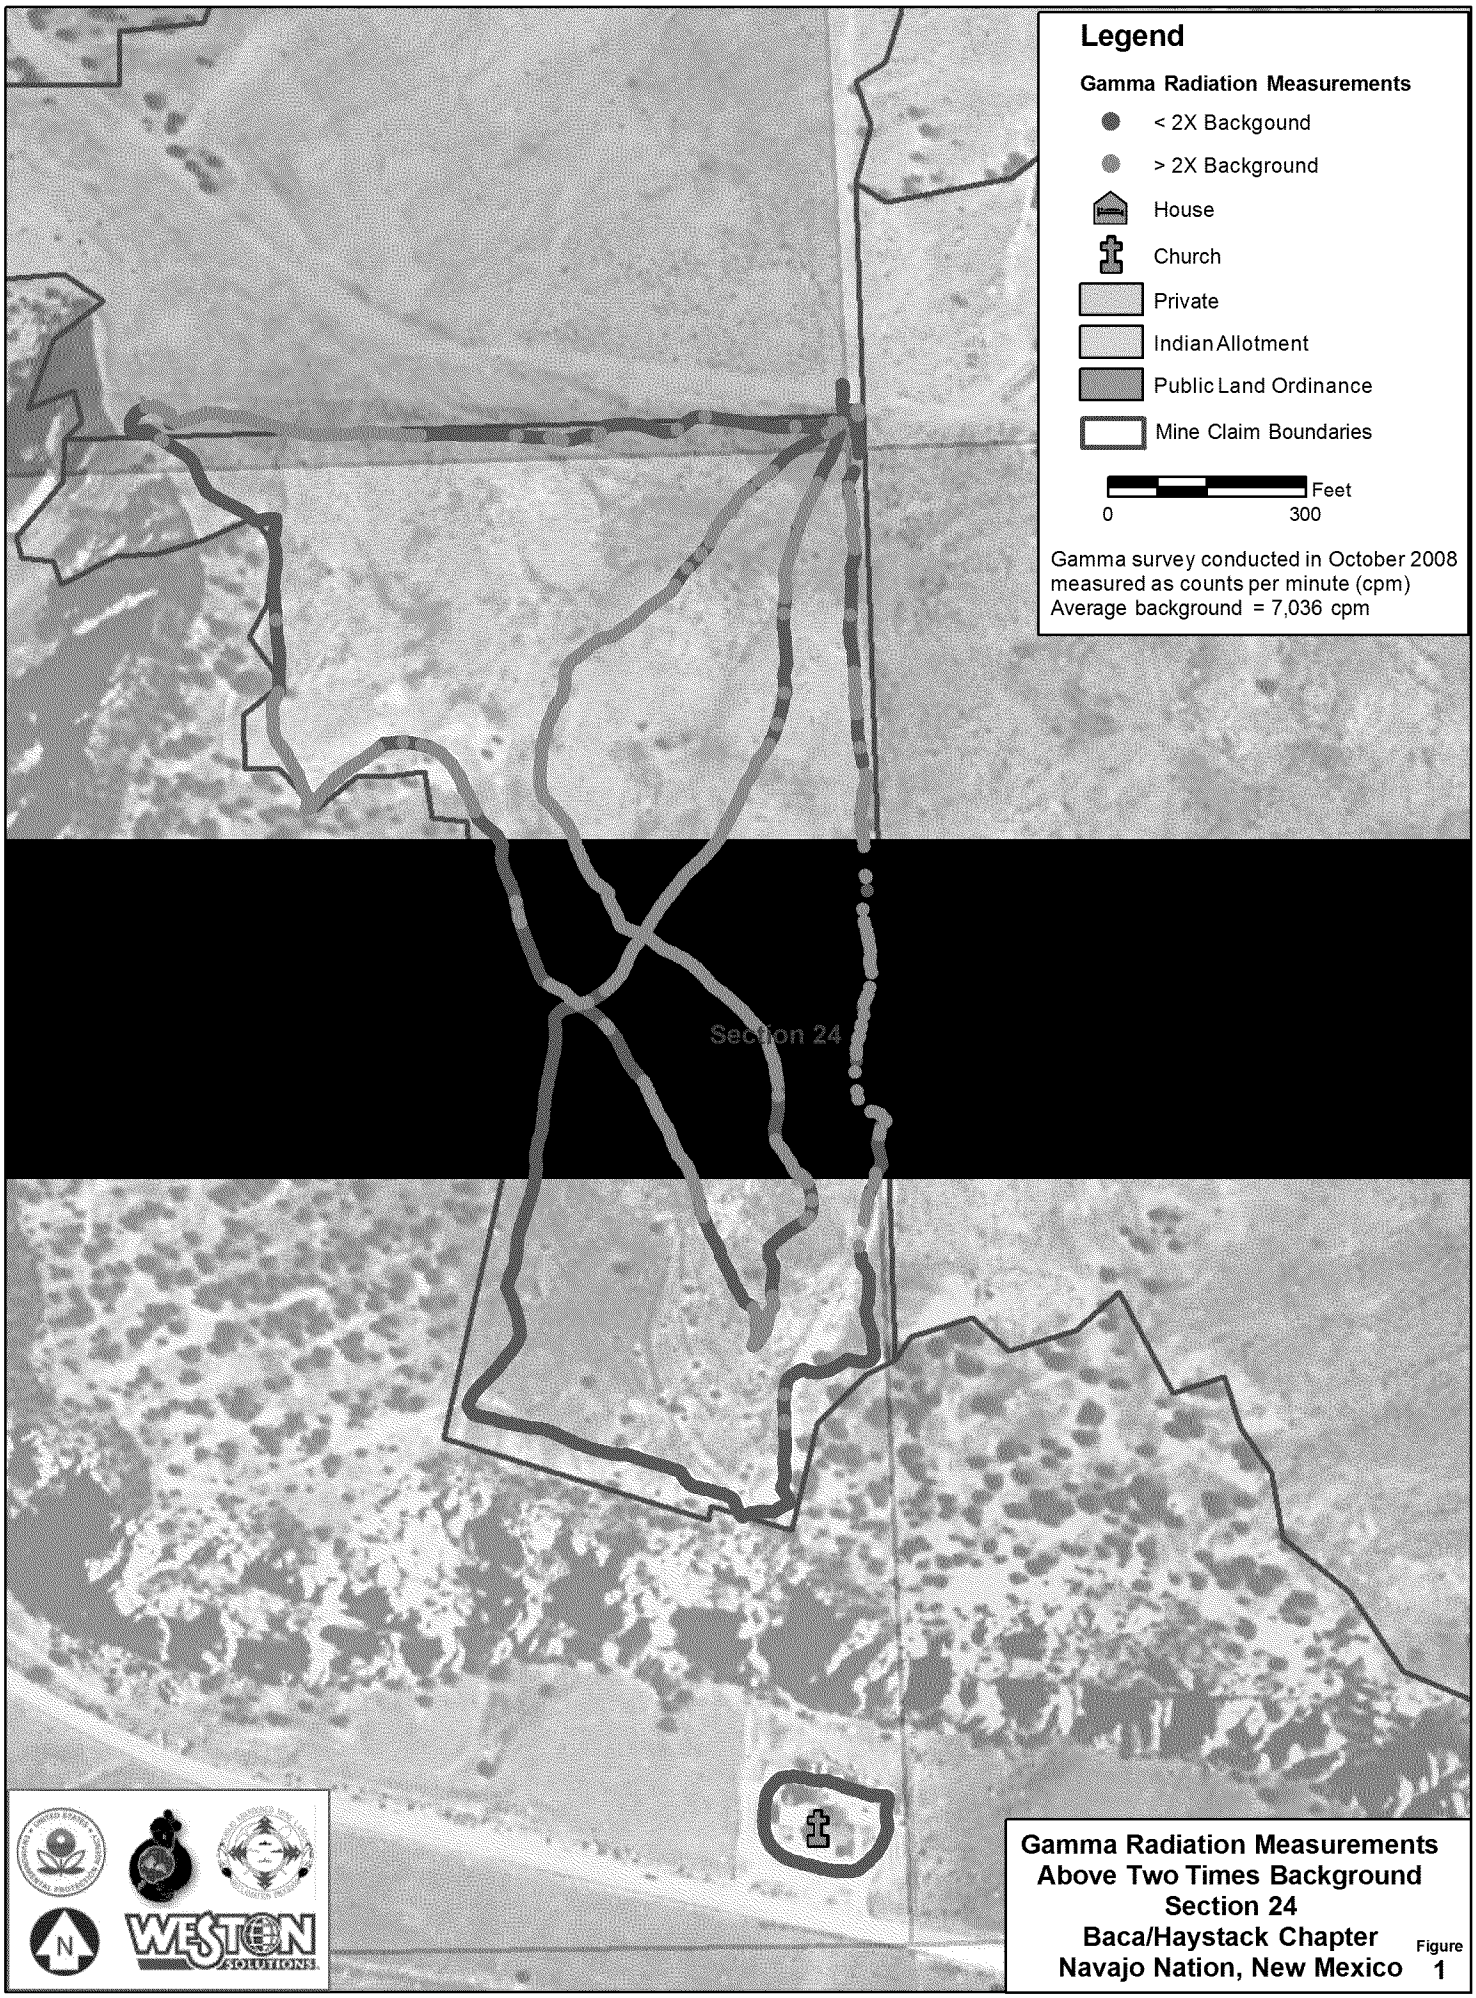
Figure **1**

A total of 3,024 gamma radiation measurements were collected from mine sites, ranging from 4,569 cpm to 594,083 cpm. The measurements are represented in Figures 1 and 2.

Gamma Radiation Measurements Above Two Times Background
Section 24
Baca/Haystack Chapter
Navajo Nation, New Mexico
