Navajo Abandoned Uranium Mine Site Screen Report

Haystack No. 2 AUM Site

Navajo AUM Eastern Region

May 2009

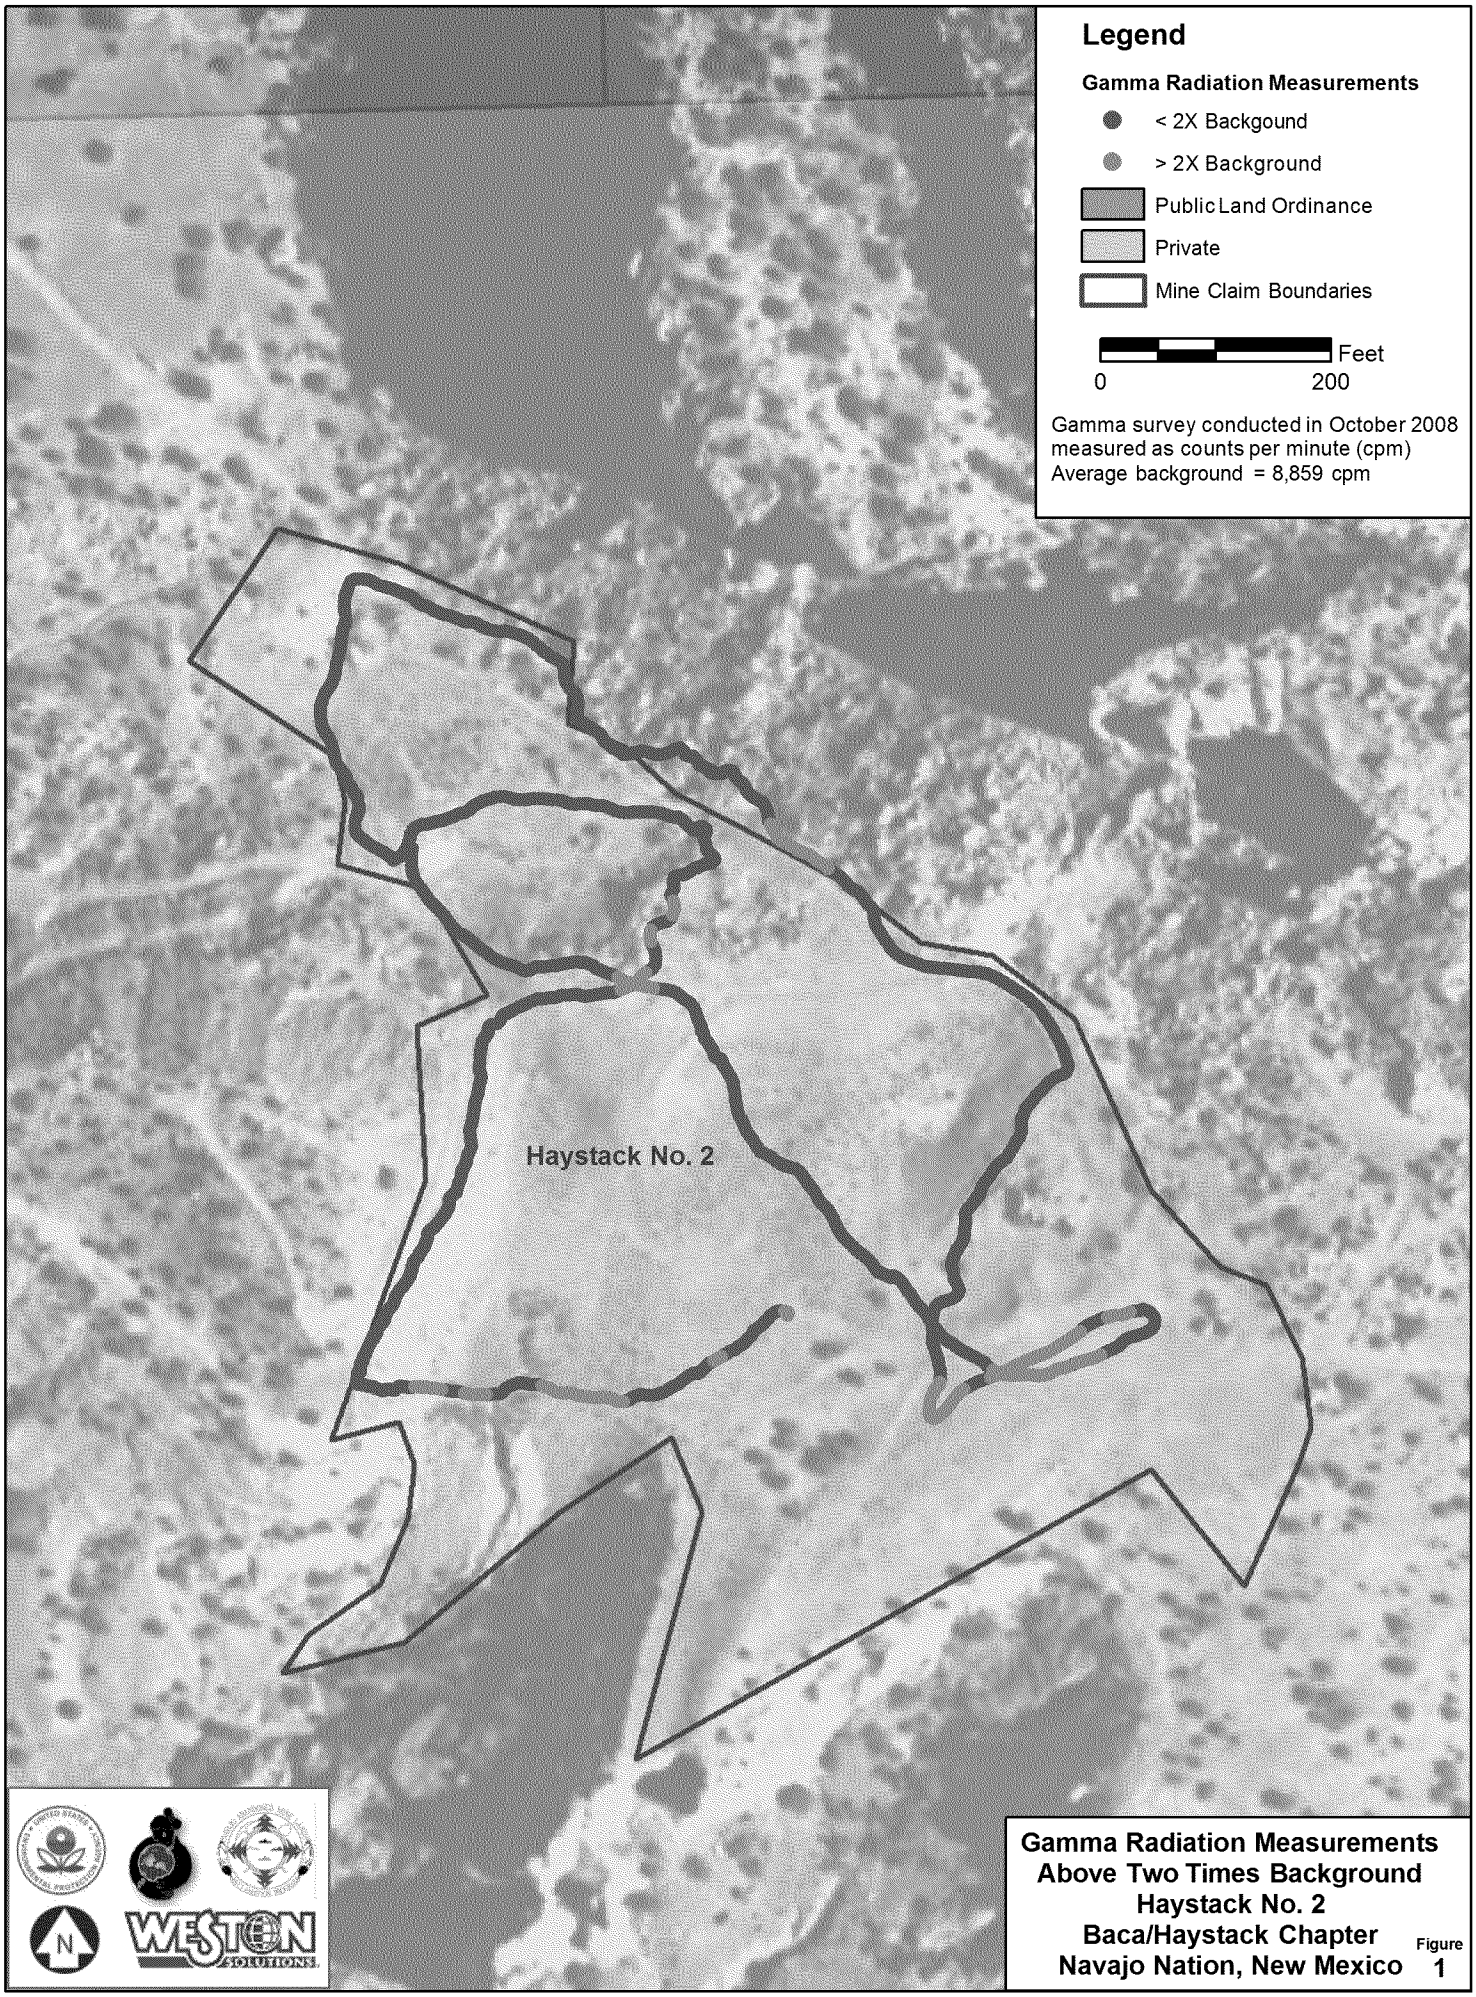
Figure 1

A total of 1,210 gamma radiation measurements were collected from the mine site, ranging from 6,155 cpm to 32,732 cpm. The measurements are represented in Figures 1 and 2. Radiological measurements collected for the New Mexico Mining and Minerals Division during a 2008 field screening survey found gamma radiation levels near the ground surface with a maximum of 90 micro Roentgen per hour (μR/hr) and a minimum of 10 μR/hr, levels at the 4-foot elevation with a maximum of 60 μR/hr and a minimum of 9 μR/hr, and background levels of 10 μR/hr.

Gamma Radiation Measurements Above Two Times Background Haystack No. 2 Baca/Haystack Chapter Navajo Nation, New Mexico

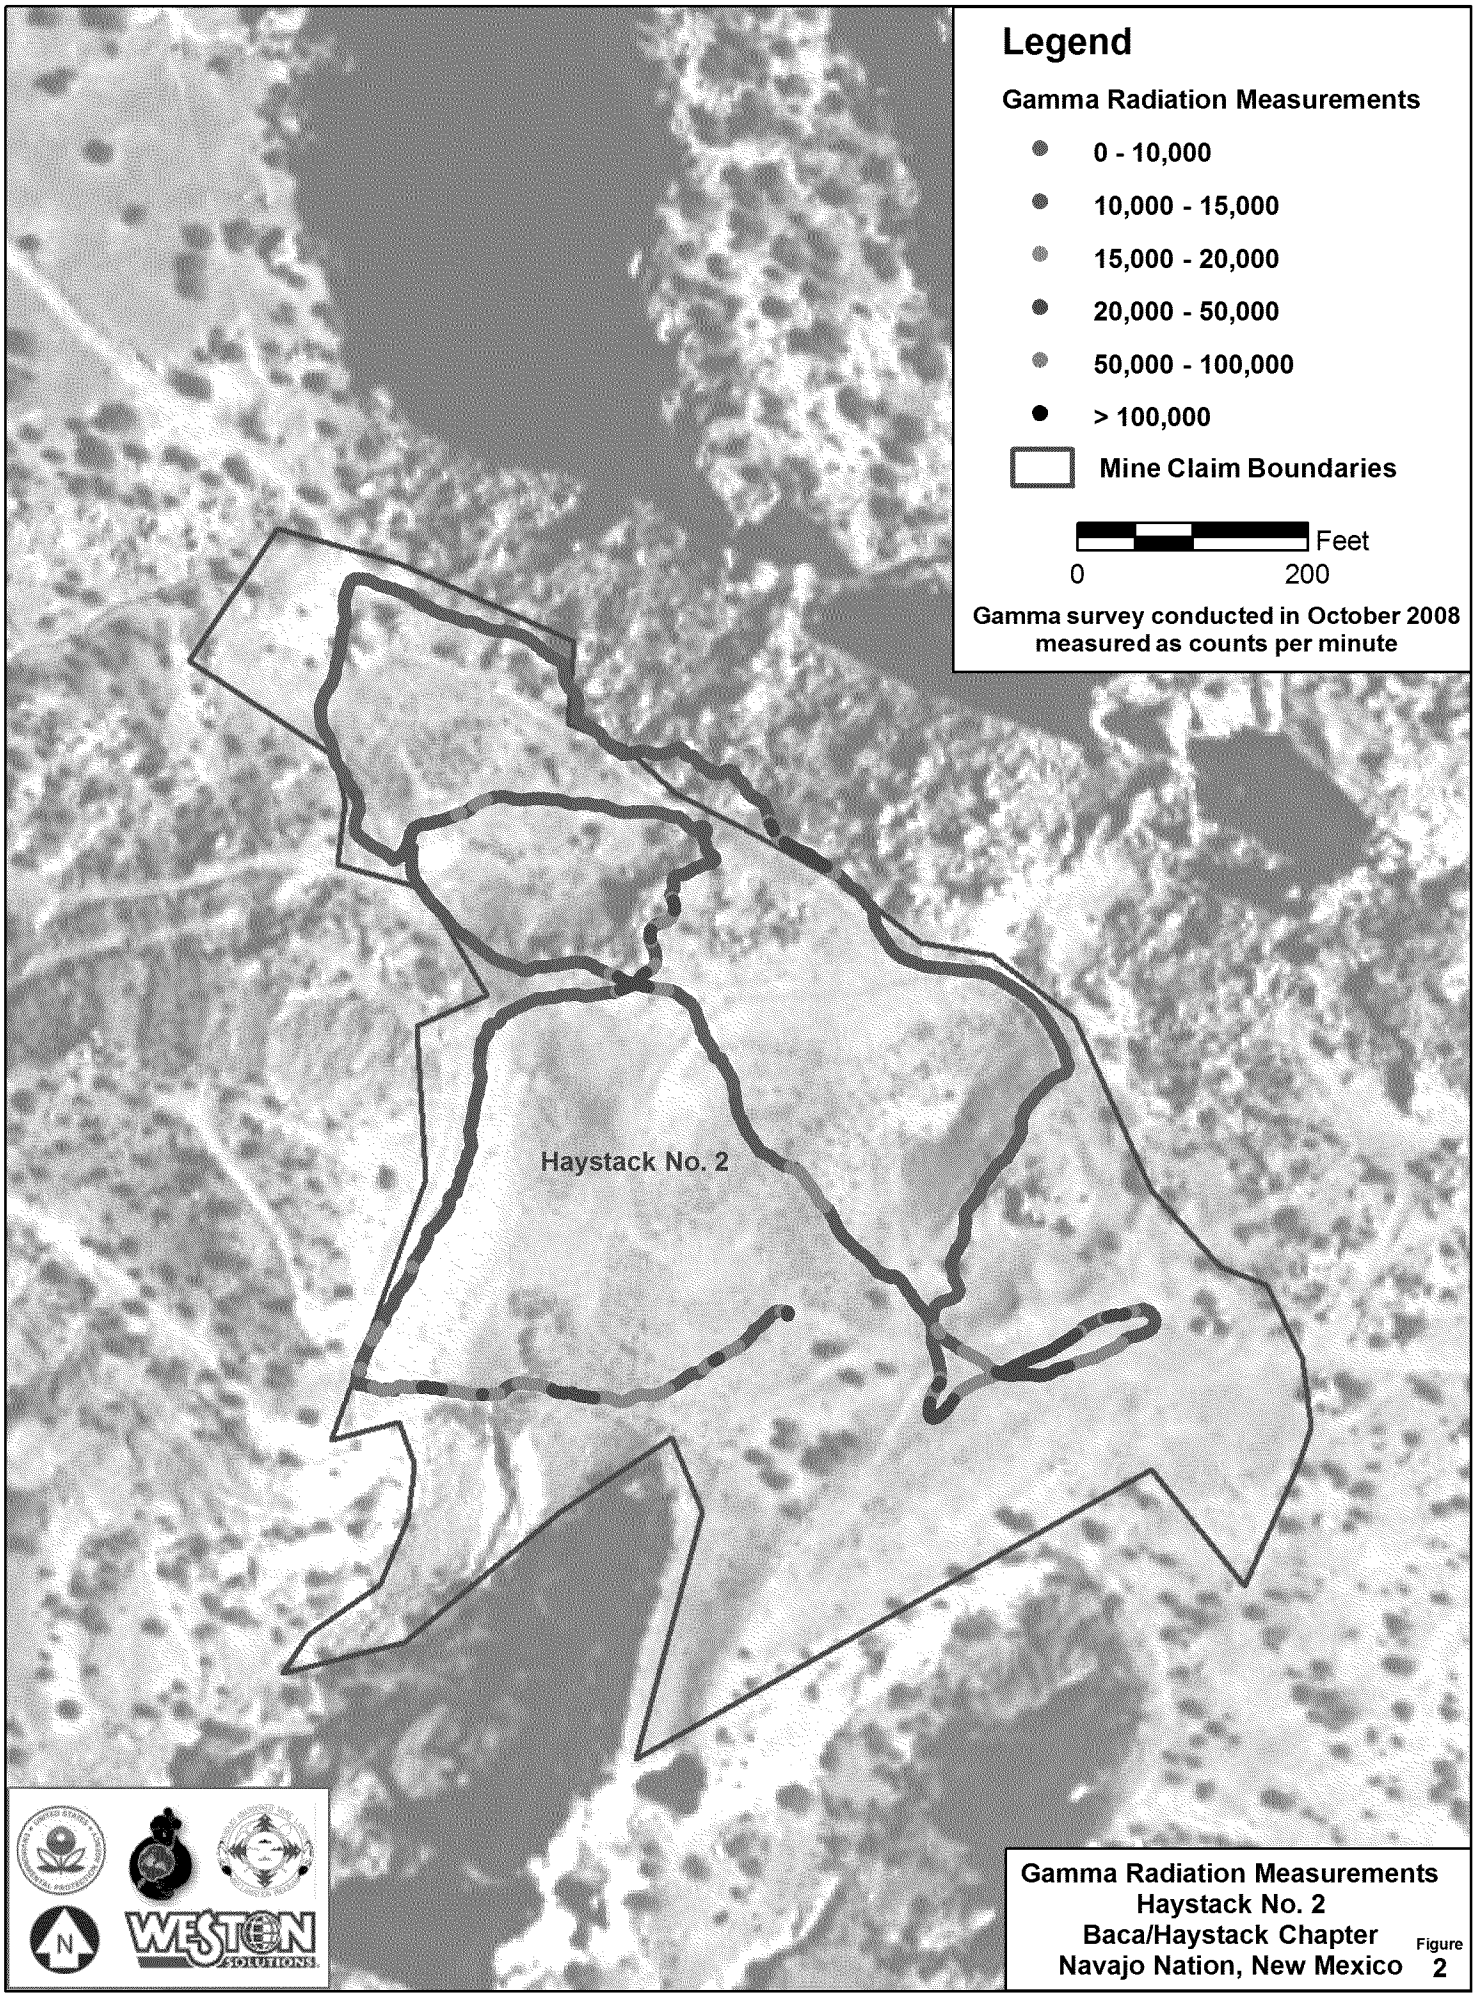
Figure 2

Gamma Radiation Measurements
Haystack No. 2
Baca/Haystack Chapter
Navajo Nation, New Mexico
